Pacific Safety of Navigation Project

Risk assessment for the Port of Honiara, Solomon Islands

April 2019

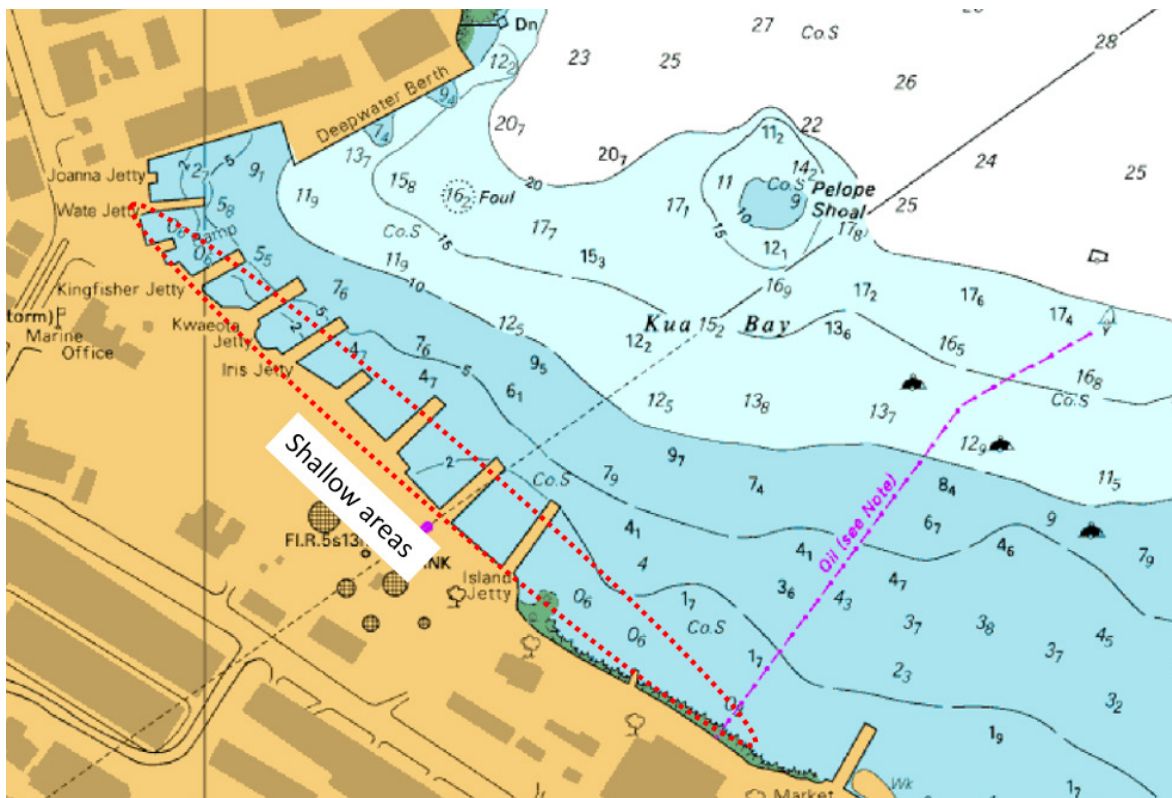
The domestic wharf area is very shallow along the shoreline. This causes domestic ships to ground, and also damages them through pounding against the hard bottom, especially during bad weather conditions.

It is recommended that SIPA dredges the shallow areas of the domestic wharf to 5 m (as vessels accessing the domestic wharf have drafts less than 5 m).

No costing was supplied for the dredging of the shallow areas, but a suggestion to use an excavator was made by the SIPA Engineering Department, with an approximate cost of SBD 4 million.

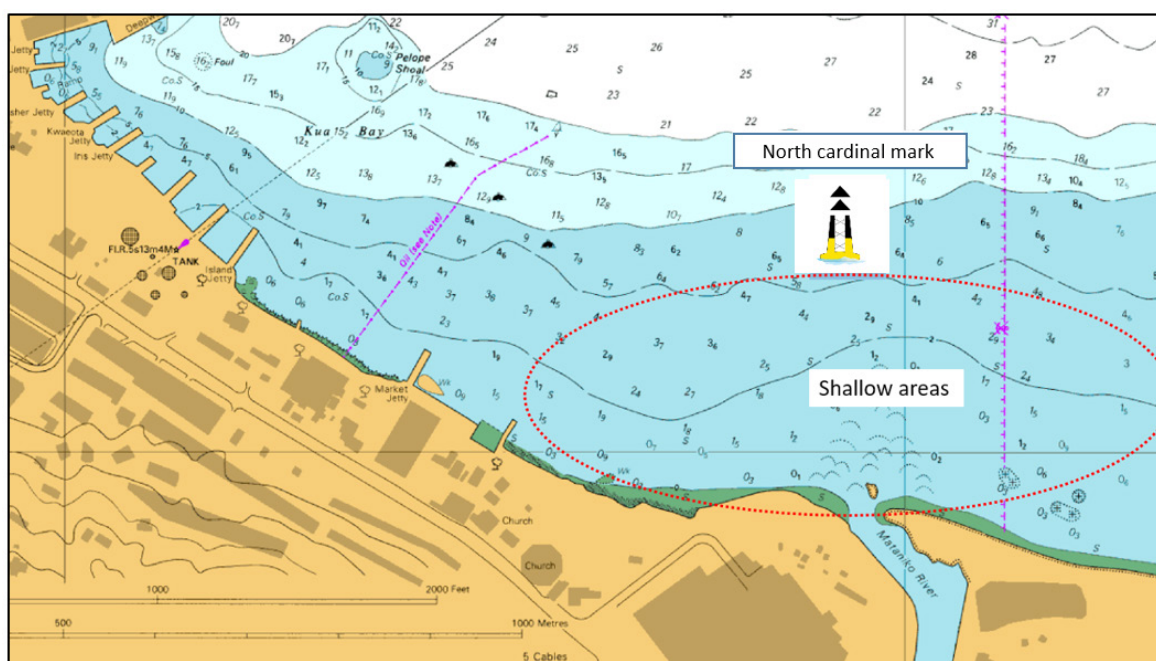
The Mataniko river mouth located to the east of the domestic wharf is very shallow. During rainy seasons, debris flows from the river and causes siltation around the approaches to the domestic wharf, in the manoeuvring area.

It is recommended to install a north cardinal mark to alert to the danger, and the safe area. A second option is to dredge the manoeuvring area down to at least 4 m so that local vessels accessing the area can safely manoeuvre without grounding.

No cost was provided for dredging. The cost for a cardinal mark was provided by SIMA as follows:

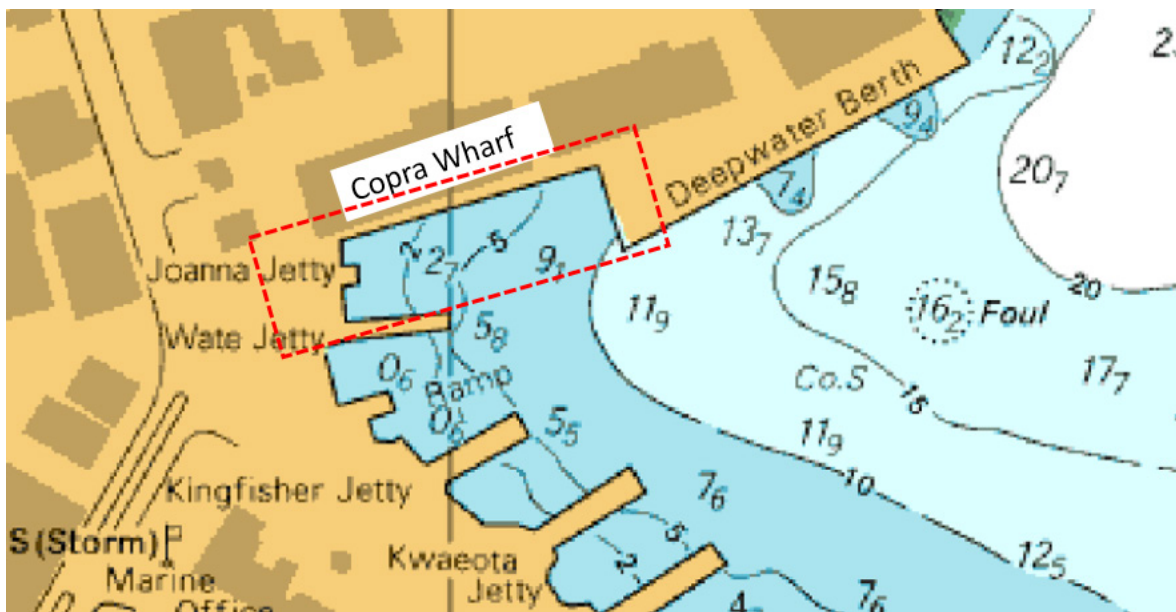
When international vessels are docked at Wharf 1, it is hazardous for vessels to access the copra wharf. It is particularly hazardous when the large vessels have their propellers running.

It is recommended that SIPA allows only certain categories of ships to access the copra wharf when international ships are docked at Wharf 1. The harbour department should also ensure no movement of vessels when an international vessel is operating. Awareness campaigns could help local users of the copra wharf to understand the hazard.

There is no capital cost to implement this recommendation. These measures can be part of the port security operations when international vessels are at berth. Port security procedures should be amended to include this.

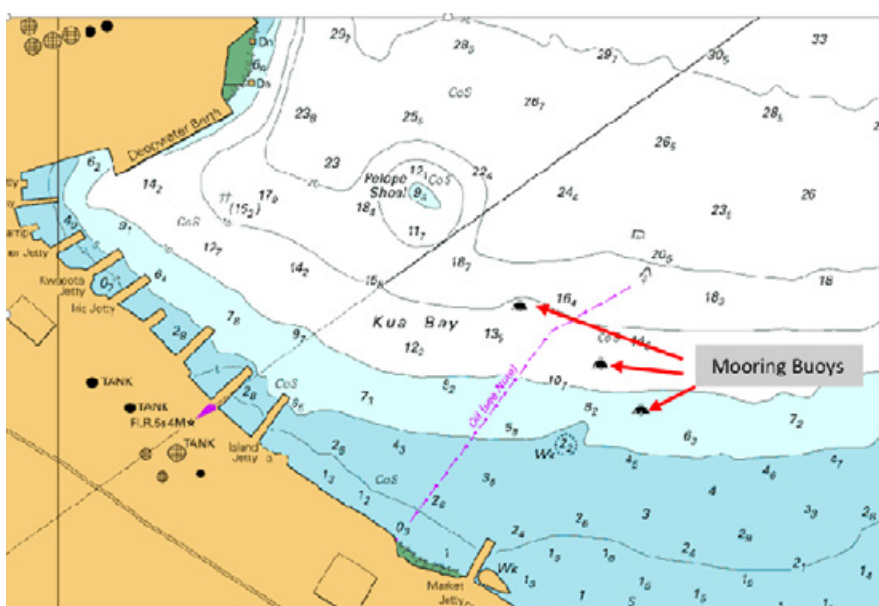
There are three mooring buoys near the oil pipeline, around the manoeuvring area to and from the domestic wharf, which are not lit and therefore not visible at night. There is also a small buoy marking the end of the oil pipeline that is not lit. These represent a hazard during night navigation.

It is recommended that the three mooring buoys are fitted with reflective tape and the buoy marking the end of the oil pipeline is lit.

The costs to implement this recommendation were supplied by SIMA as follows:
