Household Survey to Assess Vulnerabilities to Water Resources and Coastal Erosion and Inundation

Lifuka, Ha'apai, Tonga

SPC SOPAC DIVISION TECHNICAL REPORT

Secretariat of the Pacific Community
Suva, Fiji
March 2013

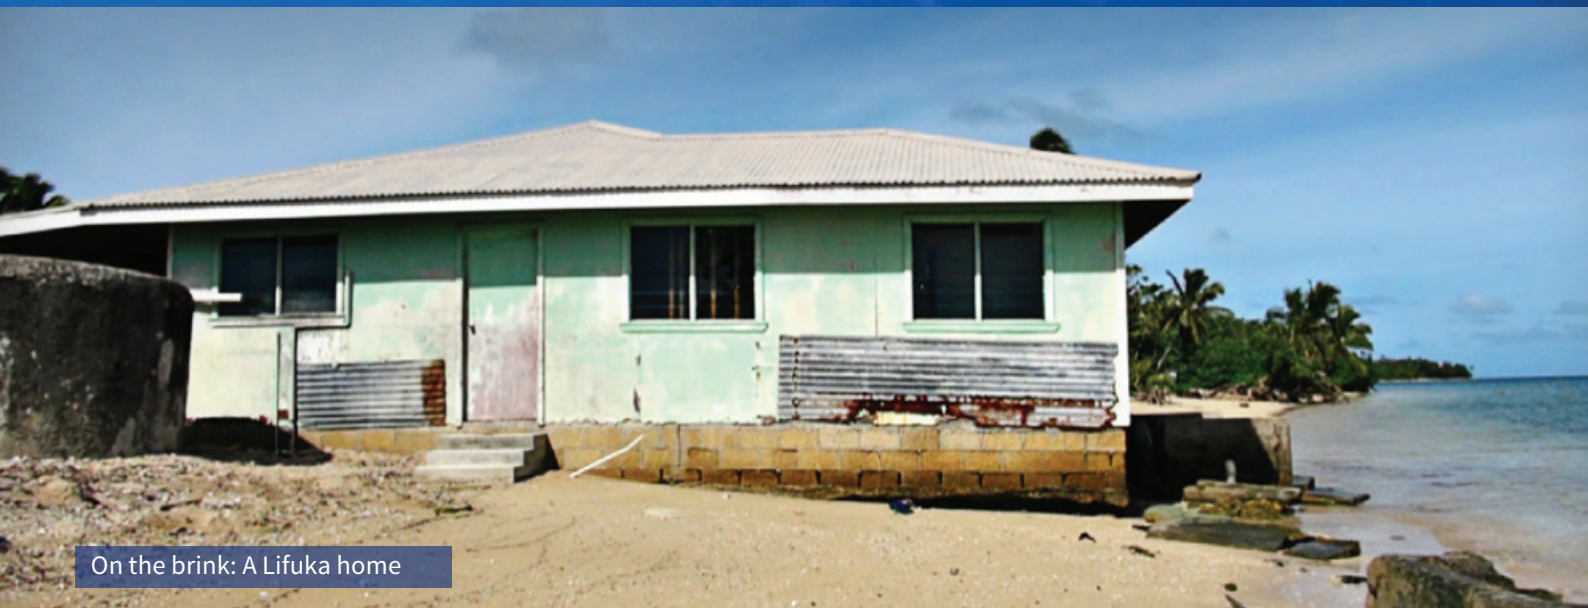
On the brink: A Lifuka home

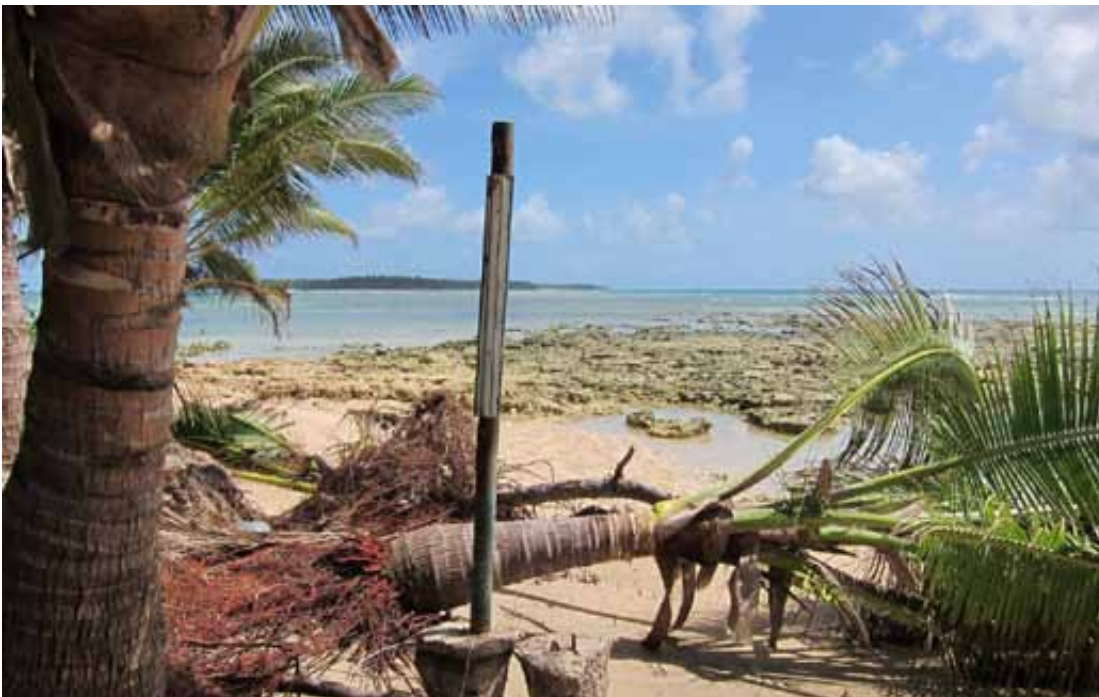
Figure 3. Erosion on the Lifuka coast, southern end of Lifuka, after Cyclone Cyril, February 2012

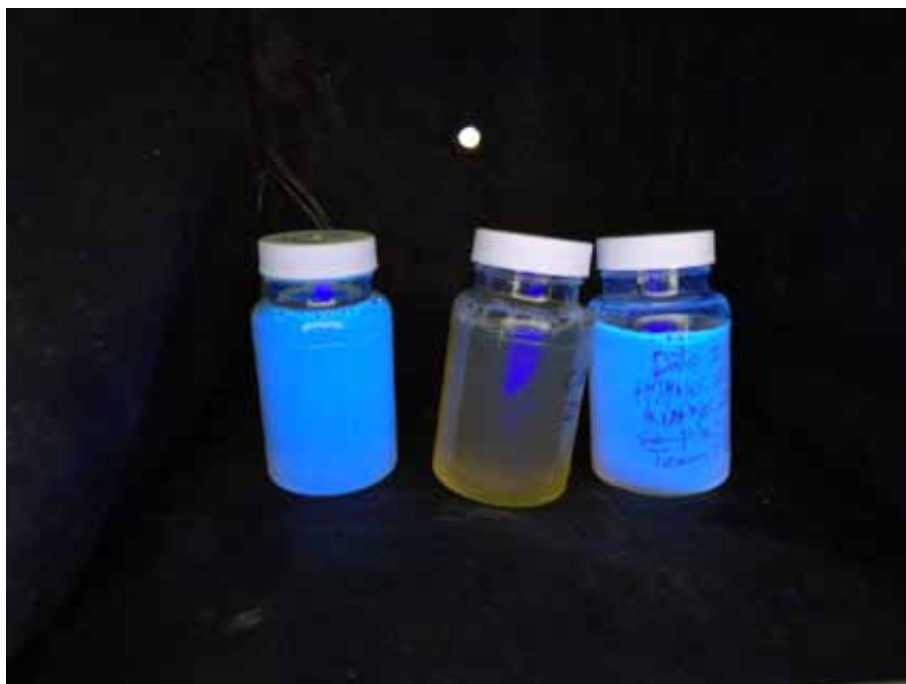
Figure 23. Water sample test results (fluorescence indicates the presence of *E. coli*)

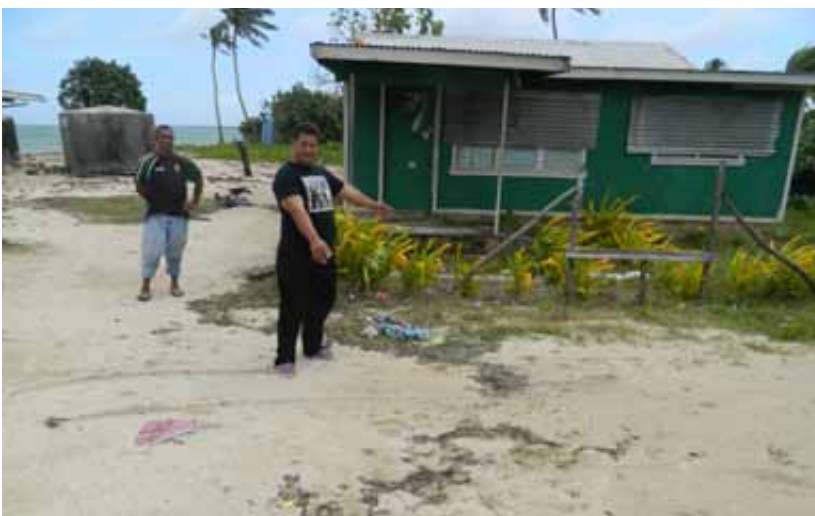
Figure 26. Example of the debris line resulting from coastal inundation in the aftermath of tropical cyclone Cyril (February 2012)

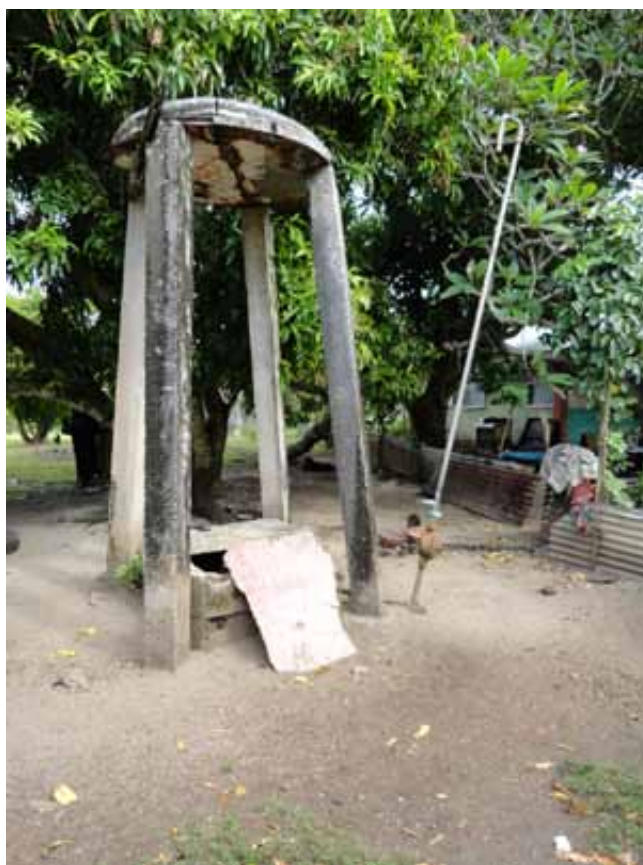
Figure 60. Domestic well in Hihifo, Lifuka, in use, where the manual pump and header tank have been replaced with a bucket

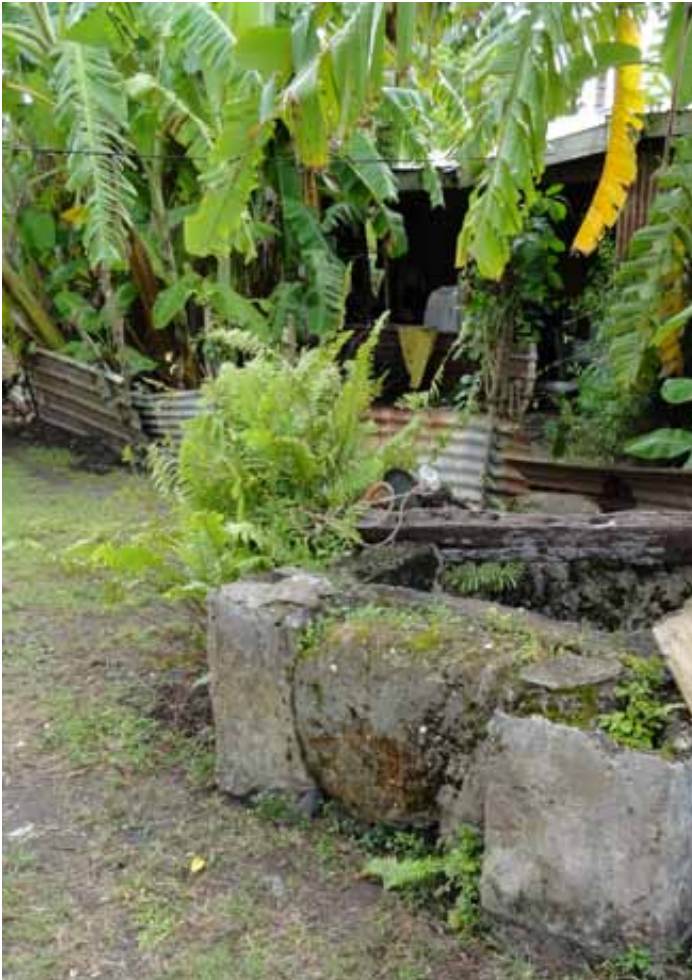
Figure 66. A typical uncovered well on Lifuka

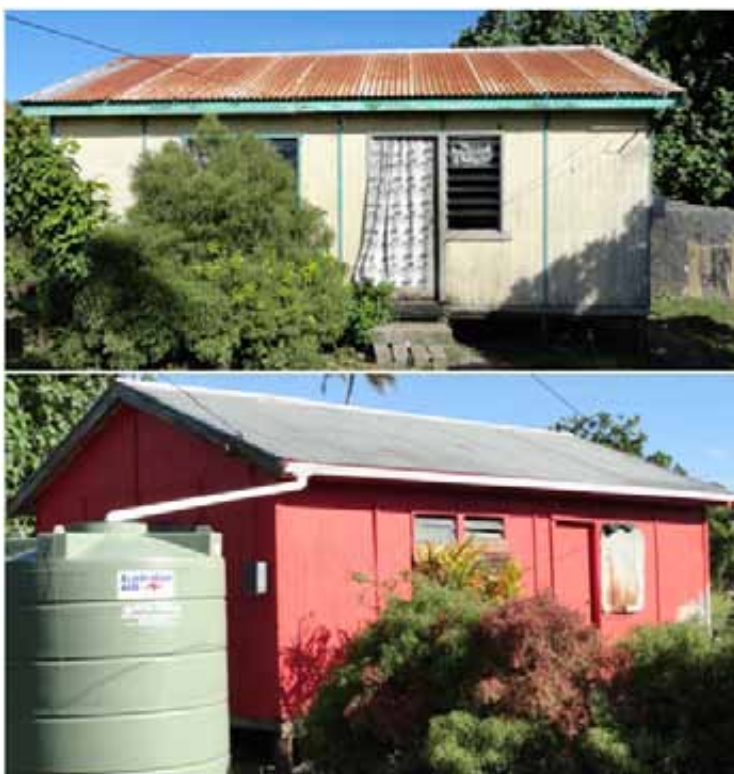
Figure 2. A rusted roof (top) and one in good condition

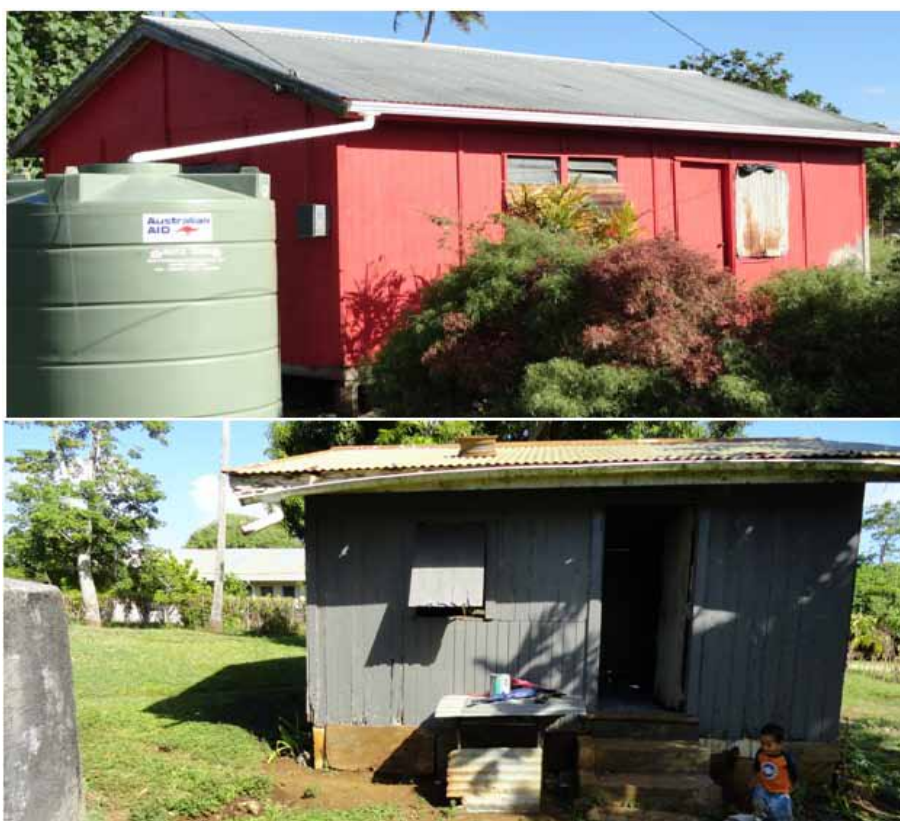
Figure 3. A good rainwater harvesting system (top) and a poor rainwater harvesting system

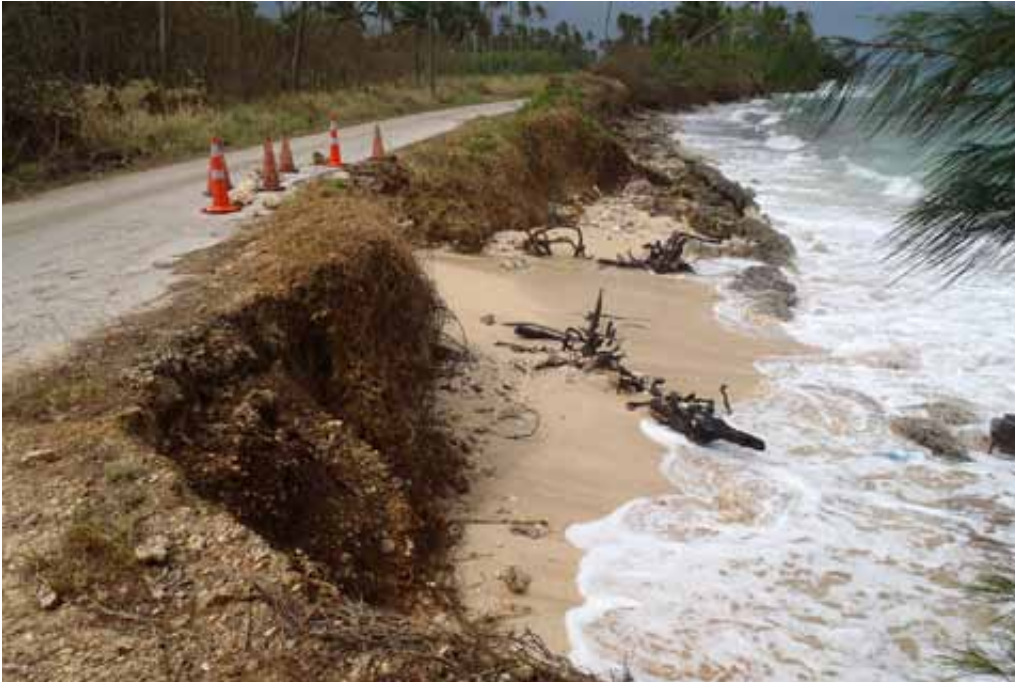
Figure 13. Road in Lifuka affected by coastal erosion following TC Jasmine

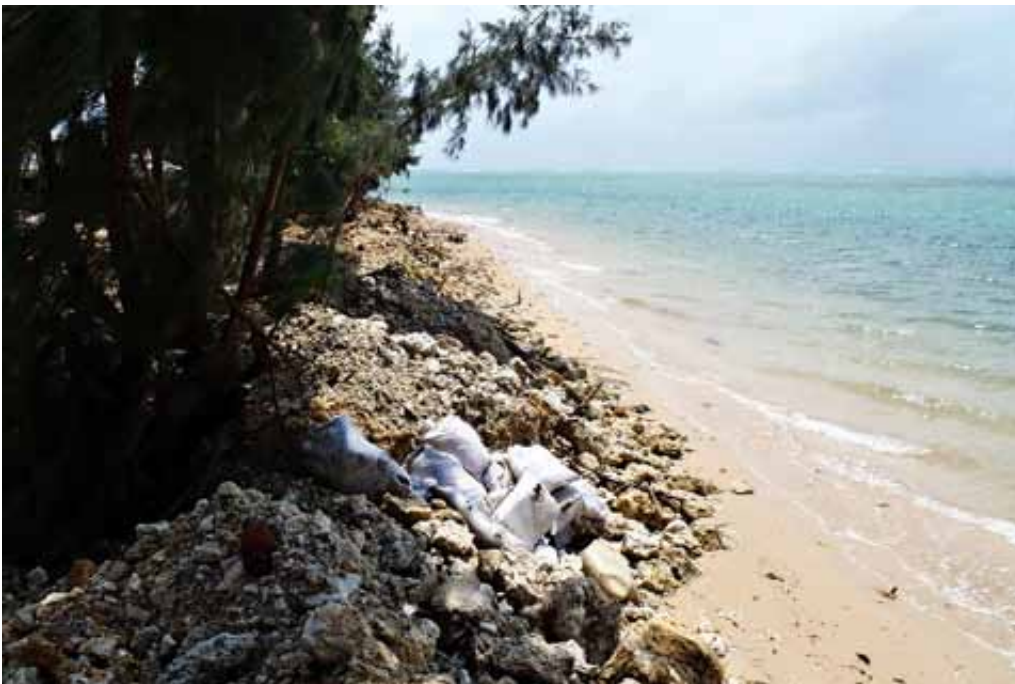
Figure 14. Damage to coastline after TC Jasmine

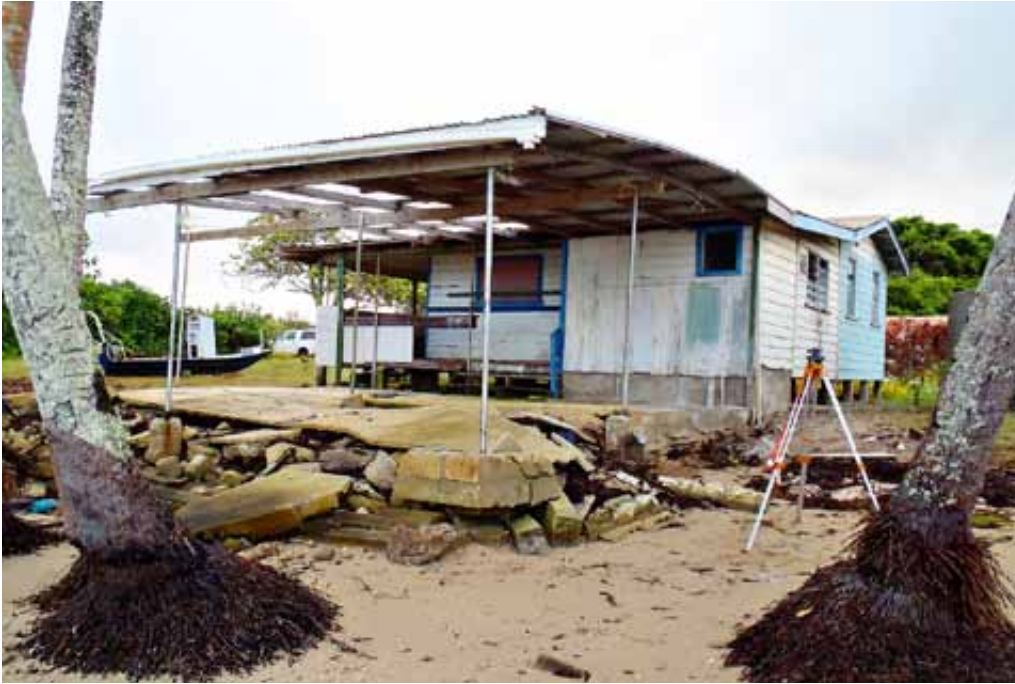
Figure 15. Damage to a house on the coastline following TC Jasmine

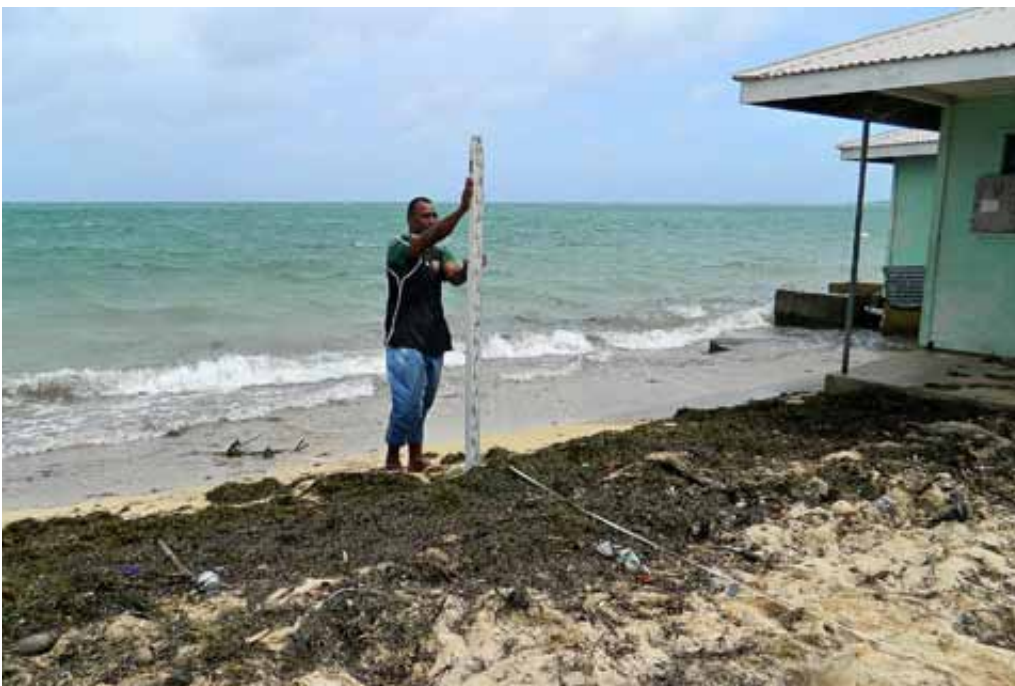
Figure 16. Inundated house following TC Jasmine

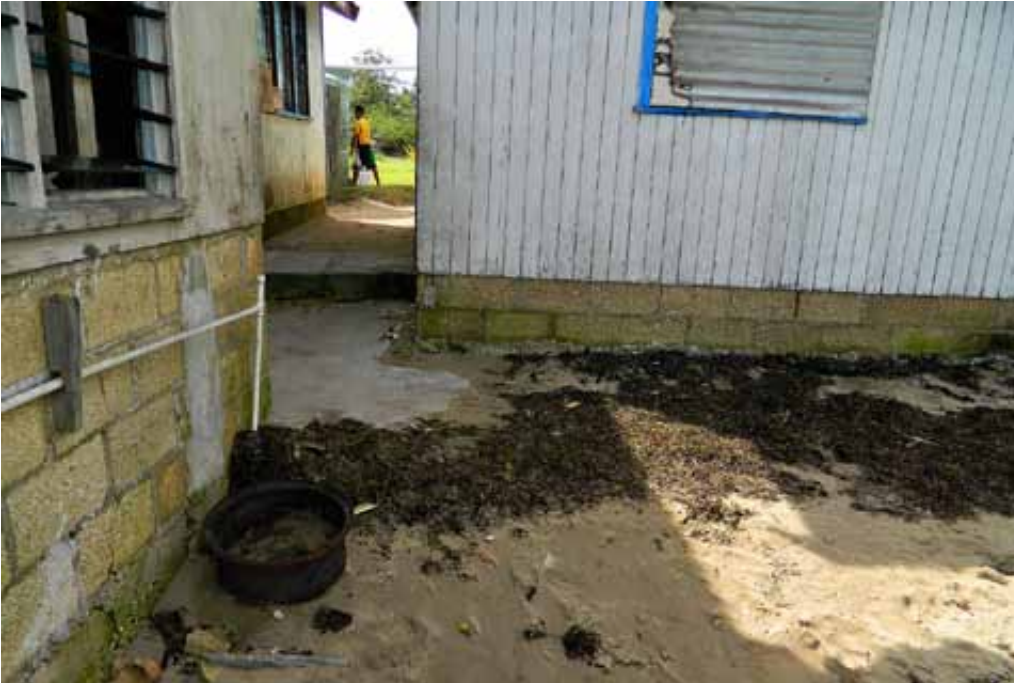
Figure 17. Marks of inundation by ocean waves

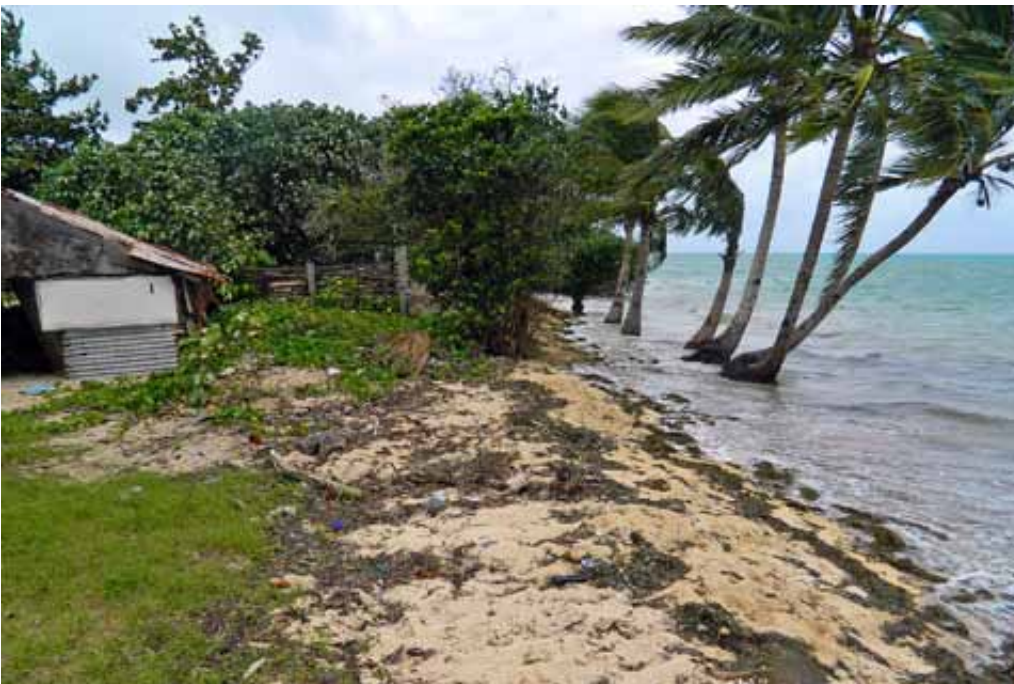
Figure 18. Inundated coastline

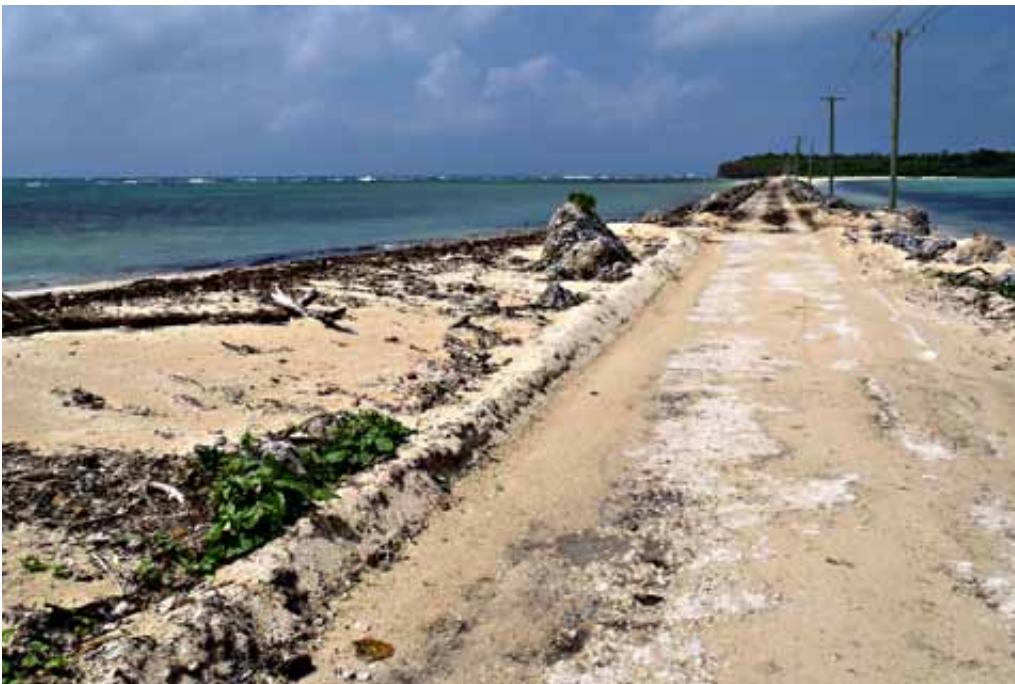
Figure 20. Causeway following TC Jasmine
