Climate and Abstraction Impacts in Atoll Environments (CAIA)

Flow meter testing, Buota and Bonriki Water Reserves,
Tarawa, Kiribati

Geoscience Division of the Pacific Community

(SPC Technical Report SPC00050)

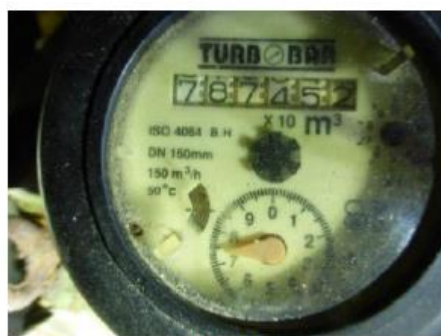
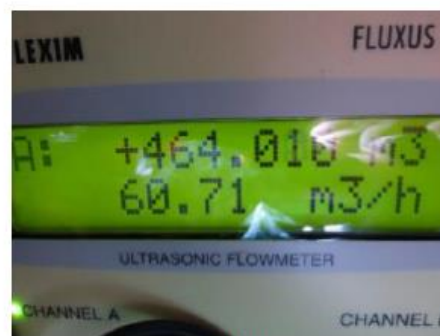
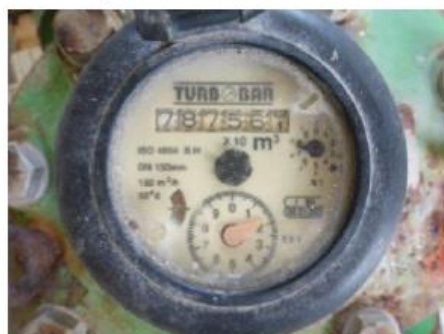
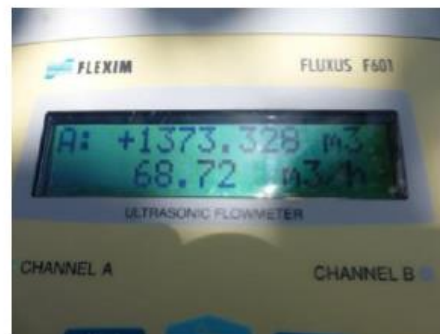
Figure 2: Water meter accuracy test at the Bonriki WTP main meter (Schwalger & Skerjanz, 2014).

Discharge recorded by - installed meter	Discharge recorded by ultrasonic flow meter	Difference	Difference in %
1,085.433	909.312	176.121	16.23%

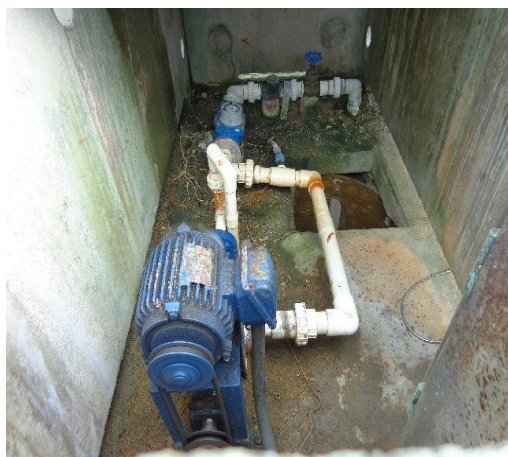
Figure 6: Typical layout in a gallery pump house, comprising the pump motor, FFM, non-return valve and a gate valve. The numerous pipe bending and connections are likely to cause turbulent flow and generate erroneous flow readings.

The improvement of FFM installation and set up as per the manufacturer's specification is critical to permit the optimum performance of flow meters. This may include the modification of pipe work in the gallery pump house to reduce turbulent flow, whilst consideration should also be made on the replacement of pumps at galleries where increased abstraction was recorded.

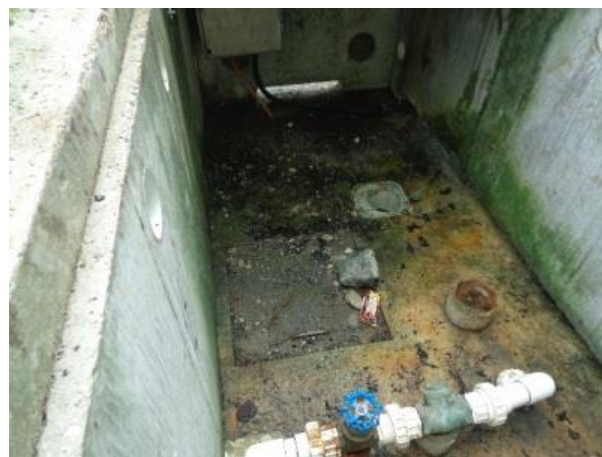
Figure 9: Gallery 2 showing no pump due to previous electrical failure.

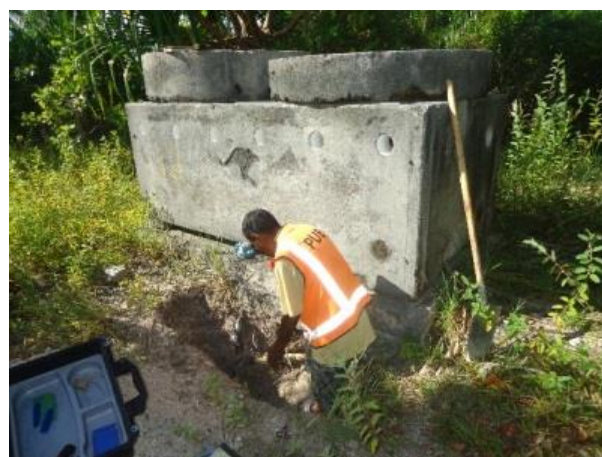
Figure 11: PUB personnel setting up UFM at gallery 12. Note that access into the pump house was prevented by the two concrete slabs.

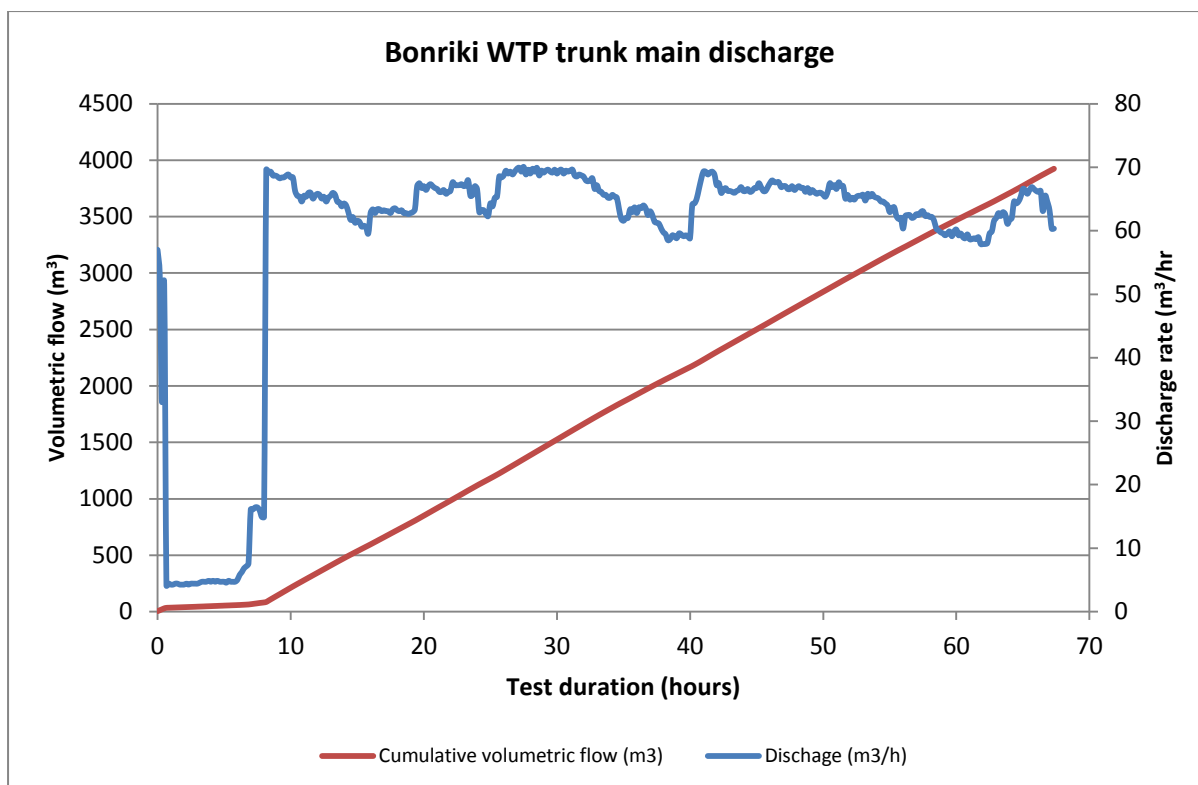
Figure 14: Water flow discharge and cumulative volumetric flow measured at the Bonriki WTP main, commencing at 2.54 pm on Friday, June 12th, 2015.

- The significant flow reduction in the early stage of the tests attributed to the accidental bursting of one of the pipes connecting galleries 4, 5 and 6, by the bulldozer for the nearby solar project.
- The main meter was tested for more than 60 hours as opposed to the agreed 48 hours to accommodate delays in both the meter testing at the Buota main (which commenced a day late) and the digging of gallery drainage pipes on Monday morning.

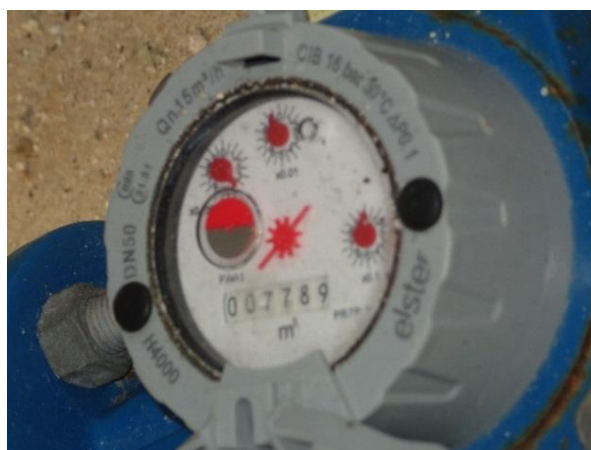
⁵ Pump at gallery 12 was not working even though the motor was on

Figure 20: FFM at gallery 12 showing 7789.994 m³ several minutes after photo at Figure 17 was taken, indicating that there was no water flow and suggesting that the pump may not be working, even though the motor was on.

The Bonriki galleries 1, 2, 3, 12, 16 and 18 will need to be retested to ascertain accurate registration of abstraction and flow-variability data, whilst several gallery pumps will need to be replaced and adjusted to perform within the safe yield parameters of each site. It is also suggested that the Buota galleries be tested to determine the actual abstraction data and flow variability within the Buota water reserve.

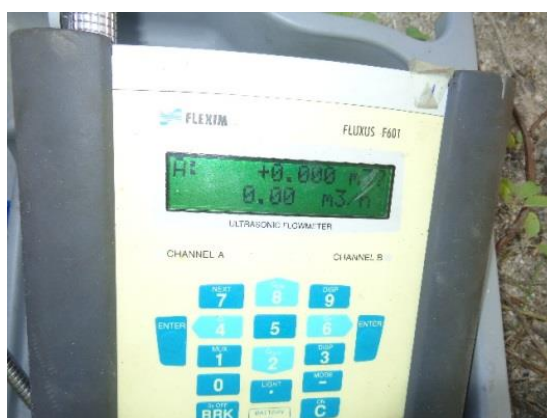
Figure 21: UFM displaying 0 volumetric flow and 0 discharge rate at gallery 12 suggesting that the pump may not be working even though the motor was observed to be on.

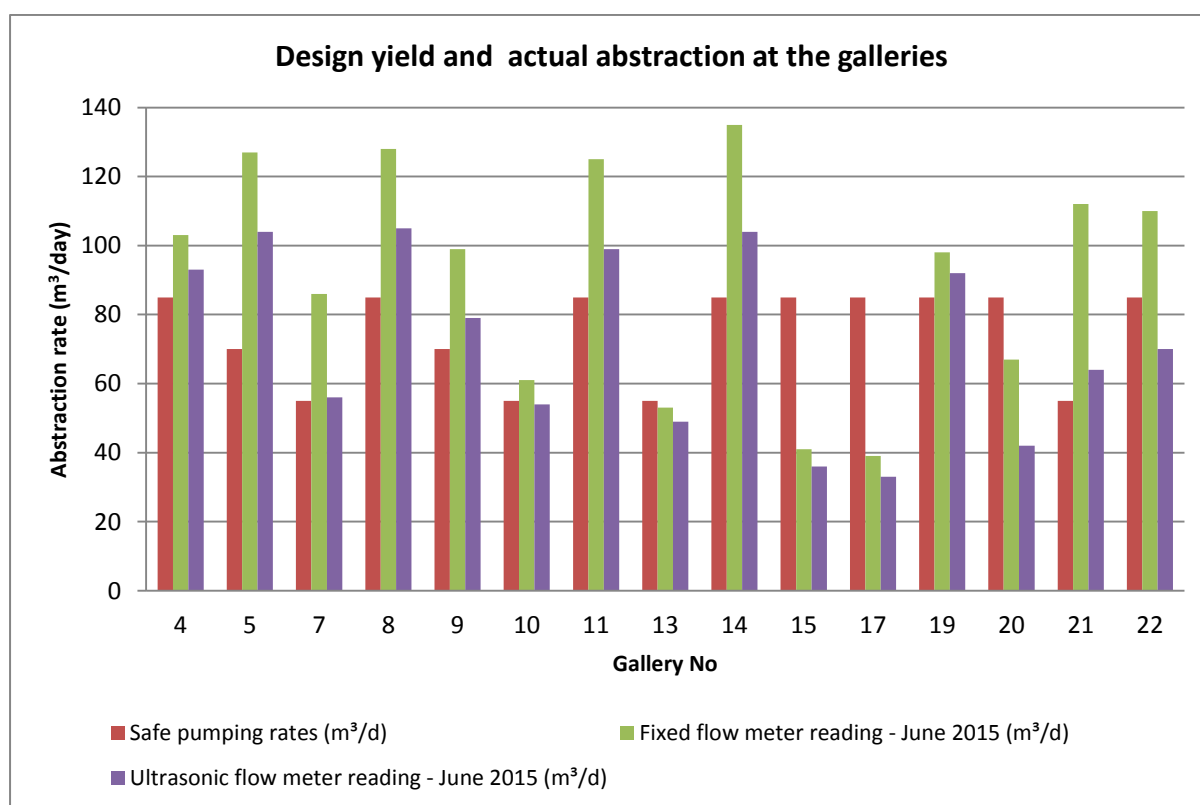
Figure 22: Design yield versus actual flow rate at the tested galleries showing increased abstraction at 9 galleries based on UFM readings.

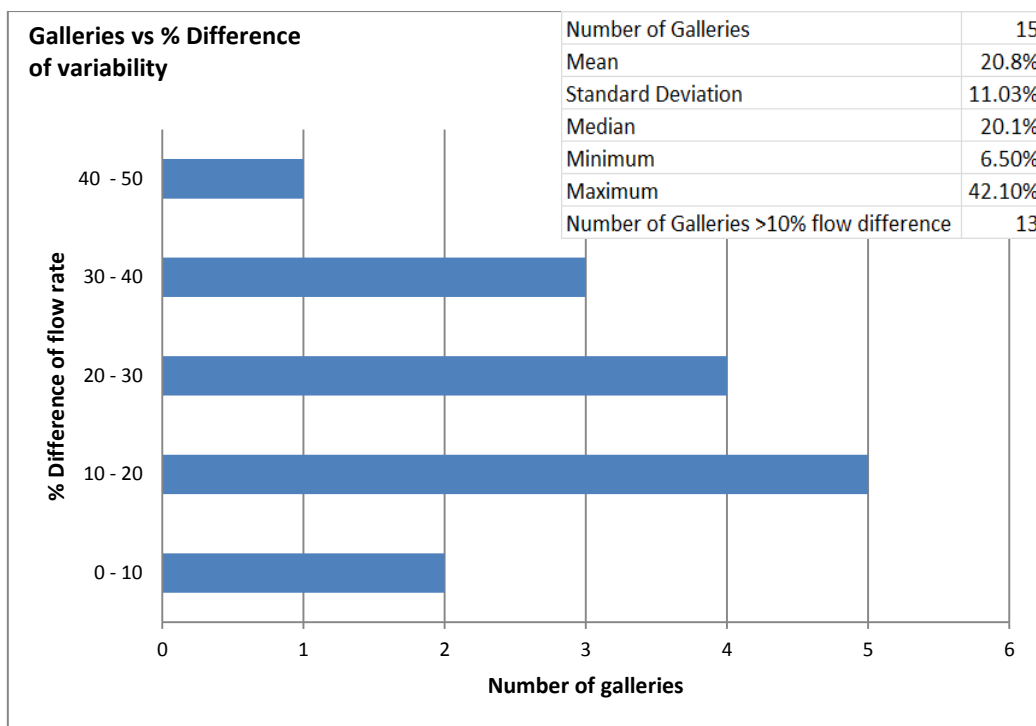
Figure 23: Statistical analysis of tested galleries in Bonriki showing more than 85% of the tested gallery meters showing flow discrepancy of more than 10%.

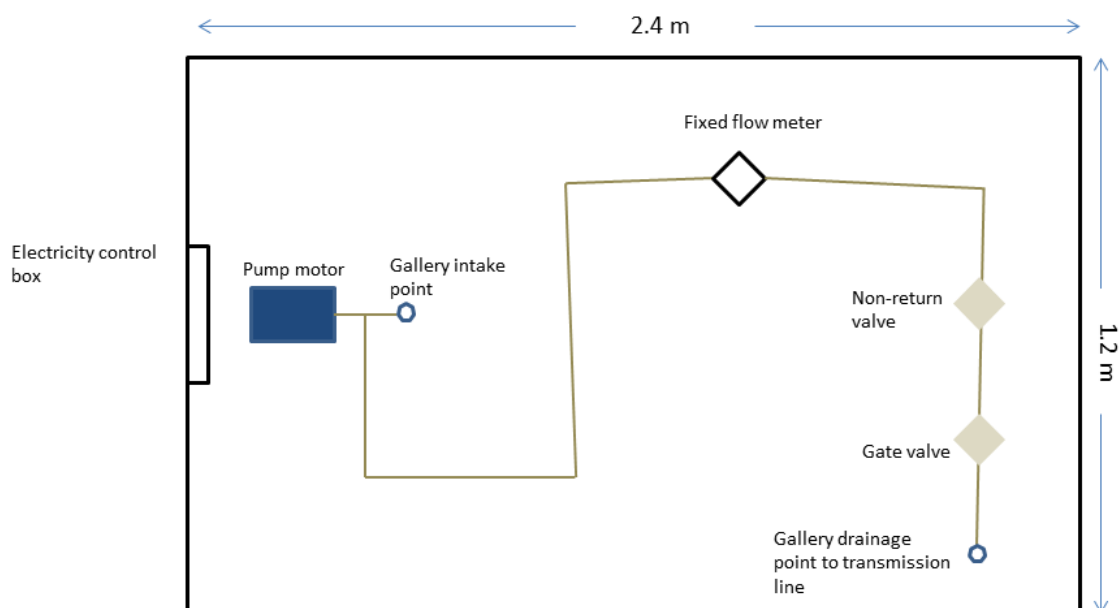
Figure A3.1: Current piping layout in the gallery pump-house with numerous connections and bending, yielding highly turbulent flow, a contributing factor to flow over-reading at the FFM.

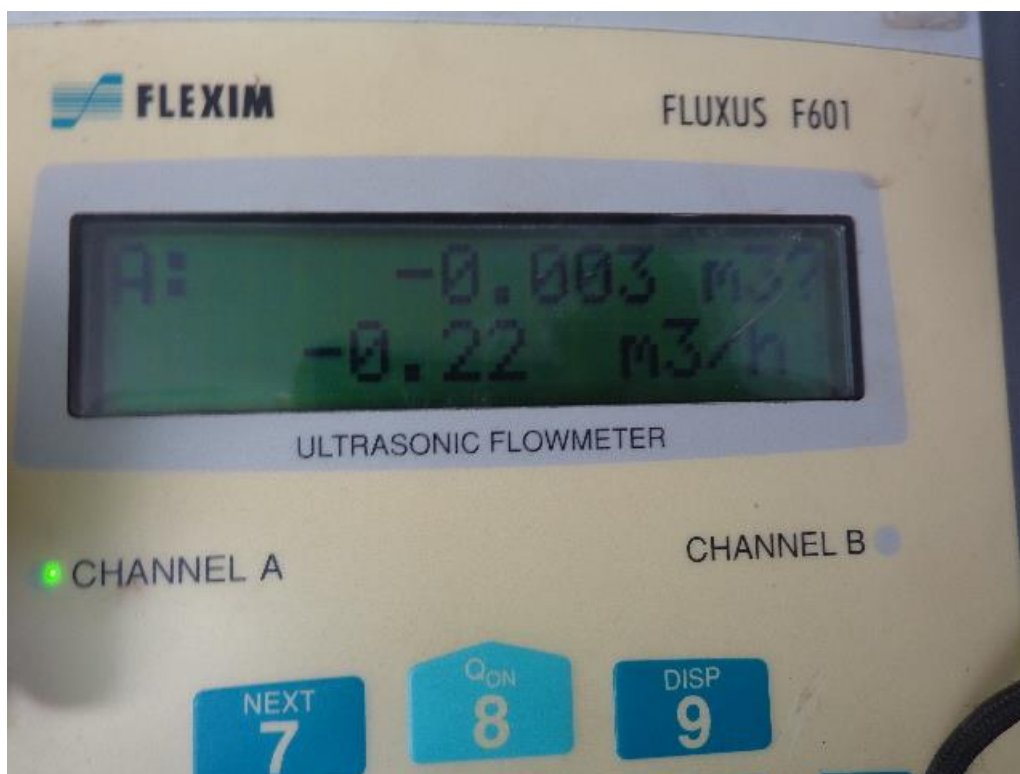
Figure A4.5: UFM showing $-0.022 \text{ m}^3/\text{h}$ at gallery 16 suggesting flow in the opposite direction.

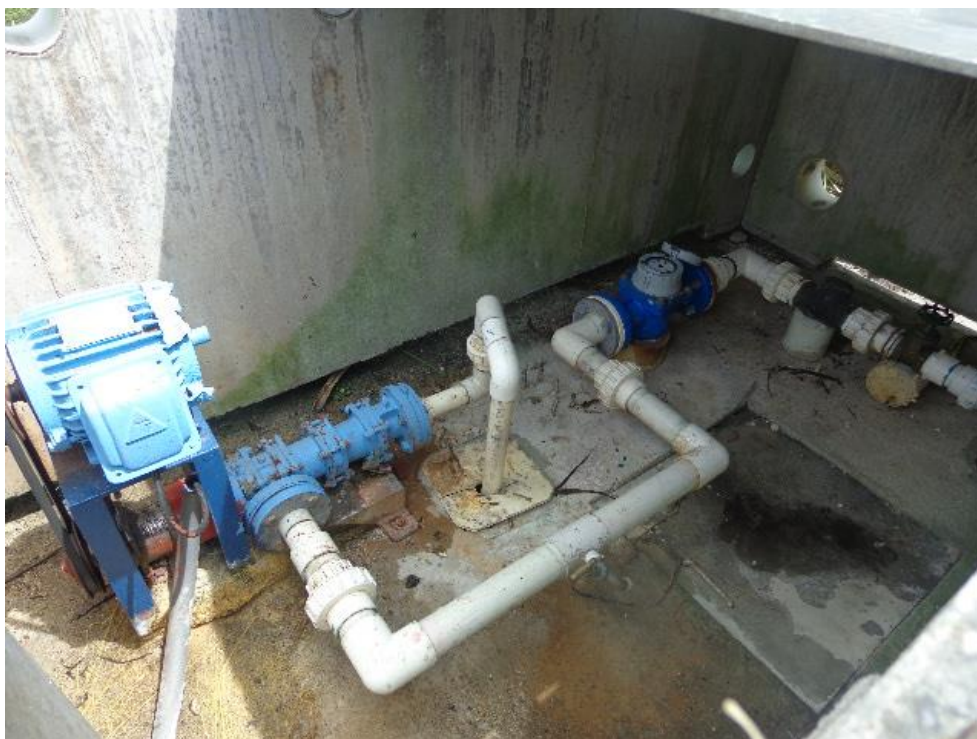
Figure A4.6: Typical pipe work set up in the gallery pump house characterised by numerous bending and connections and causing highly turbulent flow. These will need to be modified to allow more pipe length before the FFM installation to allow more laminar flow and to permit the accurate estimation of discharge flow.
