KIRIWATSAN

Water Resources Assessment

BERU ISLAND, KIRIBATI

March 2015

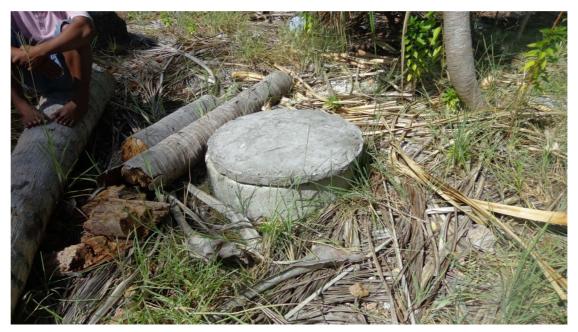
Figure 9. A communal well in Taubukiniberu Village, sited away from the residential areas and abstracted by multiple Tamana pumps.

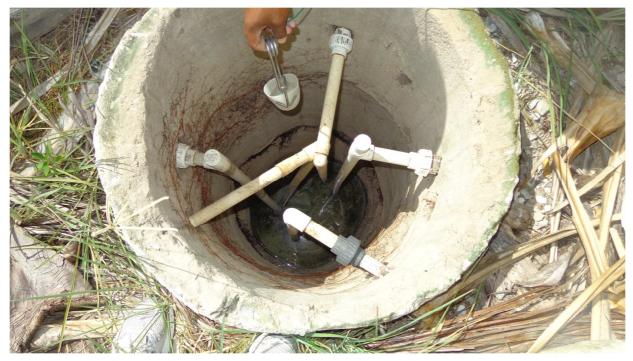
Figure 10. Multiple Tamana pumps installed in a communal well for Taubukiniberu Village.

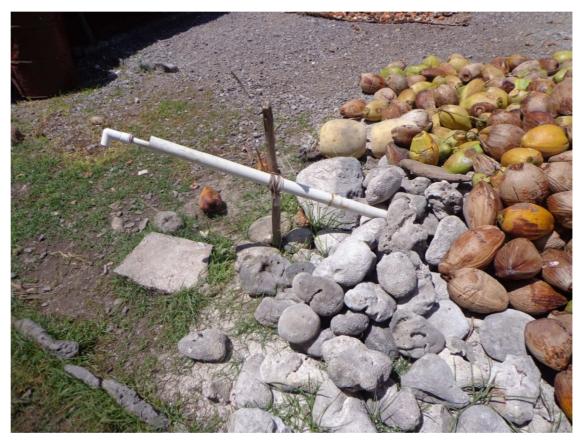
Figure 11. A Tamana pump connected to a completely covered well in Aoniman Village.

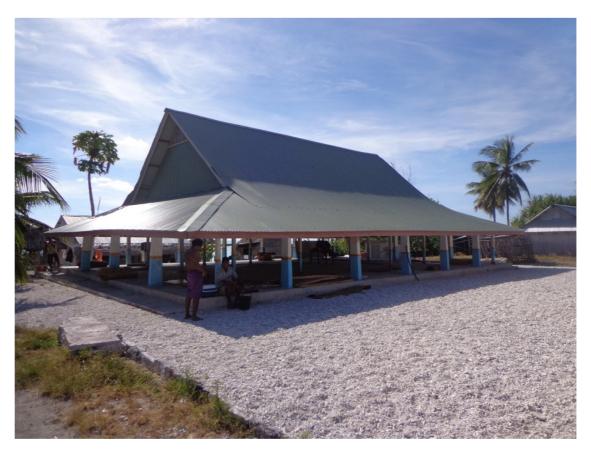
Figure 12. Aoniman KPC maneaba – *a target communal building for RWH.*

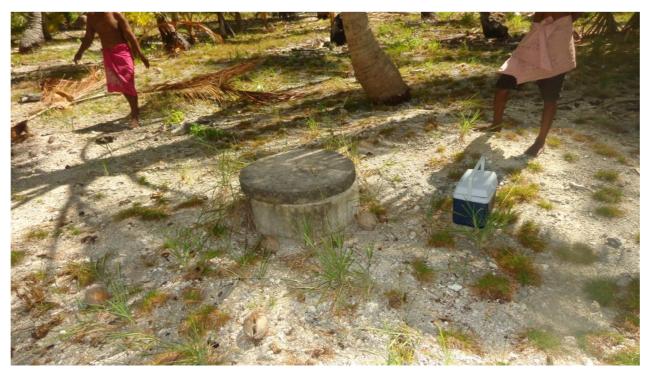
Figure A11-1. A covered communal well, abstracted by hand pump, Autukia Village.

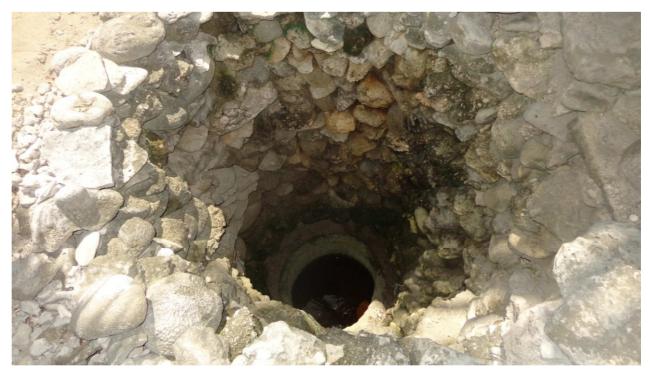
Figure A11-2. Well using both concrete rings and coral rocks as casing materials.

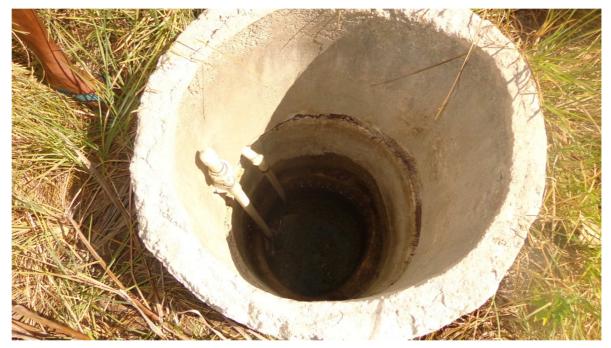
Figure A11-3. Multiple Tamana pump distribution lines from a communal well.

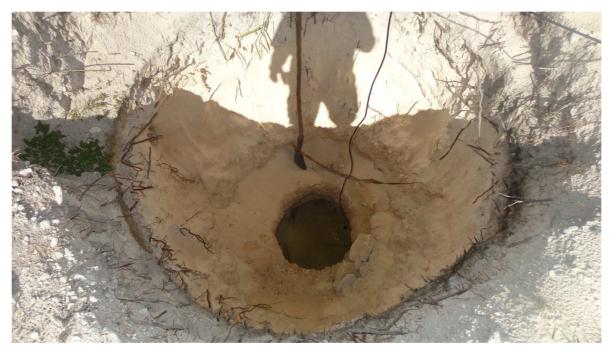
Figure A11-4. Example of an uncased well in Autukia Village.

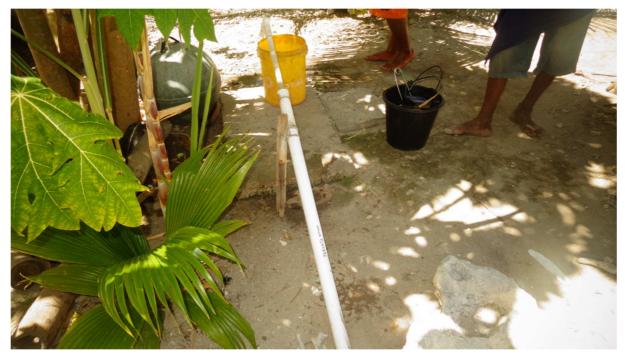
Figure A11-5. Tamana pump used in Tabiang Village.

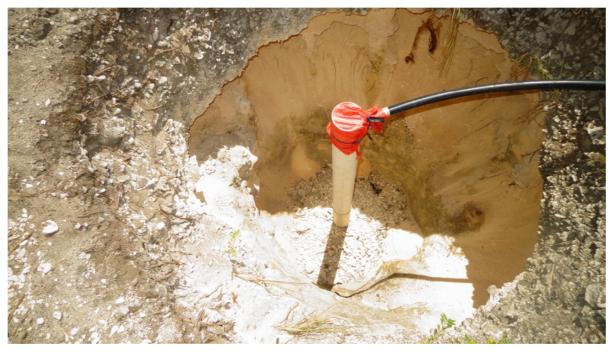
Figure A11-6. A partially buried well accessed by Tamana pump and using PVC pipe

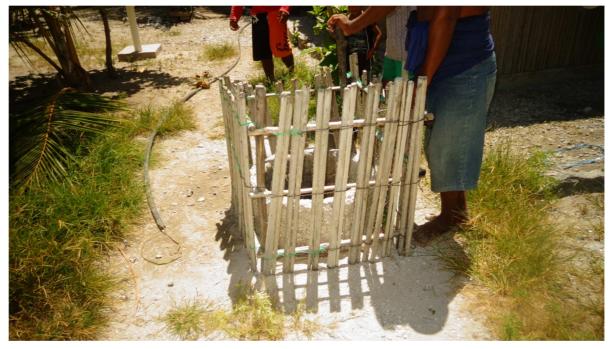
Figure A11-7. Example of timber fencing to regulate access to wells.

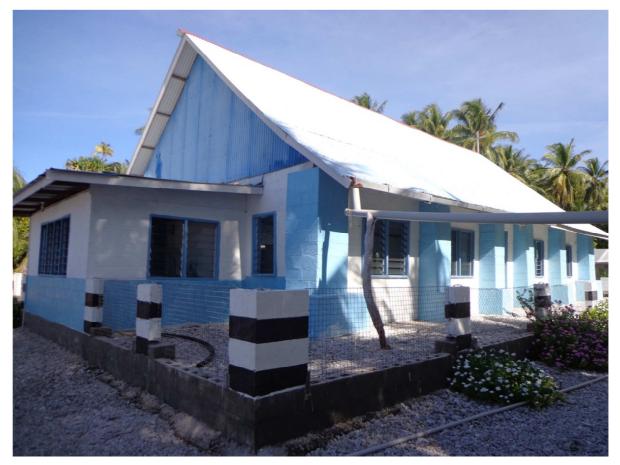
Figure A11-8. Catholic Church in Aoniman Village – a potential RWH centre.

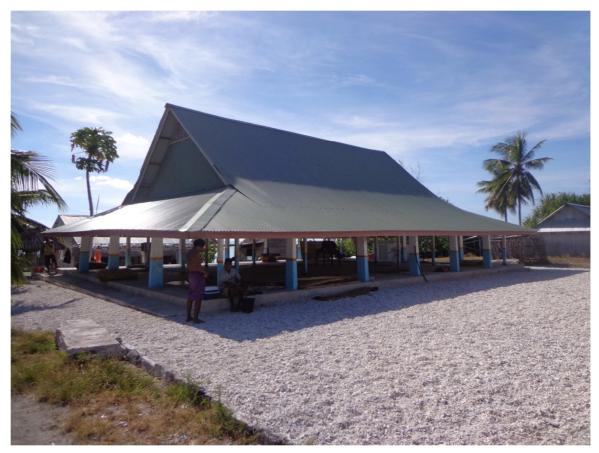
Figure A11-9. KPC maneaba *in Aoniman Village, a target RWH communal building.*

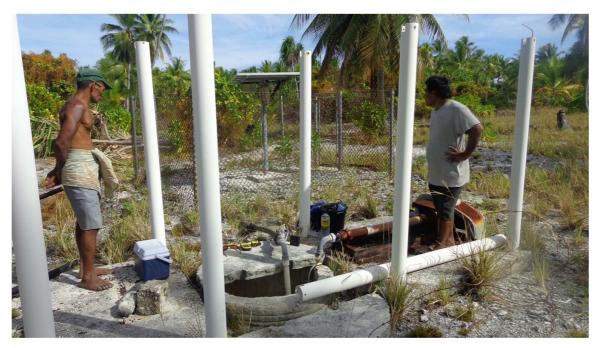
Figure A11-10. Solar pump system at Hiram Beigham High School serving the entire school and Rongorongo Village community. Note the new solar panel separately fenced in the background for security.

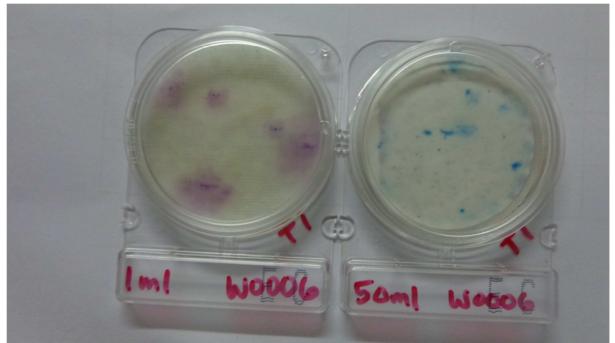
Figure A11-11. Example of compact dry plate of a groundwater well sample from Aoniman Village.
