# Pacific Safety of Navigation Project

## Risk assessment for Luganville harbour, Espiritu Santo, Vanuatu

Francesca Pradelli and Salesh Kumar

Suva, Fiji, 2020

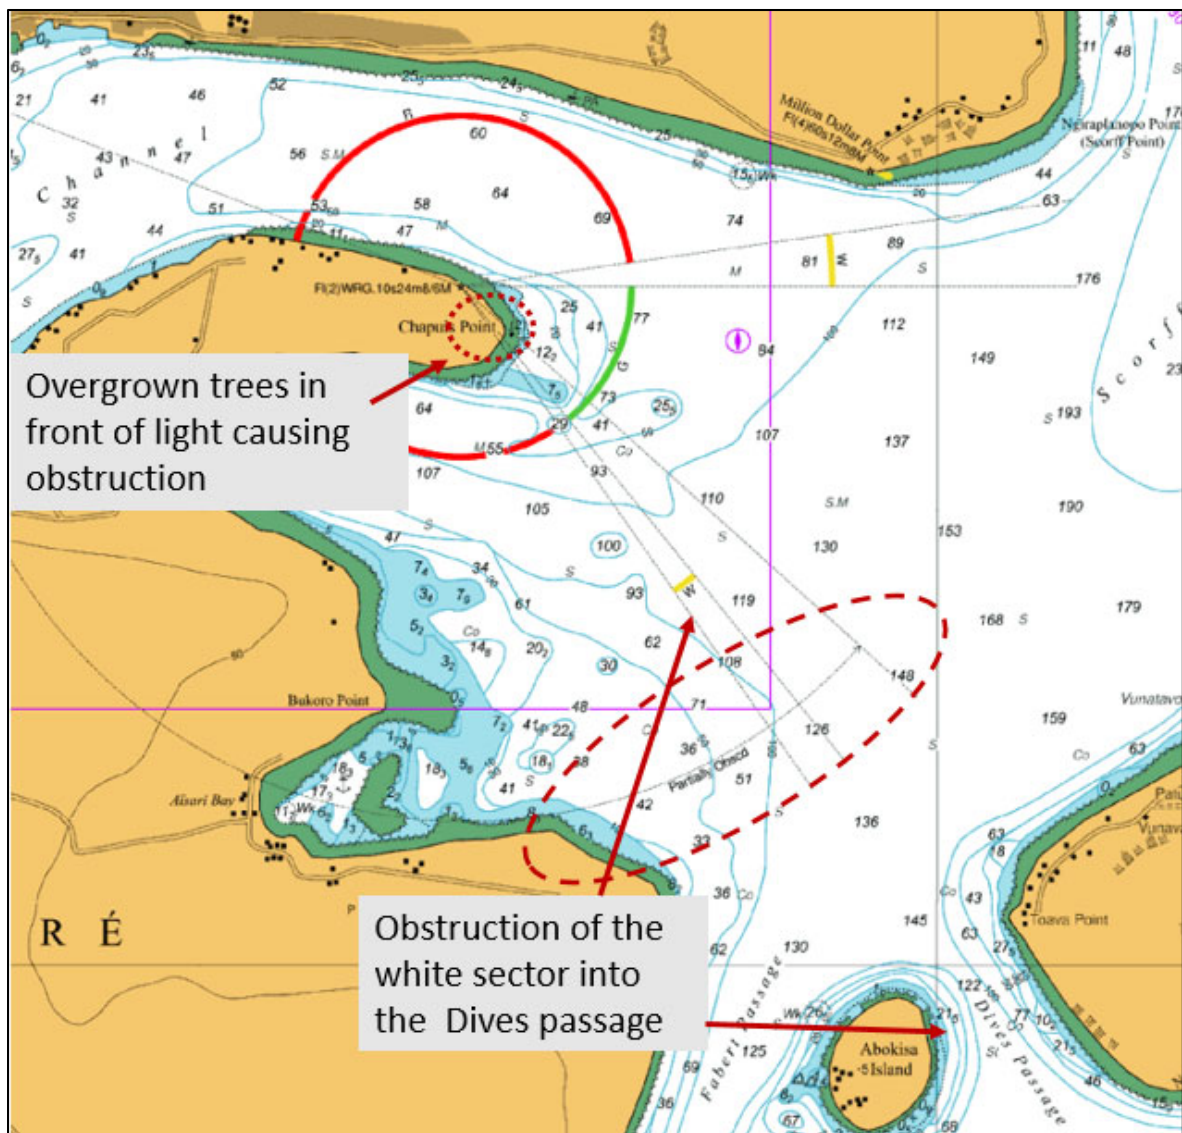
Figure 4:. Chart BA 138\_1 showing the sector light obstruction details

This recommendation addresses potential grounding of domestic vessels at night on the east coast of Aore Island and on Guyon Reef at the Mel Cofe wharf. This is mainly due to the lack of AtoNs and to land issues. There is an area of overgrown trees in front of the Aore east (Chapius point) light that obstructs the light into the Dives Passage. The light from Aore west is also obstructed by vegetation growth, obstructing the light into the Georges Philippar Passage. The following recommendations are made:

Recommendation	Amount (vatu)
5. Acquisition by the government of the land title so that trees that obstruct the sector light on Aore east can be cut (Figures 1 and 4).  Latitude: 15-32.004234S; Longitude:167-12.832535E	0

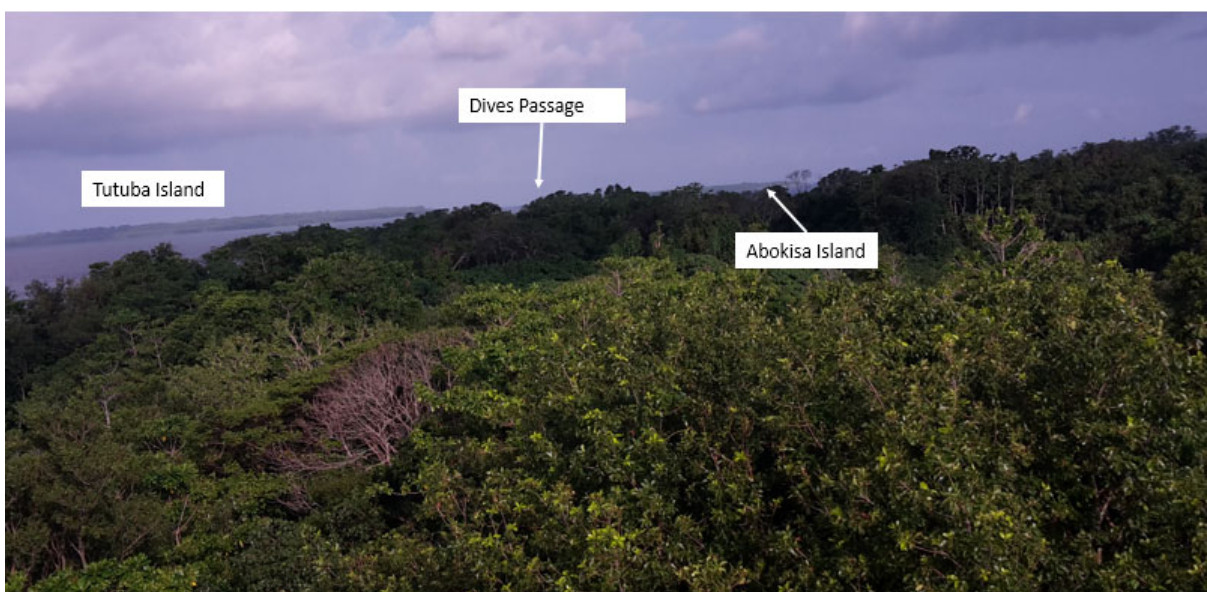
Figure 5: View from the top of the sector light tower showing the trees obstructing the light.

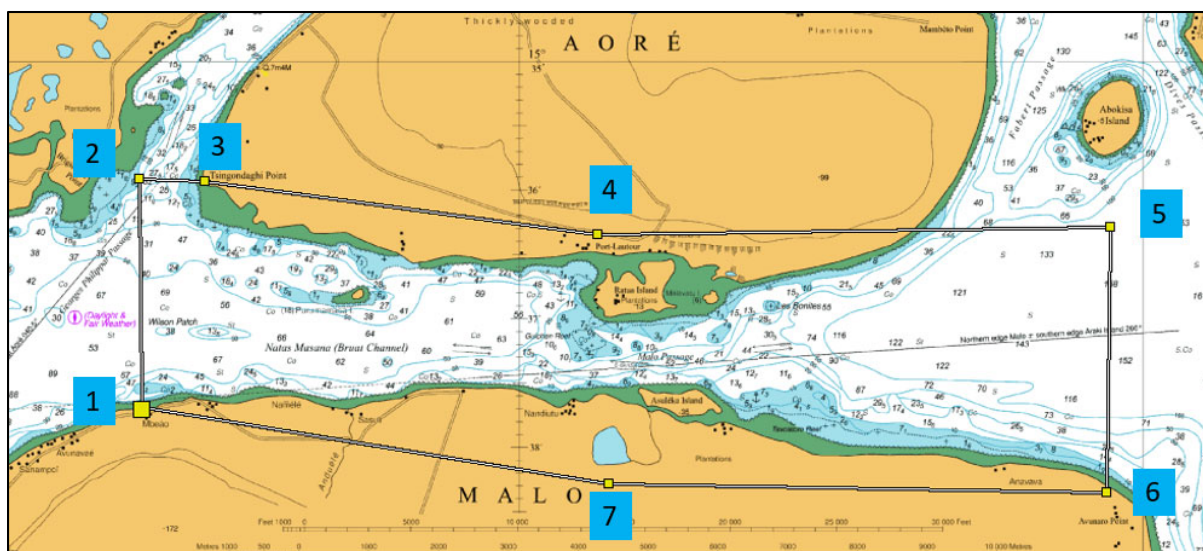
This is mainly due to the lack of special AtoNs marking the boundaries of the MPA area. It is recommended that the boundaries at positions 1, 2, 5 and 6 of the MPA area be clearly marked with special buoys. An H Note should be sent to the charting authorities informing them of the new MPA to be updated on the new edition of charts.

Figure 13: Chart showing the boundary of the MPA.

Recommendation	Amount (vatu)
Purchase and installation of 4 special buoys at the following positions: 1. 15-37.067S; 167- 06.984E 2. 15-35.916S; 167-06.966E 5. 15-36.294S; 167-14.718E 6. 15-37.208S; 167-14.718E	1.5 million
Purchase and installation of spare emergency wreck-marking buoy.	600,000
Send H Notes to PCA	0
<b>Total cost</b>	<b>2.1 million</b>
<b>Maintenance cost</b>	<b>110,000</b>
