Pacific Safety of Navigation Project

Risk assessment for Namukulu and Avatele harbours, Niue

November 2019

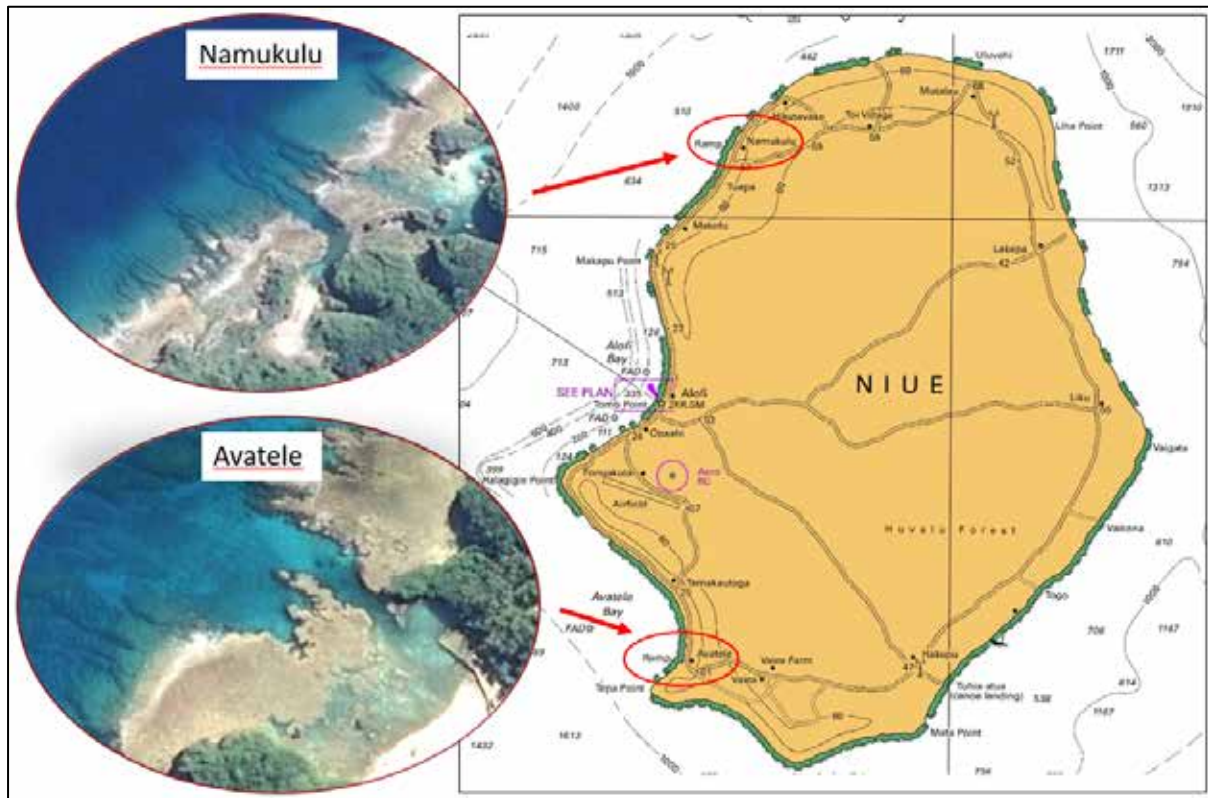
Figure 1. Chart of Niue at a scale of 1:150,000, and Google Earth images of Namukulu and Avatele harbours.

Chart NZ 845 shows Niue at a scale of 1:150,000 (Fig. 1). There is no small-scale coverage of Avatele harbour on the chart.

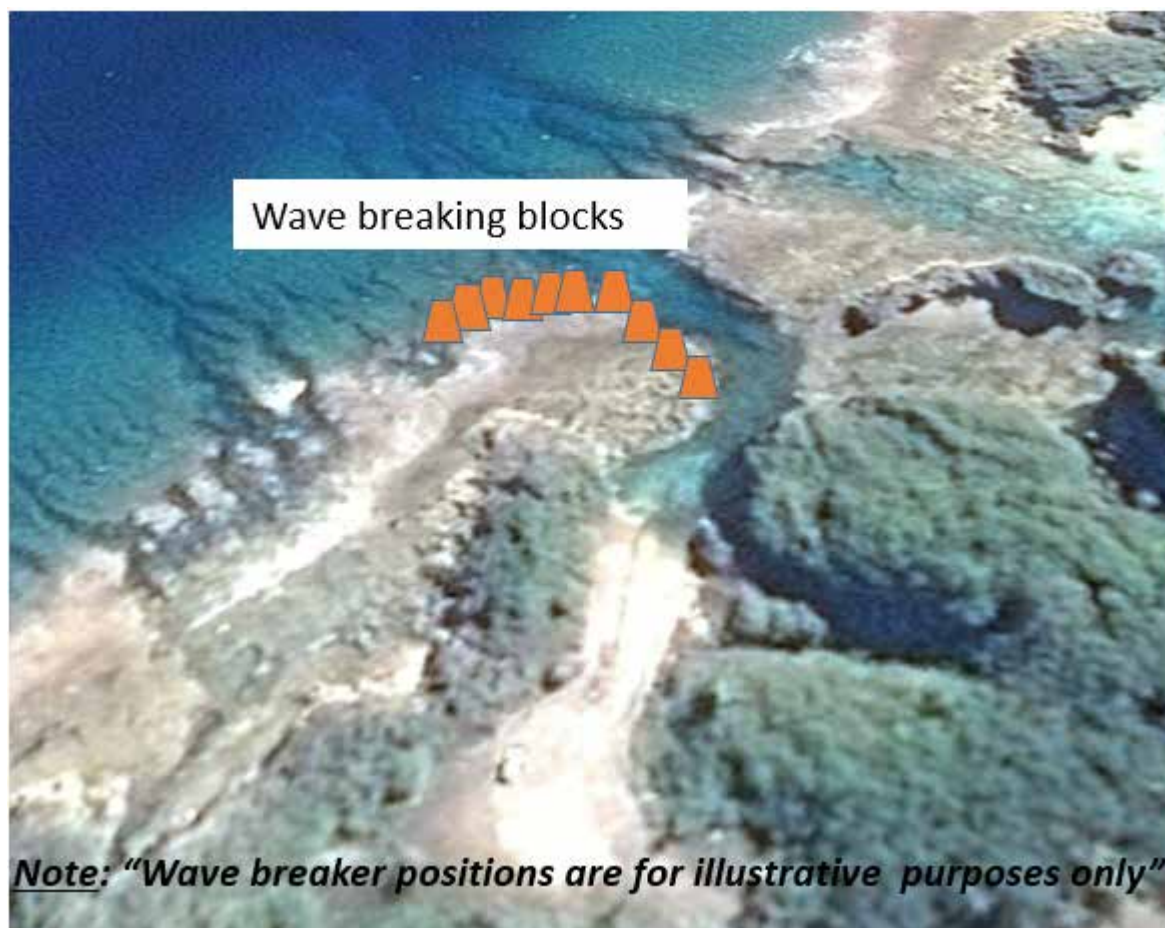
Recommendation 3 (addressing foundering scenario)

On occasion, s when vakas capsize in the channel, and this is caused by strong currents and large waves inside the channel.

It is, therefore, recommended that a coastal engineer be engaged to conduct a feasibility study of the technical options and costs (i.e. installing wave-breaking blocks, and dredging and widening the channel), and that a proper wave inundation model and environment impact assessment be carried out for Namukulu.

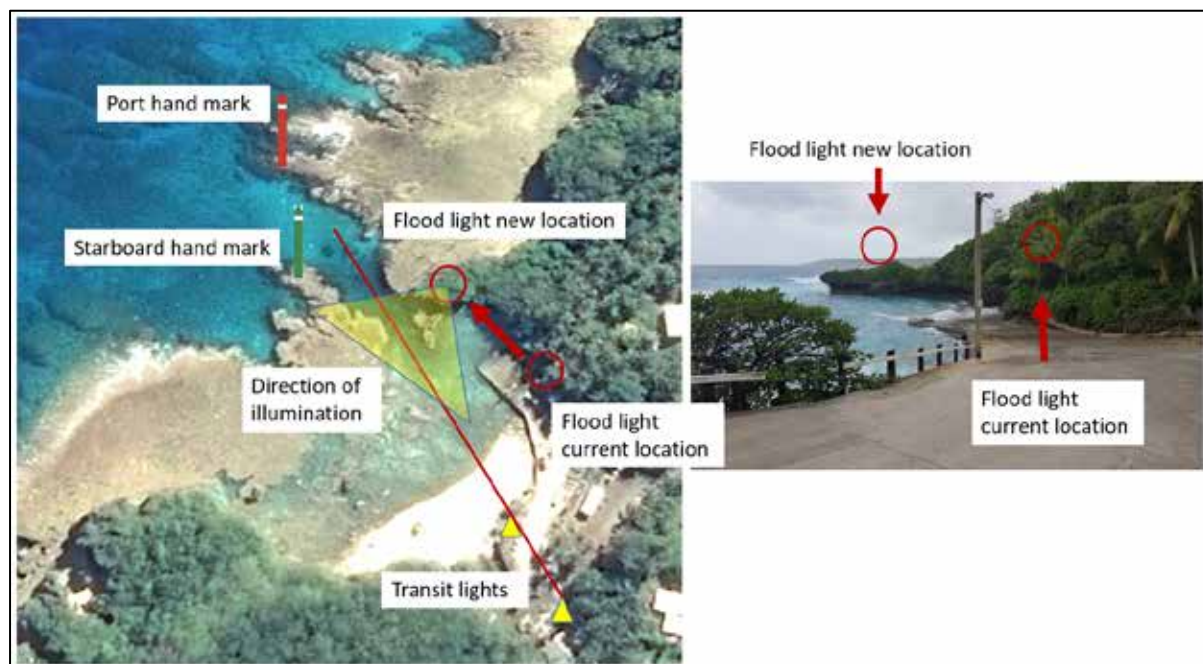
Recommendation 2 (addressing grounding scenario)

This recommendation addresses the potential grounding of a small boats and vakas on the reef at the channel's entrance.

It is recommended that two lit fixed lateral markers (port and starboard channel markers) be installed at the channel entrance, and that transit lights be installed on shore to help guide boats in.

It is also recommended that the position of the current floodlights at the ramp be relocated on the rock above the choke point, and that the direction of illumination point towards the west. In addition, it is recommended that IALA Level-1 AtoN Manager and Level-2 Technician training be provided to relevant staff, and that a regular AtoN maintenance plan be developed to keep the AtoN performing at their optimal levels.

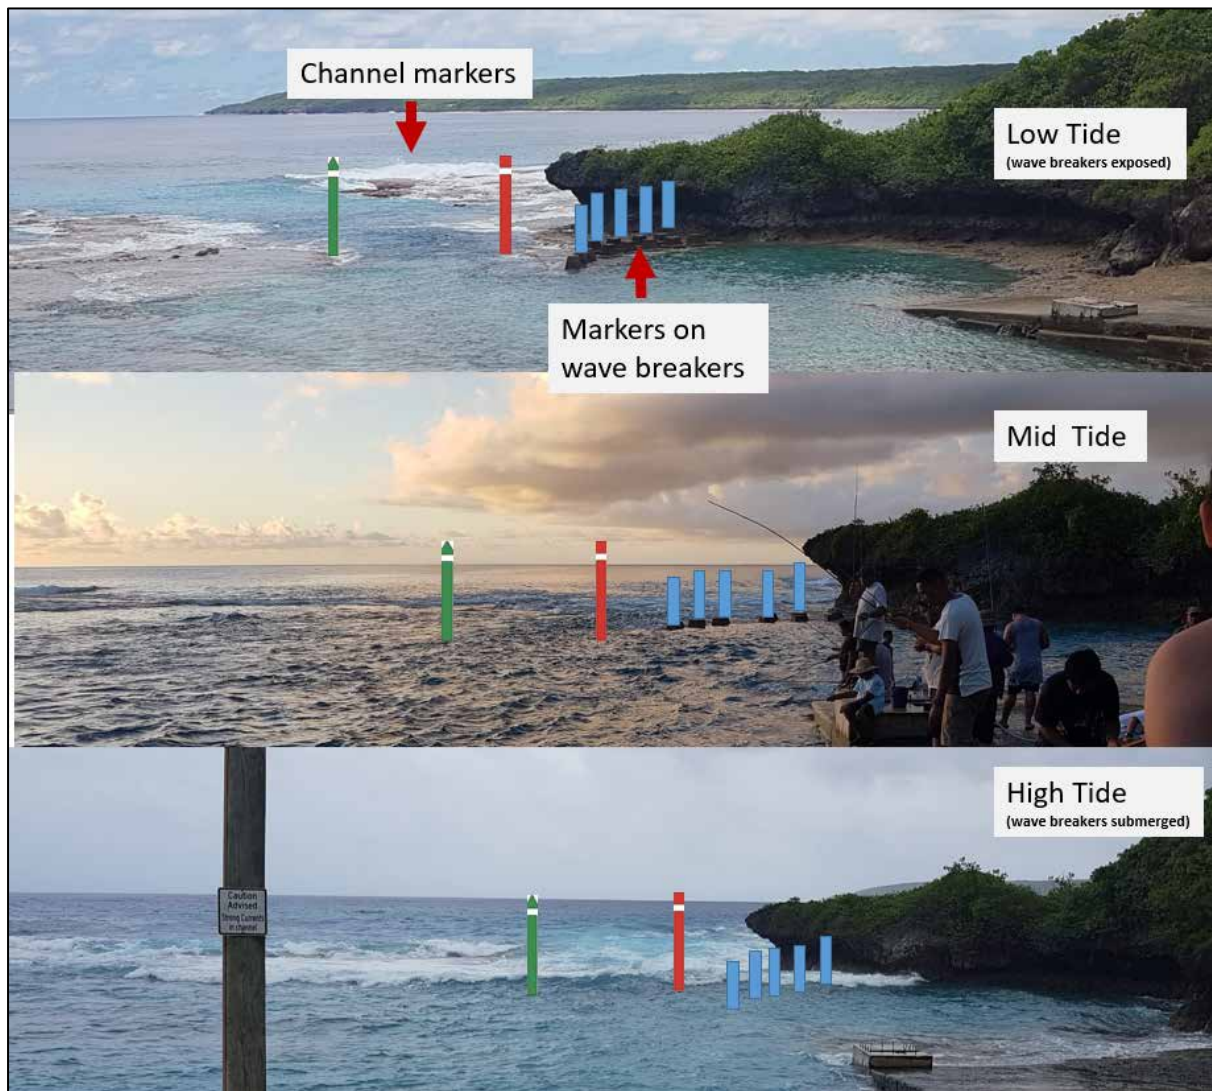
There are several wave breaking blocks in front of the Avatele boat ramp that are exposed at low tide and are fully submerged during high tide. These blocks are hazardous for boats approaching the ramp at high tide.

Proposed placement of markers at channel entrance and on wave-breaking blocks.

It is recommended that two lit channel markers (port and starboard) be installed at the entrance of the choke point, and that lit markers be installed on some of the block so that they are visible to mariners at high tide and at night.

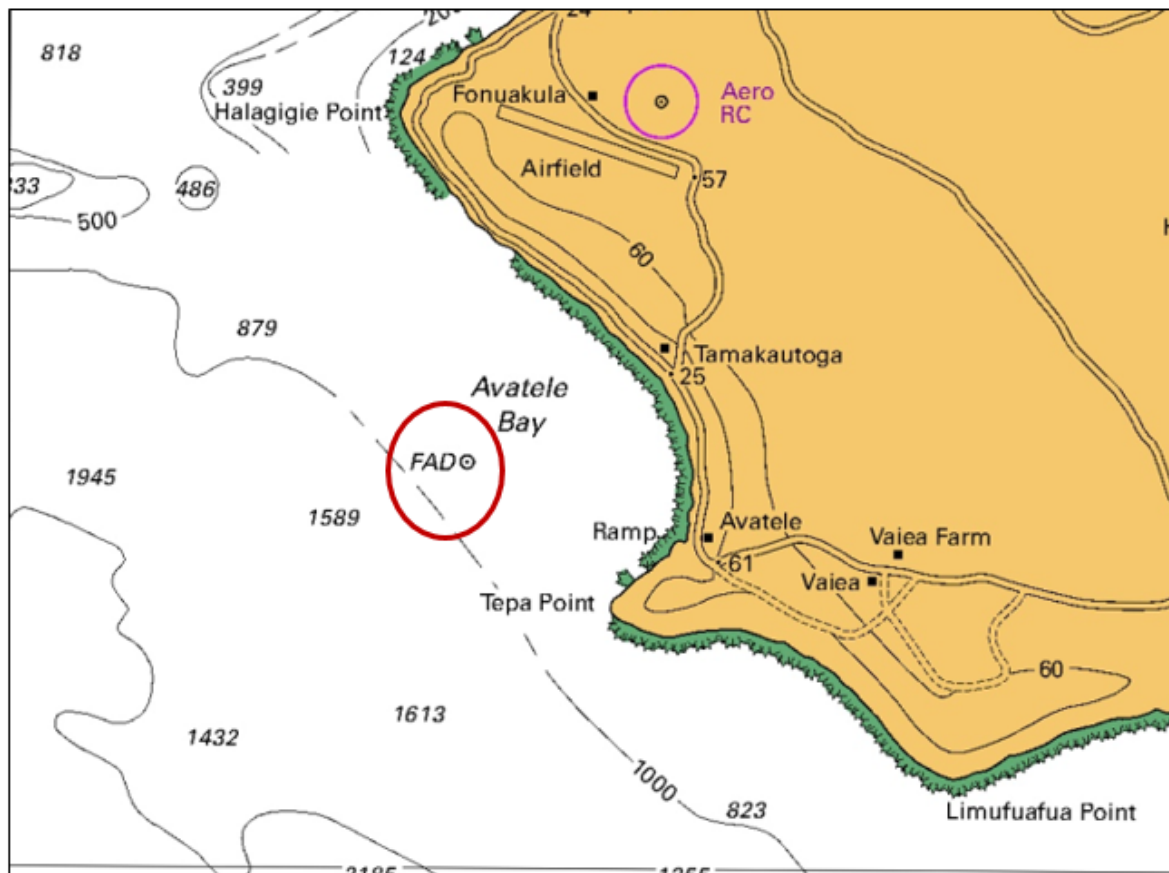
Recommendation 4 (addressing allision scenario)

This FAD is not conspicuous at night, and thus poses a danger for boats fishing around it at night.

It is recommended that a strobe light be installed on the FAD that will make it visible for mariners at night. The following IALA guidelines should be consulted in detail when implementing this recommendation: GL #s 1073 and 1145.

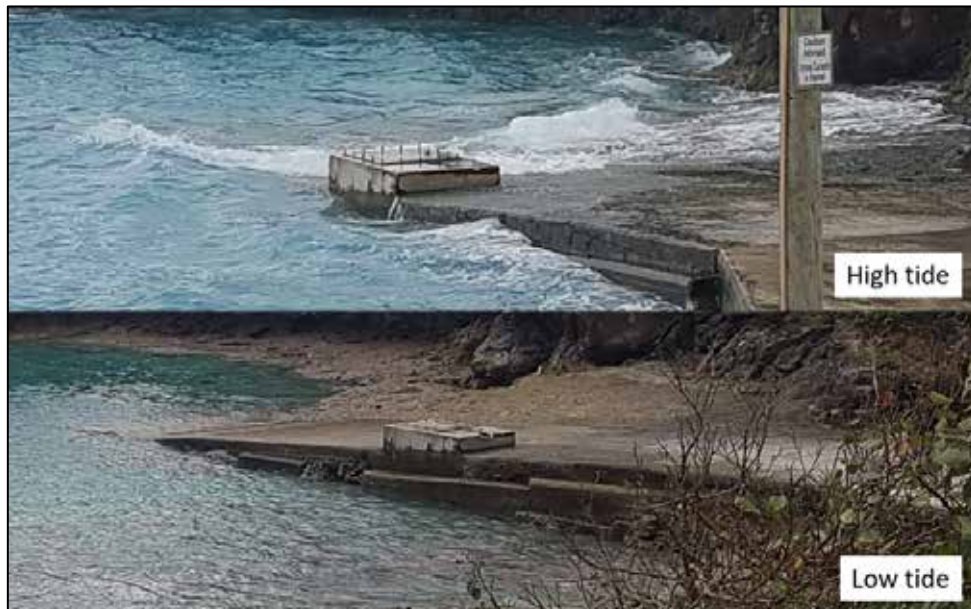
Recommendation 5 (addressing allision scenario)

Outside of cyclone season (April to October), a crane is used at the ramp to assist fishermen with launching and recovering their boats. There are currently no fenders alongside the Avatele ramp, and boats on their return typically allide with the ramp.

It is recommended that fenders be installed along the ramp face to prevent boats hitting and damaging the ramp and boats. This will enable users to safely come alongside and reduce the risk to as low as practical.

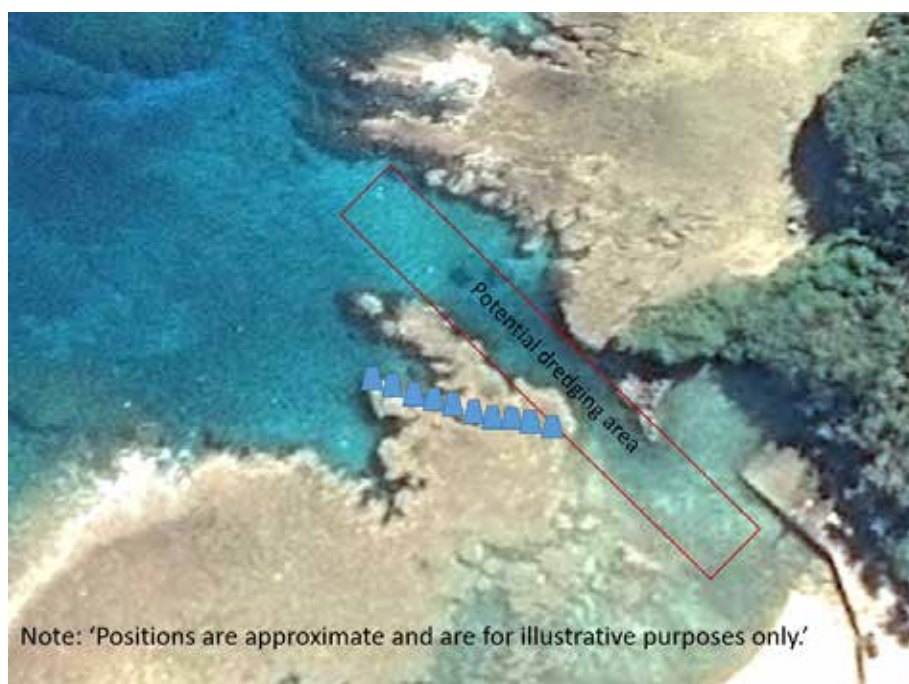
Recommendation 6 (addressing foundering scenario)

On occasion, canoes capsize in the channel to Avatele harbour as a result of strong currents and big waves.

It is, therefore, recommended that a coastal engineer be engaged to conduct a feasibility study of the technical options and costs (i.e. installing wave-breaking blocks, and dredging and widening the channel), and that a proper wave inundation model and environmental impact assessment be carried out of Avatele harbour.
