# RECOMMENDATIONS FOR DESIGN OF A COASTAL PROTECTION SYSTEM FOR SHORELINE PROTECTION YAREN DISTRICT, REPUBLIC OF NAURU (RON)

*May 2001*

*SOPAC Technical Report 317*

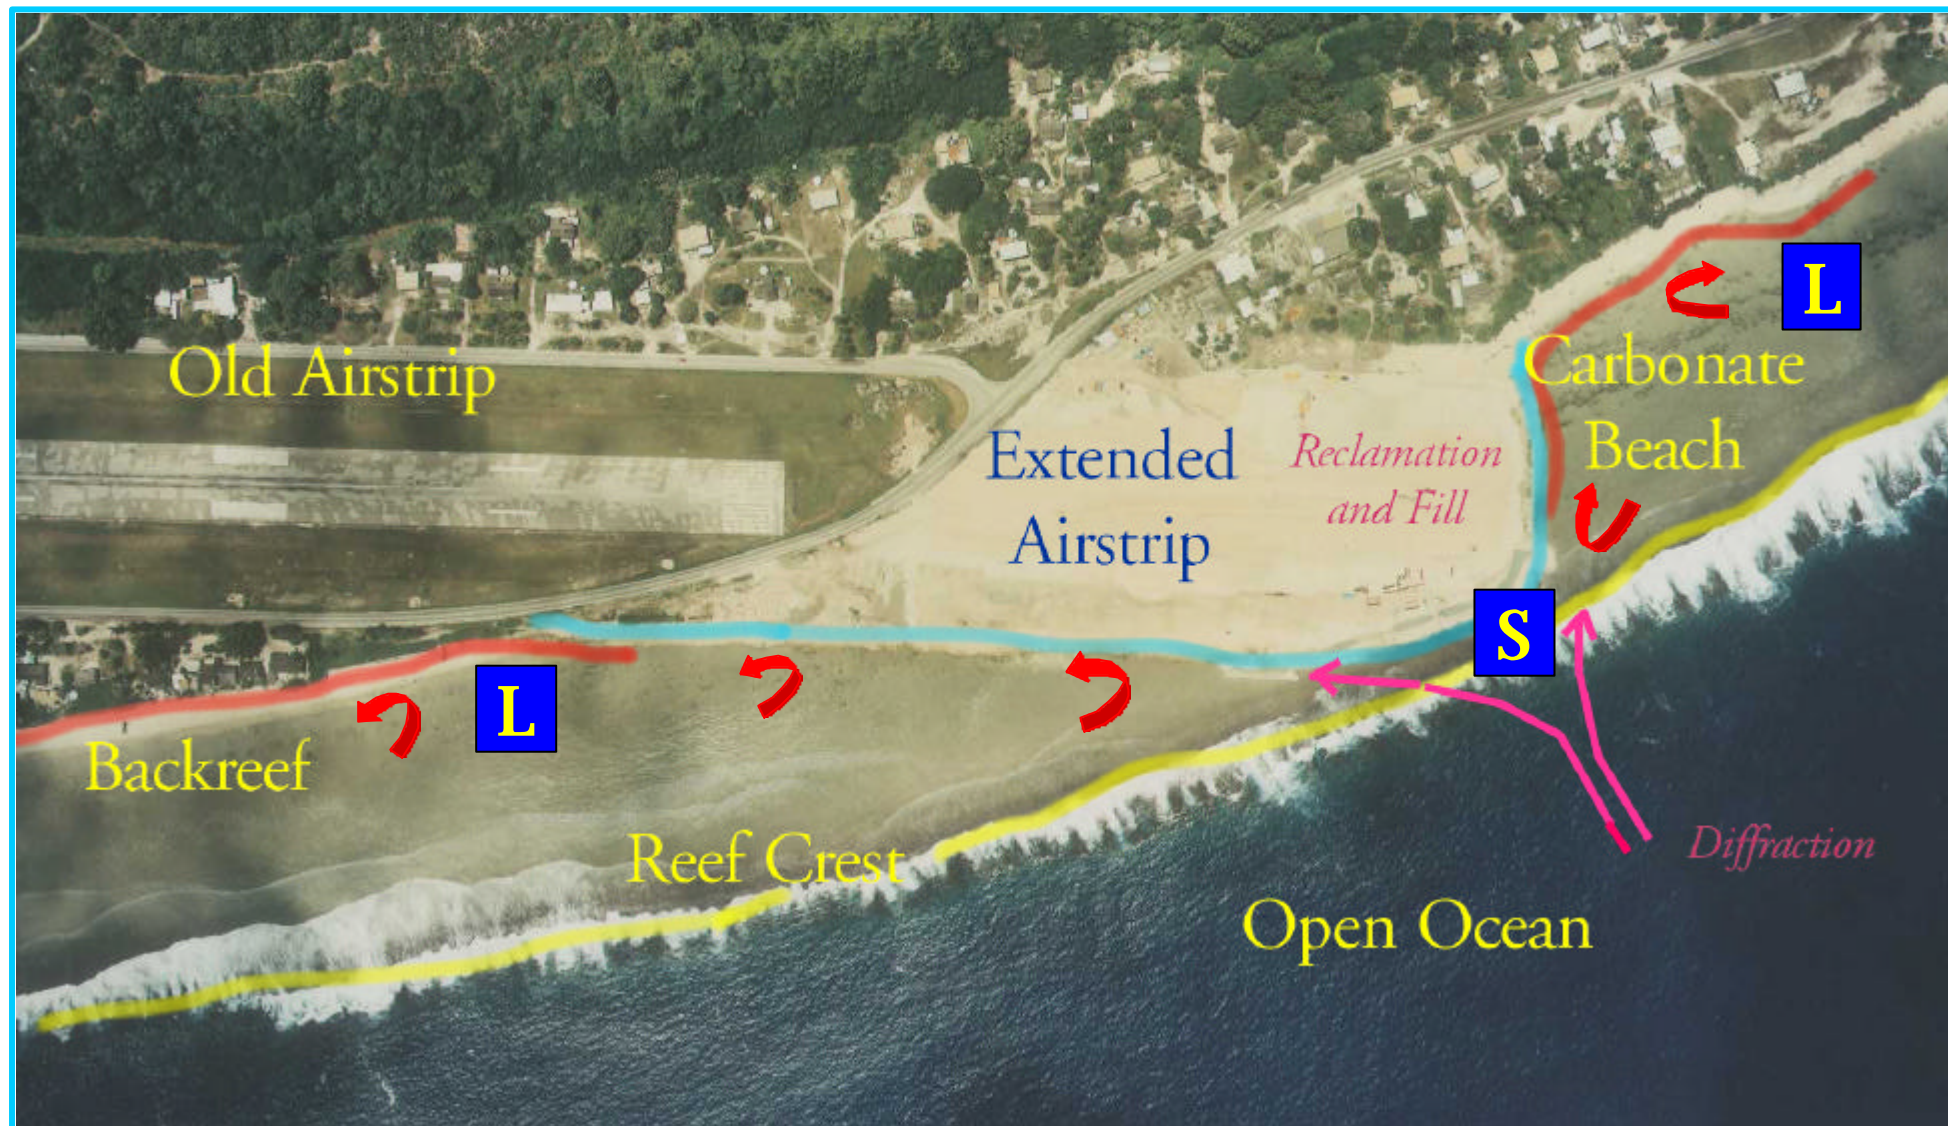
- waves approaching the problem area diffract around the airport extension reclamation and fill site, shown in Figure 3;
- diffraction is to both the east and the west (pink arrows; Figure 3);
- diffracted waves cause longshore currents (L; Figure 3) to be generated in opposite directions, from the seaward-most part of the reclamation and fill site (S; Figure 3);
- this causes longshore currents to flow both to the east and west of the fill site;
- both longshore currents are more significant at high tides, especially EHWST, when waves are larger and the

- water depth (effective submergence) is greater in the area;
- both longshore currents cause erosion points to develop (from point S; Figure 3) on both sides of the reclamation/fill site;

- these have caused loss of fine, loose and cohesionless carbonate sands and gravel from beaches to east and west of the airport extension site (S; Figure 3);

- the loss to the west has been greater than on the east, as longshore is dominantly to the south, reducing scouring to the east;
- longshore currents generated by these diffracting waves cause significant removal of beach sediment along the coast, at the problem site (areas in red; Figure 3); and

Figure 3. Location of Yaren District, the eroding coast (red), the reef areas and adjacent reclaimed and filled new section/extension of the airstrip. L-longshore current; S-seaward part of fill site.

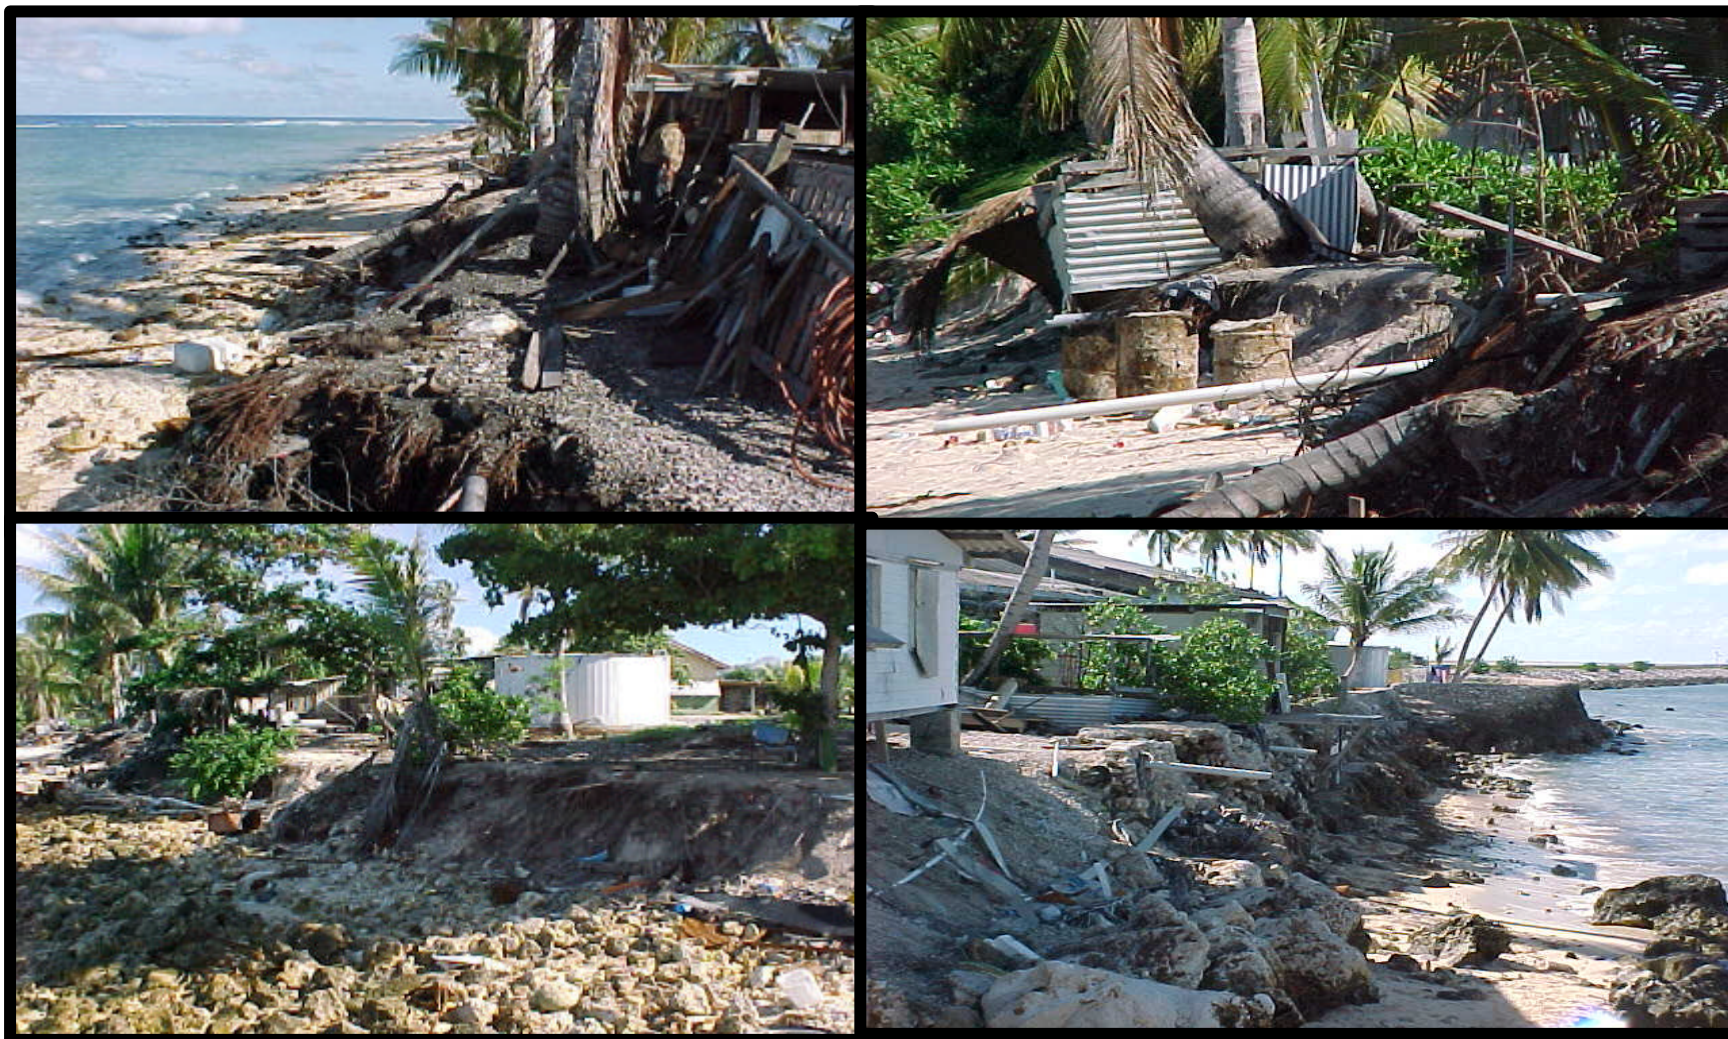
- the erosion scarp at the problem coastline is between 0.80 m and 1.75 m high (Figures 4 and 5);
- the erosion scarp is vertical, with some overhanging sections where coconut palm roots still bind shallow and surface soils (Figure 4);

- in addition, older coastal protection is evident here at the study sites, from the litter of limestone boulders and masonry wall rubble, along the upper beach (Figure 4);

Figure 4. Erosion characteristics of the problematic coastline.

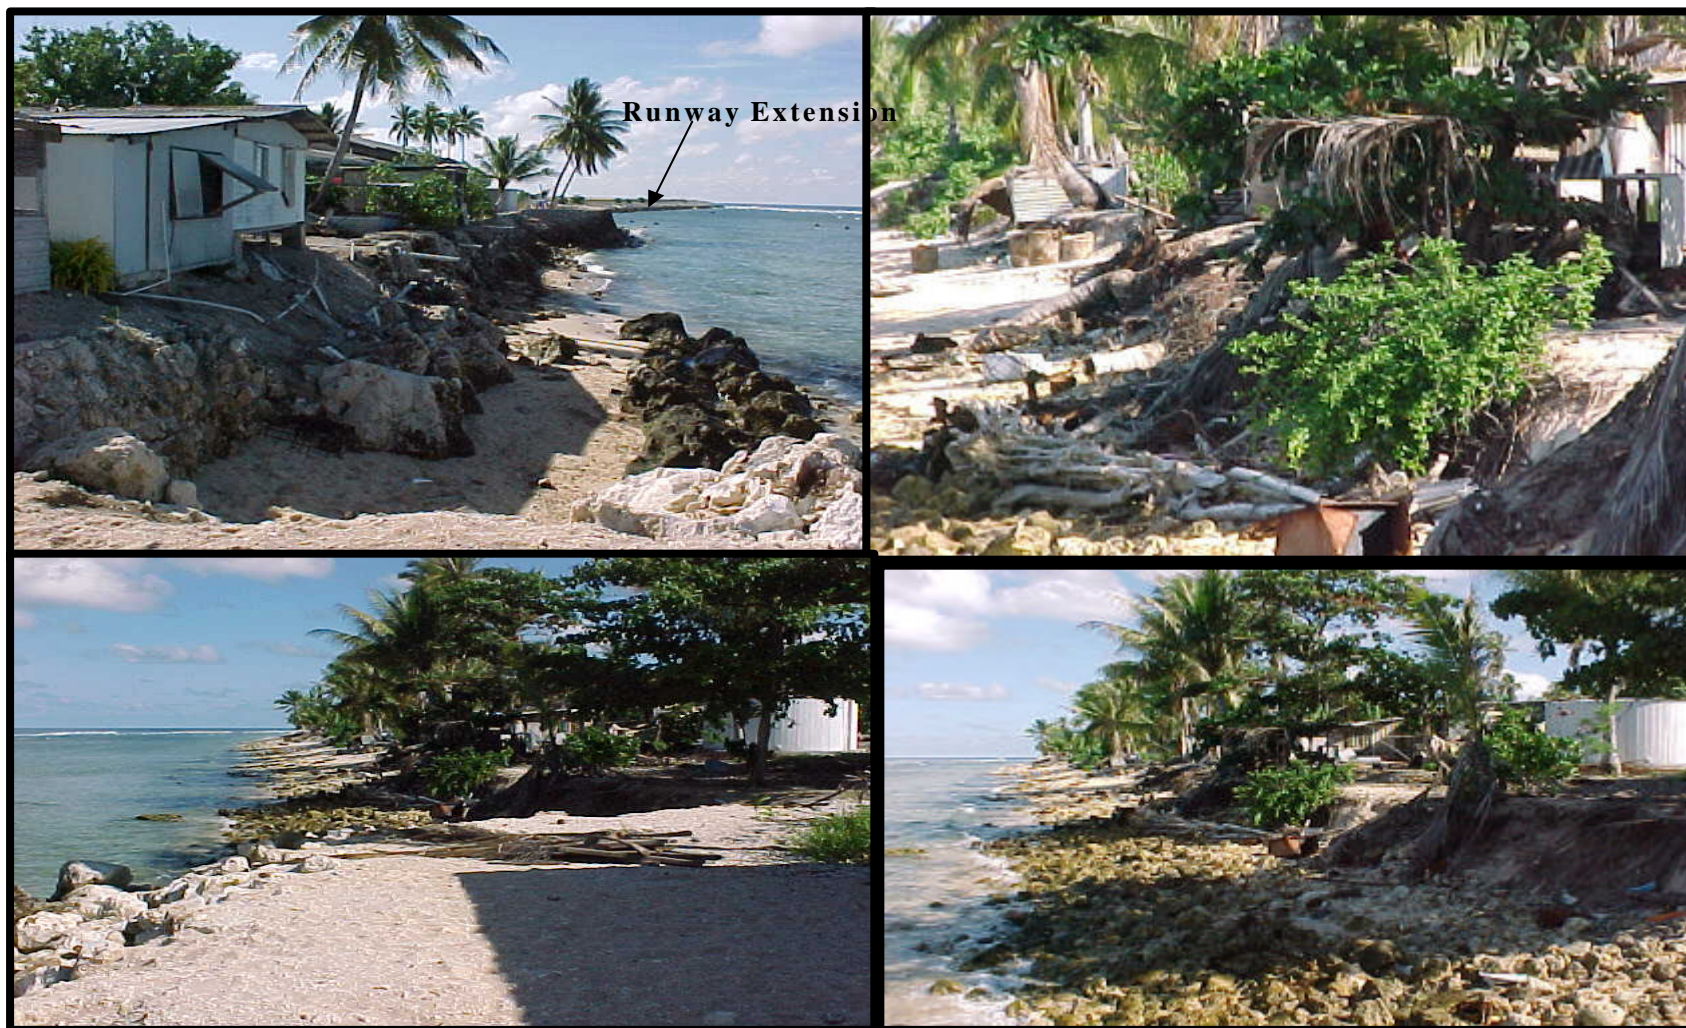
Figure 5. Erosion characteristics of the problematic coastline.

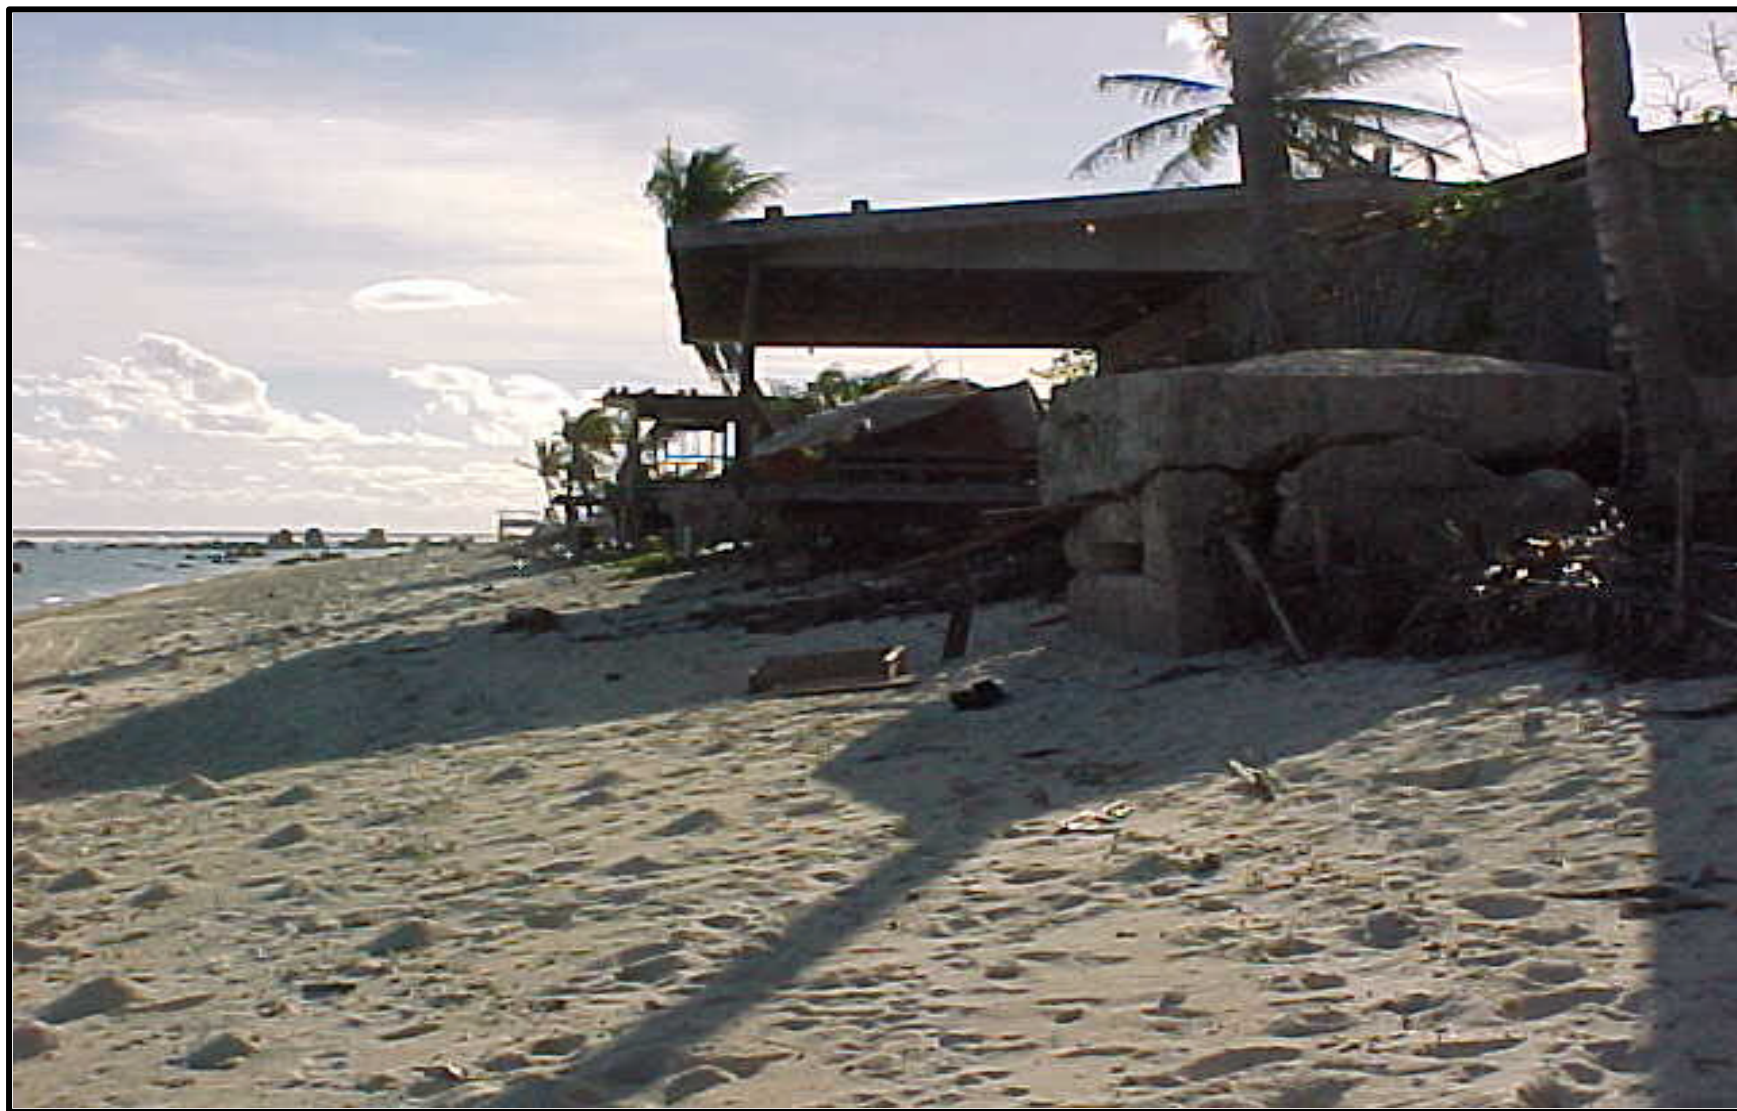
- a medium to fine, carbonate sand beach,
- the beach is about 6 m wide with a 12-15° slope towards the sea (Figure 6);
- sands are clean, with less than 5 % fines;

*Figure 6. Characteristics of the eroding beach (looking west).*

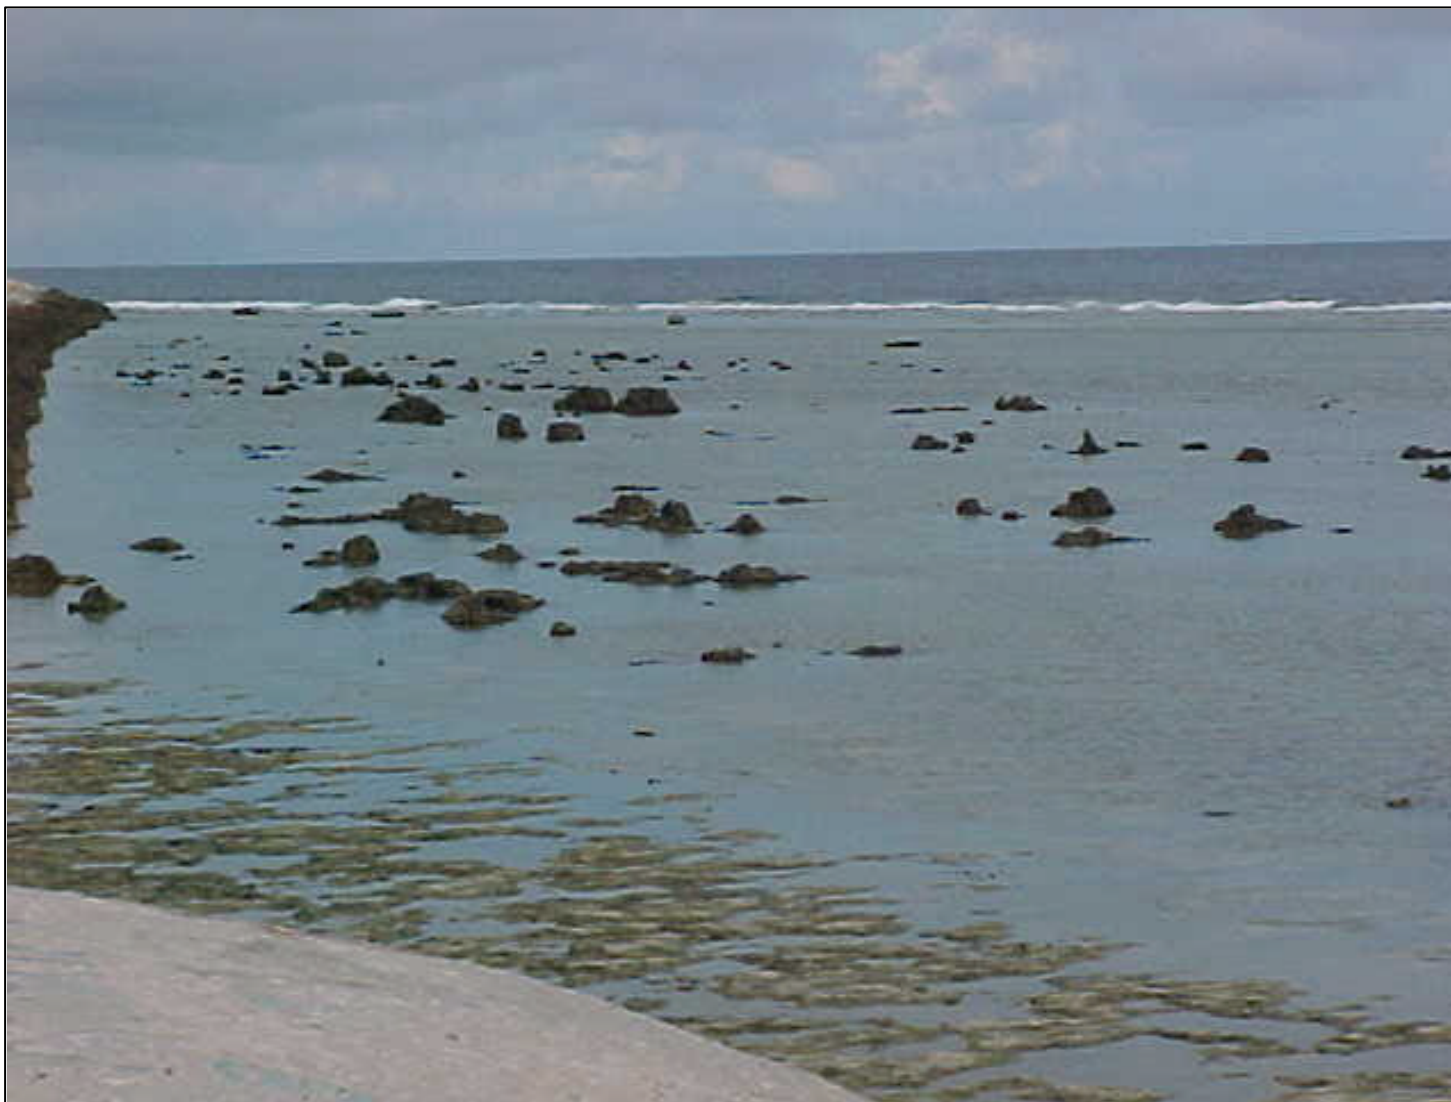
- the backreef is strewn with angular limestone boulder fragments (eroded from adjacent coastlines and in-situ) and also derived from failed coastal protection structures (Figure 7);

*Figure 7. Elevated, Holocene backreef area covered with green algae.*

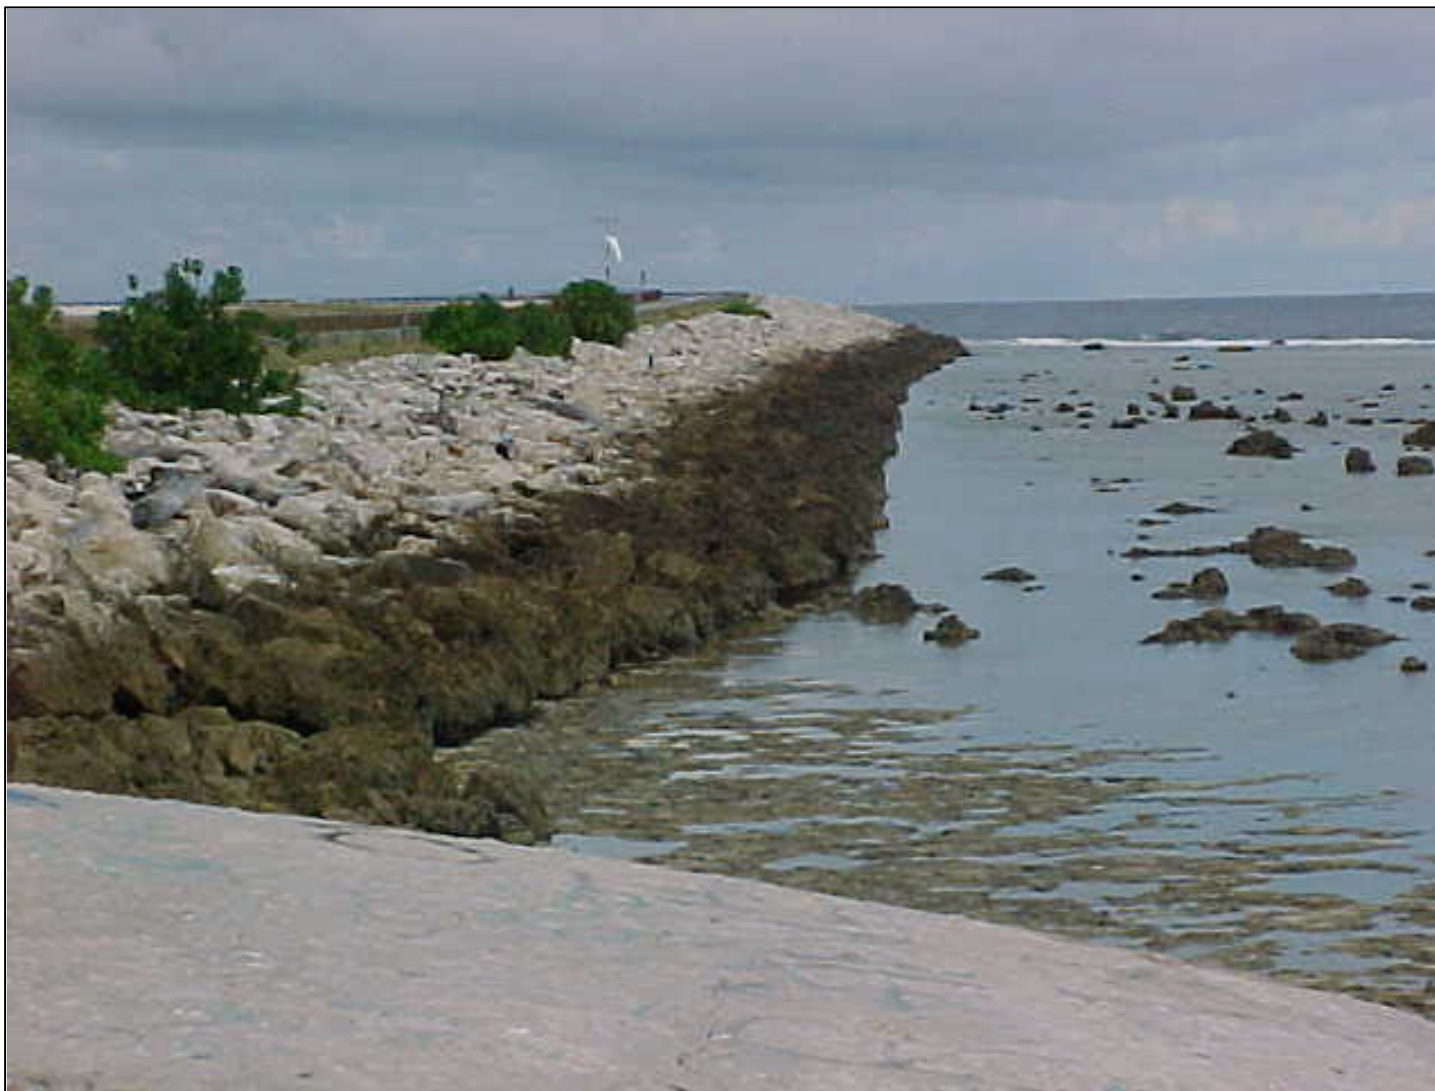
- Figures 13 and 14 show the airport reclamation and fill site;
- note the rip-rap revetment protecting the reclaimed site (Figure 15);
- the rip-rap is made of dolomitic limestone from Nauru;
- note also the green brown algae covering boulders in Figure 15;
- Figure 16 shows part of an old, almost vertical (85°), 1.65 m high and 0.75 m wide (at the top) masonry retaining wall at the problem site. Note strewn 0.30 m diameter, limestone boulders from damaged wall sections (also Figure 17);
- sand and fine gravel are deposited between boulders;

*Figure 15. Details of the limestone rip-rap revetment along the airport fill site.*

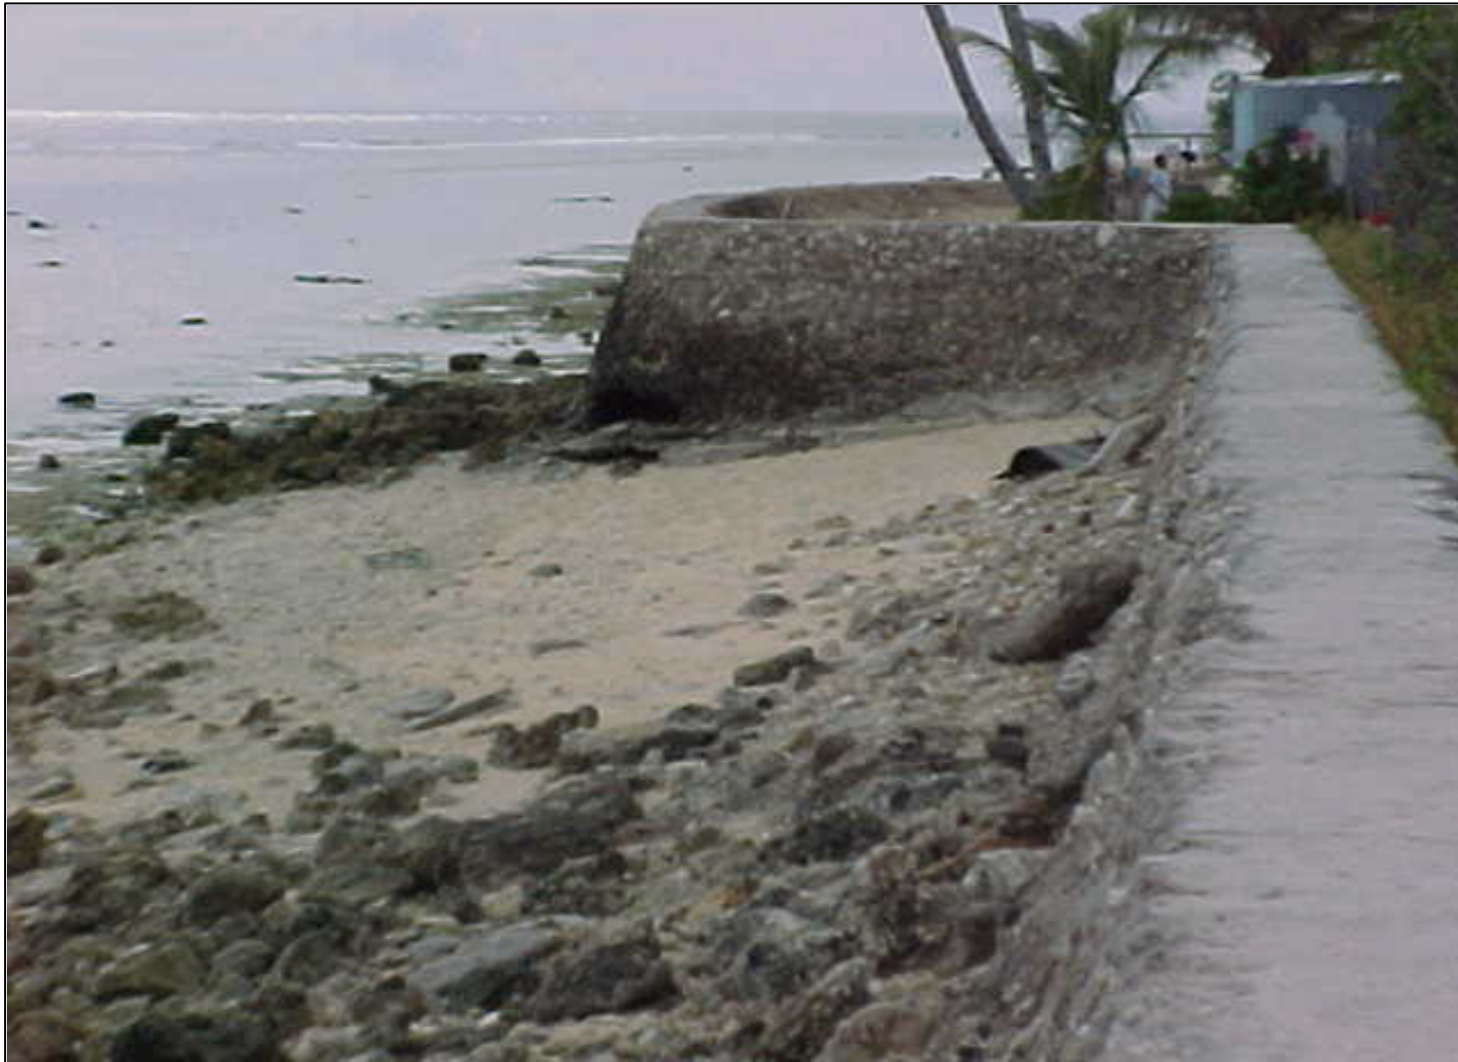
*Figure 16. Part of an old masonry retaining wall at the erosion site.*

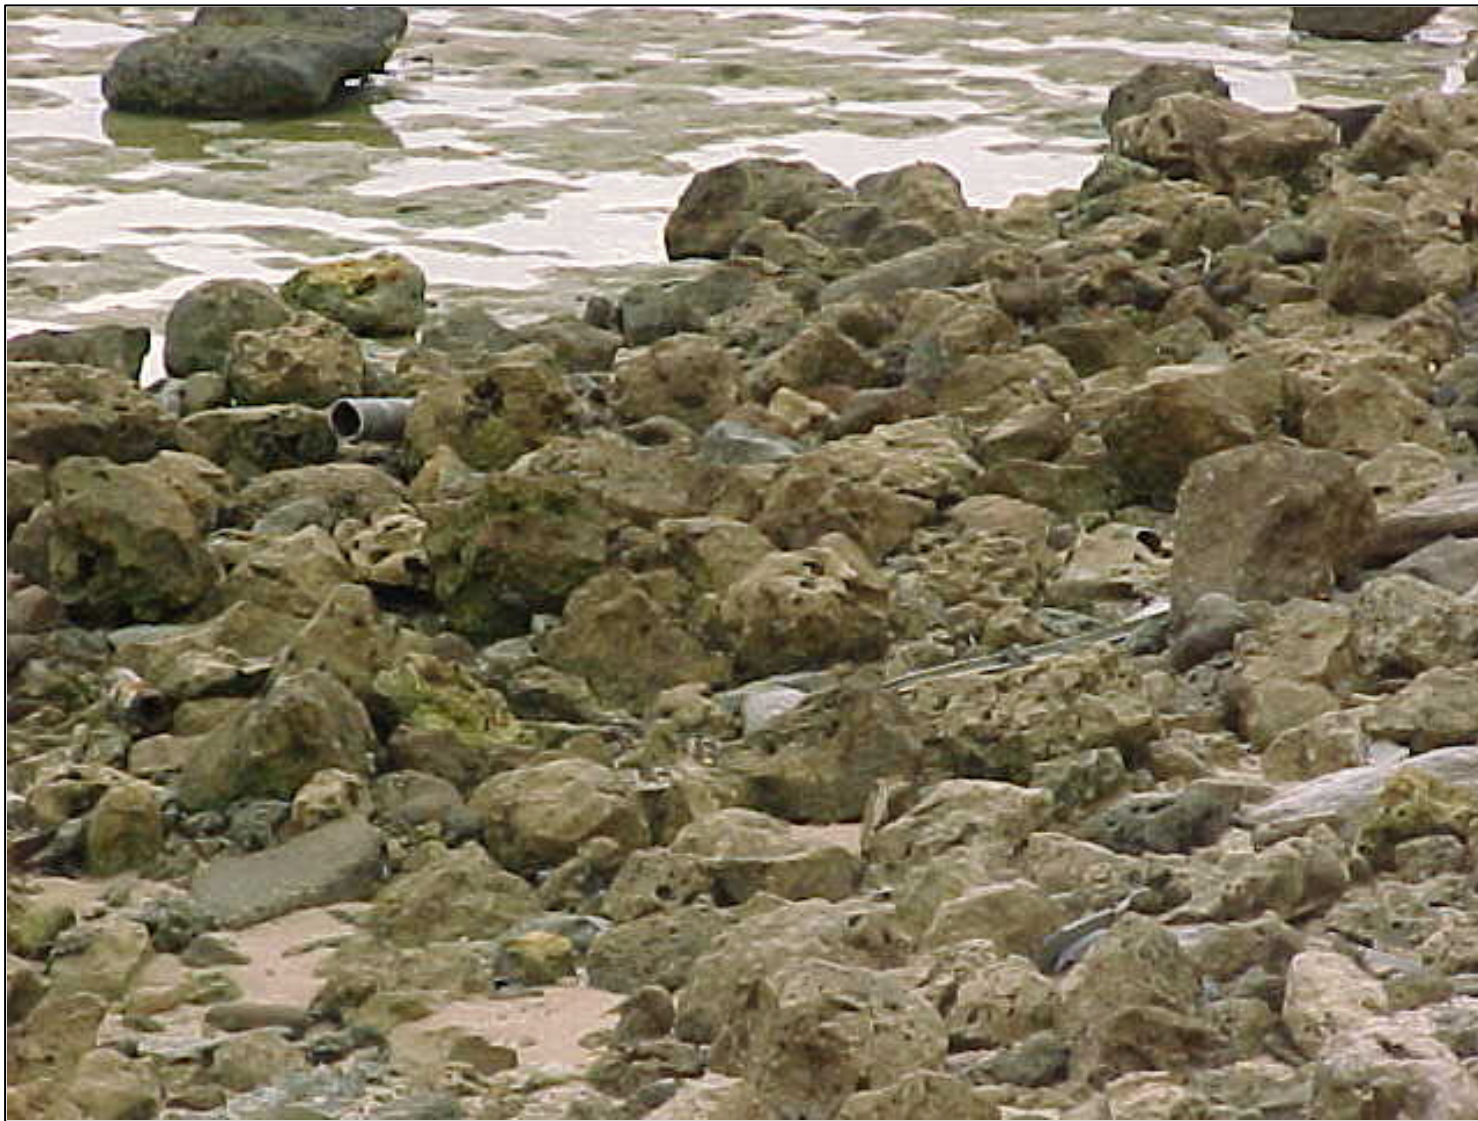
*Figure 17. Limestone boulders from failed coastal protection structures.*

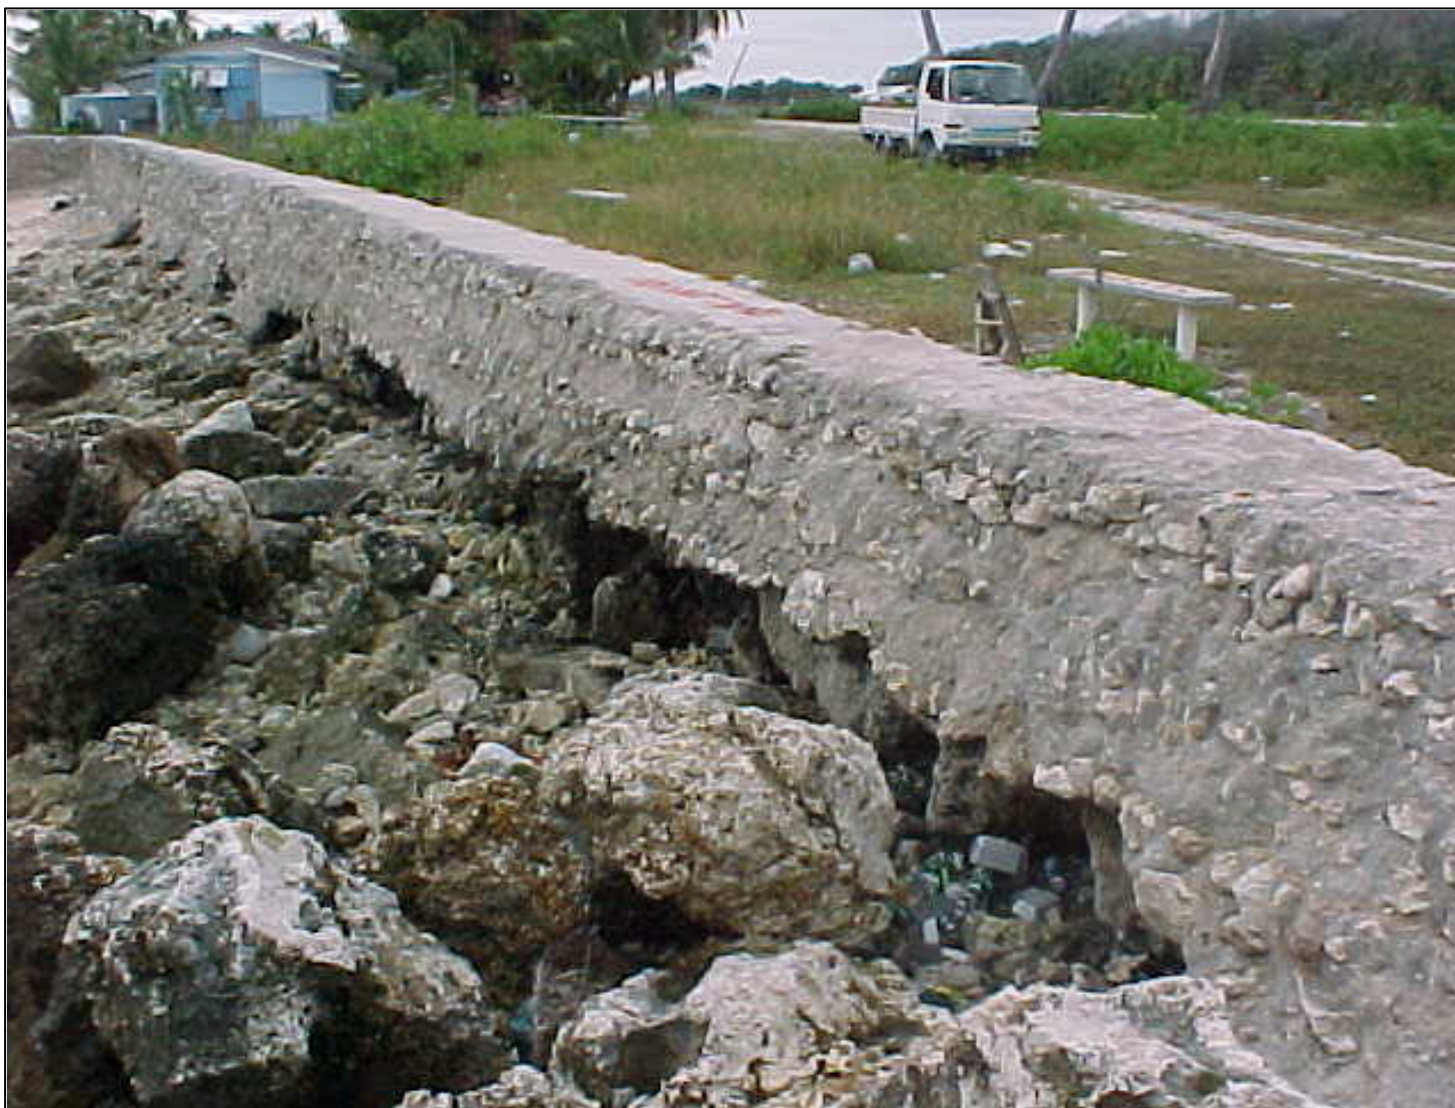
- Figure 18 shows basal scouring and undermining of the retaining wall shown in Figure 16;
- Figures 19-22 show large cavities in various sections of the masonry wall, produced by wave-induced erosion and scouring;

- eroded cavities like those above cause dislodgment of boulder aggregate from within the structure leading to loss of internal support;
- since masonry walls do not possess tensile strength, the wall eventually cracks due to loss of support and integrity and fails;

*Figure 18. Basal scouring of the retaining wall in Figure 16.*

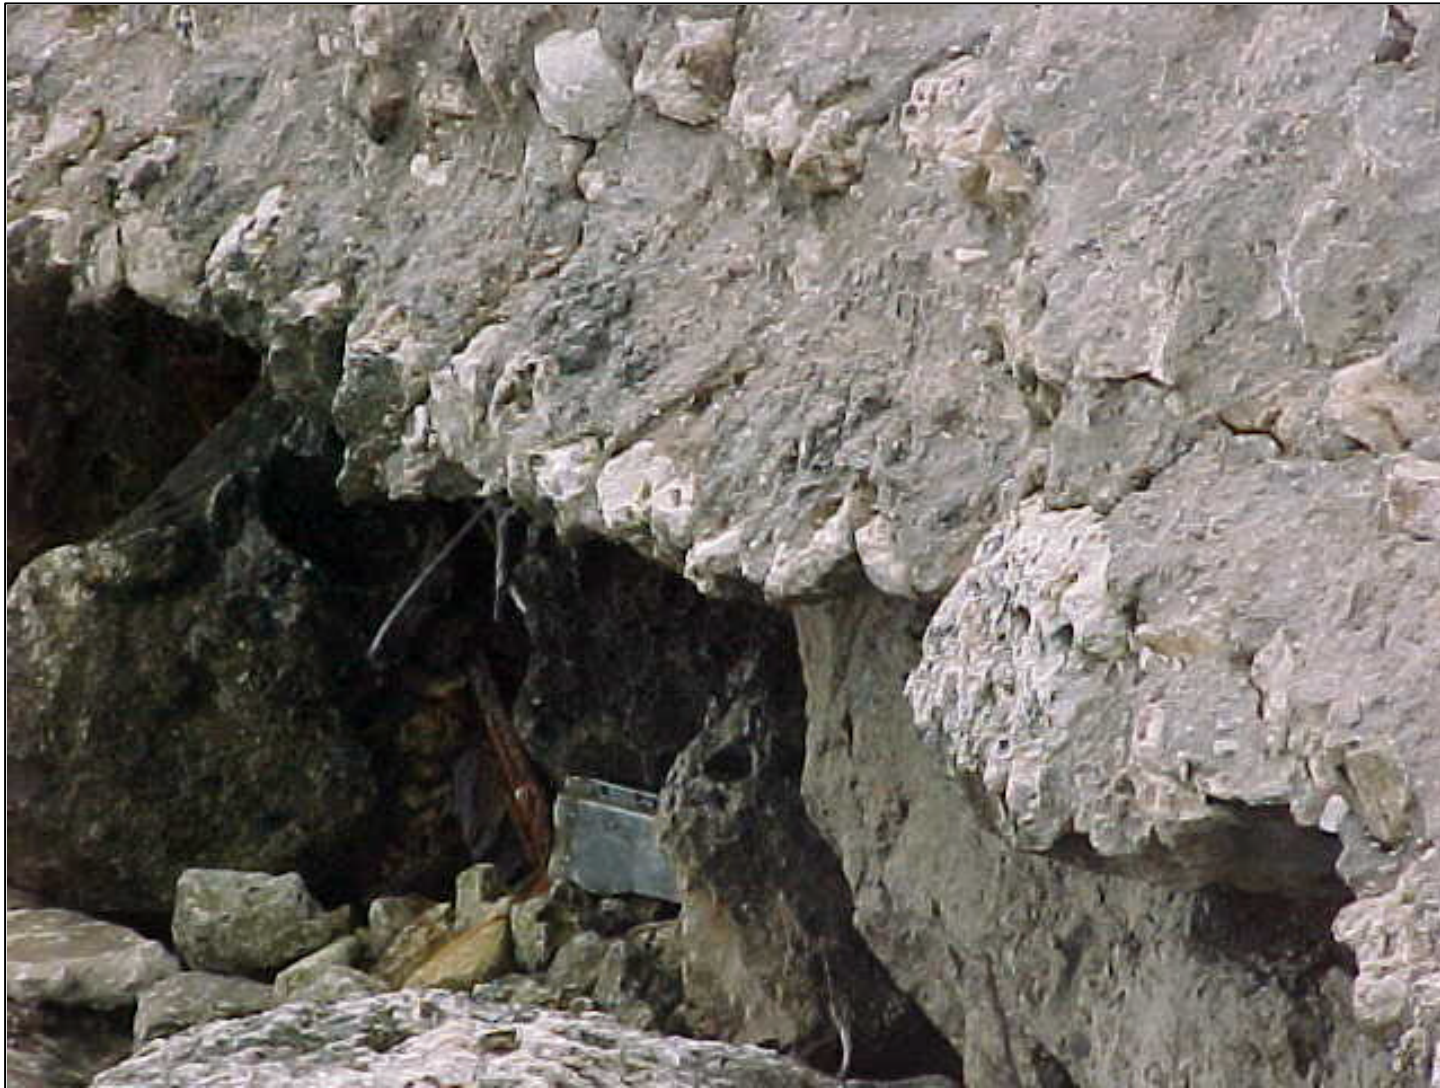
*Figure 19. Details of the scoured western section of the scoured retaining wall.*

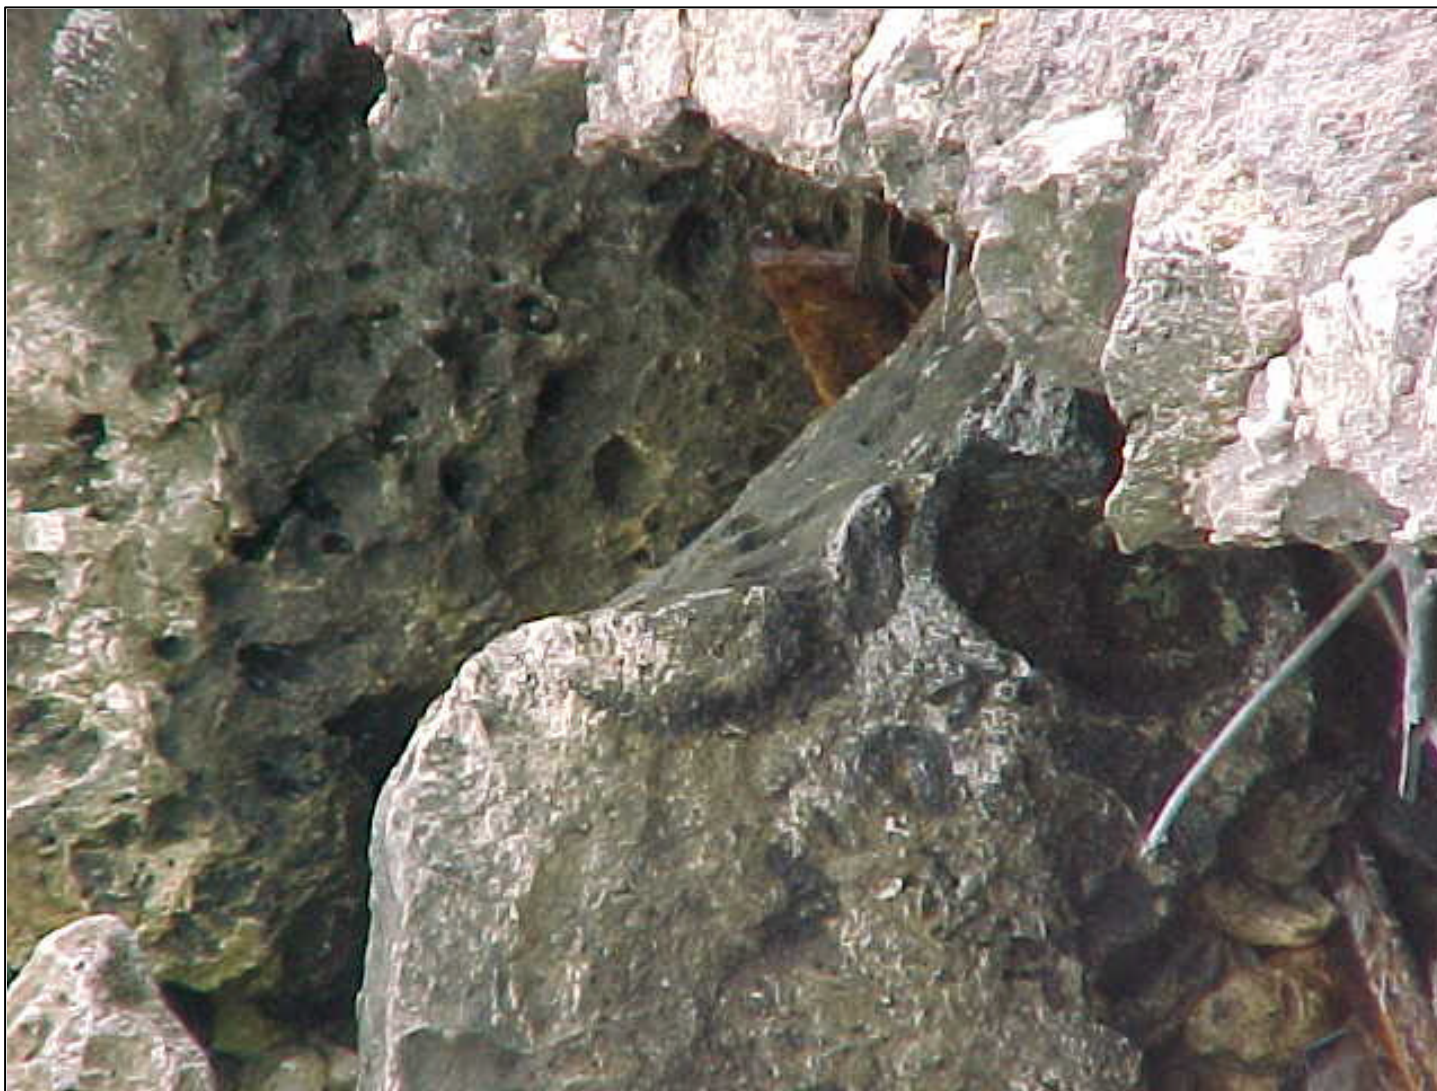
*Figure 20. Large cavities at the base of the scoured retaining wall.*

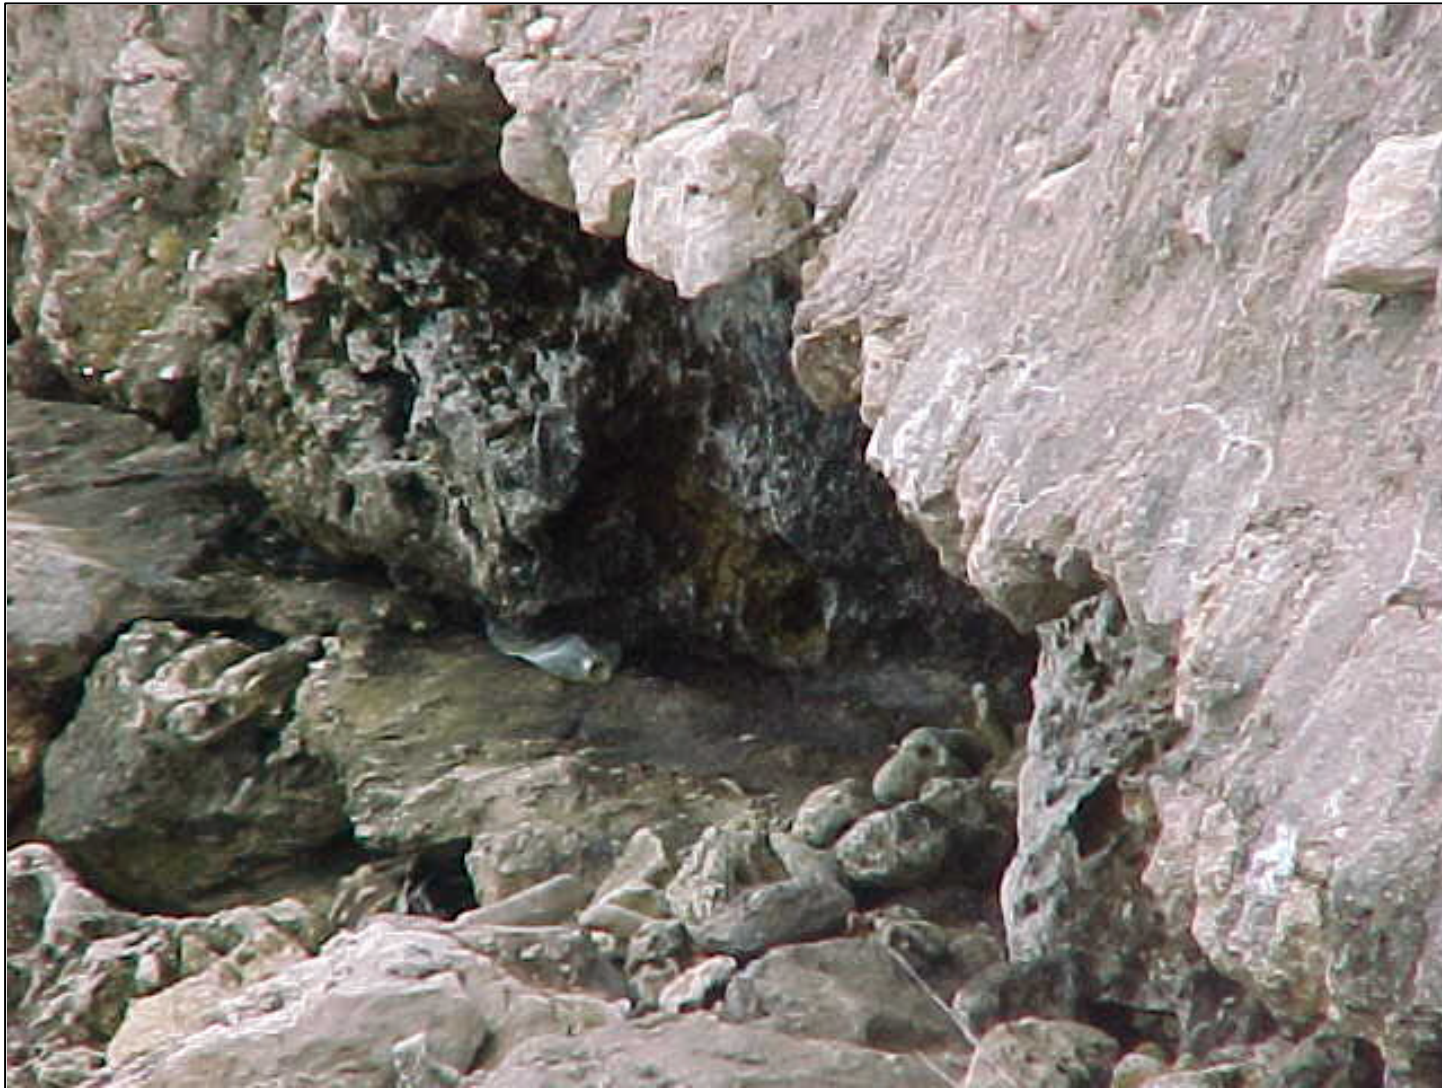
*Figure 21. Removal of boulder aggregate at the base of the retaining wall on the eastern side of the structure.*

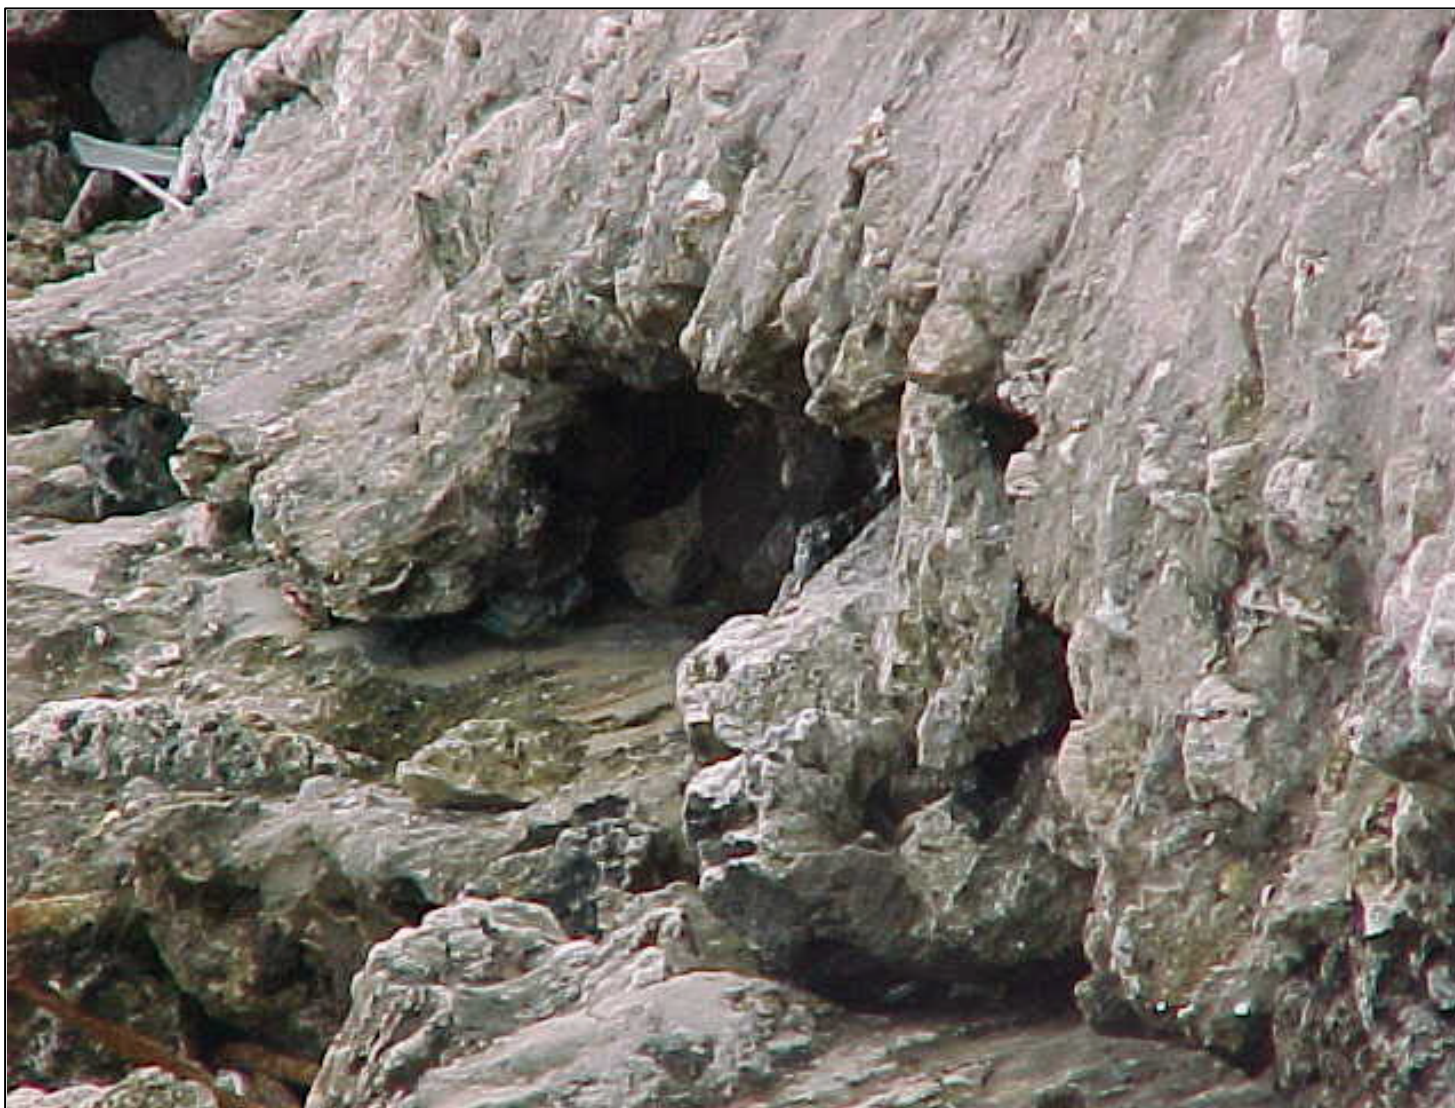
*Figure 22. Scouring and removal of wall aggregate due to wave action and abrasion.*
