# RECOMMENDATIONS FOR DESIGN OF A COASTAL PROTECTION SYSTEM FOR SHORELINE PROTECTION YAREN DISTRICT, REPUBLIC OF NAURU (RON)

*May 2001*

*SOPAC Technical Report 317*

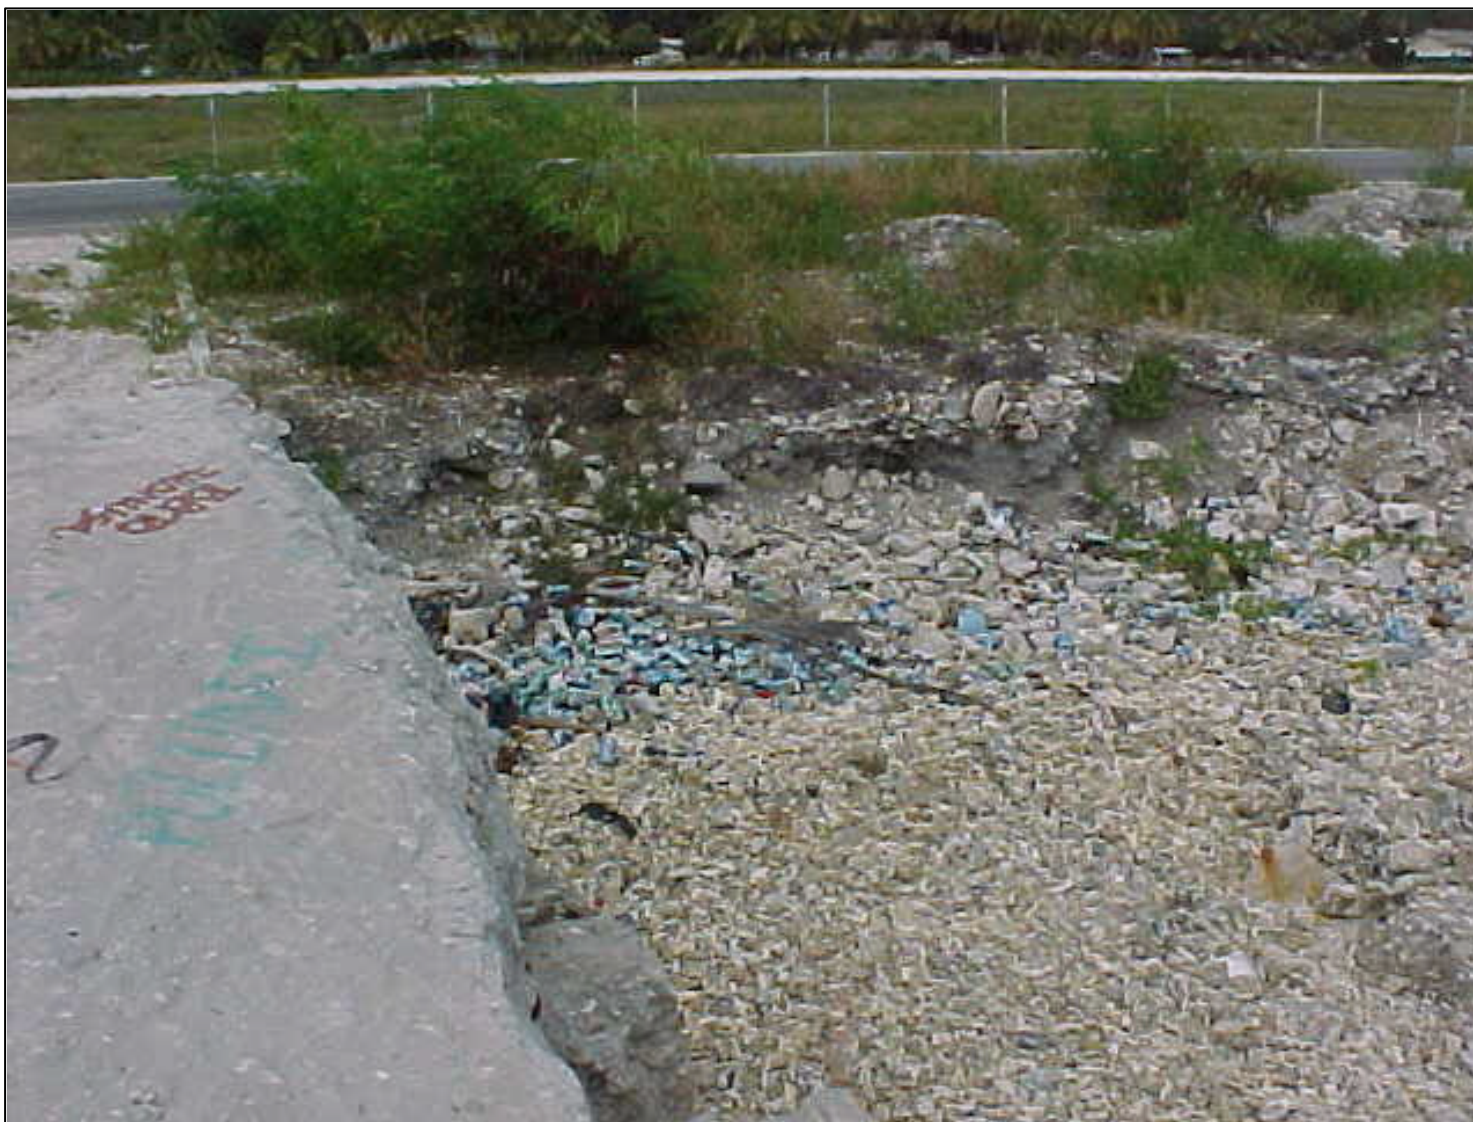
- Figure 23 shows erosion and scouring at the western corner of the rip-rap revetment system, at the airport fill site;
- the above is caused by flanking or the absence of protection at the end of the rip-rap revetment system and is the product of longshore currents;

Figure 23. Erosion scarp at the western end of the airport rip-rap revetment.

- two outer layers with a width of 10 m; this is the primary armor of the revetment;
- the revetment should be winged, that is, the ends of the revetment should not be open to wave attack, but should be built into the adjacent land or "closed";

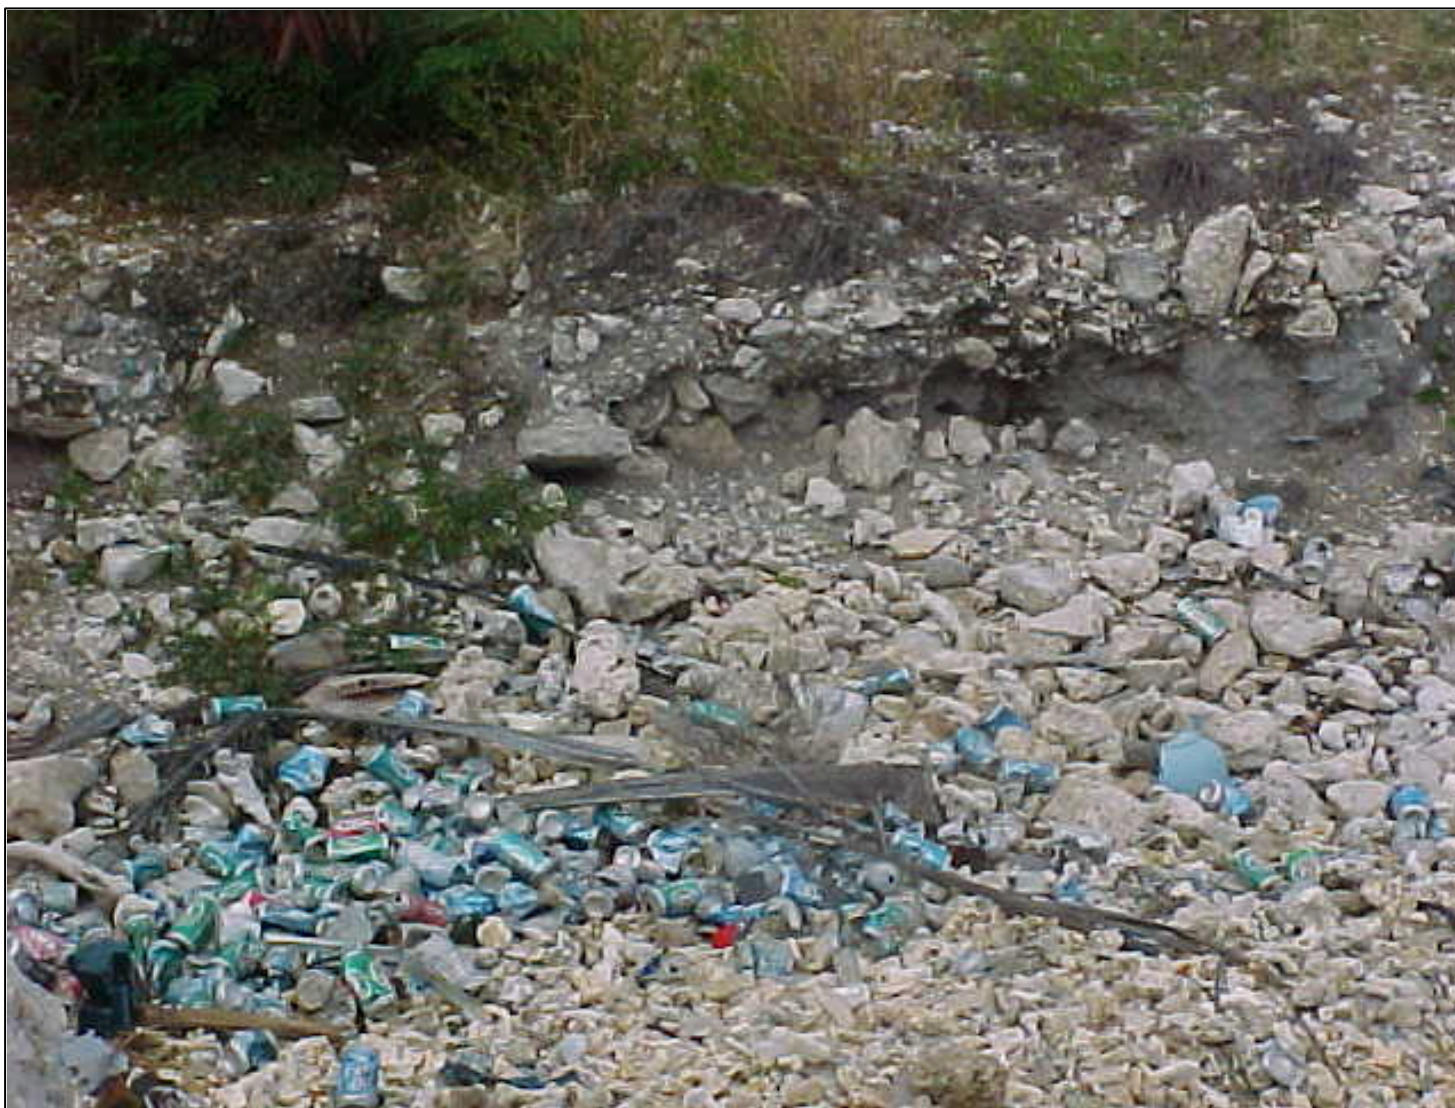
- the height of the scarp is about 0.75 m and exposes coarse, angular limestone fill material (Figures 24 and 25), with undercut sections (Figure 25);
- the entire fill site is contained by a slightly curved (at the top) concrete gravity wall (Figure 26), about 6 m above mean sea level;

*Figure 24. Details of the erosion scarp in Figure 23. Note dislodged gravel and small boulders.*

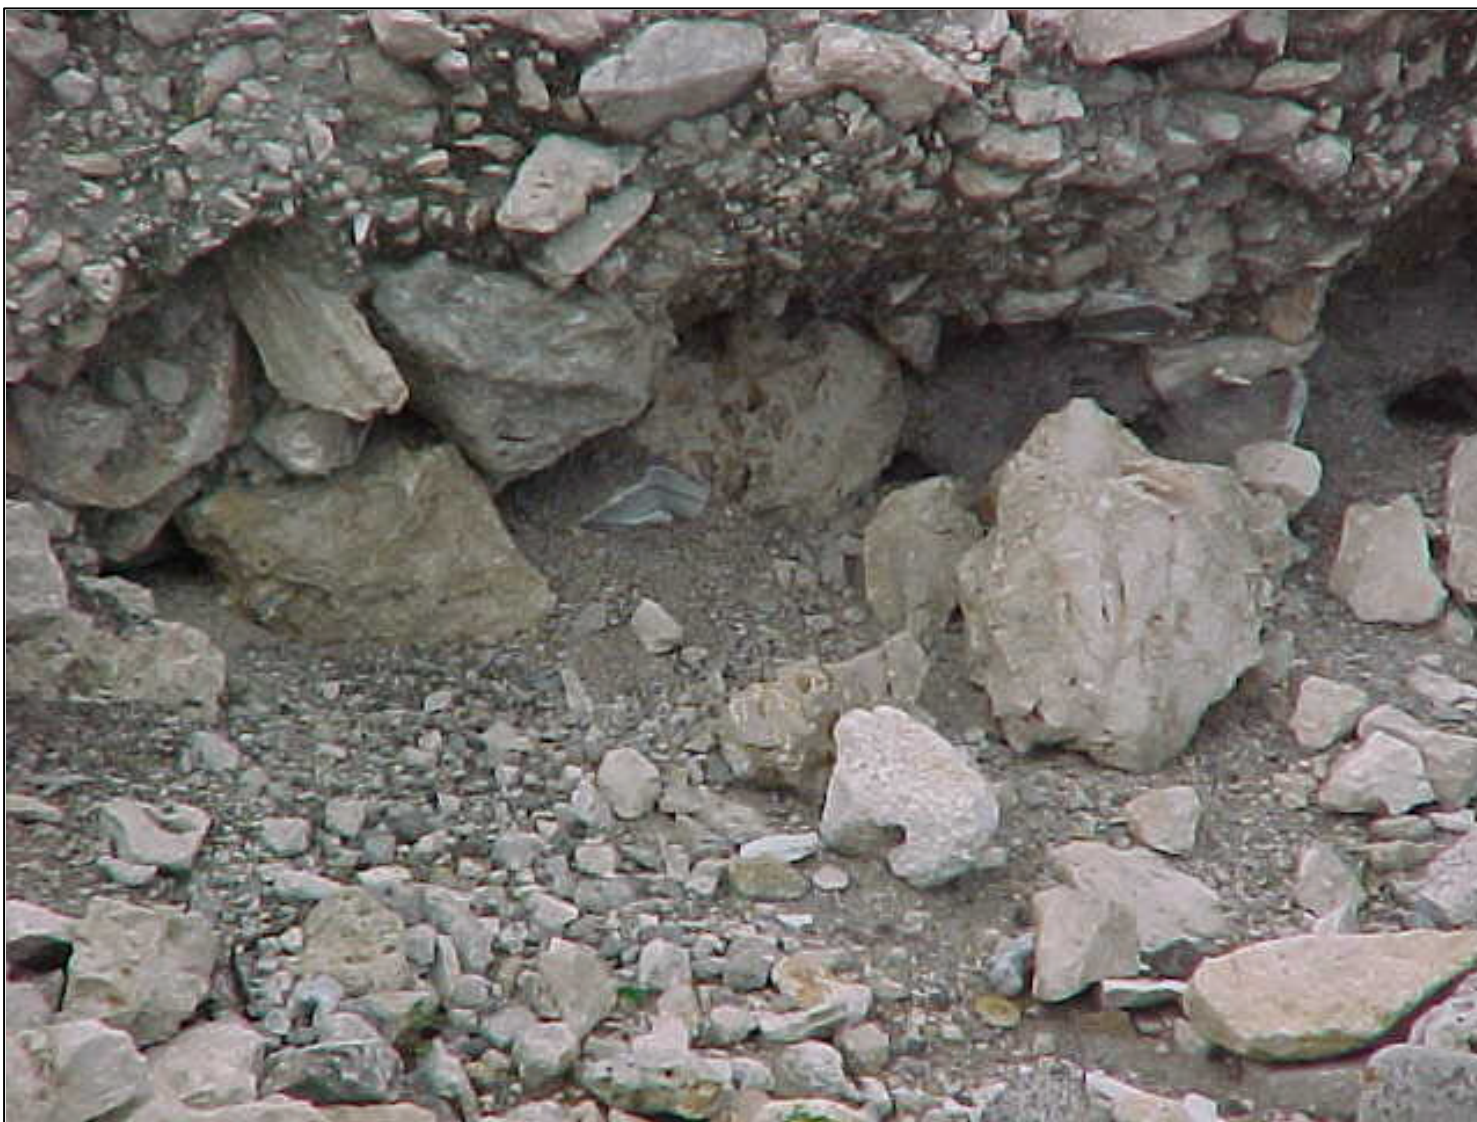
*Figure 25. Characteristics of the scoured area at the erosion scarp in Figures 23 and 24. Note the exposed aggregate fill.*

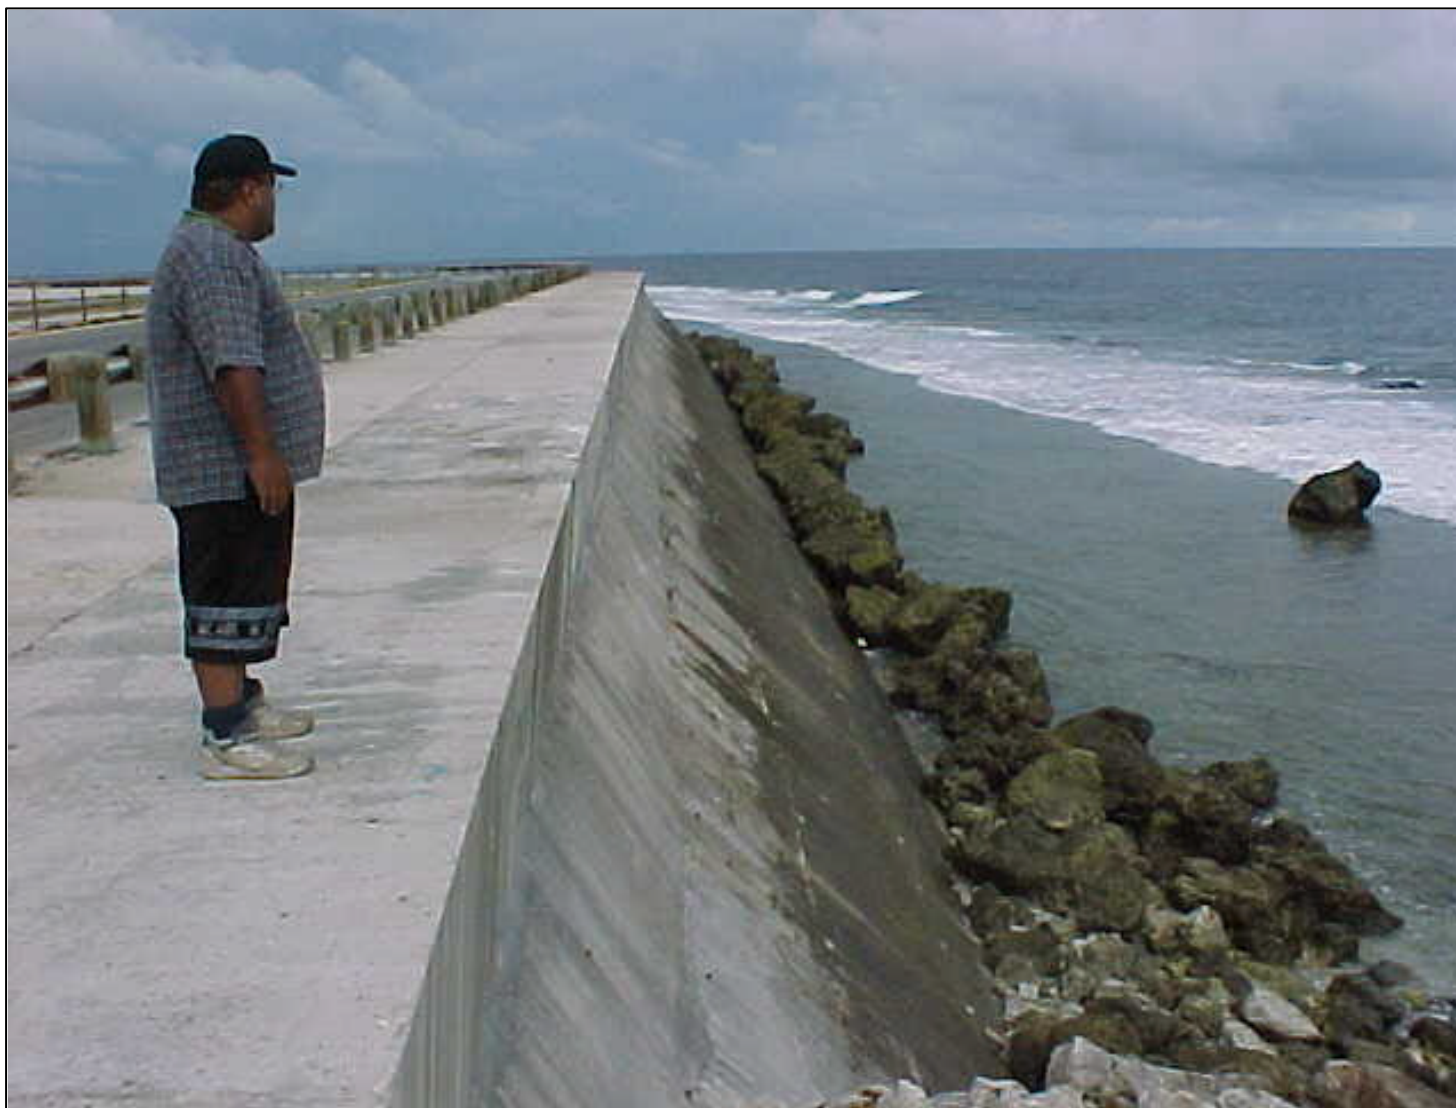
- the top of the wall is about 2.5 m wide;
- toe protection is provided at the base of the wall, in the form of 0.75-1.25 m diameter limestone rip-rap (Figures 26 and 27);

*Figure 26. Gravity concrete retaining wall at the outer perimeter of the airport fill site. Looking east.*

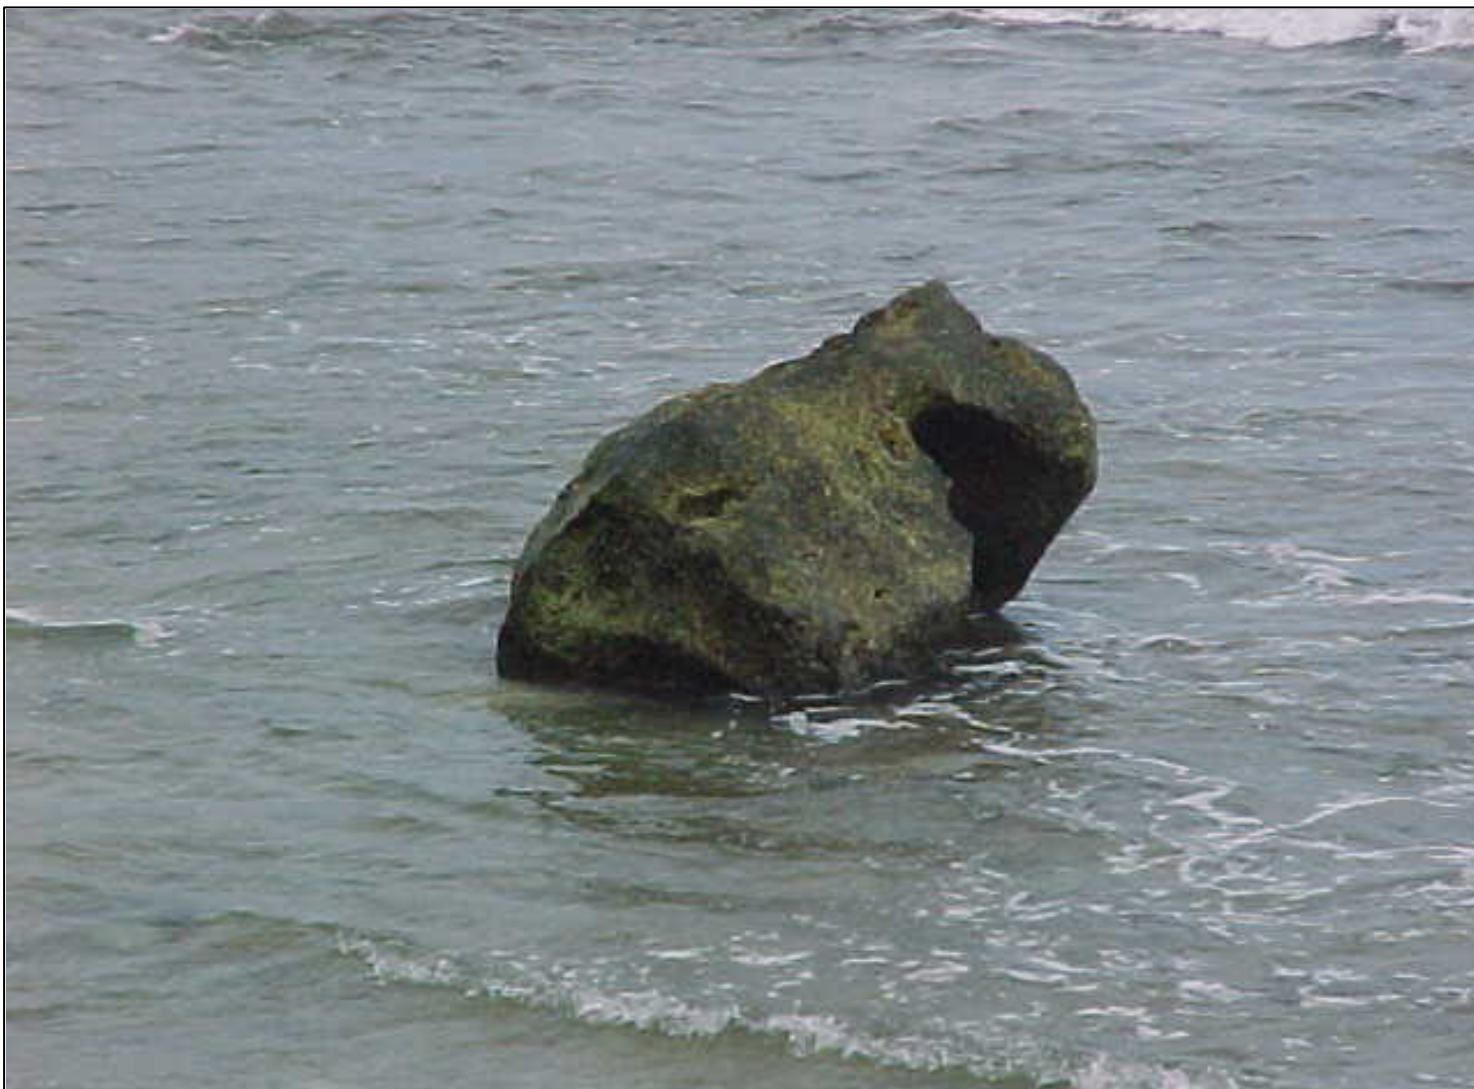
- toe rip-rap may occasionally be dislodged by large waves and during extreme events (Figure 27) and therefore not entirely stable;
- Figures 28-30 show some features of the eastern part of the coastal rip-rap revetment at the airport fill site;

*Figure 27. Dislodged limestone rip-rap boulder removed from the base of the gravity wall (Figure 26).*

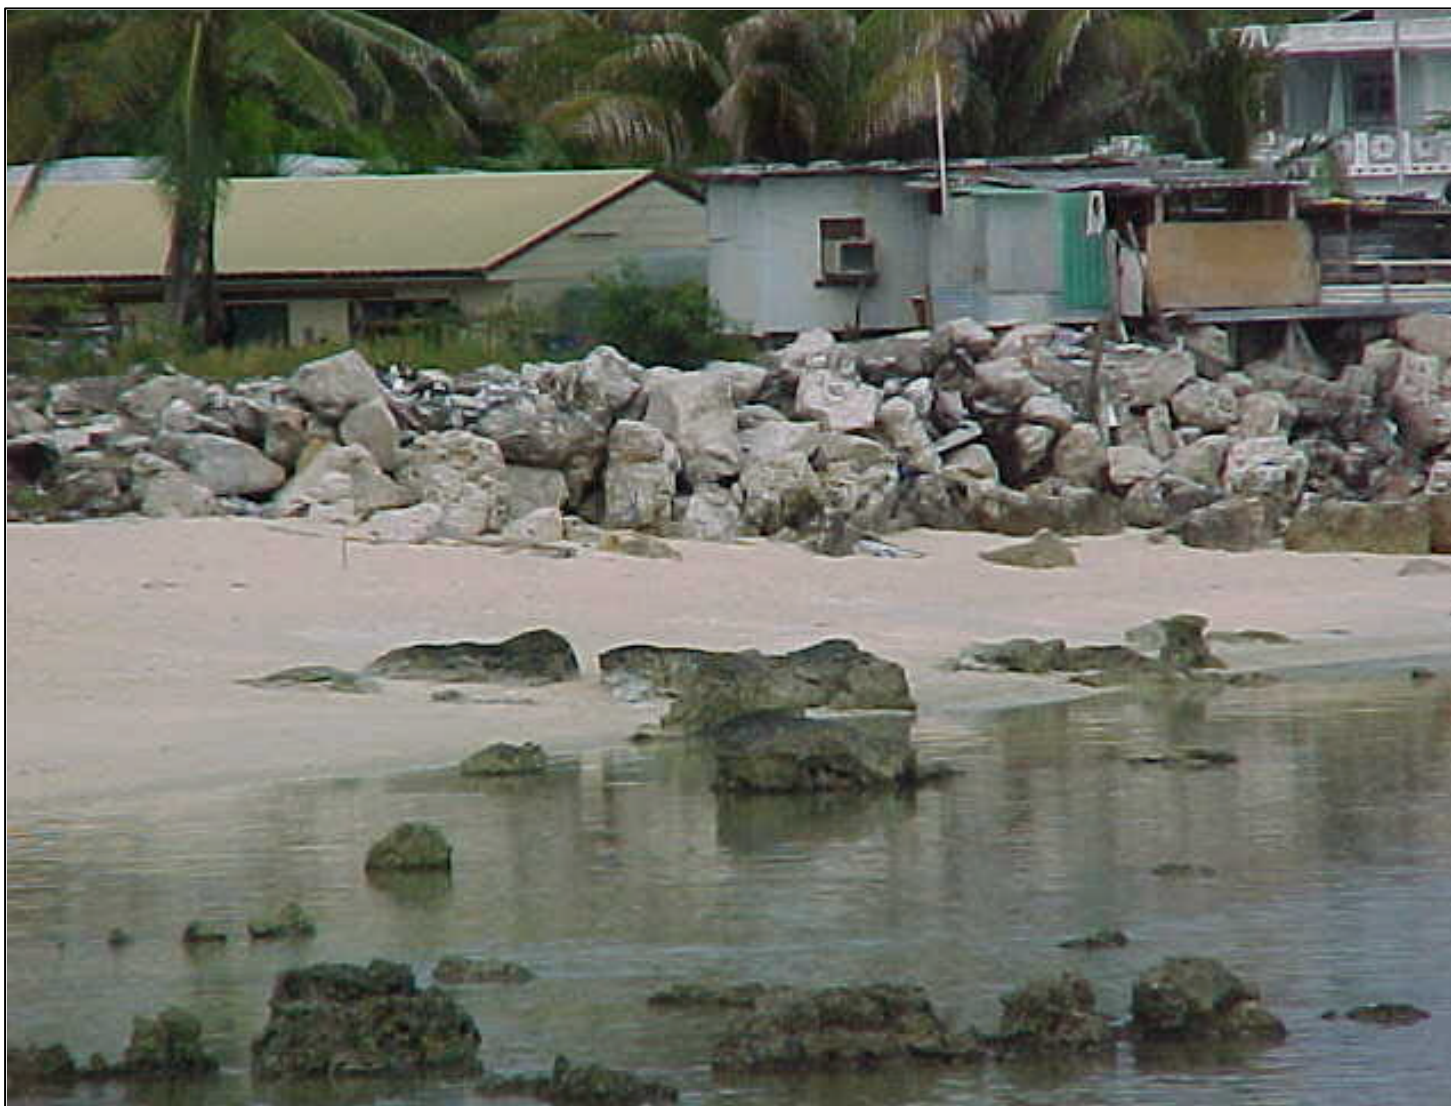
- the residents on the eastern side of the airport fill site have also protected their property with limestone rip rap (Figure 32), indicating erosion problems there as well.

*Figure 32. View looking northeast, showing randomly placed limestone boulders for protection of residential property along the natural coastline to the East of the airport fill site. Note the gentle sandy beach and natural limestone pinnacle in the water.*
