EU EDF 8 – SOPAC Project Report 79  
Reducing Vulnerability of Pacific ACP States

## **SAMOA TECHNICAL NOTE**

### **HYDROGEOLOGICAL LIAISON MISSION TO SAVAI'I**

19<sup>th</sup> to 24<sup>th</sup> September 2006

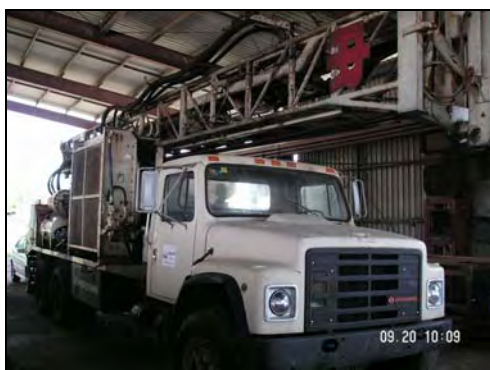
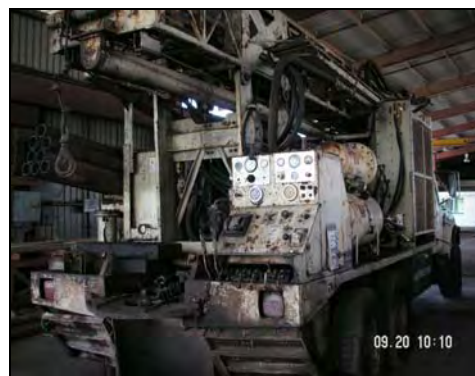
*Secondary inspection undertaken at 16:15hrs, 22/09/06. Driller (of past 2 years – no formal overseas training undertaken – he has learnt “on-the-job”) is Mr Vaalele and Elec-Mechanical Engineer Mr Manuele both on site. Truck moved outside of garage area and the four hydraulic platform support rams were lowered. All hydraulic support rams exhibiting massive leakage of hydraulic fluid – will directly contaminate works soil area, and undoubtedly cause similar groundwater pollution problems on any virgin drilling site. Failure or partial slippage of one or more of these during drilling operations could prove catastrophic for either the borehole, the rig, or the operatives, or any combination of these. The rig mast was then raised and one of the two principal hydraulic mast rams was also clearly leaking. Air compressor leaking oil and significant air pressure losses at numerous points within the compressed air hoses and joints – again potentially fatal if one blows off. The drill stem drivehead is sticking occasionally in the mast, not travelling freely up-and-down, The drilling control panel is a mess, few legible labels on gauges or hand controls. Water temperature gauge and both air pressure gauges are non-functional. Driller also reported that the engine turbocharger is non-functional. No trials were undertaken to witness*

*any drill stem lifting or rotary drilling operations. The leakage of hydraulic and compressor fluids and loss of compressed air pressure not only pose a severe groundwater pollution hazard, but also an unacceptable health and safety risk to rig operatives and nearby observers.*

- It is apparent from simple initial visual inspection that the SWA drilling rig has some very obvious mechanical and hydraulic problems requiring significant investment to enable it to be returned to a fully efficient drilling operation. In its current condition it is highly unlikely to be able to perform at all adequately in the hard basalt terrain of northwest Savai'i without frequent breakdowns, probably terminal! The leakage of hydraulic and compressor fluids and loss of compressed air pressure not only pose a severe groundwater pollution hazard, but also an unacceptable health and safety risk to rig operatives and nearby observers. The author of this report is not a qualified drilling rig mechanical engineer, and it is urgently recommended that such a person is commissioned to undertake a full and detailed condition survey of the rig to determine the relative costs and resources required to enable refurbishment, or alternatively recommend decommissioning/scrapping and utilising external drilling contractors. It is understood that an expert audit such as this is proposed by the PDA consultants, and this is commended and should be endorsed. Terms of Reference (see Annex B) for review of the SWA drilling rig were subsequently drafted on 15/12/06, and provided to WaSSP to enable them to issue a *“Call for Proposals”*. A shortlist of potential contractors for invitation to tender was also supplied.
