Pacific Safety of Navigation Project

Risk assessment for Port Vila harbour, Vanuatu

March 2019

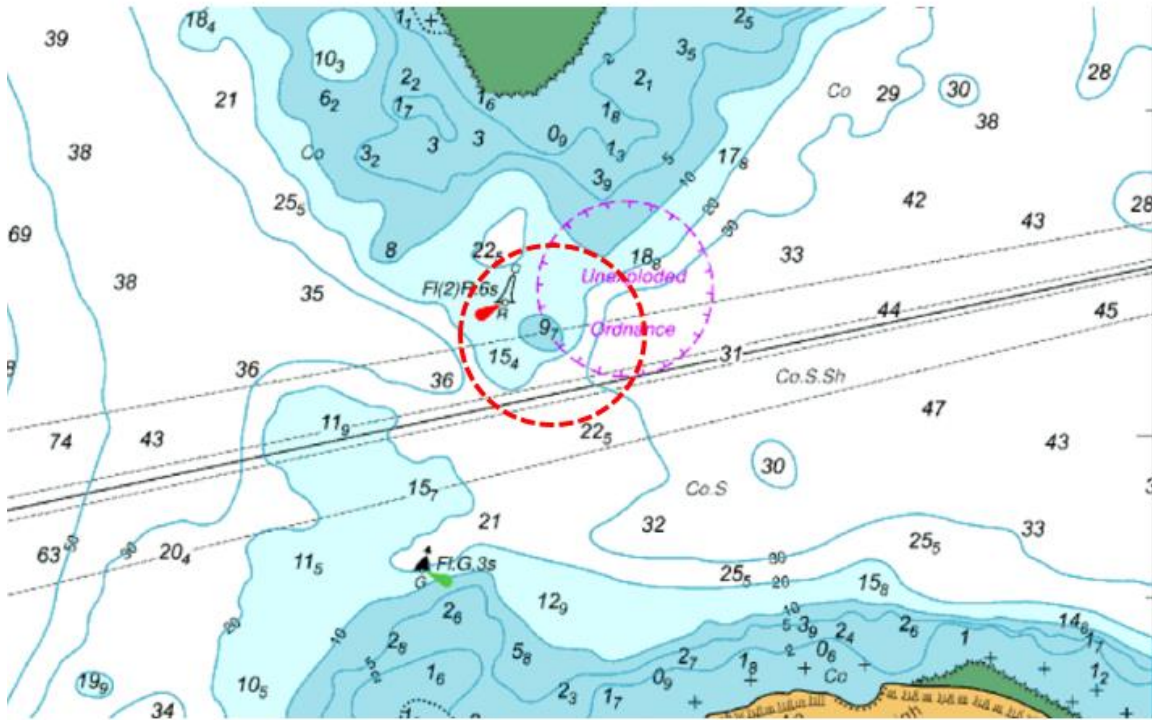
This recommendation addresses potential collisions of large vessels manoeuvring to get in or out of Port Vila Bay with anchored vessels in Port Vila Bay.

It is recommended that mandatory pilotage services be enforced when large vessels are entering or leaving Port Vila harbour during bad weather. It is also recommended to establish a designated non-anchorage area in Port Vila Bay and move the current anchorage areas away from the main route into the wharf; and send a hydrographic note to the United Kingdom Hydrographic Office (UKHO) for amendment to the charts and notice to mariners.

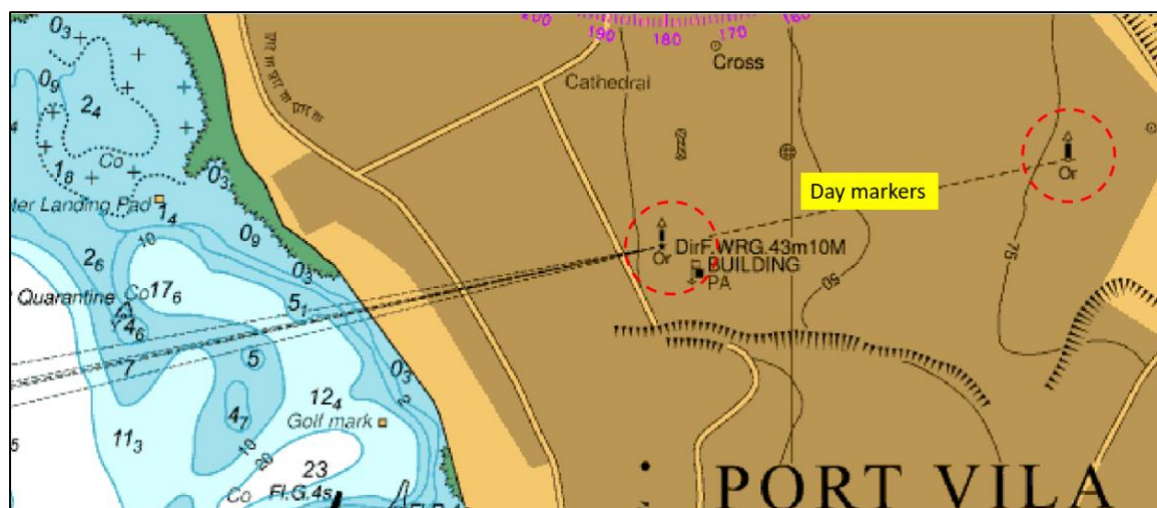
The two daymarks on the leading lights shown in the chart below are not conspicuous against the background. This can pose problems for incoming ships when the lead lights are not working.

It is recommended that a bigger board be erected to replace the current daymarks to make the marks more conspicuous.

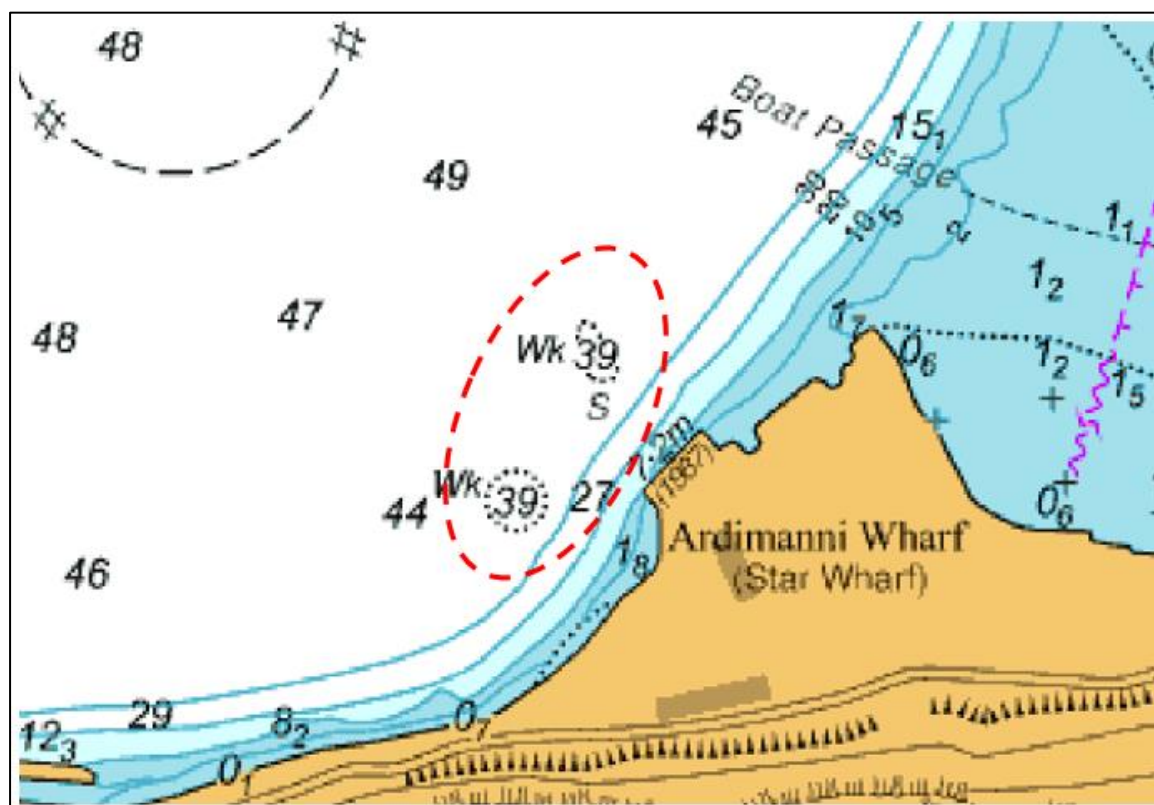
There are two wrecks close to Lapetasi Wharf as shown on the chart below. These wrecks are a potential danger for ships that drop anchor to berth alongside the wharf, as the anchors can get tangled in the wrecks causing serious damage to the vessel, crew and wharf.

It is recommended that the wrecks be removed, or that there is a mandatory tug boat service for vessels berthing at Lapetasi Wharf to reduce the risk to as low as reasonably practicable.
