# VIBRATION ANALYSIS OF THE ISIS SYNCHROTRON DIPOLE MAGNETS

J. Brower, A. Yaqoob, Rutherford Appleton Laboratory, Oxfordshire, UK  
G. Squicciarini, N. S. Ferguson, ISVR University of Southampton, Hampshire, UK

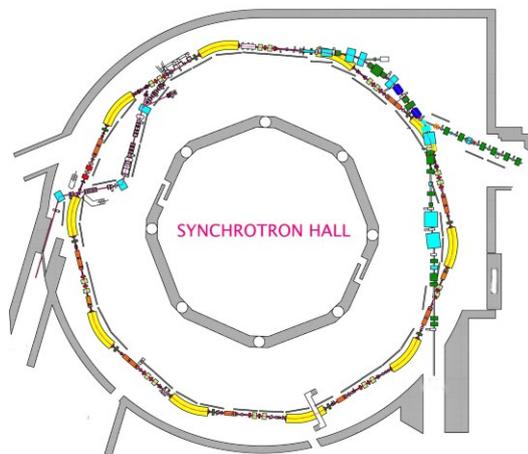
Figure 1 – The ISIS synchrotron with its ten operational dipole magnets highlighted in yellow

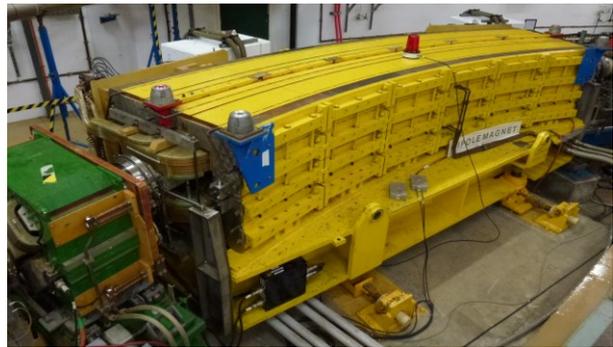
Figure 2 – Synchrotron dipole magnet

The synchrotron contains ten super-periods (SP), each accommodating one 30 tonne dipole magnet (identified as D0-9) (Fig.2). Each dipole comprises an upper and lower yoke supporting an upper and lower coil, which collectively surround the vacuum vessel. A 3 MW main magnet power supply (MMPS) delivers up to 400 A AC at 50 Hz superimposed on a 662 A DC current. This generates a ramping 0.2 - 0.7 T magnetic field, bending the beam 36 degrees laterally in each straight.

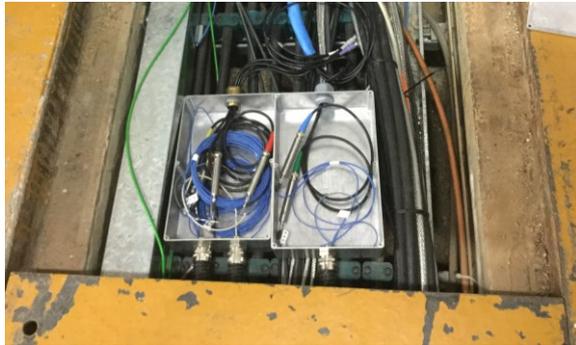
Figure 3 – Termination boxes housing in-line conditioning amplifiers and wiring beneath synchrotron hall floor

The amplifiers were placed in screened boxes within cable ducting (Fig 3) from which 20 m of coaxial cable connected them to National Instruments® (NI) [6] data acquisition (DAQ) equipment housed in a low activity shielded area. In total, eight removable sensors were held by screw threads using PEEK washers glued to equipment. These were attached to the yokes, coil brackets and vacuum vessel of D6 and D7 (Fig 4). Three further sensors were used: one dummy sensor to quantify induced environment cable noise, one floor mounted sensor to quantify room vibration and one sensor with no earthed trunking to further compare induced cable noise. The DAQ system employed was a PXI chassis containing a PXIe-6133 controller and PXIe-4497 sound and vibration module. The module delivered a 4 mA current excitation powering the amplifiers, with anti-aliasing filters providing additional signal conditioning.

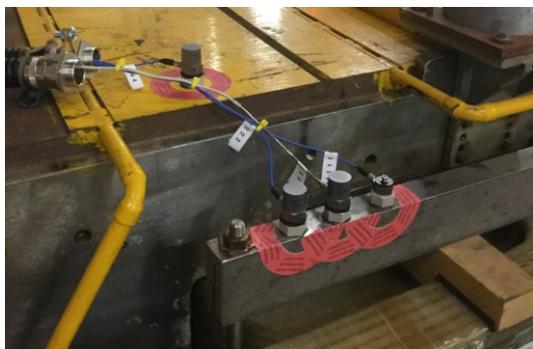
Figure 4 – Sensors on upstream yoke and coil bracket of D7

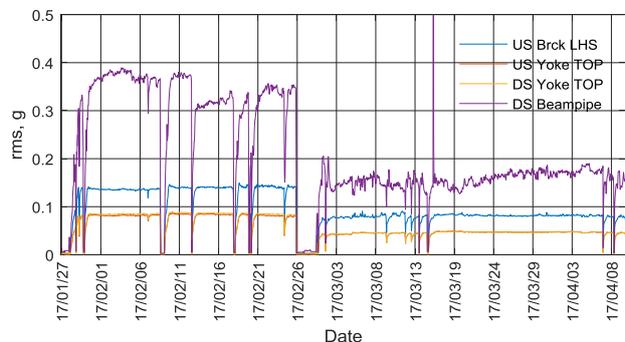
Figure 5 - RMS vibration levels for D7 during first cycle of machine operation

Figure 5 shows the acceleration data from sensors on both ends of the yoke, coil bracket and downstream vacuum vessel (beampipe) of D7. The time window of the RMS measurements was 3 minutes but if reduced, would clearly show more frequent events due to increased granularity. Sudden drops in vibration occurred at various times due to MMPS rundown, temporary faults or planned shut-down maintenance. The vibration levels of the vacuum vessel were the highest at 0.3-0.4 g across the duration of February, peaking on February 4<sup>th</sup>. This component showed the biggest fluctuation over time and took the longest to reach a steady-state amplitude after a shut-down period. All four traces show a significant drop in vibration levels on 26<sup>th</sup> February when the beam energy was intentionally reduced to 700 MeV after the

maintenance day. The sharp peak occurring on the 14<sup>th</sup> March is unclear, possibly due to a momentary sensor or acquisition fault.

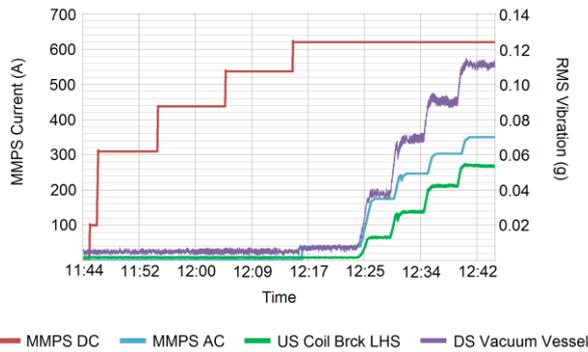
Figure 6 - Correlation between MMPS current ramp and D7 vibration

Figure 6 shows a more detailed view of the MMPS DC and AC outputs together with the corresponding RMS vibration from two sensors on D7; the upstream coil bracket (s/n 47208) and vacuum vessel (s/n 47641). The AC ramping is clearly identifiable from the sensors showing that the vacuum vessel has double the amplitude, this is as yet unexplained. For all of the acquired data, the frequency content of the vibration exhibits discrete tonal components at multiple integers of 50 Hz with the 100 Hz component dominant (Fig 7). This was found to be 10-20 dB above the 50 Hz component. Higher order harmonics were also clearly evident in the spectrum up to the maximum frequency analysed, but these were generally at least 20 dB below the 100 Hz component. In addition to the 50 Hz harmonics, there was also a series of harmonics for a fundamental frequency component of 25 Hz, these were much lower in level (60-80 dB below the 100 Hz) and may reflect the presence of a vibration mode at nearly 25 Hz.

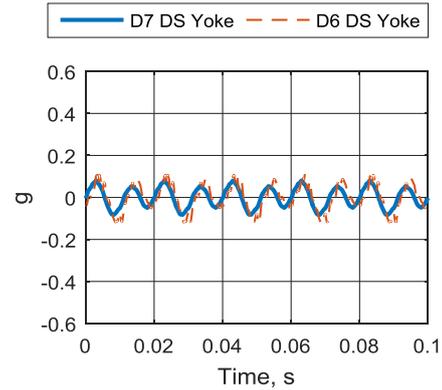
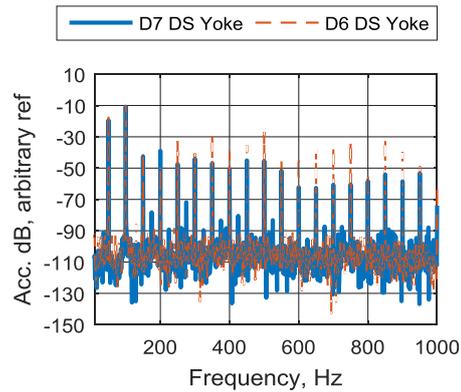
To confirm that the data from D7 was representative, measurements were taken over 10 days of a second cycle of operation from identical downstream yokes located on D6 and D7 (s/n 47640 and s/n 47639). Figure 7 upper graph shows similar amplitudes of 0.2 g peak to peak with a small phase difference and the lower graph, using FFT analysis, shows identical frequency components, however with different amplitudes.

Figure 7 - Data from downstream yoke on D6 and D7. Upper graph time domain signals and lower graph corresponding frequency spectra

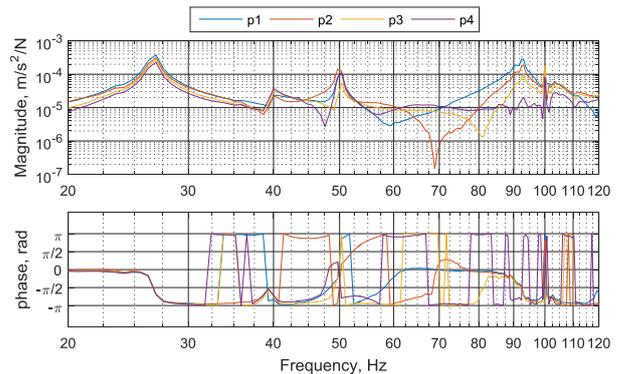
To identify how different magnet components vibrate with respect to each other, modal analysis on the response data was conducted using controlled excitation to identify the natural frequencies, mode shapes and damping. Figure 8 shows the transfer functions between the acceleration responses measured at the upstream yoke sensor (s/n 47211) and the force from an impact hammer. The latter was applied at four points on the top of the yoke, p1 to p4, which were equally spaced on the top of the yoke between the upstream end and the magnet longitudinal midpoint respectively. There was a clear presence of a vibration mode at around 26Hz with all four points moving in phase. There were peaks at 40 and 50 Hz; the latter was likely due to electrical noise while the reason for the 40 Hz remains unclear.

Neither of these two peaks showed the 180° change of phase typical of vibration modes as they pass through resonance and the coherence function (not shown here) drops in this range. At around 93 Hz there is a broad peak and at the same frequency the phase for points p1 to p3 shows the 180° change of phase.

Figure 8 - Magnitude and phase of measured point and transfer accelerances at 4 points on the top of the yoke of D7 for excitation at point p1

The study collected 1.5 TB of data across 90 days of operation from 11 sensor locations. The typical signal-to-noise ratio (S/N) of the data was >20 dB from all sensors. Comparing data from two adjacent sensors (s/n 47639 & s/n 47640) mounted on the downstream upper yoke following the same cabling route, one using earthed KOPEX trunking and one without, showed no difference to the S/N ratio. Comparisons between the dummy sensor (s/n 47210) and an adjacent sensor (s/n 47208) mounted on the upstream coil bracket of D7 again showed no impact on signal quality from extraneous noise at full beam energy. Sensors mounted adjacent to magnetic field of <80 mG on the coil bracket of D7 had no measurable interference. There was also no measureable impact on any data within the measured bandwidth from any sensor due to RF, radiation or beam however there was 50 Hz electrical noise in the recorded data (Fig 8)

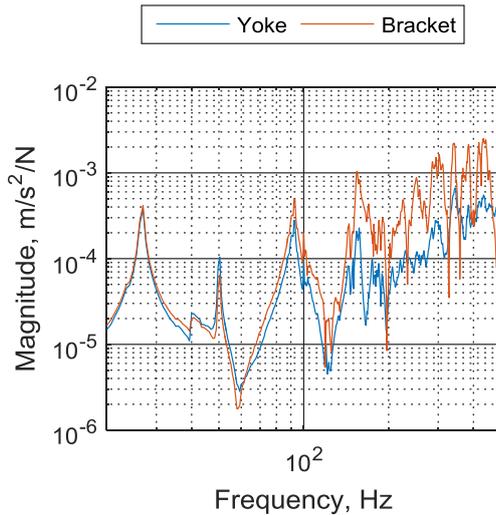
Figure 9 - Point accelerances measured on the yoke of D7 at p1 and transfer accelerance between p1 and the coil bracket

Figure 9 shows the point accelerance at p1 compared with the transfer accelerance between p1 and the sensor on the coil bracket (s/n 47208). Two natural frequencies were identified at 26.7 Hz and 92.3 Hz. The damping ratio was 11.3% for mode 1 and 15% for mode 2. The yoke and the coil bracket were found to vibrate with the same amplitude and phase (not shown here) up to 100 Hz, above which the higher flexibility of the bracket resulted in higher vibration levels and different phases.
