# Melekeok Conservation Network In Situ Water Quality Monitoring Report Palau

By Leena M Mesebeluu  
Ministry of Natural Resources, Environment, & Tourism, Palau  
April 2021

Produced by GEF Pacific International Waters Ridge to Reef Regional Project,  
Pacific Community (SPC), Suva, Fiji

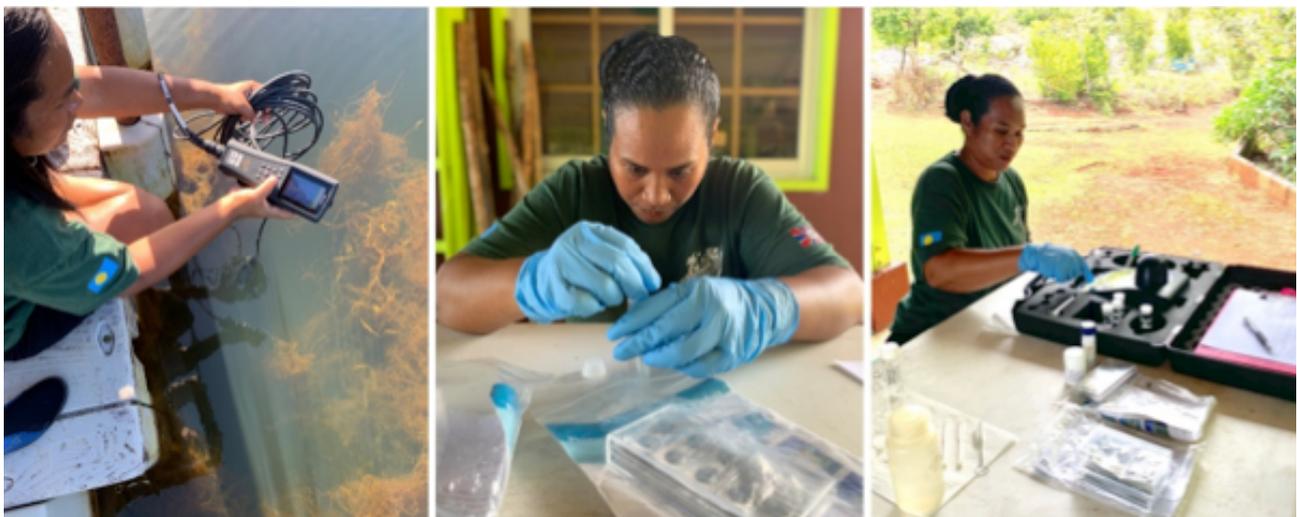
Figure 8. Ms. Oberang Antonio conducting fieldwork and sample analyses

Monitoring occurred twice a month from September 2018 to September 2019. The lake and its corresponding streams are not uniform in depth and width. For the YSI multiprobe, sampling locations were sampled mid-depth except for site 1, which is a shallow stream. For nutrients, samples were obtained by immersing a hand-held open bottle with the mouth of the bottle directed towards the current.

Nutrient samples were obtained and analysed the same day (taken in the morning and analysed by noon) at the NNR Field office. Field blanks and nutrient samples collected were prepared based on YSI 9300 Photometer manual instructions.
