CCOP/SOPAC Technical Report 82

**INITIAL SURVEY OF THE BETIO/BAIRIKI
CAUSEWAY, TARAWA, REPUBLIC OF KIRIBATI**

September 1987

John R Harper

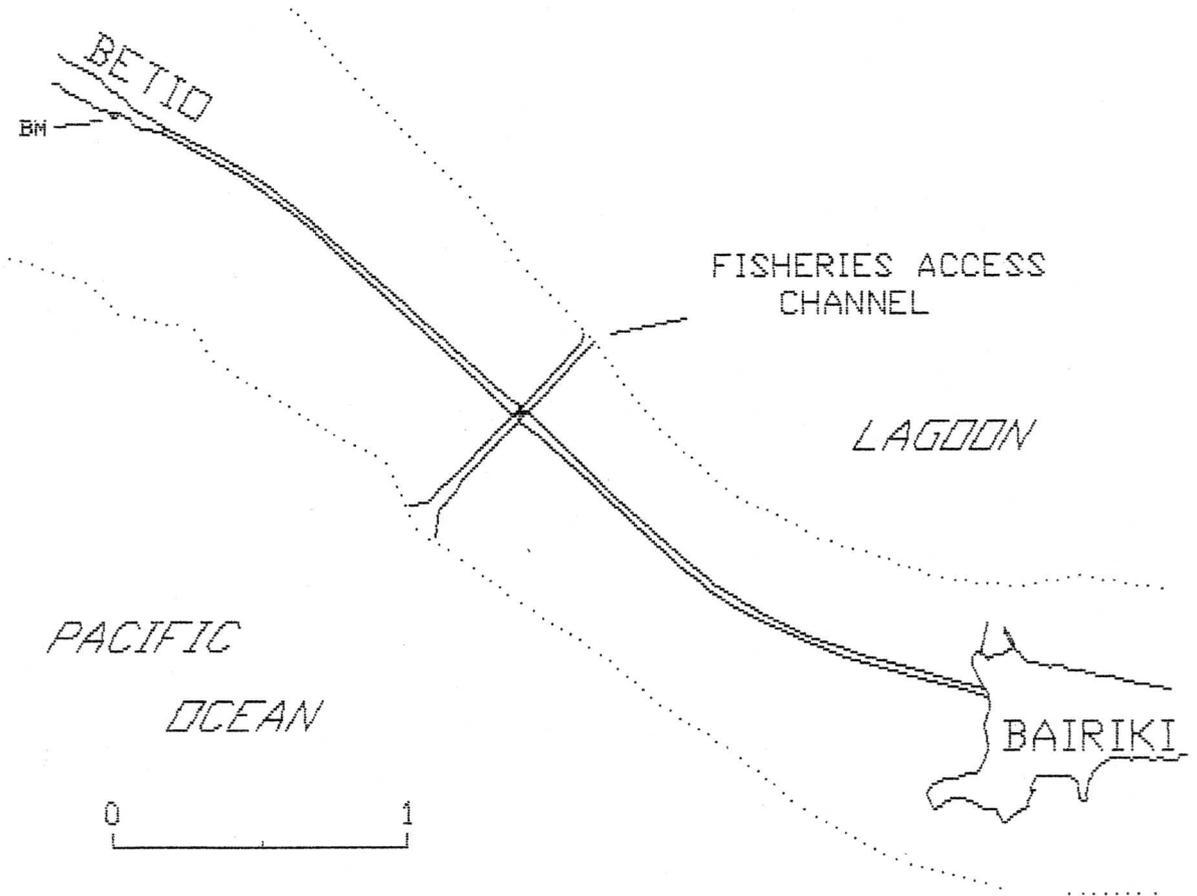
FIGURE 2 Location of the Betio/Bairiki causeway and fisheries access channel.

The causeway is of solid fill construction, 3.4 km long and contains a single breach as access for small fishing boats, known as the "fisheries access channel" (Figs 2, 3). Although no "as built" drawings have been produced, construction followed design very closely, and design drawings adequately depict construction detail (Bill Young, pers. comm., 1987). Design sections are shown in Figure 4 and design specifications provided in Table 1. The concrete slope protection consisted of "grout-filled fabric" which took on the appearance of concrete pillows.

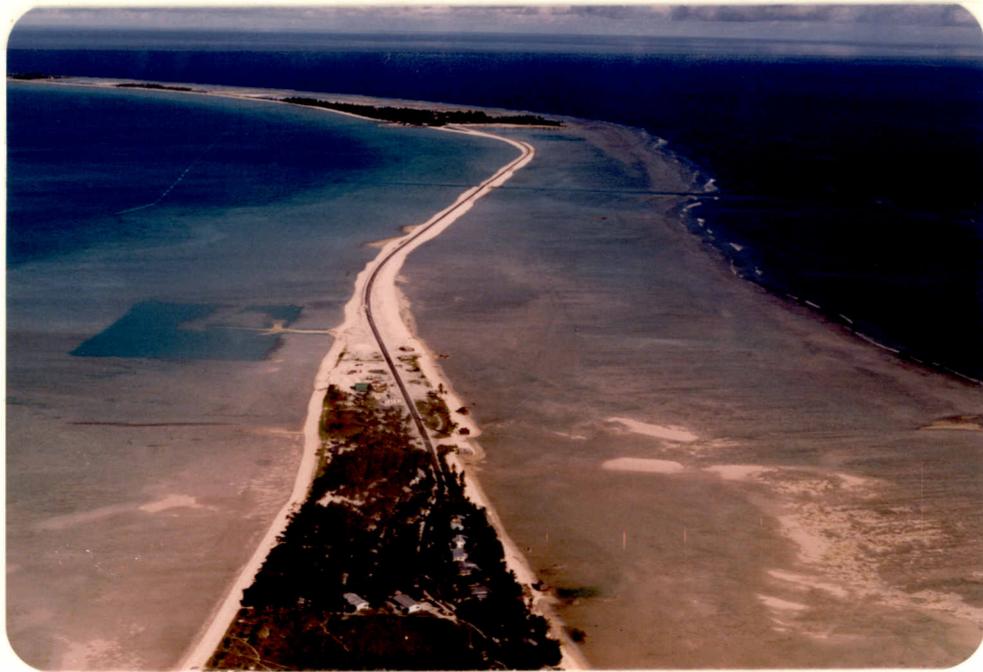
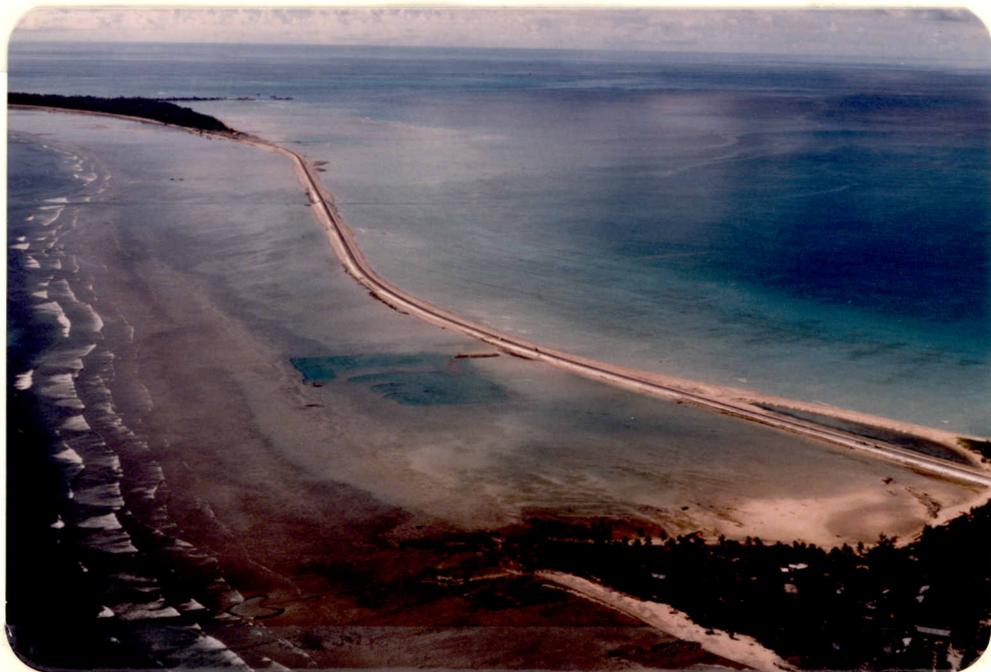
FIGURE 3 (a) Aerial photograph of the Betio end of the causeway looking eastward (September, 1987).

(b) Aerial photograph of the Bairiki end of the causeway looking westward (September, 1987).

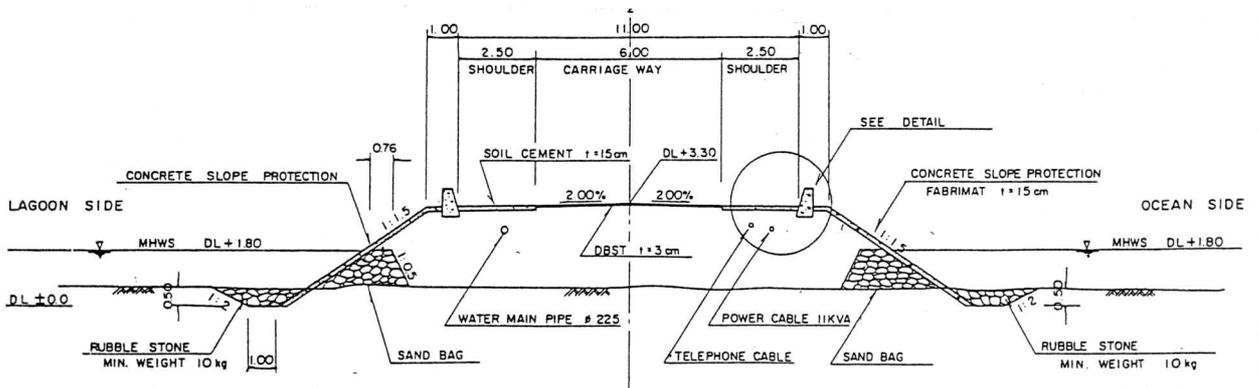
A design formation height of +3.3m was chosen to allow for some camber of the causeway road surface. In addition, concrete dividers or parapets extend up to +3.8m to provide additional protection against wave run up (Fig. 4).

FIGURE 4 Typical design cross-section of the causeway
(from JICA, 1985)

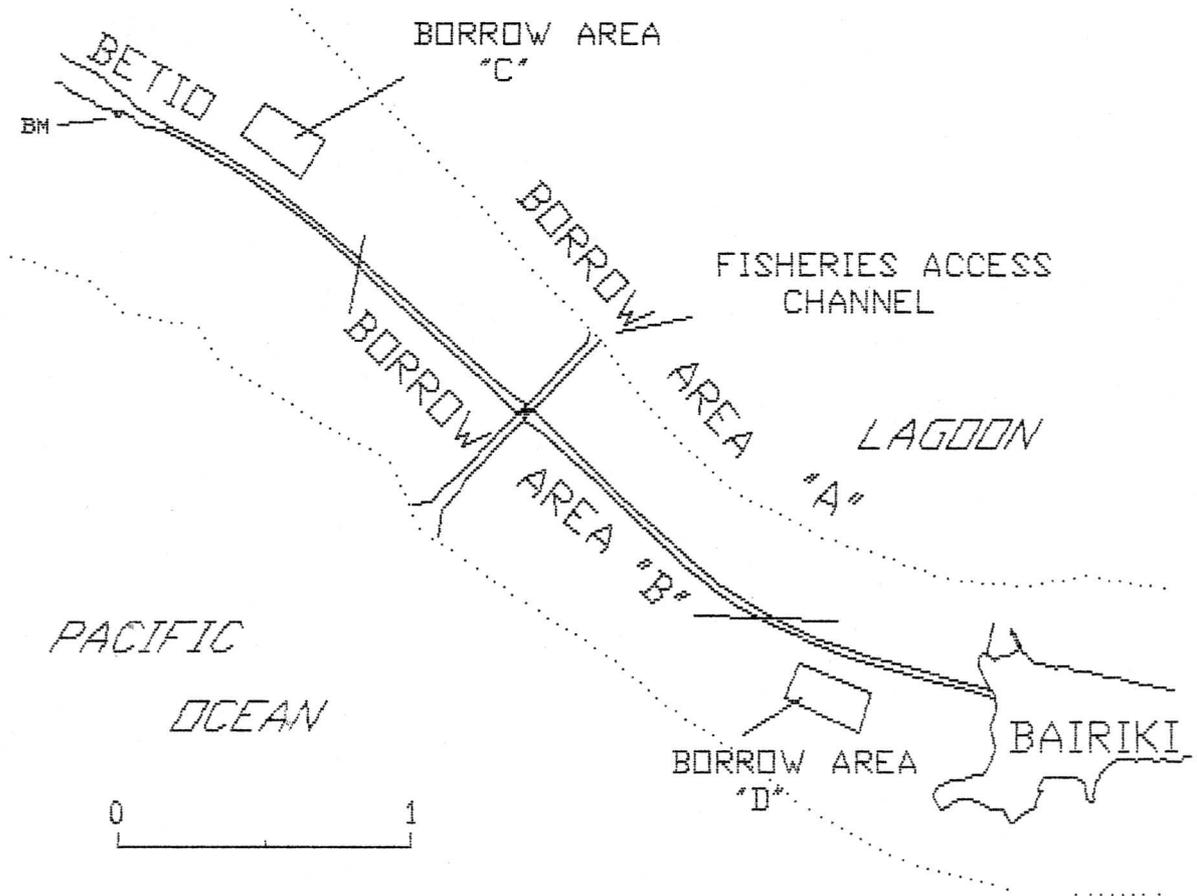
Fill was taken from 3 areas near the causeway (Fig. 5) in addition to the aggregate from Bonriki. No precise estimates on the amount of fill taken from each area are known, however, previous estimates of fill in the bars along the causeway alignment, referred to as Borrow Area "B", were in the order of 90,000m³. Amounts taken from borrow Areas "C" and "D" could have been as much as 75,000m³ each (JICA, 1985). In addition, as much as 22,000m³ was excavated from the fisheries channel, an unknown amount of which was used for toe-protection and fill.

FIGURE 5 Location of borrow areas from which fill material was taken for the causeway. Area "A" was not used during the latest construction phase but was used during a previous construction attempt.

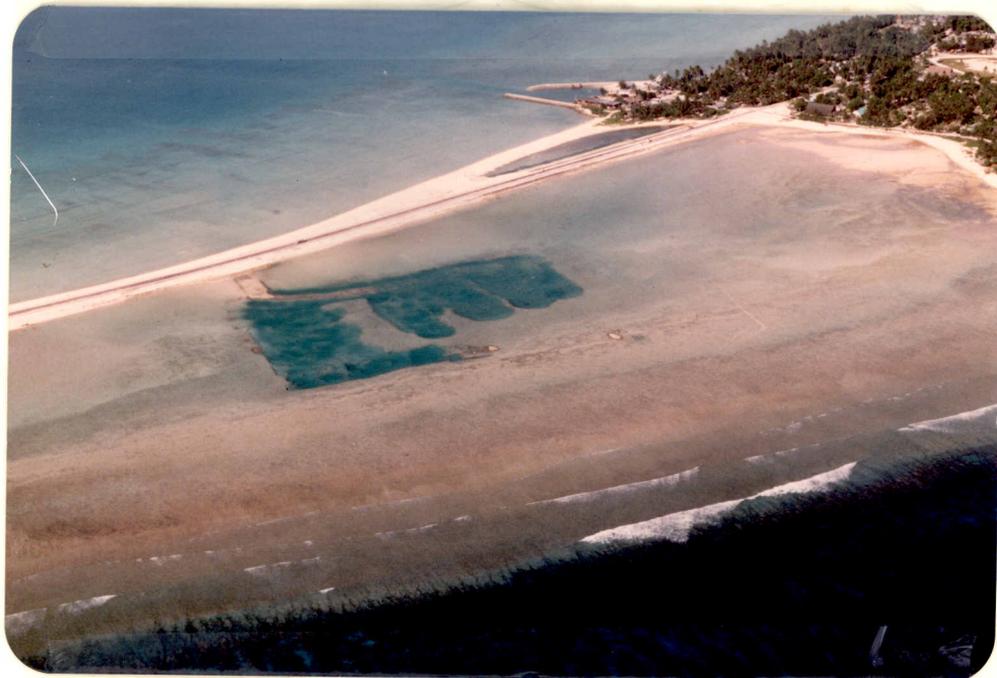
Borrow pits were made in two areas, one to the southeast and one to the northeast of the causeway (Borrow Areas "C" and "D" of Figure 5). There is no documentation on the amount of material removed and pits did not follow the original design. They are smaller in area and considerably deeper (Fig. 7). As such, they are likely to act as significant sediment sinks until such time as they are

FIGURE 7 Aerial photograph of Borrow Pit "D" near Bairiki (September, 1987).

filled. This may involve up to 150,000m³ (design estimates of fill required for causeway; JICA, 1985).

1. In that the borrow pits and fisheries access channel appear to be acting as sediment sinks to the system, it is recommended that (a) the pits and (b) the channel and immediate approach areas be sounded to monitor changes in sand volumes. This will allow refinement of the sediment budget.
2. The surveys of sand accumulation adjacent to the causeway should be repeated at four-month intervals during the first year to ascertain sand accumulation rates.
3. Beach profiles on Betio and Bairiki should be resurveyed in early 1988 and subsequently at four-month intervals to monitor potential effects on beaches, particularly Betio.
4. Acquire a SPOT satellite image of South Tarawa to document areal extent and morphology of reef flat sand bodies (i.e., develop baseline data on immediate post-construction sand distributions).

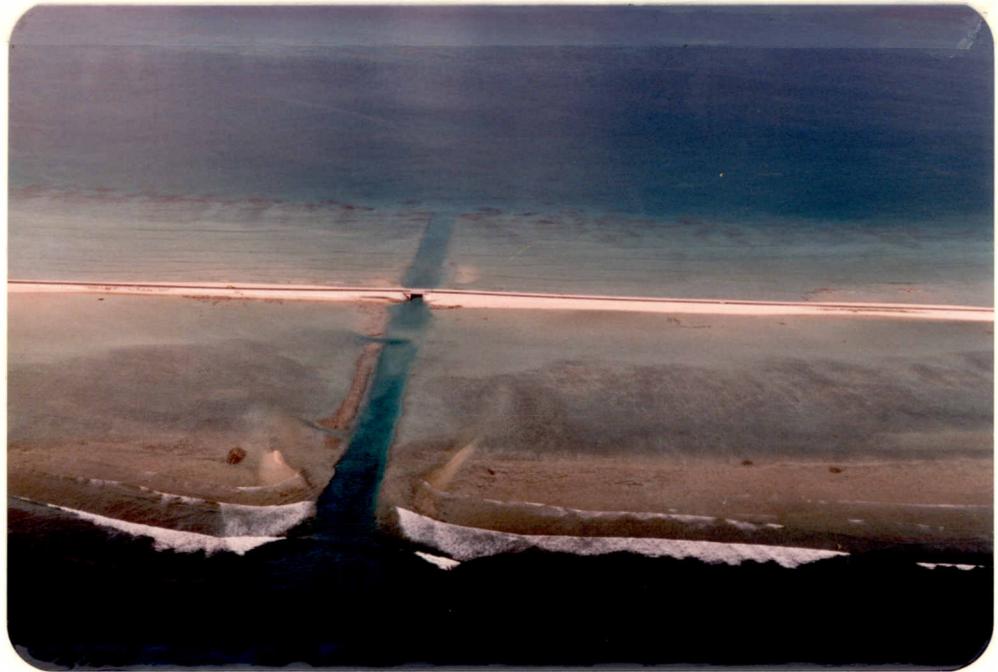
Channel In general, the fisheries access channel appears to be performing as per design (e.g. providing all-tide access across the reef) with one exception. At a location approximately 100m south of the bridge, the channel is infilled with sediment to a depth of -0.2m relative to datum (Fig. 8). With this exception, the channel appears to be near design depth at most locations. Also, observations of breaking waves at the reef edge at high tide indicate that wave breaking does not occur at the channel mouth.

The reason for the channel infilling is of potential significance to the sediment budget of the area. There is ponding of water between the outer reef and the causeway. The base of the reef flat appears to be about 0.5 to 1.0m above datum and as the tide level falls below this level, water and sand drain off longitudinally into the channel. The sand apparently accumulates where the longitudinal flow intersects the channel, although this is surprising given the strong currents that occur in the channel (design estimates were up to 3 m/s or 6 knots; JICA, 1985). Up to 500m³ has accumulated there since the channel opening.

Sand accumulation is of concern because it affects the navigability of the channel (water depth of about 0.3m at MLWS) and because it indicates that the channel is a significant sediment sink for sand production on the south reef flat. The 500m³ of sand accumulation is equivalent to the annual sand production for the south reef flat adjacent to the causeway (refer to section "Sediment Budget" for details).

FIGURE 8 (a) Fisheries access channel looking toward the lagoon. Note the shoal area in the channel due to draining of the reef flat. Note also the greater beach width to the right of the bridge, indicating a right-to-left longshore transport (westward) on the ocean side.

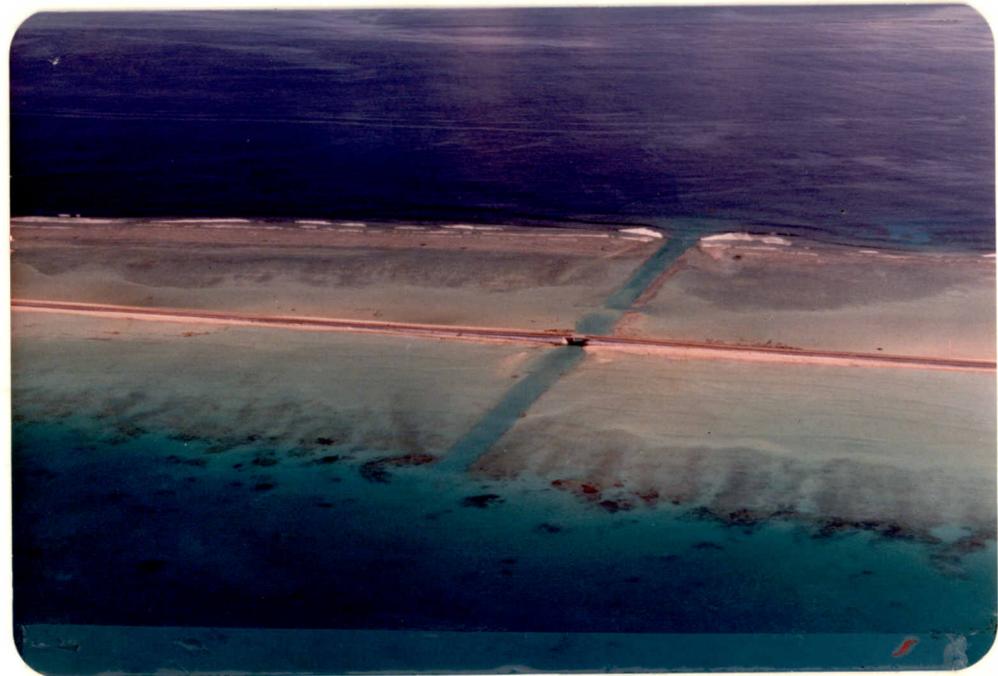
(b) Fisheries access channel looking toward the ocean. The greater beach width to the right of the bridge indicates a right-to-left longshore transport (eastward) on the lagoon side.

side of the fisheries channel (Table 2). The measurements suggest east-to-west transport on the ocean side and west-to-east transport on the lagoon side. The fisheries channel appears to be a sediment sink for material being transported in either direction along the causeway (Fig. 8).

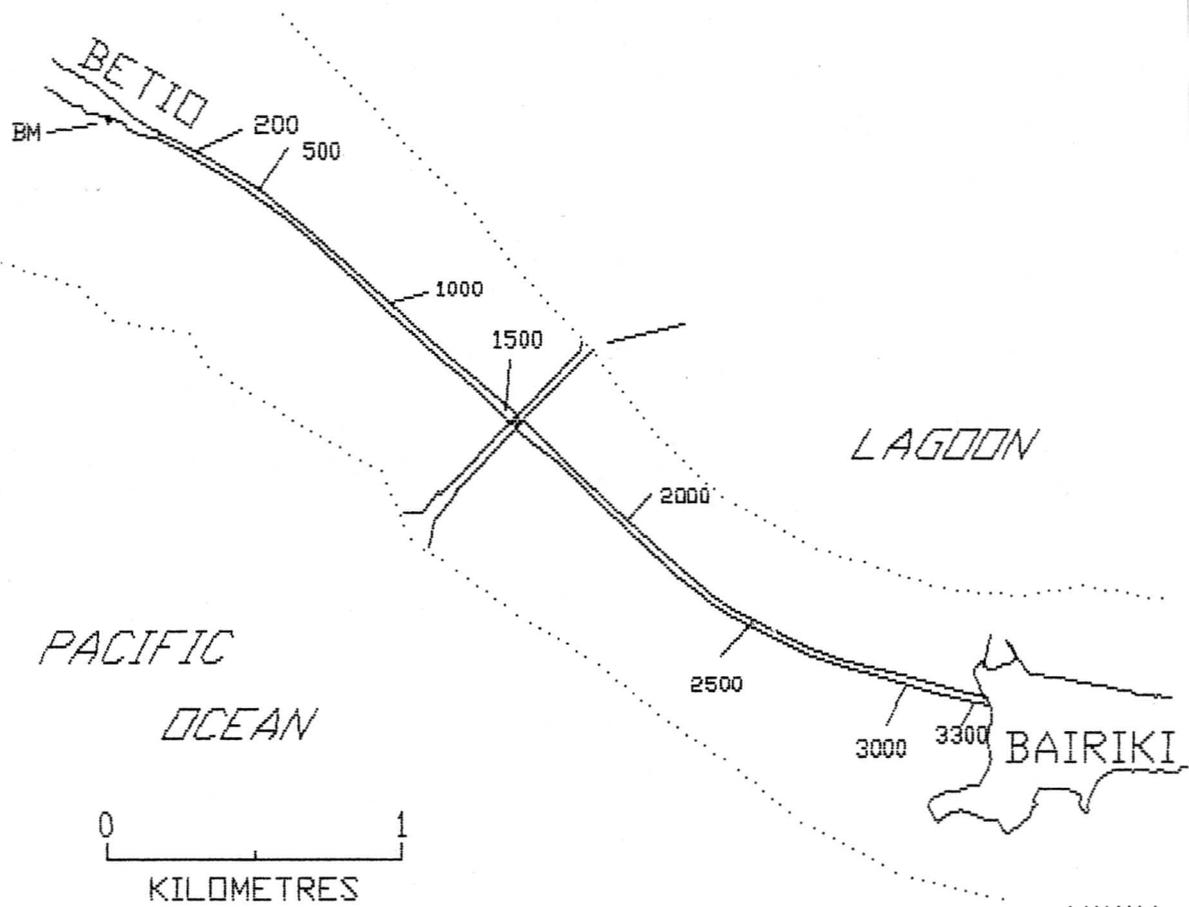
In September 1987, cross-causeway profiles were surveyed at 100 m intervals along the causeway (Fig. 9) to estimate sediment accumulation adjacent to the causeway. Beach profiles and survey data are included in Appendices A and B. An example of a post-construction beach profile is included in Figure 10.

FIGURE 9 Location of causeway beach profiles. Profiles were surveyed every 100 m, beginning at location 200 (near the western end of the causeway) and extending to location 3300 (near the eastern end of the causeway).

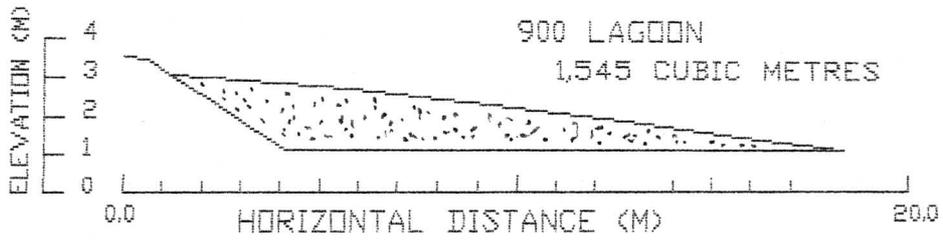
Sediment accumulation volumes were estimated by (a) measuring the cross-sectional area between the causeway design profile and the beach surface, and (b) extrapolating this area to the 50 m sections on each side of the profile. The volume of sediment associated with each profile is indicated in Table 2. The data are useful for assessing the immediate post-construction performance of the causeway and the potential effects on the local sediment budget.

FIGURE 10 Example of a beach profile adjacent to the causeway. The shaded area indicates accumulated sand material.

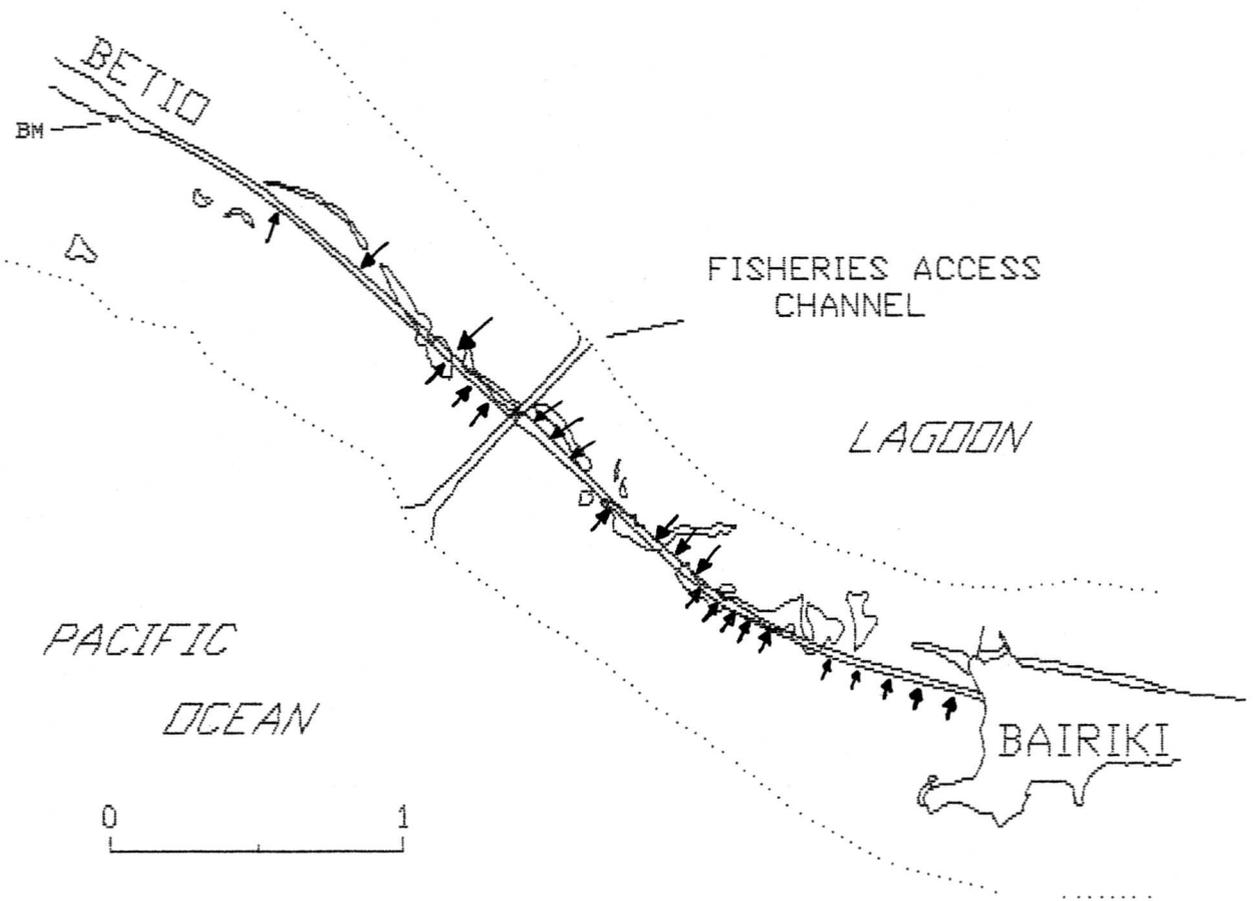
Alongshore variations in sediment accumulations are more significant on the ocean-side of the causeway (Table 2) and there are several locations, where virtually no sediment has accumulated. An overlay of the pre-causeway bar positions in

1969 (Fig. 11) indicates that the areas of present sediment deficiency cannot be correlated with former tidal channel positions.

FIGURE 11 Relationship of bar positions (June, 1969) to present areas of sediment deficiency (indicated by arrows).

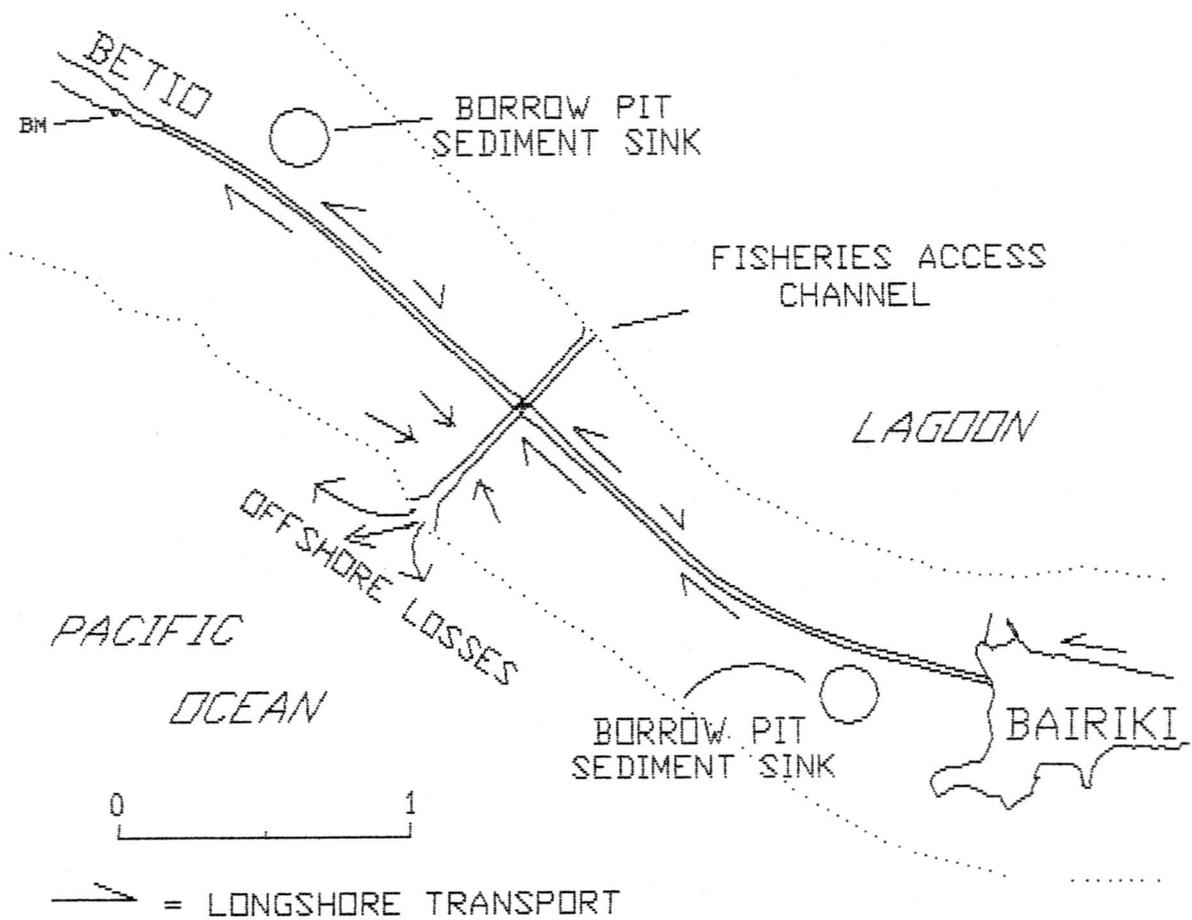
Major features of the observed sediment transport system are summarized in Figure 12. At the time of the survey, longshore transport appeared to be to the west on the ocean side and to the east on the lagoon side. It is anticipated that the net (long-term) drift along the ocean side will be to the west. However, the apparent eastward longshore drift along the lagoon side is probably due to the anomalous occurrence of westerly winds for 1987. Past accumulations of sand to the east of the Betio and Bairiki jetties indicate dominant east to west transport. However, these areas are currently being eroded, supporting the observation that the westerly winds may be temporarily causing eastward transport along the lagoon shore.

The fisheries access channel has completely silted in at one location (est. 500m³) and appears to be interrupting longshore sediment transport. If the net transport in the channel is to the south, most of the sediment will be lost off the reef edge and lost from the system.

FIGURE 12 Summary of sediment transport paths around the causeway (larger arrows indicate present dominant transport directions).

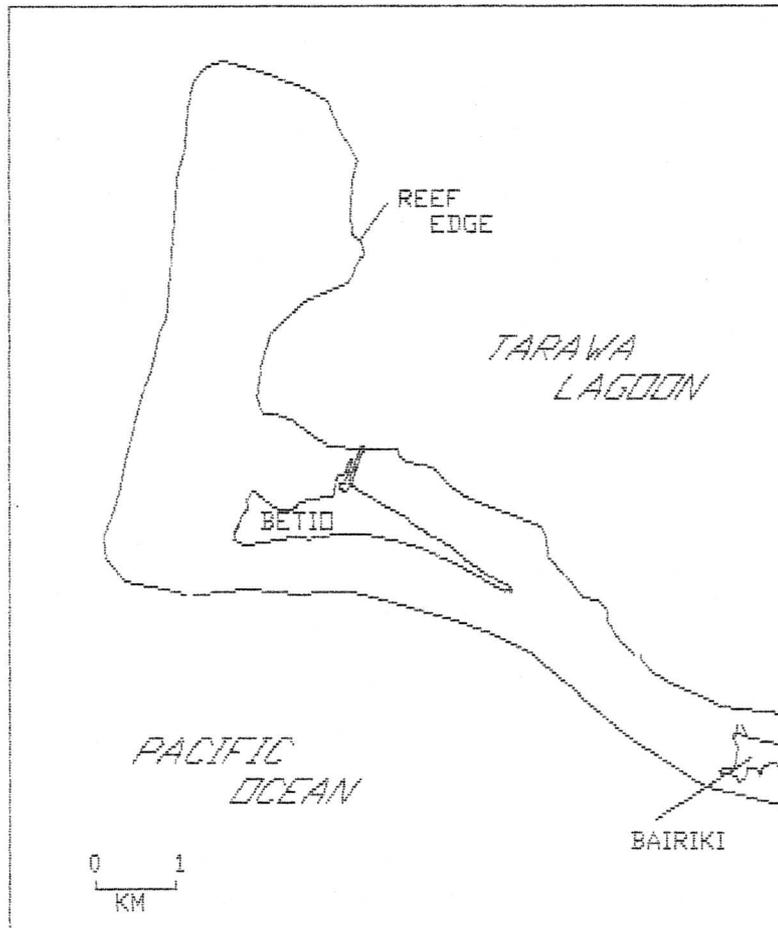
A sediment budget was developed to assist with an assessment of potential impacts. This sediment budget is summarized in Table 3. For purposes of this discussion, the area of concern is the Betio to west Bairiki coastline and reef area (Fig. 13). Any increase of sediment losses to this system could result in accelerated coastal erosion on Betio.

FIGURE 13 The area of the "coastal system" used in the sediment budget calculations.
