# Multibeam Bathymetry Survey Rangiroa, French Polynesia

September 2013

**SPC SOPAC TECHNICAL REPORT (PR106)**

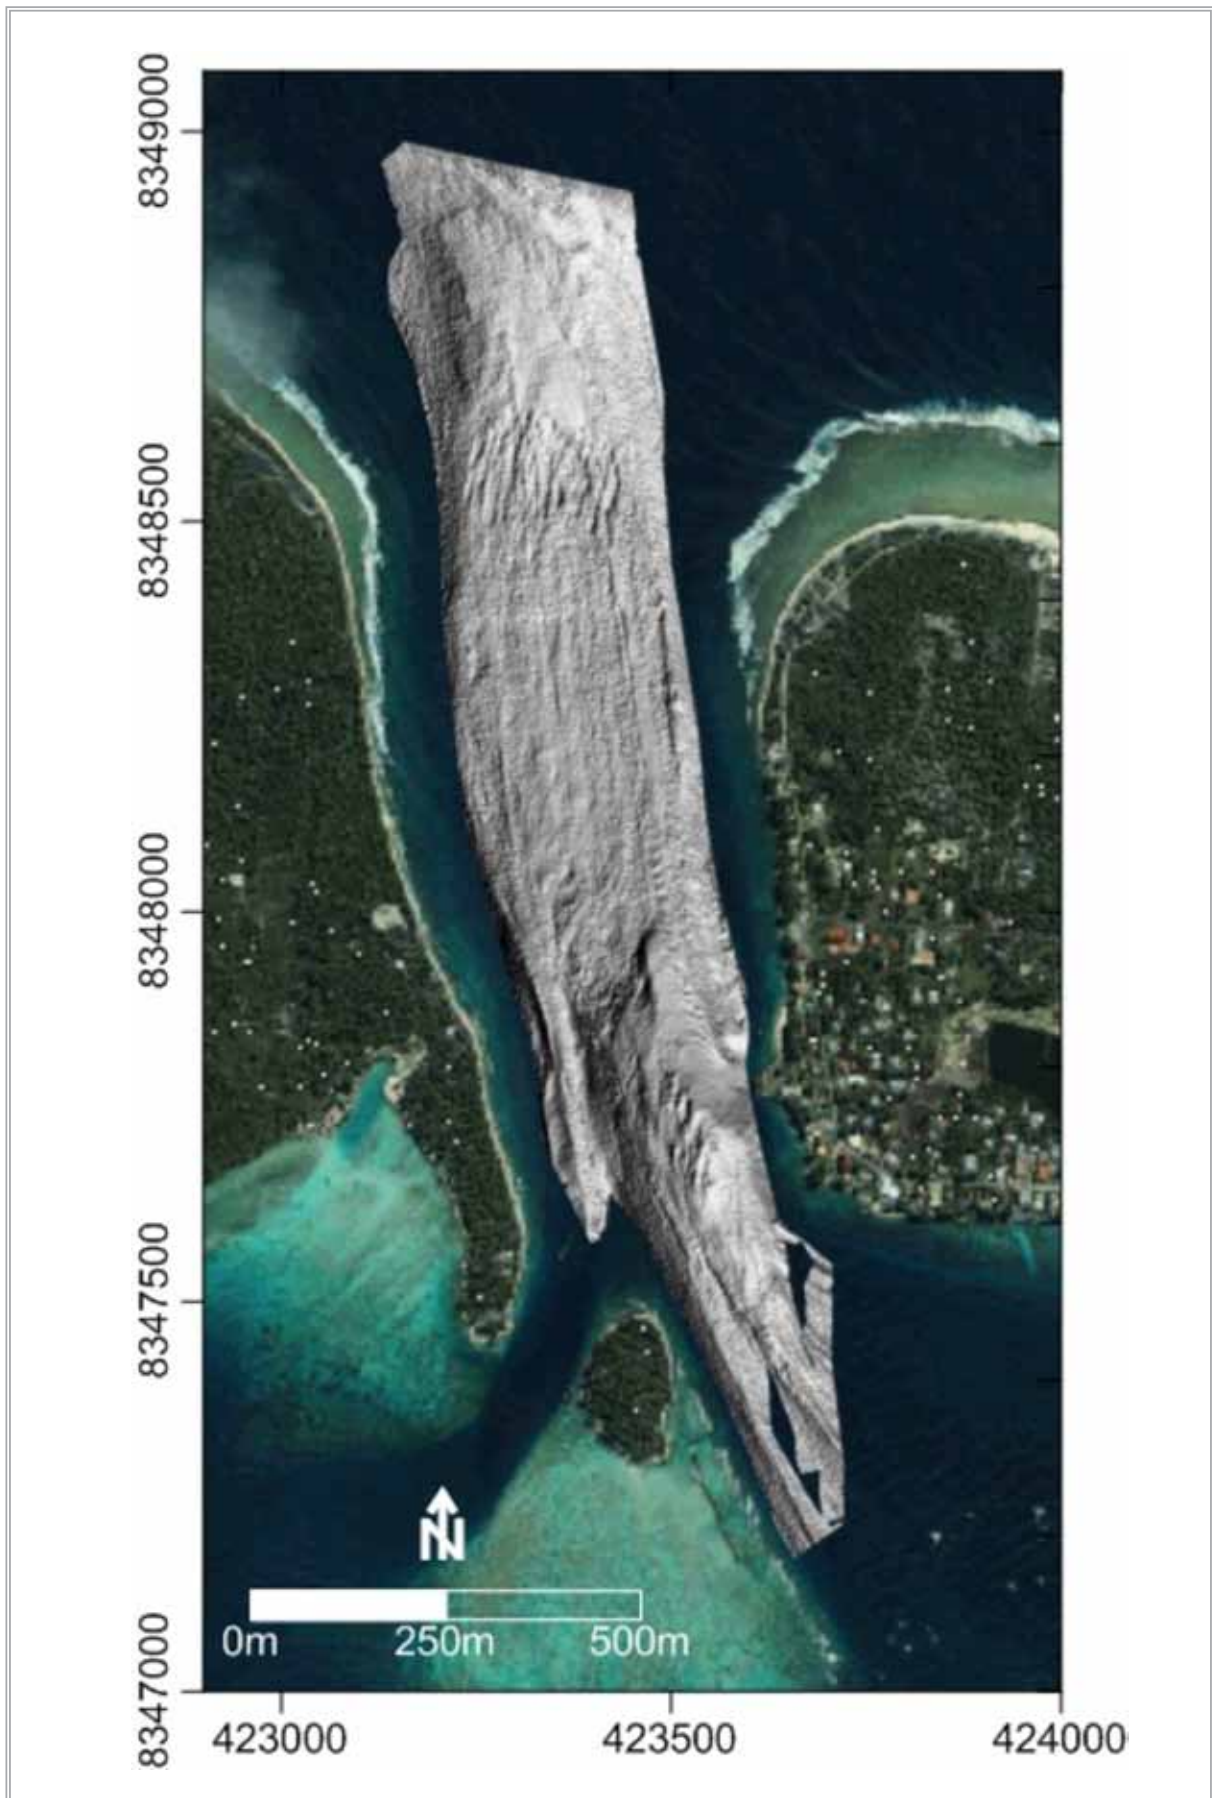
Figure 9: Shaded relief map of Tiputa channel. Sun illumination angle from the northwest.

Bathymetric data provide information on the depth and morphology of the seafloor, as well as the shape and size of submarine features. Bathymetric derivatives (shaded relief maps, and three-dimensional rendered surfaces) can be used in addition to the high resolution bathymetry to aid visual interpretation of the seabed morphology (Figure 7 to Figure 10).
