COASTAL GEOLOGY AND HAZARDS OF NIUE

August 1996

SOPAC Technical Report 233

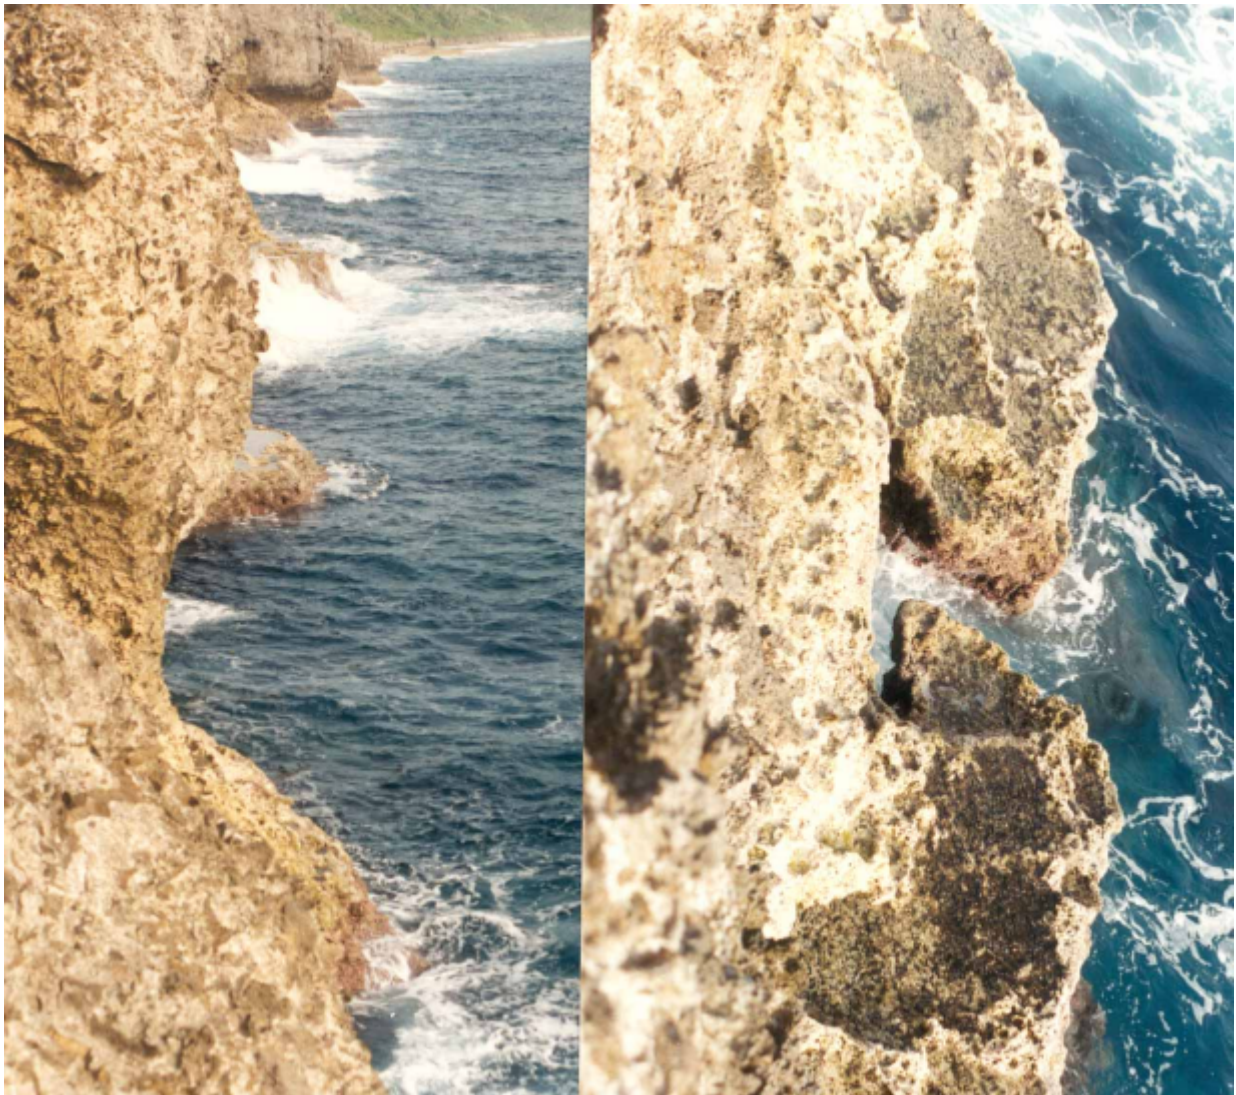
Figure 5. Left: View south along cliffs from Anaana, with southeast swell refracting around Tepa Point. Note the fragmentary 2-4 m platform and lack of platform development at present sea level. Right: Narrow 2-4 m platform, looking down from top of cliff at Anaana. (DLF/ 5 Nov 1995).

Narrow constructional terraces at 2-4 m elevation are found locally between Limufuafua and Tepa Point (Schofield, 1959), elsewhere along the east coast (Jacobson and Hill, 1980b) and near Anaana (Figures 5 and 6). The outer rim of this terrace is built up by nullipores (Agassiz, 1903), which are thought to flourish in spray from blowholes at the Tepa and Anaana sites. Erosional notches at about 2.5 m (the "8 ft notch"), found at Tepa

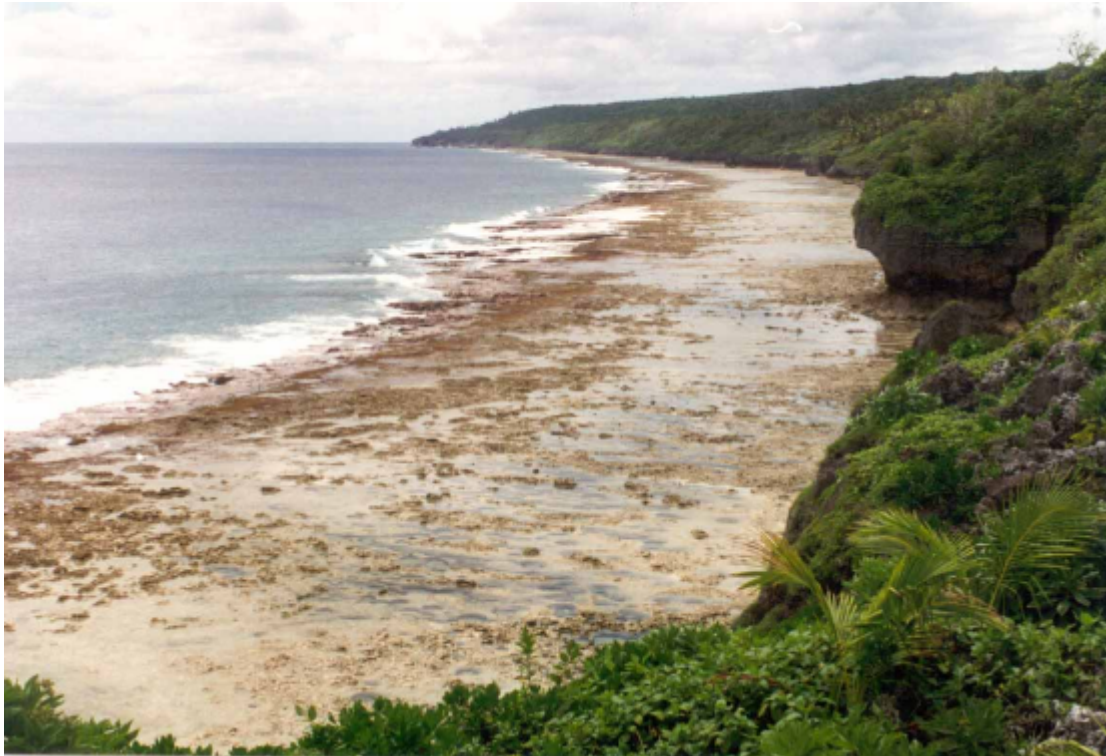
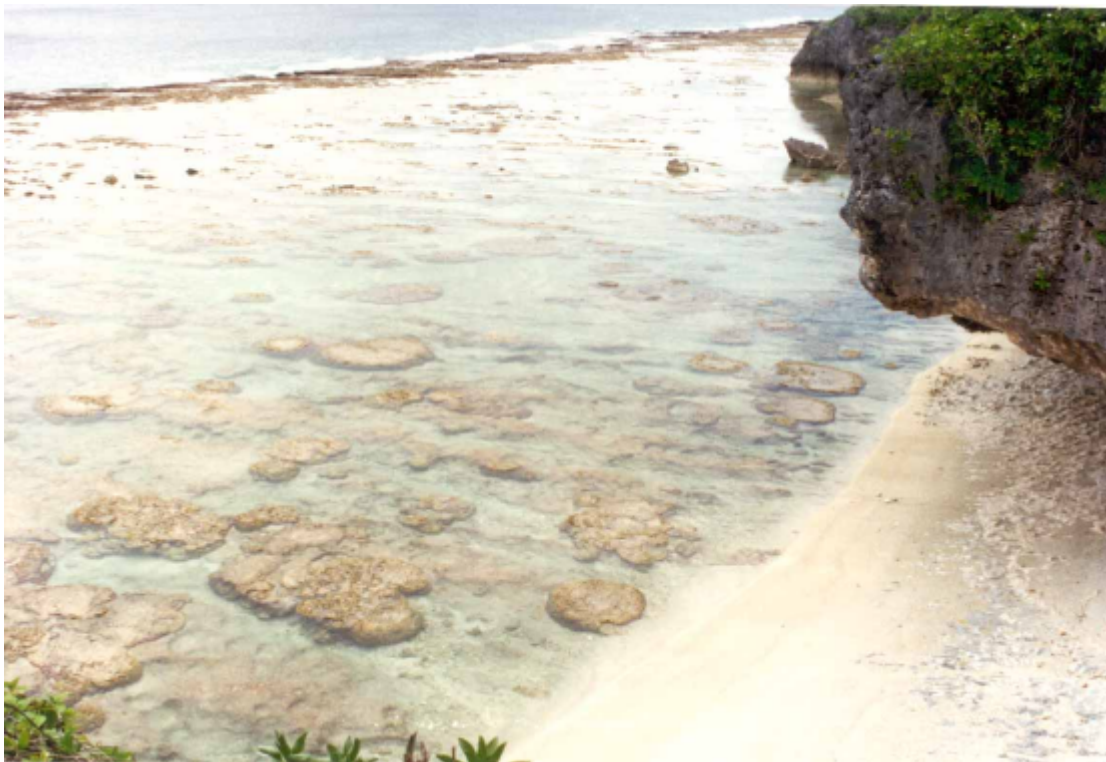
Figure 7. Top: General view of wide reef platform at Tamakautoga, looking northwest from new resort site. Bottom: Beach, overhanging cliff, platform and reef at Tamakautoga Beach (survey site 4). (DLF/ 6 Nov 1995).

The developing terrace at present sea level consists of a fringing rock platform and reef complex ranging up to 120 m wide (Figures 7 and 8; Forbes 1996). This is described in more detail later in the report. Submarine terraces are present at depths of about 12 m and 36 m along the west coast off Alofi (Figure 8; Schofield, 1959) and reported in depths of about 36 m off Avatele in the south (Kevin Fawcett, pers. comm., 10 November 1995).

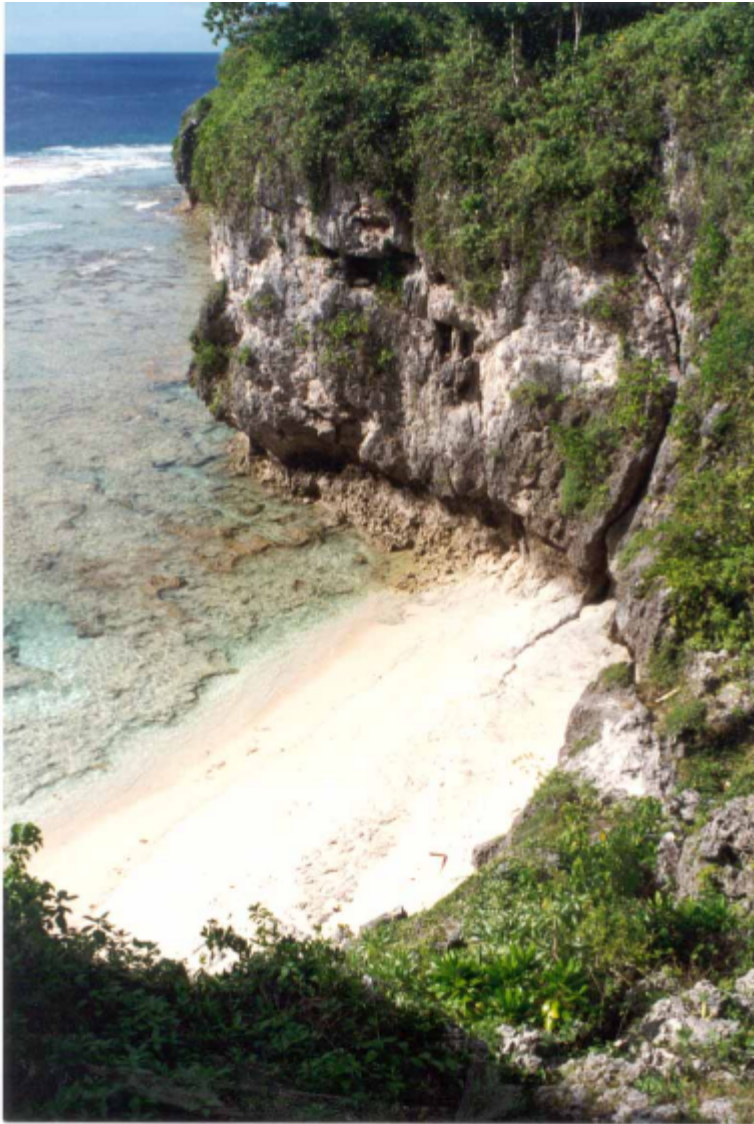
Figure 10. Hilo Beach (survey site 1), from lowest remaining step on access path (17.5 m above sea level). Note wide reef platform, undercut cliffs, steeply dipping fracture at back of beach, lower terrace remnant above and behind beach, and thin sand over rock outcrop (DLF/ 7 Nov 1995).

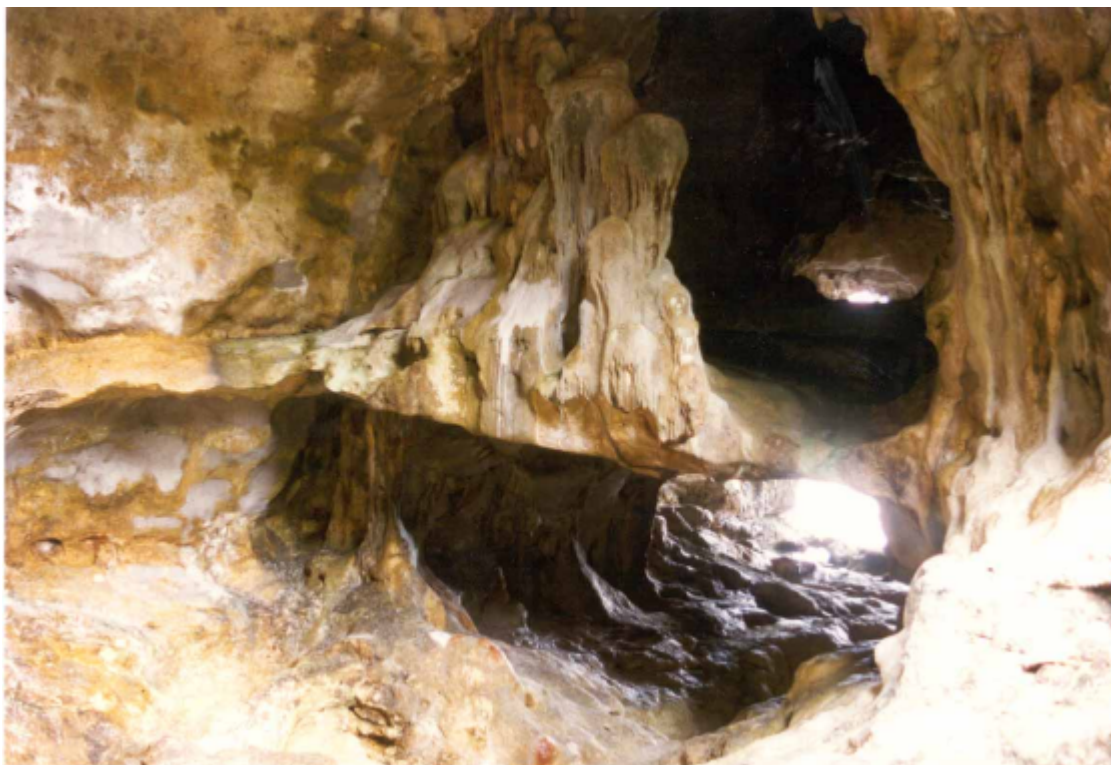
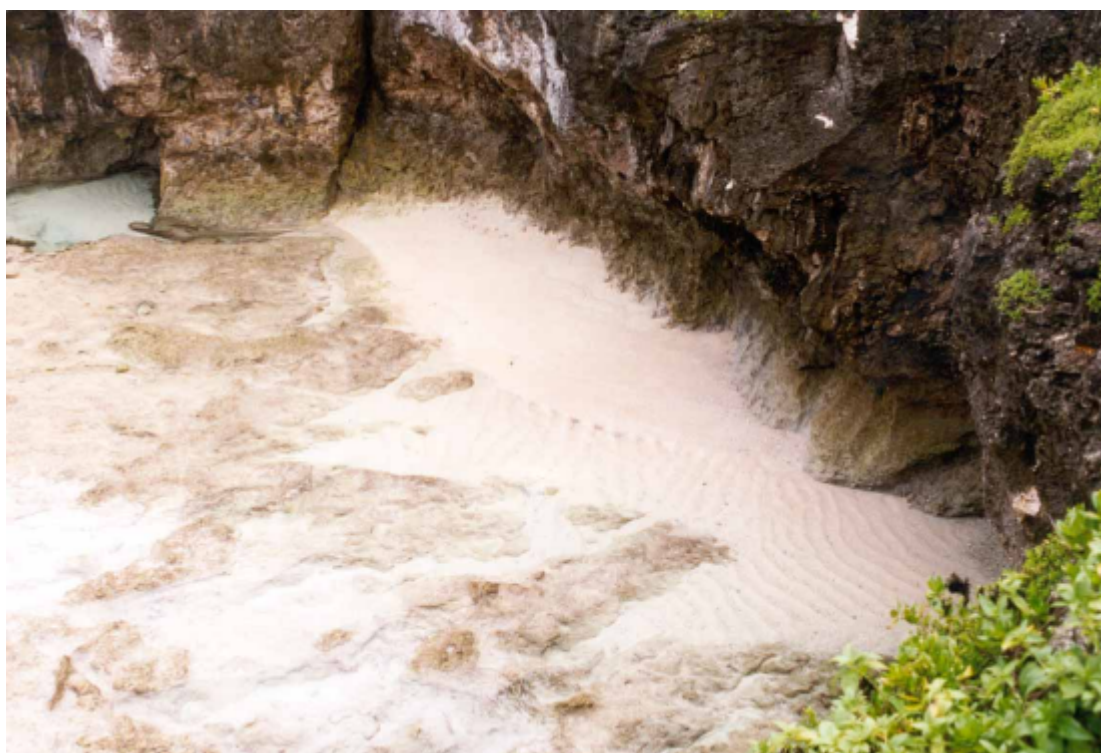
Figure 11. Top: Double-storey passage to the sea in Palaha Cave, northwest coast south of Tuapa. Bottom: Small beach with rippled sand immediately north of Palaha Cave. (DLF/ 11 Nov 1995).

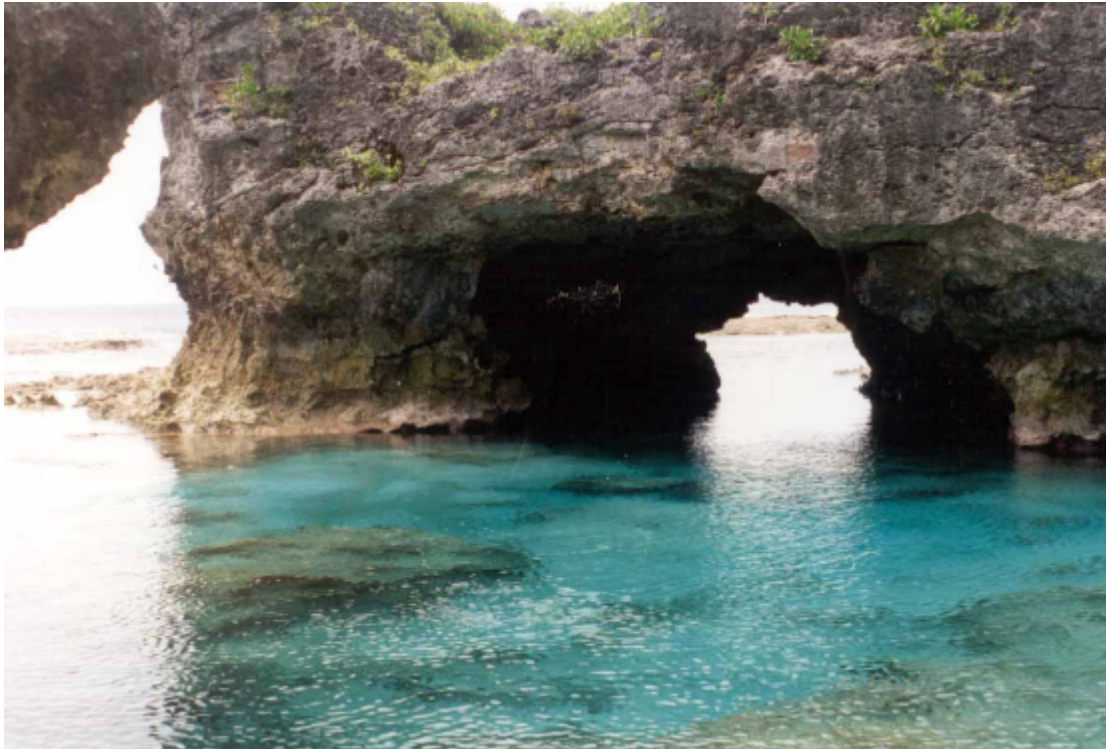
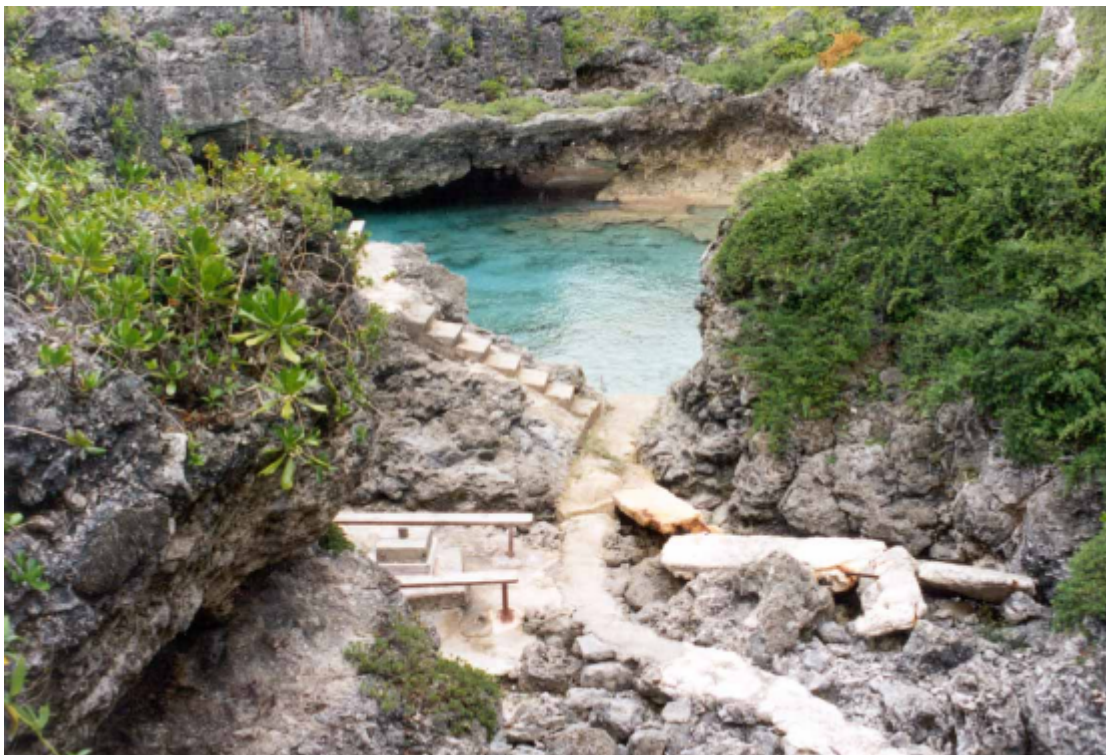
Figure 12. Top: Arch representing seaward extension of unroofed cave at Makalae, north side of Limu Sea Track. Bottom: Path and picnic facilities damaged during Cyclone Ofa, Makalaea, Limu Sea Track (DLF/ 11 Nov 1995).

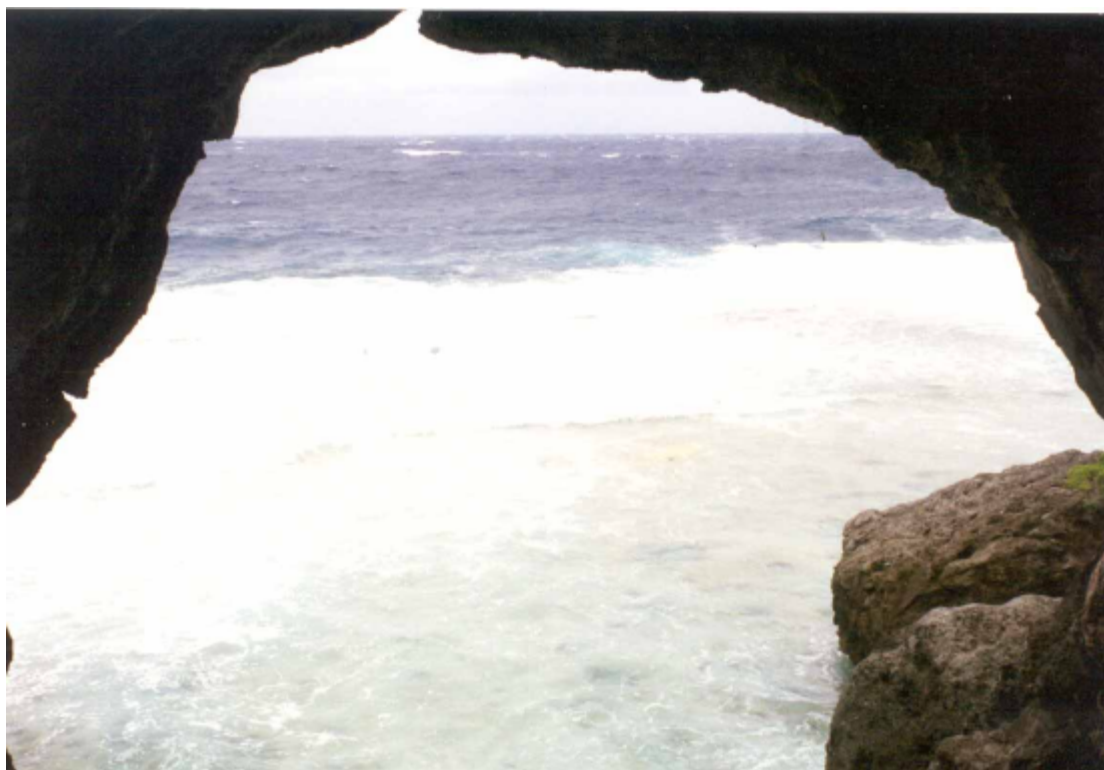
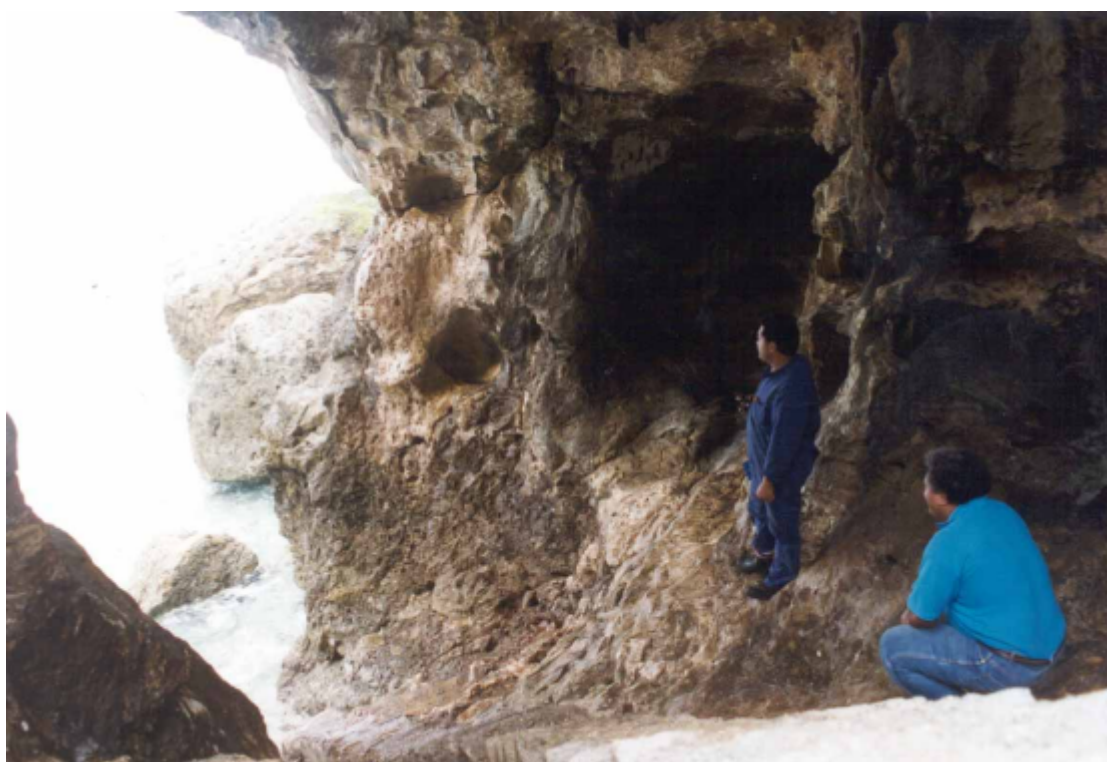
Figure 13. Top: Heavy surf under southeast tradewinds, showing waves breaking along the outer reef rim, framed by roof of cave at Tauta (sampling site 6). Bottom: Canoe access steps in cave at Tauta (DLF/9 Nov 1995).

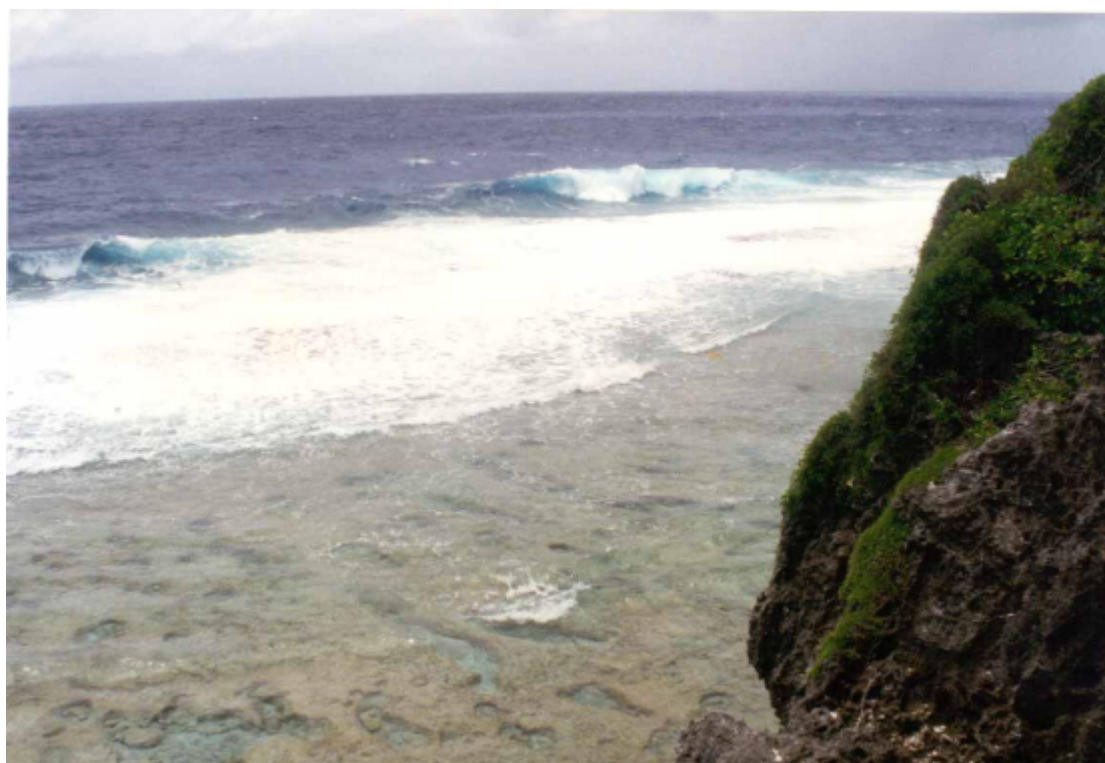
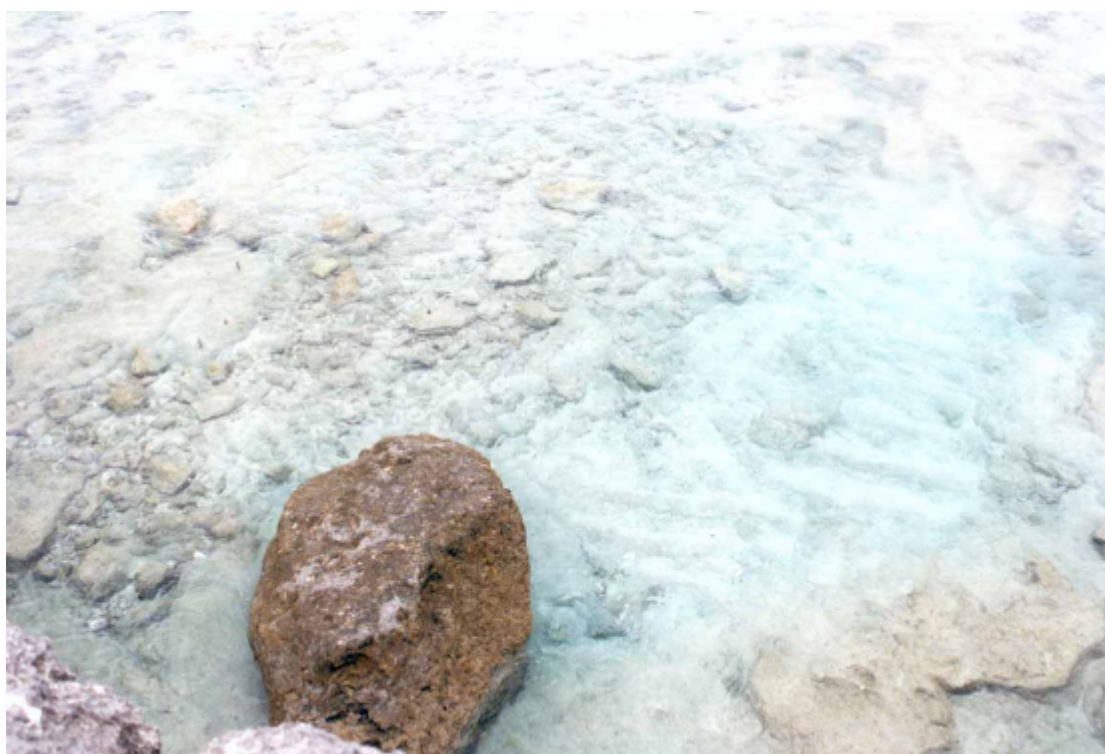
Figure 15. Top: Surf break at outer reef rim and bore propagating across the platform at Vaitafe, northeast coast. Bottom: Boulder, blasted pool, rock debris, and thin sand on inner platform at Vaitafe (DLF/ 9 Nov 1995).

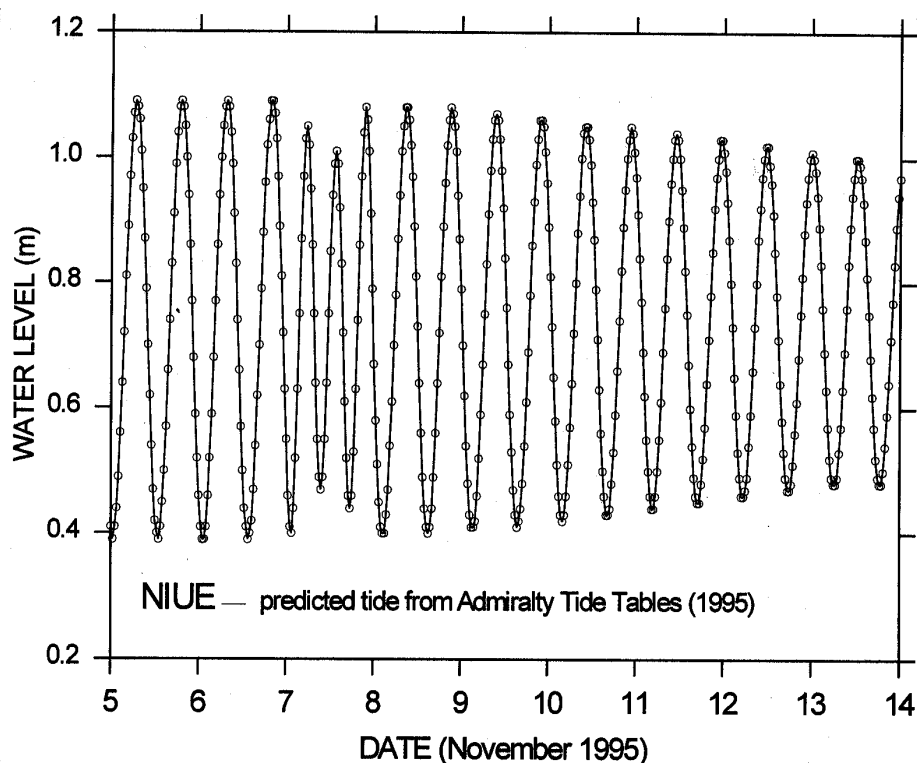
Figure 16. Predicted tide levels for Niue, 5-13 November 1995, from simplified harmonic method and data in 1995 Admiralty Tide Tables.

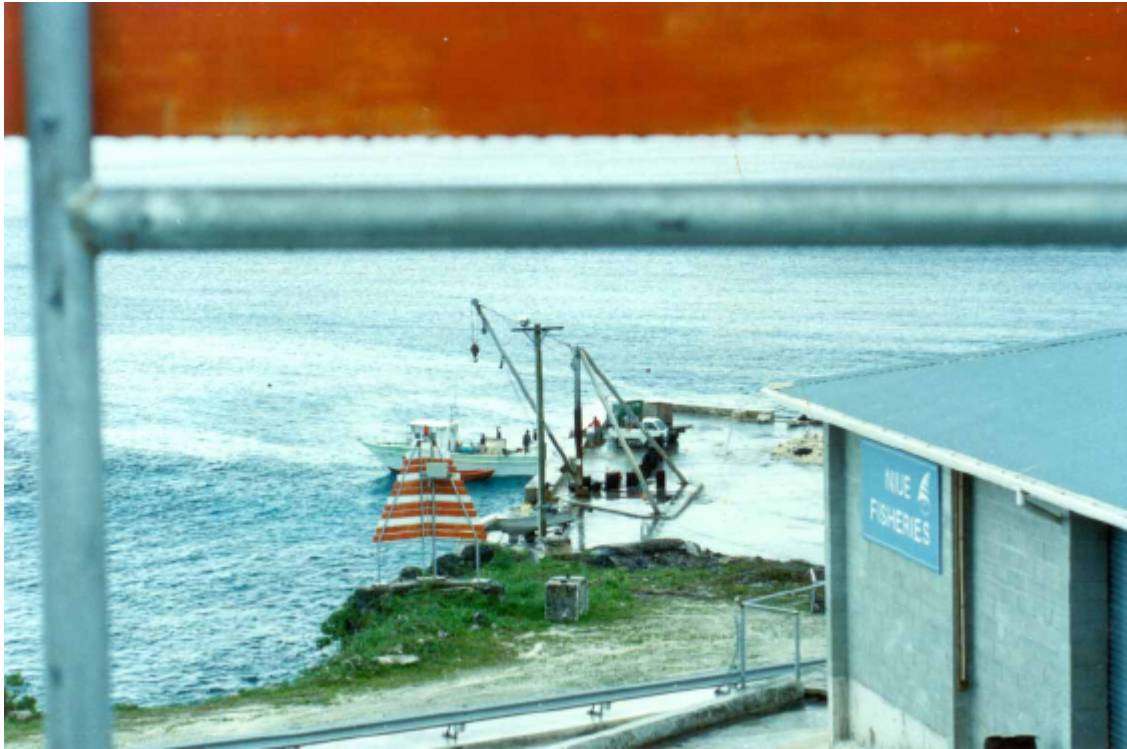
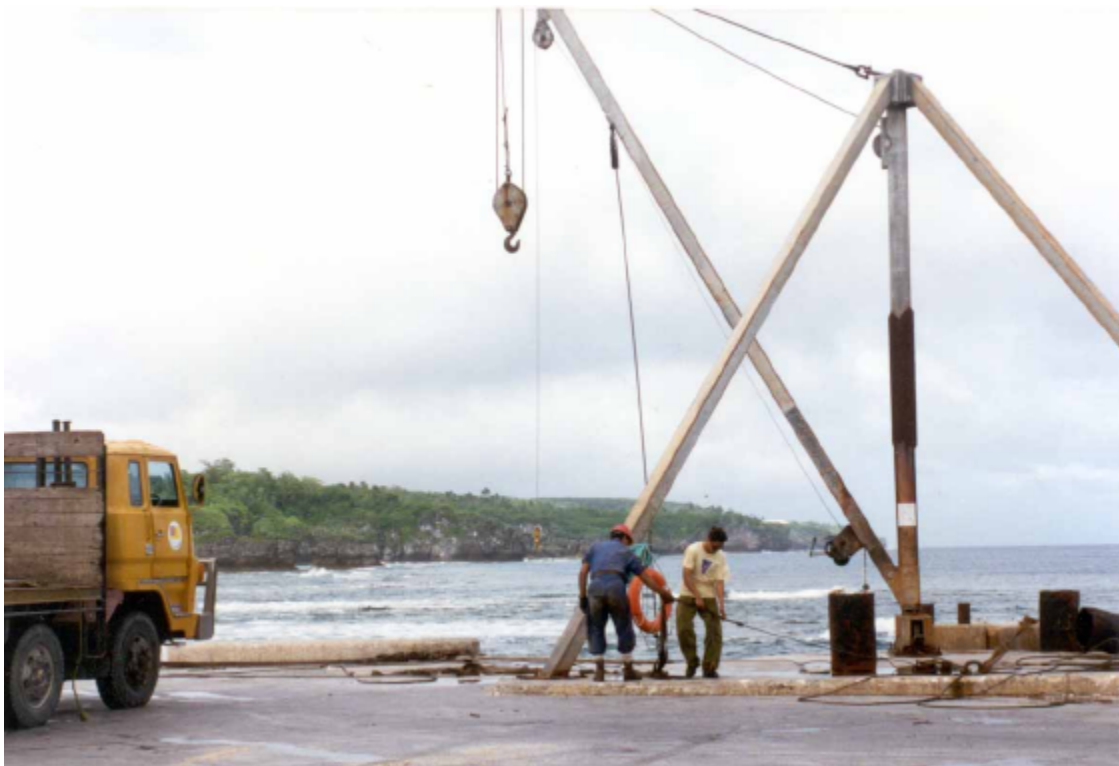
Figure 17. Top: Alofi Wharf from the upper road. Bottom: Dragline operations to clear debris from channel, Alofi Wharf. (DLF/ Nov 1995).

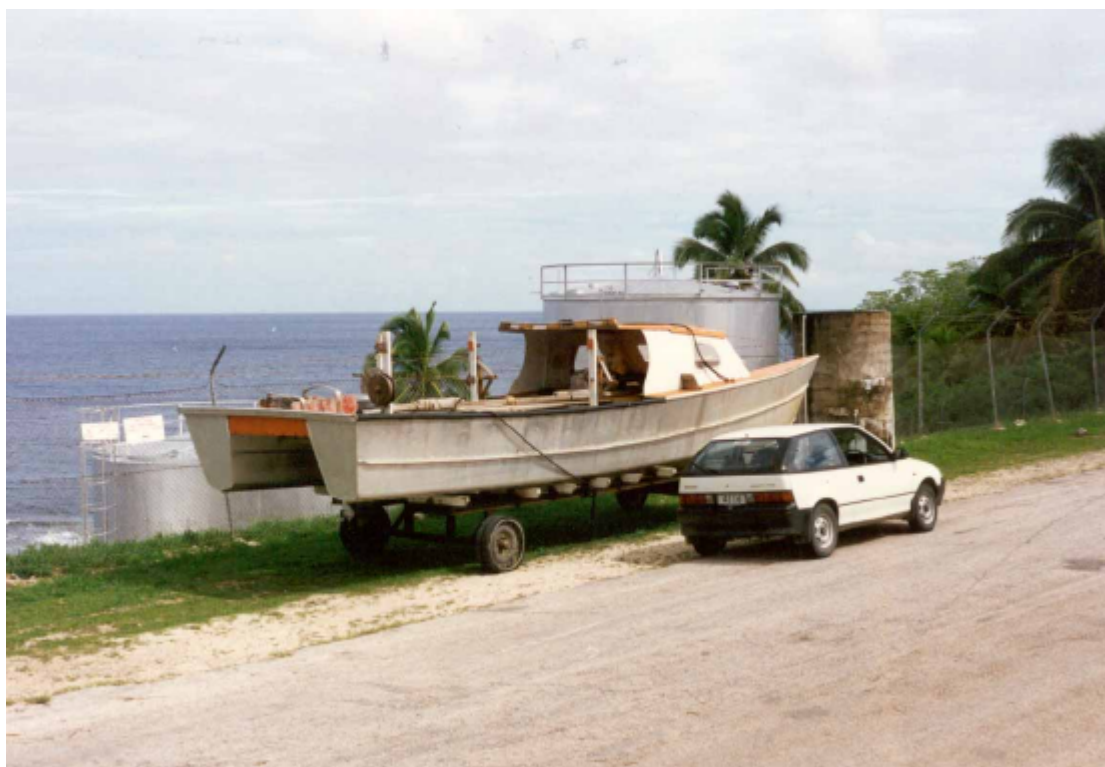
Figure 18. MAFF catamaran with rental car for scale. Fuel storage tanks is background, Alofi (DLF/ 12 Nov 1995).

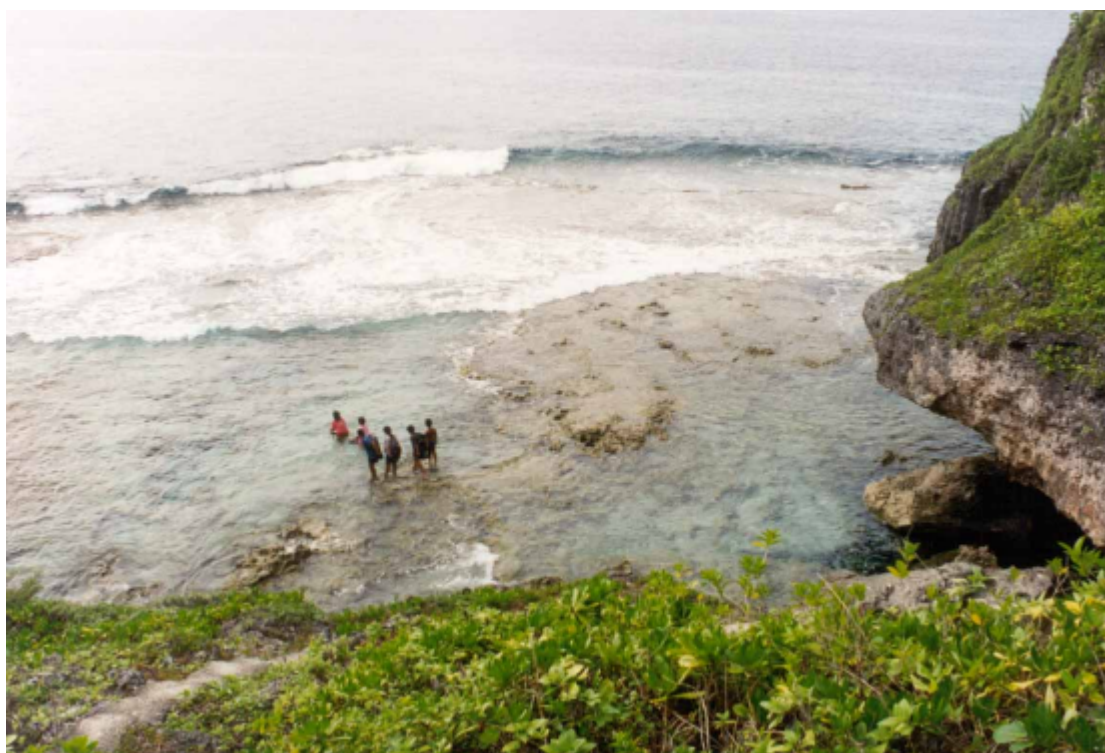
Figure 19. Amanau Reef from halfway down the sea track. Note irregular platform, reef rim, and undercut cliff with collapse block. Teenagers for scale (DLF/ 5 Nov 1995).

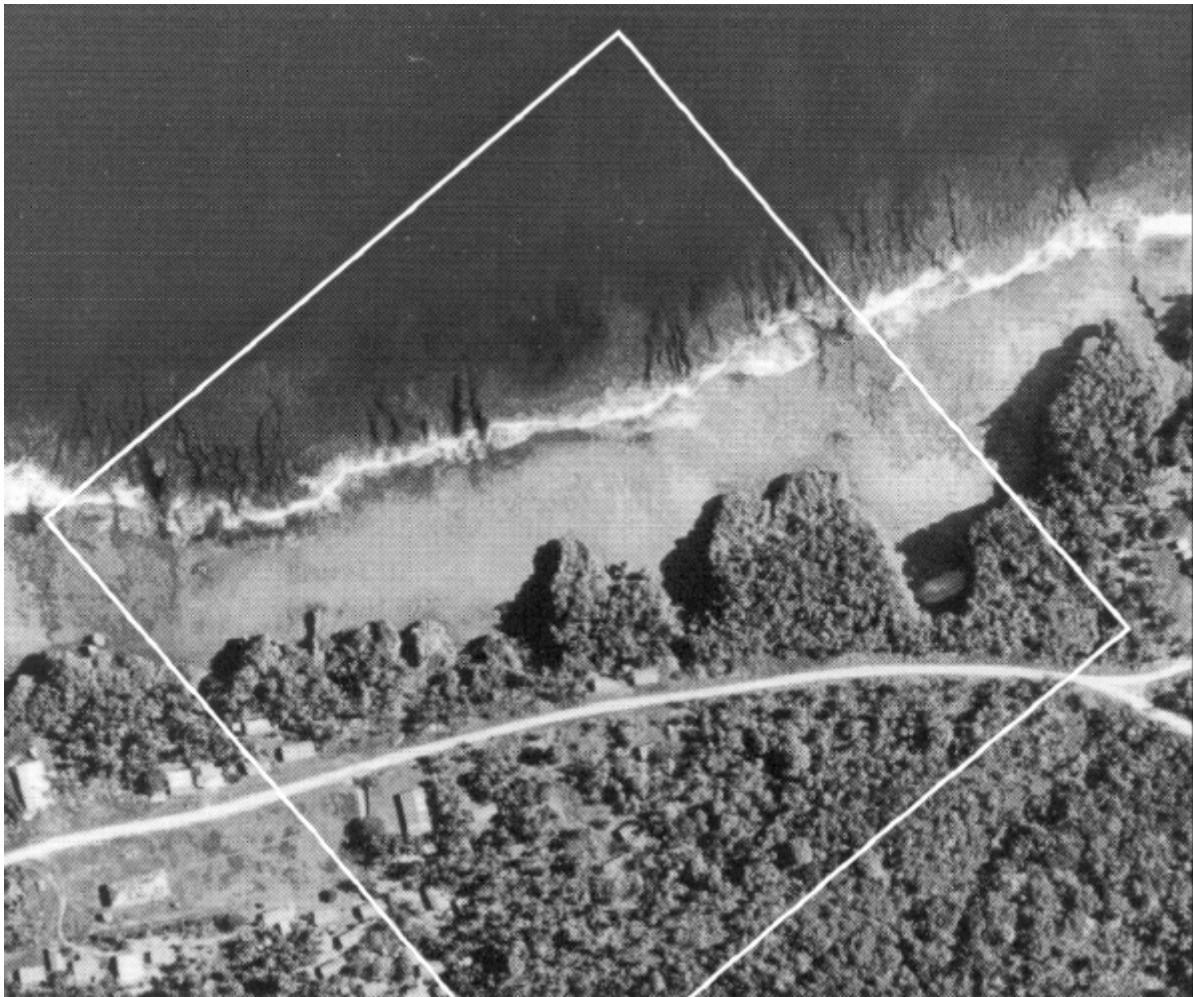
Figure 21. Detail of 1981 air photograph of northwest coast in the vicinity of Tuapa, showing village green, road, cliffs, platform. reef rim, and seaward slope of reef with spur-and-groove morphology. Hio Beach at right. Box outlines the extent of Figure 26.

Narrow and wide reef platforms were discriminated using a width of 30 m as the cutoff and the outer edge of the reef rim as the outer boundary. In general, the reef extends beyond this limit to include a spur-and-groove zone or outer submarine reef slope (Figure 21), but this could not be consistently observed in the aerial photography.

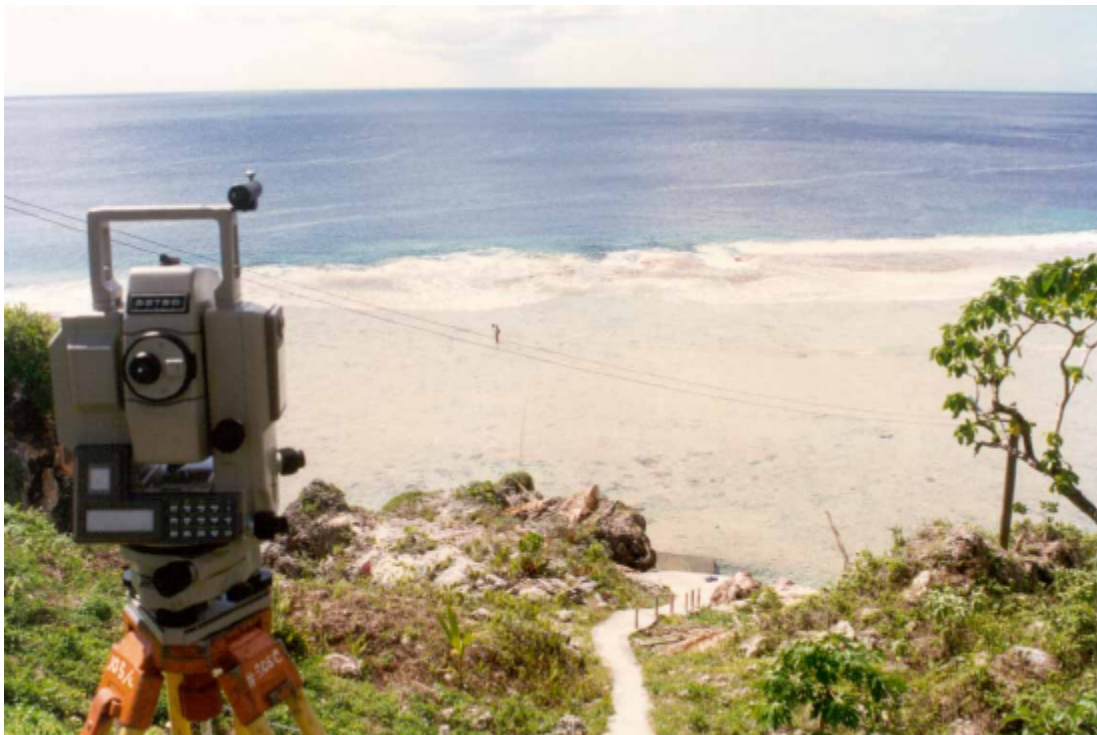
Figure 22. Tuapa Landing from top of sea track, with Sokkia Set 2C total station survey instrument in foreground. Chainman Sione Tongiakona, carrying the survey target, is halfway across the reef platform in the distance. (DLF/ 7 Nov 1995).

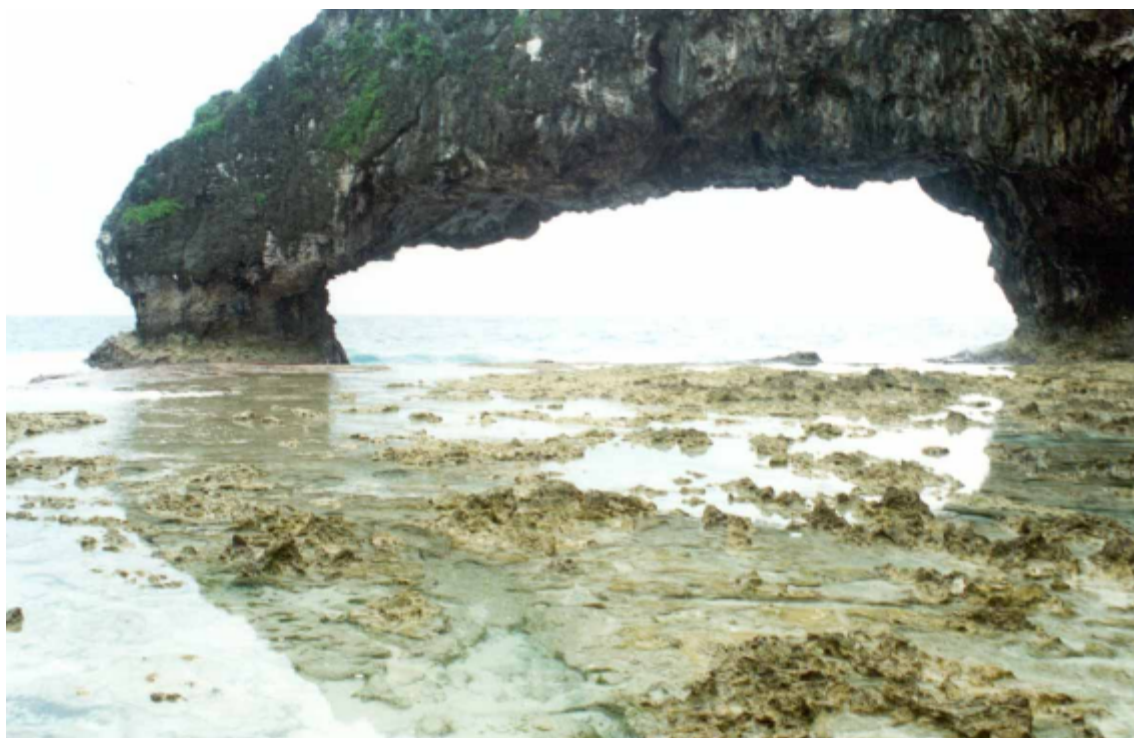
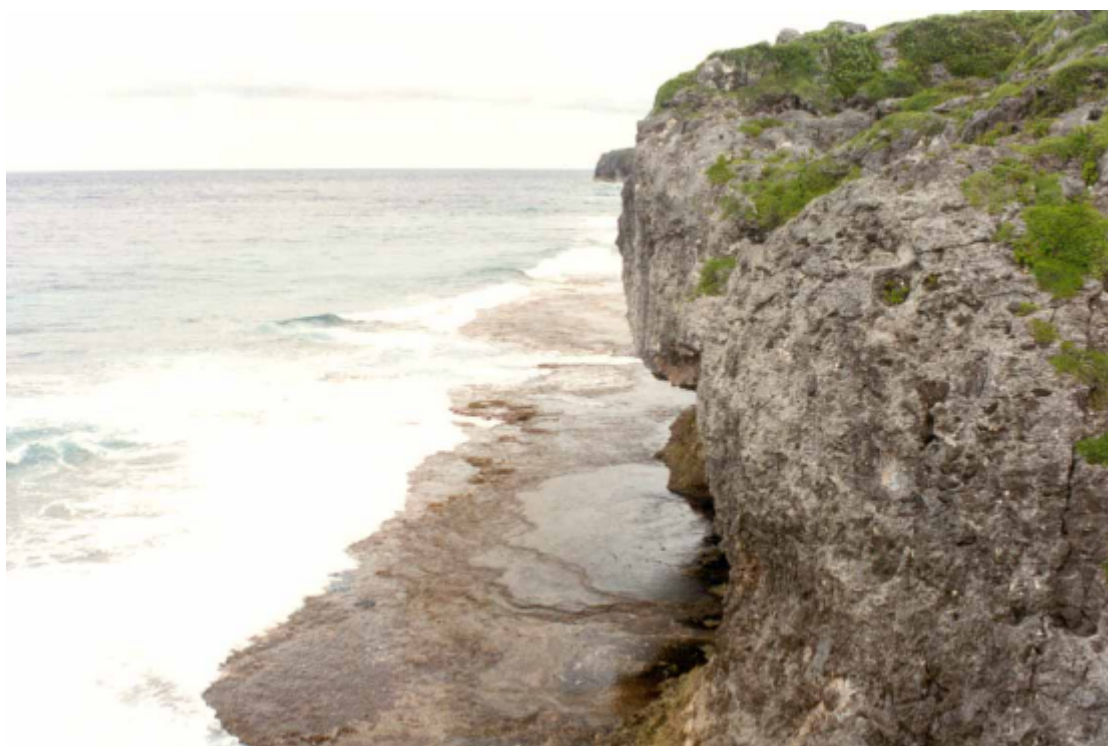
Figure 23. Top: Erosional shore platform and limestone arch at Talava ("The Arches"), north coast. Bottom: Narrow platform and undercut cliffs, looking east from Uluvehi Landing toward Vaihakea, north coast near Mutalau. (DLF/ 11 and 6 Nov 1995).

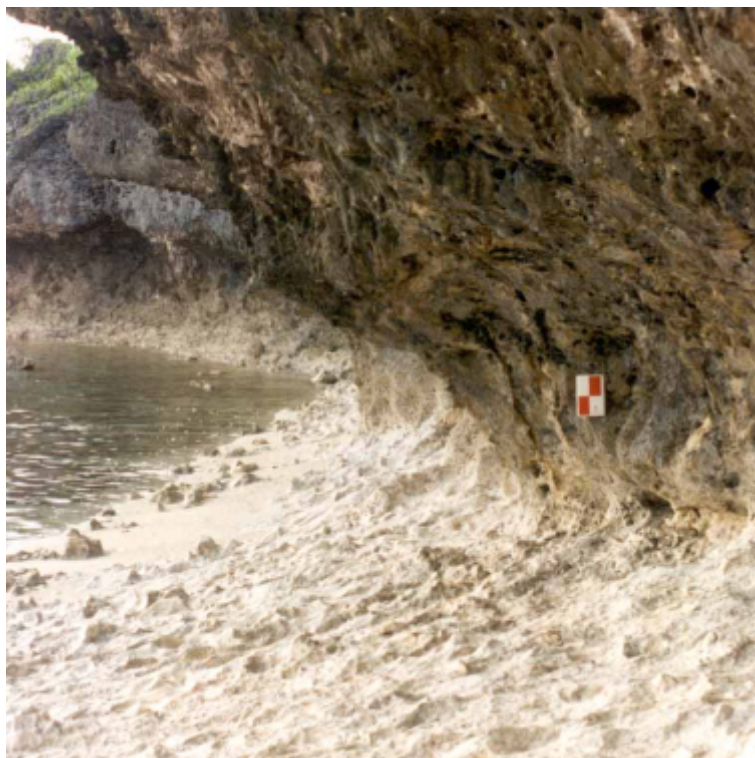
Figure 24. Top: Erosional notch in cliffs adjacent to Tamakautoga Beach (survey site 4). Notebook 181 x 121 mm provides scale. Right: Linear solution lobe structures on basal ramp of notch. Lens cap 62 mm diameter for scale (DLF/ 7 Nov 1995).

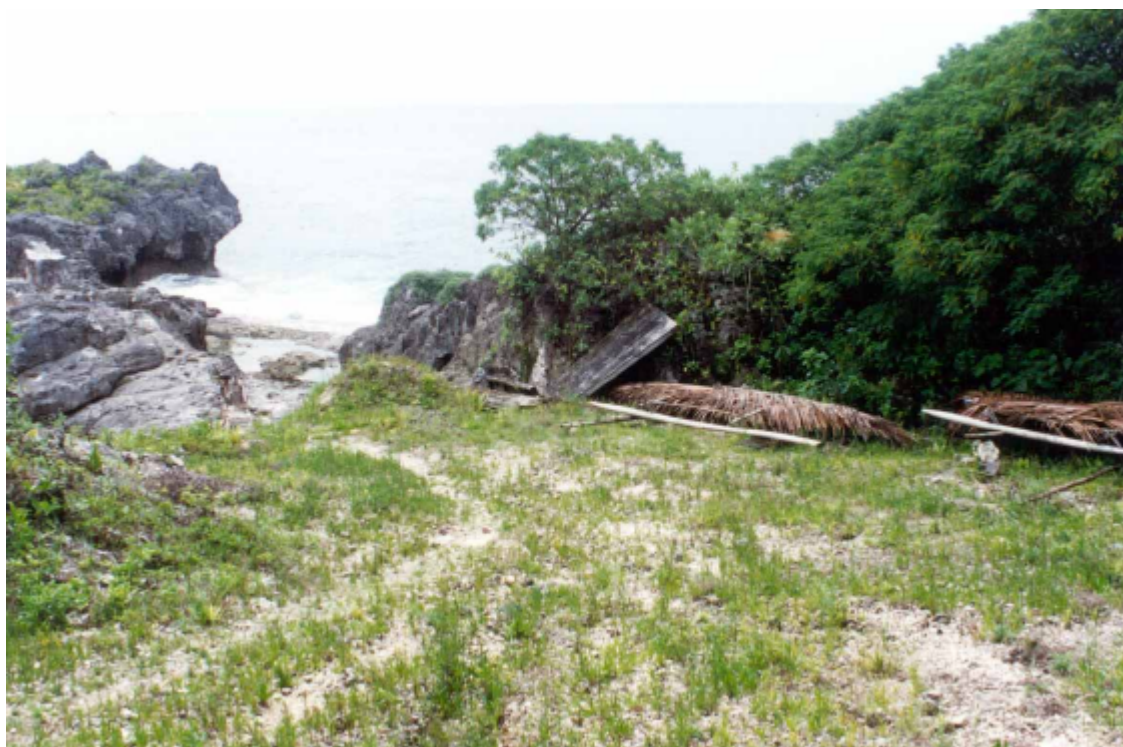
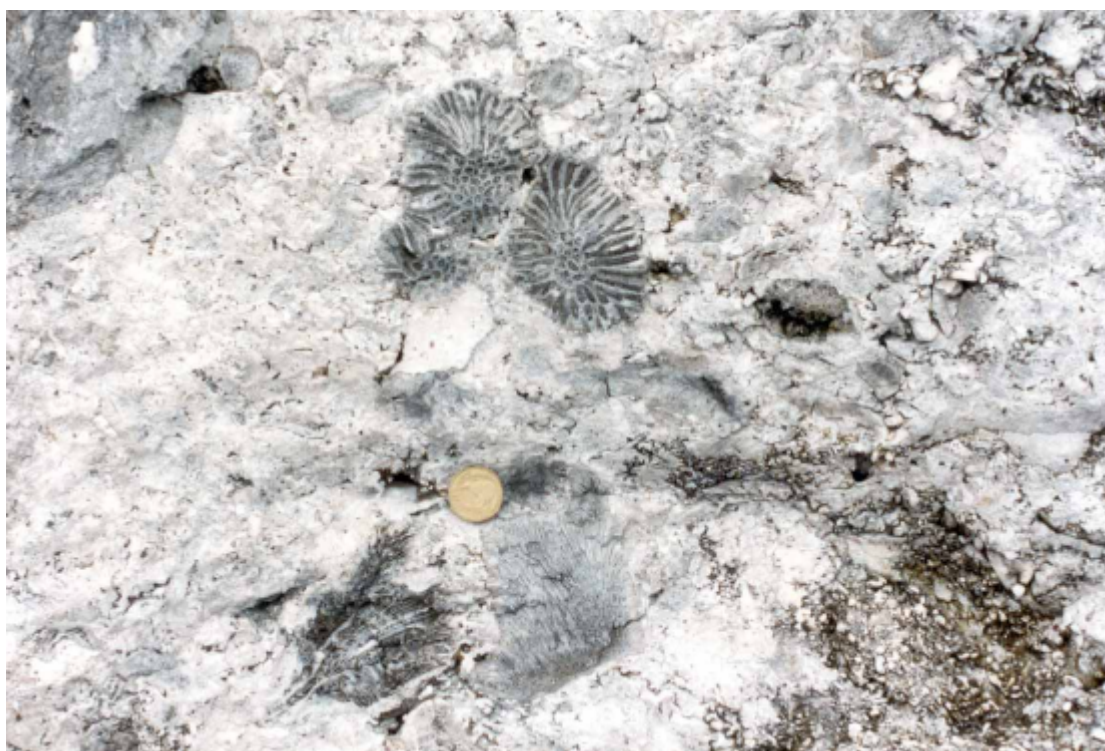
Figure 25. Top: Opaahi Landing, showing rough gravel access track, canoes, and damaged concrete structure. Bottom: Detail of coral structures in limestone at Opaahi Landing. NZ\$1 coin (22 mm diameter) for scale (DLF/ 11 Nov 1995).

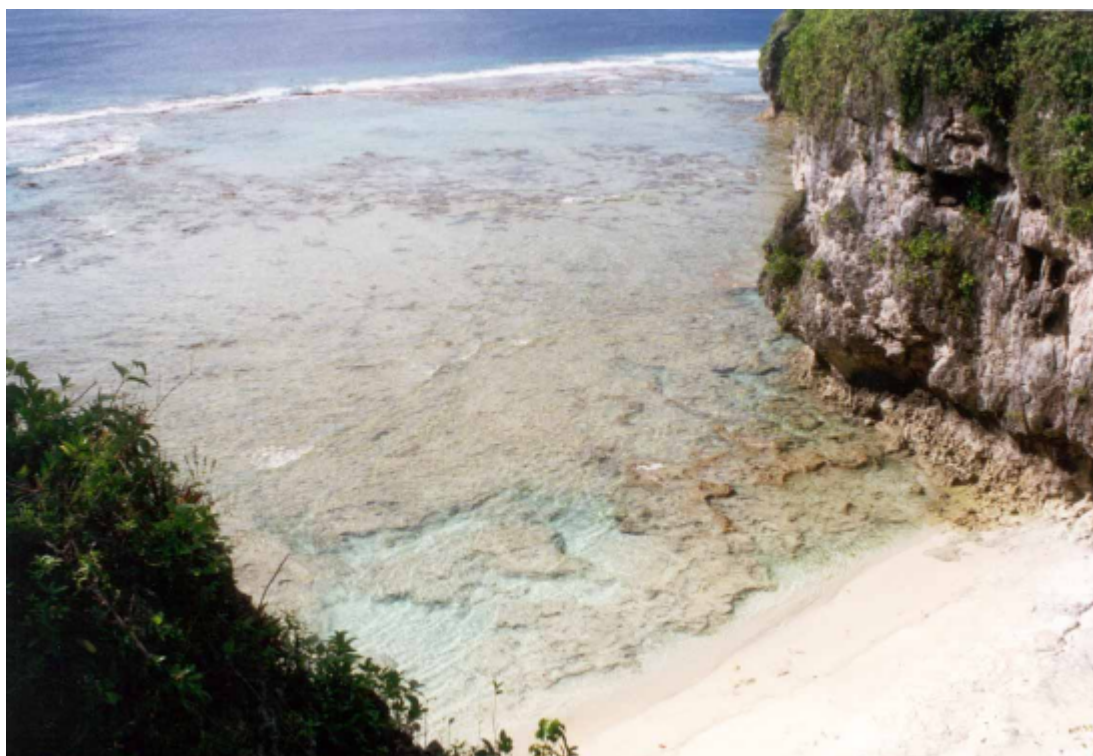
Figure 27. Hio Beach platform and reef, seen from top of cliff at low tide. Bottom: Close-up of beach and nearshore sands sampled at Hio Beach, mid-tide. Note fracture cutting across head of embayment at back of beach (DLF/ 7 Nov 1995).
