COASTAL GEOLOGY AND HAZARDS OF NIUE

August 1996

SOPAC Technical Report 233

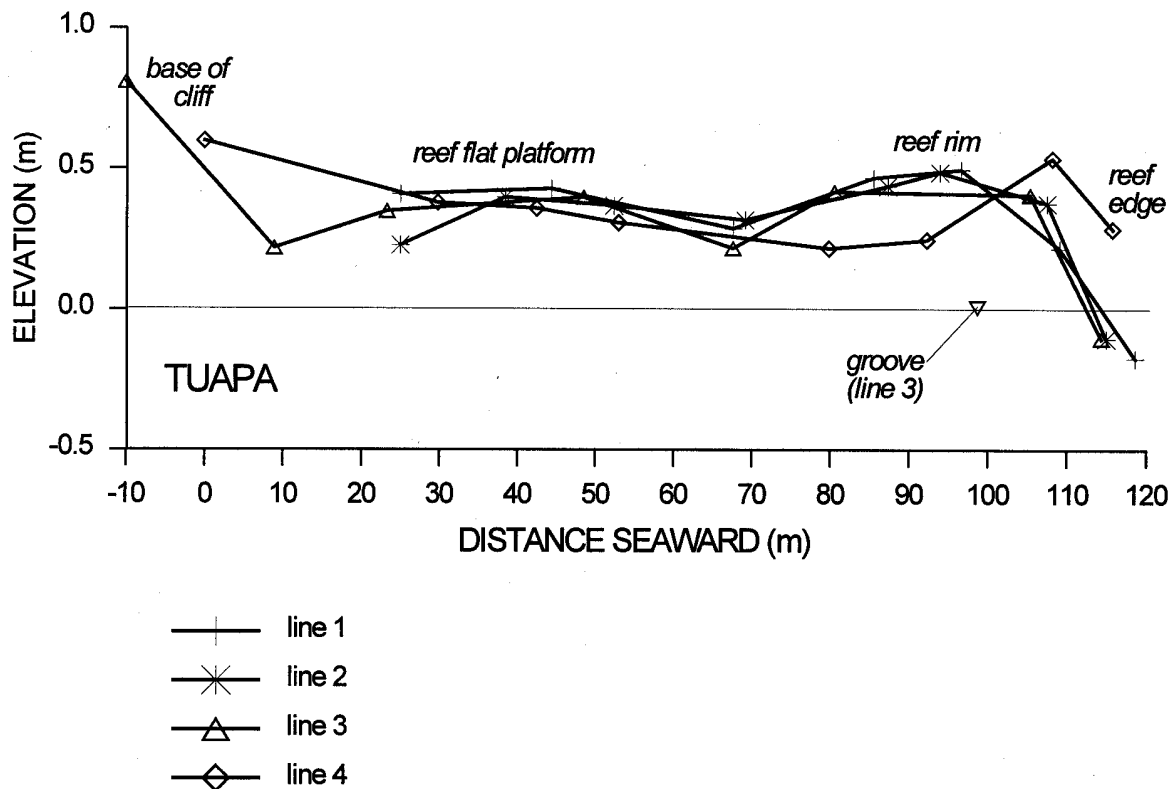
Figure 31. Surveyed profiles across reef rim and erosional platform at Tuapa Landing, 7 November 1995 (see Figure 30 for locations). Note similarity of lines 1 to 3 and contrasting profile on line 4.

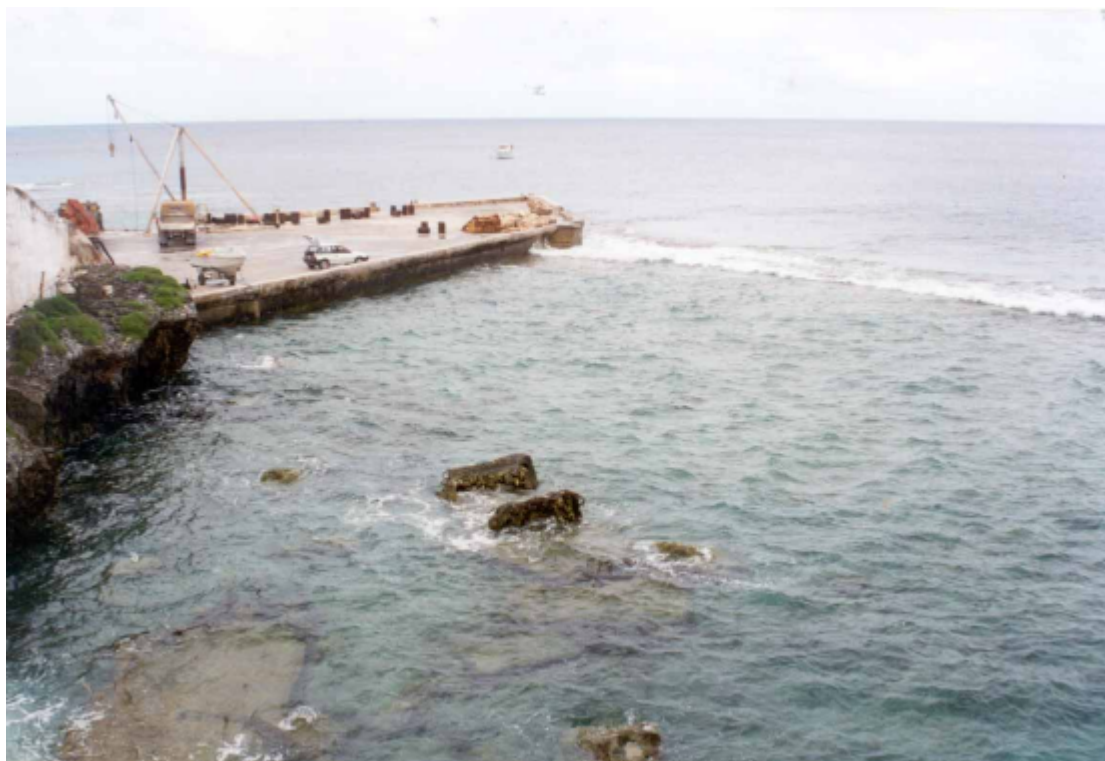
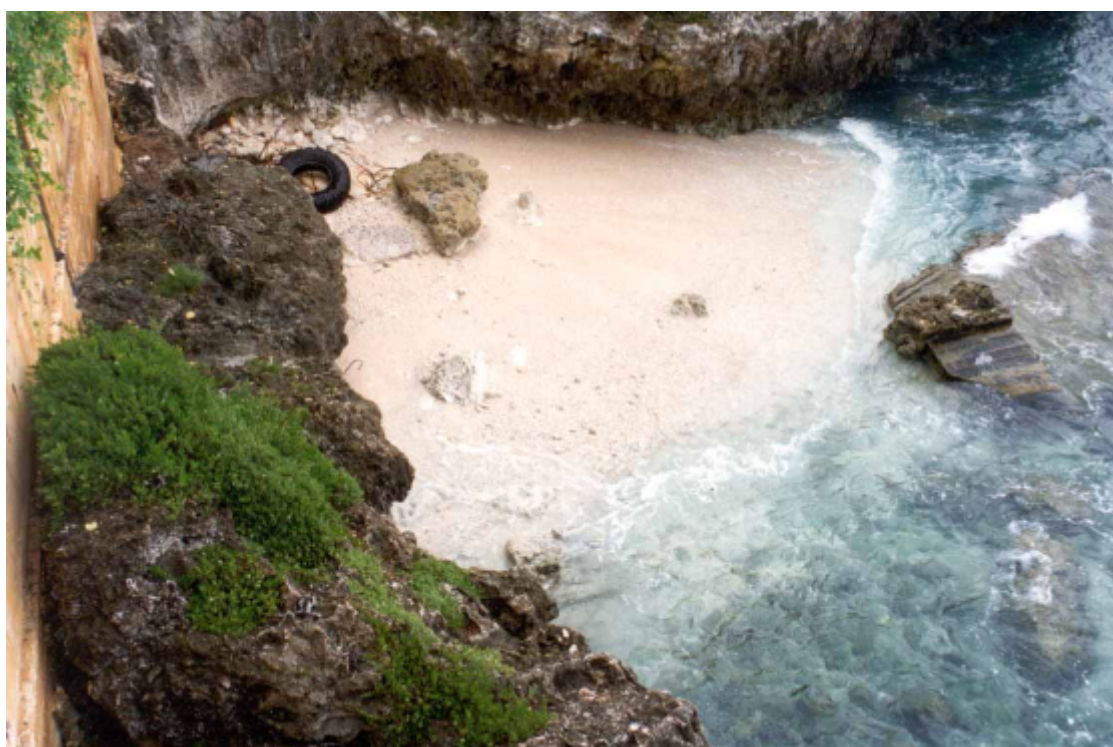
Figure 33. Top: Alofi Wharf from the fuel tanks. Bottom: Pocket beach at base of seawall north of Alofi Wharf. (DLF/ 10 Nov 1995).

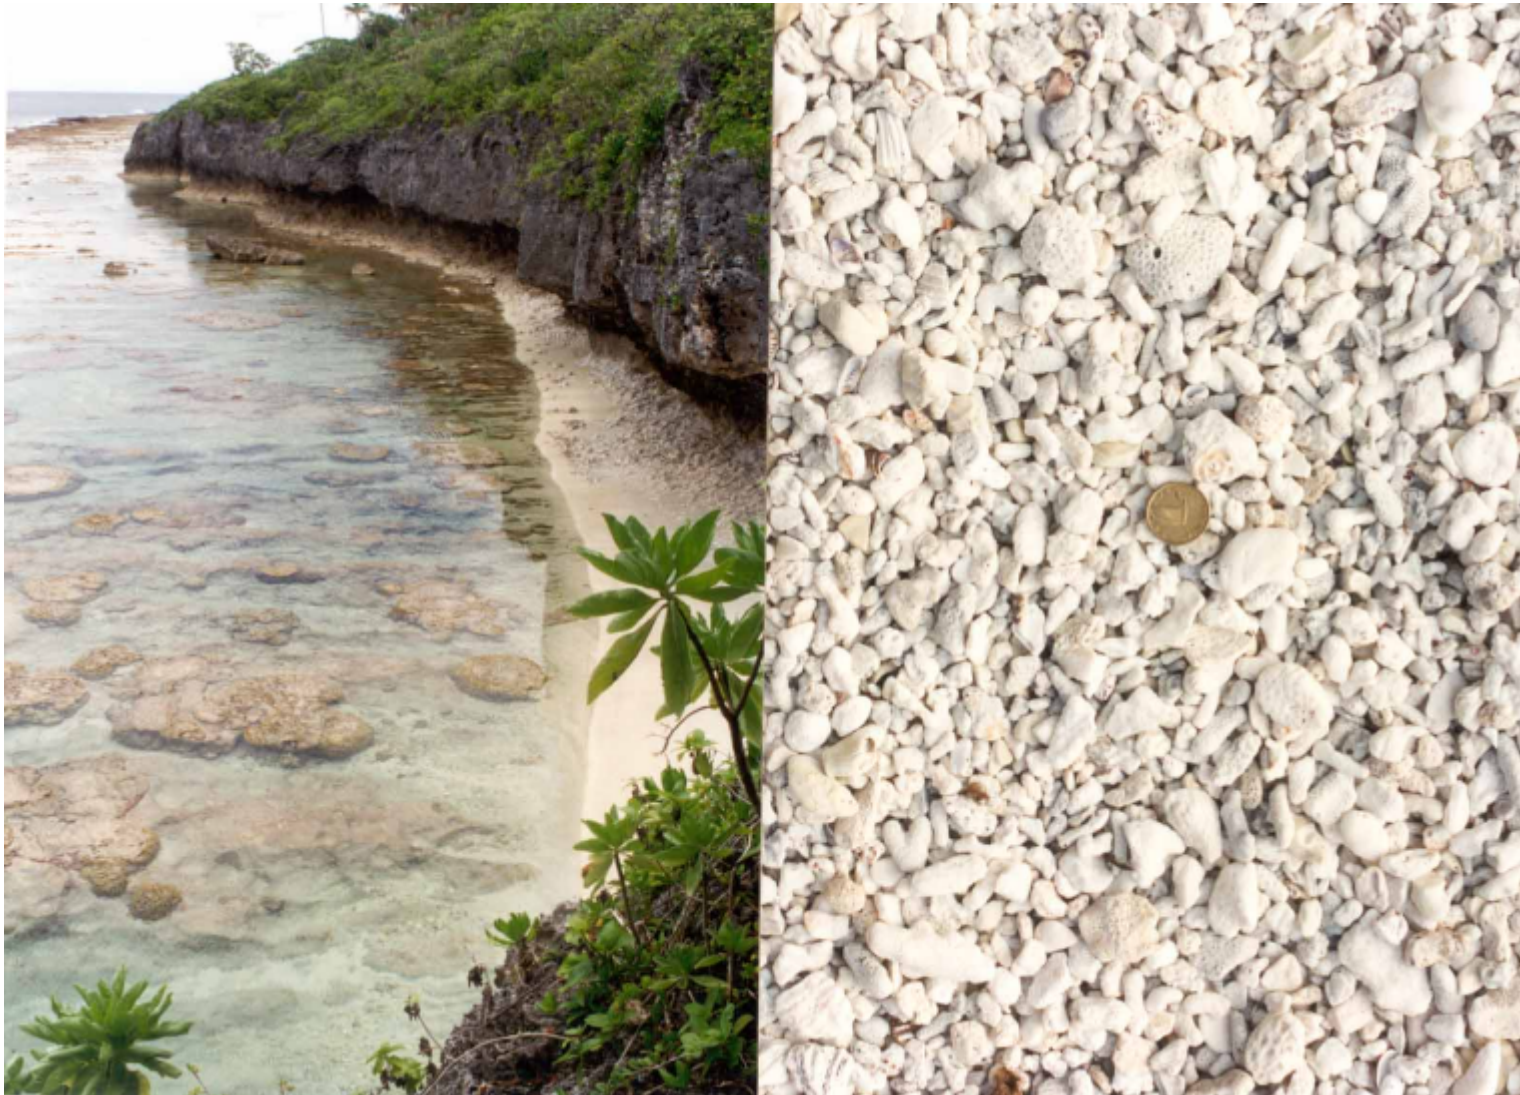
Figure 35. Left: Inner part of platform from top of cliff, Tamakautoga Beach (site 4). Right: Detail of sediment on beach berm at same site. NZ\$2 coin (26 mm diameter) for scale. (DLF/6 Nov 1995).

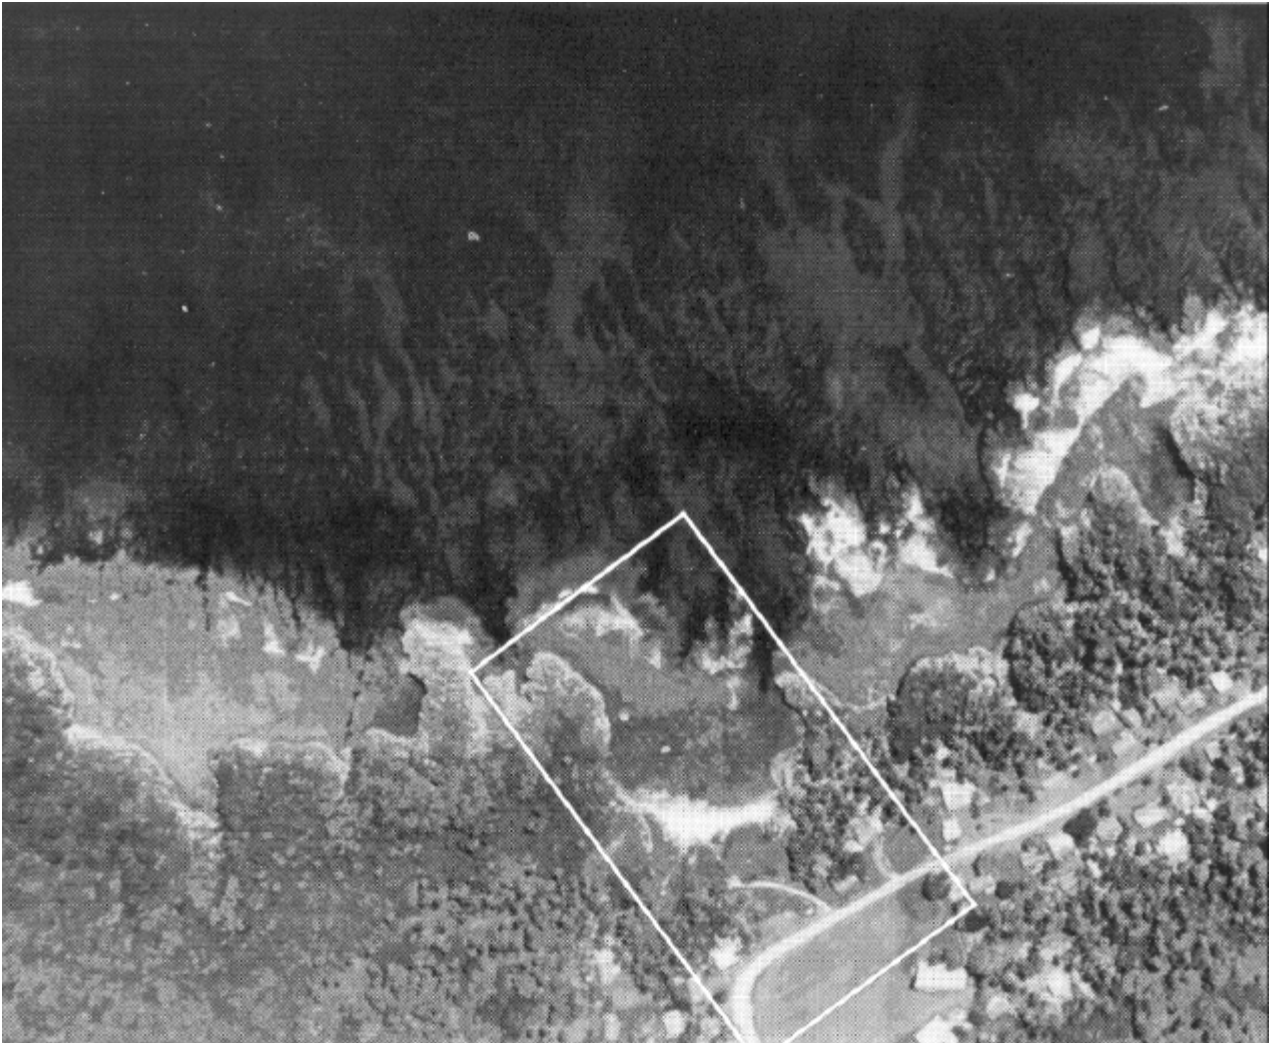
Figure 38. Part of 1981 air photograph showing Avatele Beach and vicinity before blasting and construction of boat-launching ramp. Note irregular reef edge and sand on shallow terrace outside reef. Box outlines area shown in Figure 40.

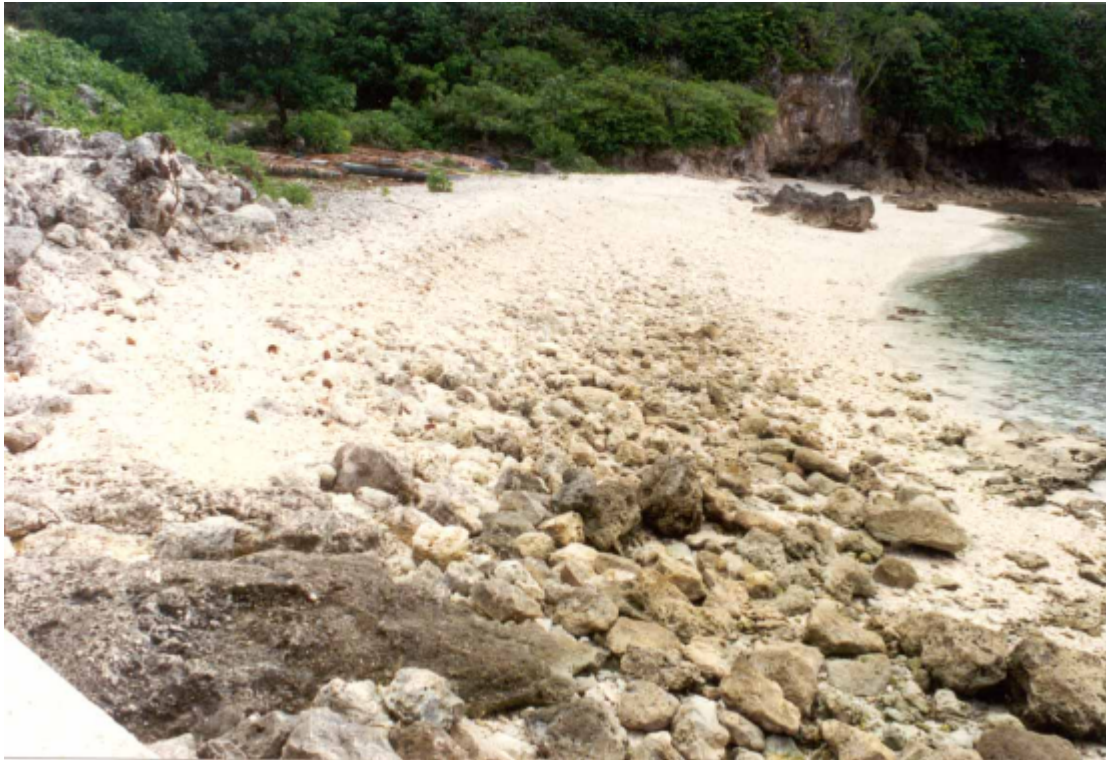
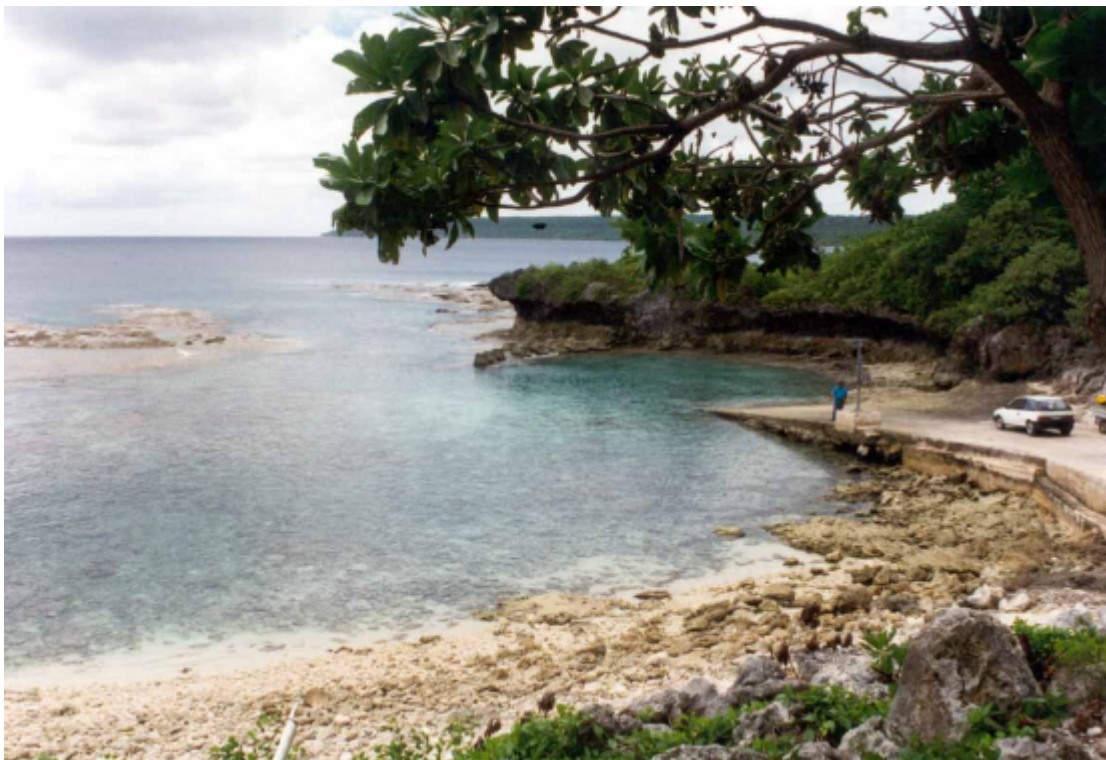
Figure 39. Top: Avatele Beach, looking west along crest from access road. Bottom: General view of cove and boat launching ramp at Avatele (DLF/ 8 Nov 1995)

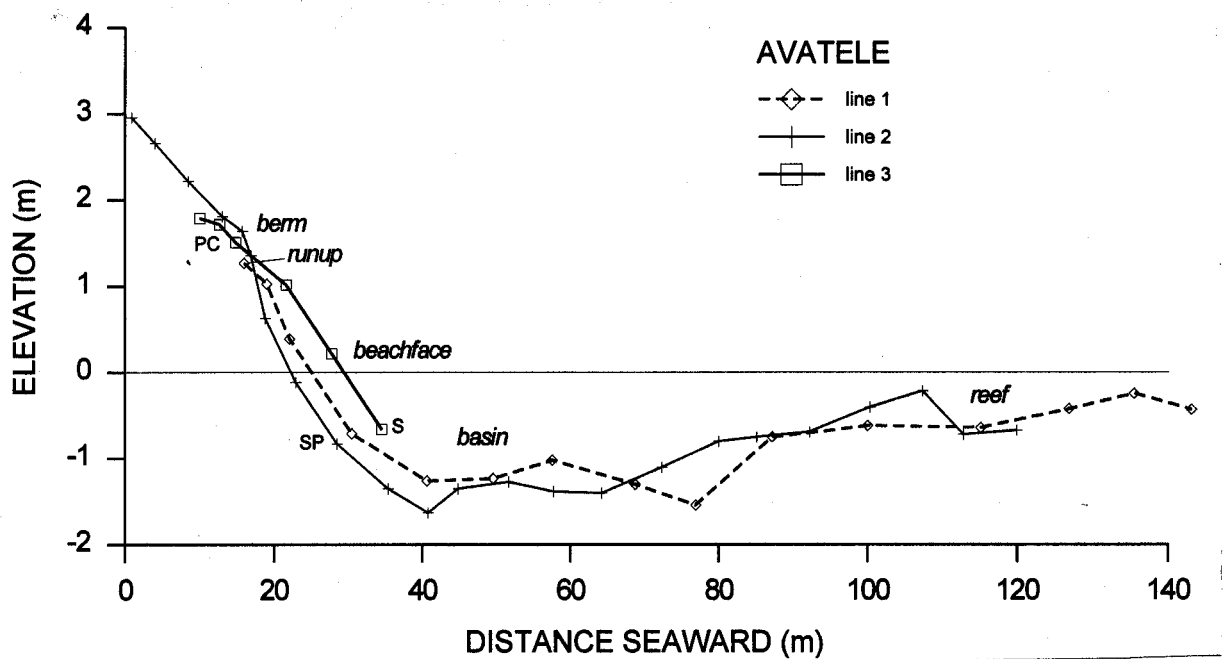
Figure 41. Surveyed profile across beach, cove basin, and barrier reef at Avatele, 8 November 1995 (see Figure 40 for locations).

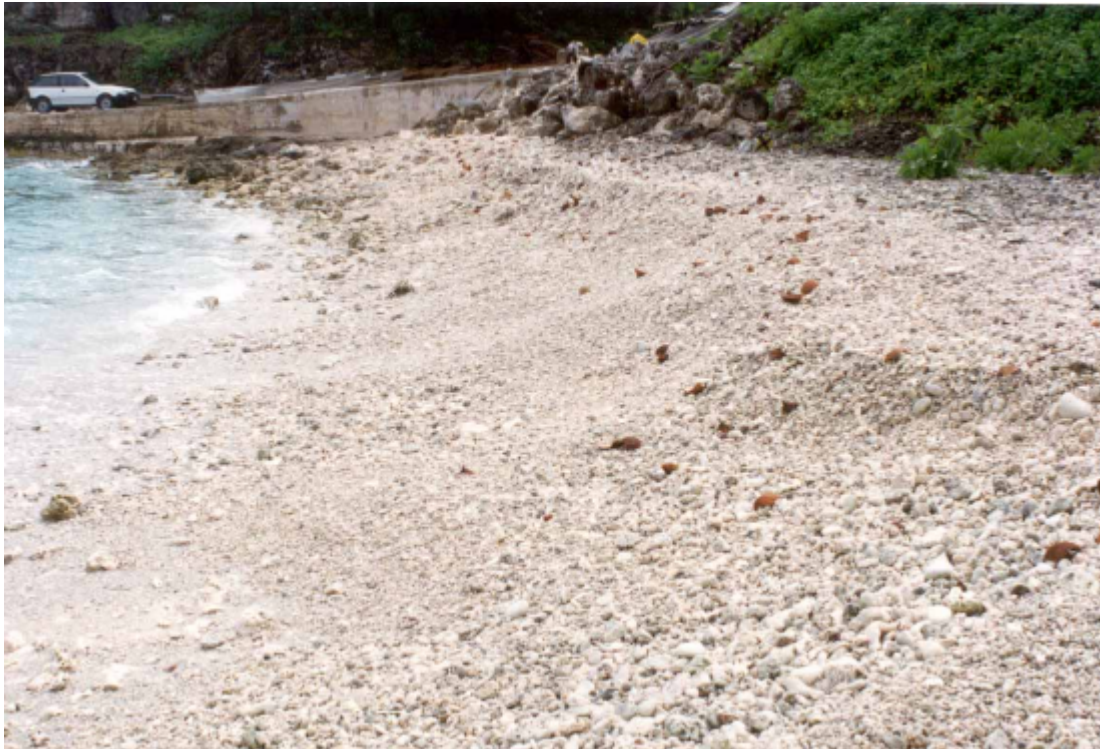
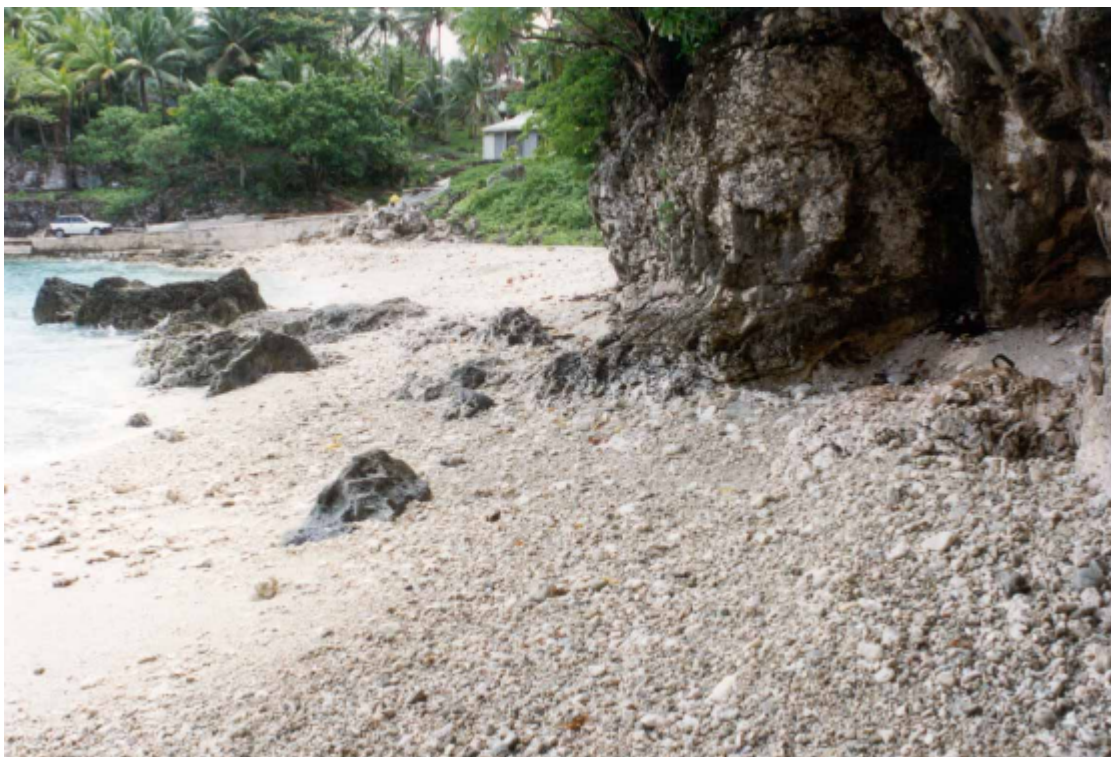
Figure 42. Top: Avatele Beach, looking east along beachface below berm. Rental car on access ramp in background. Bottom: Same as above, from a point further west along the beach below the cliff, at location of samples 5 and 6. (DLF/ 10 Nov 1995).

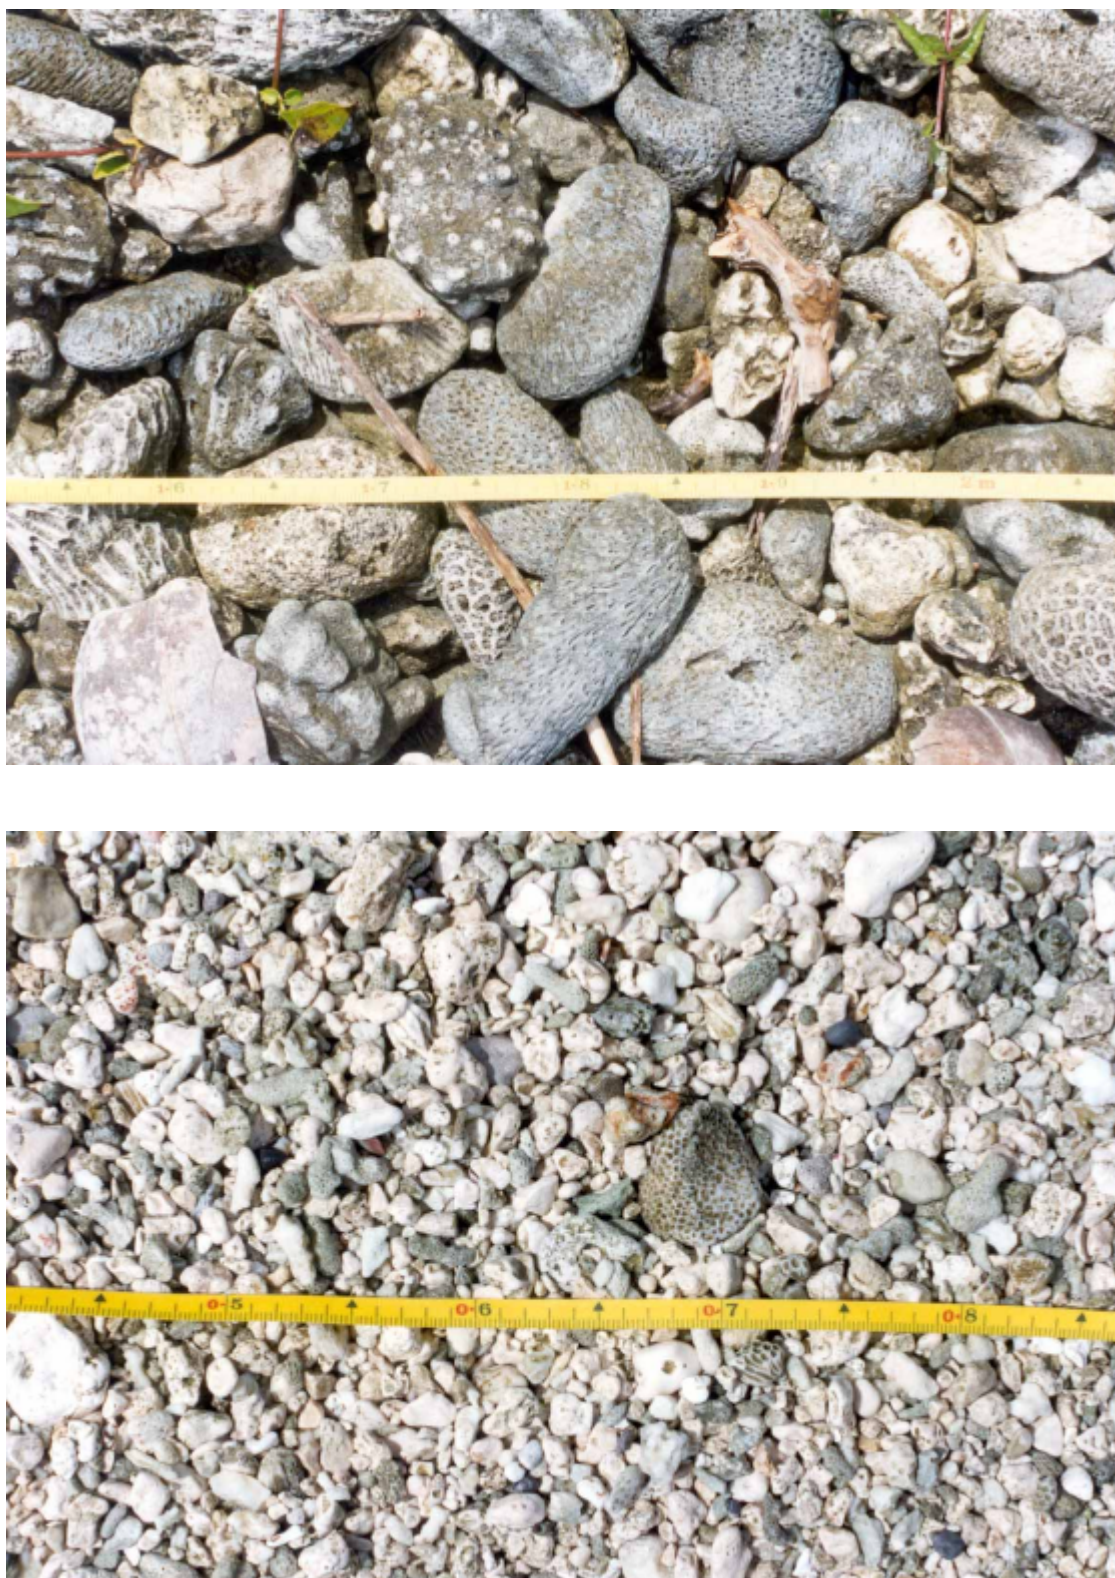
Figure 43. Top: Sample p18, storm ridge, Avatele Beach. Bottom: Sample p20, beachface swash lobe, Avatele Beach. See Figure 40 for locations. Scale in metres with 2 mm graduations (DLF/ 10 Nov 1995).

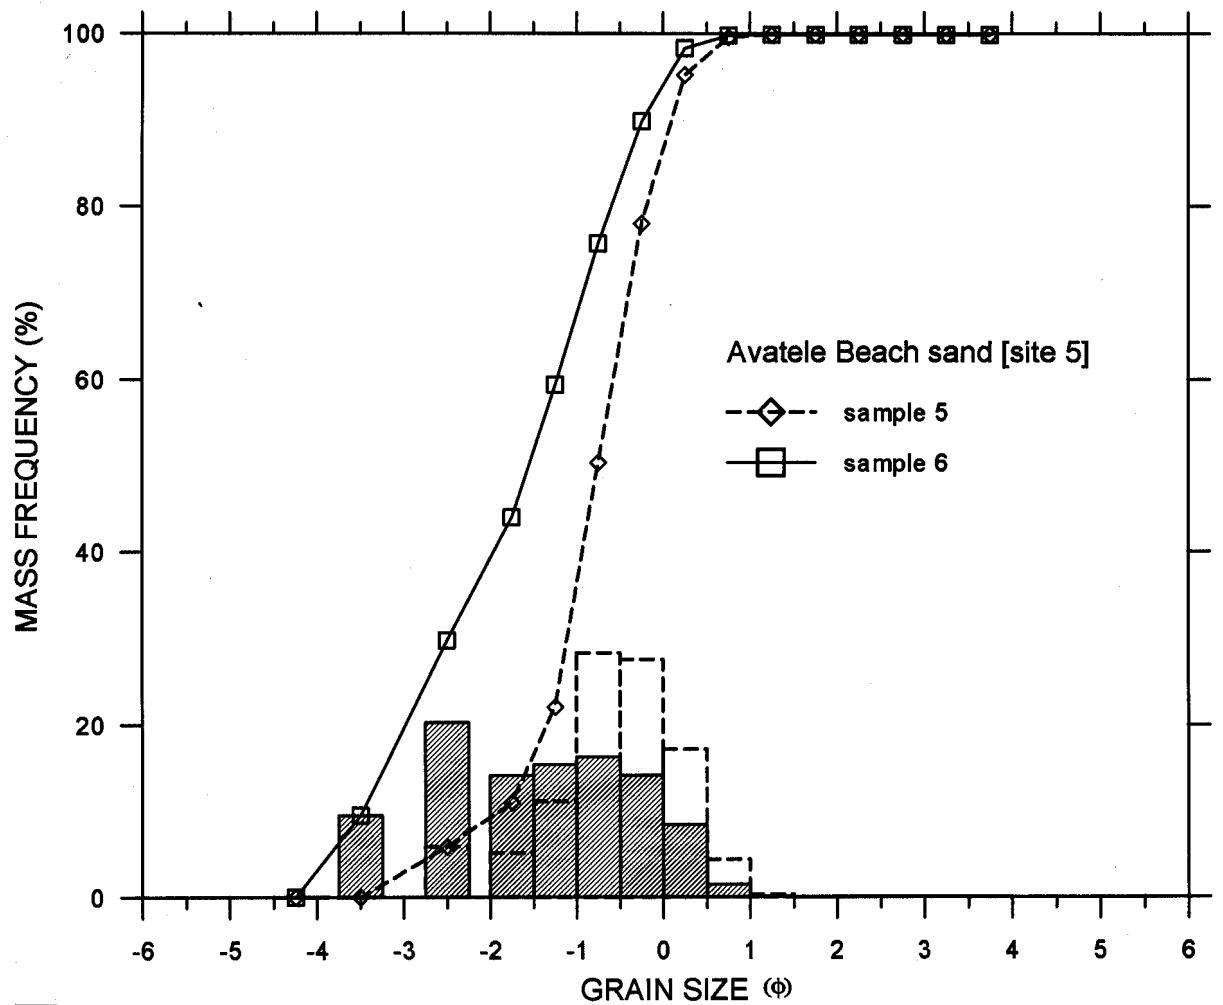
Figure 44. Grain-size distributions of sand samples (5 and 6) from Avatele Beach.

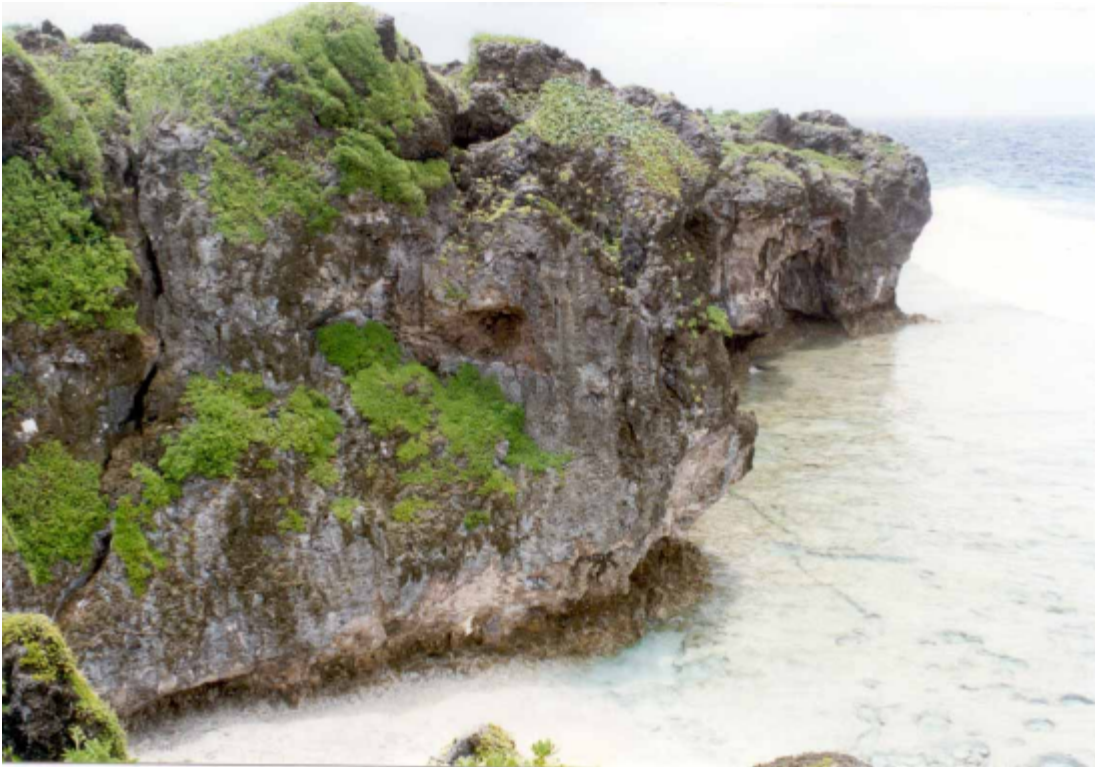
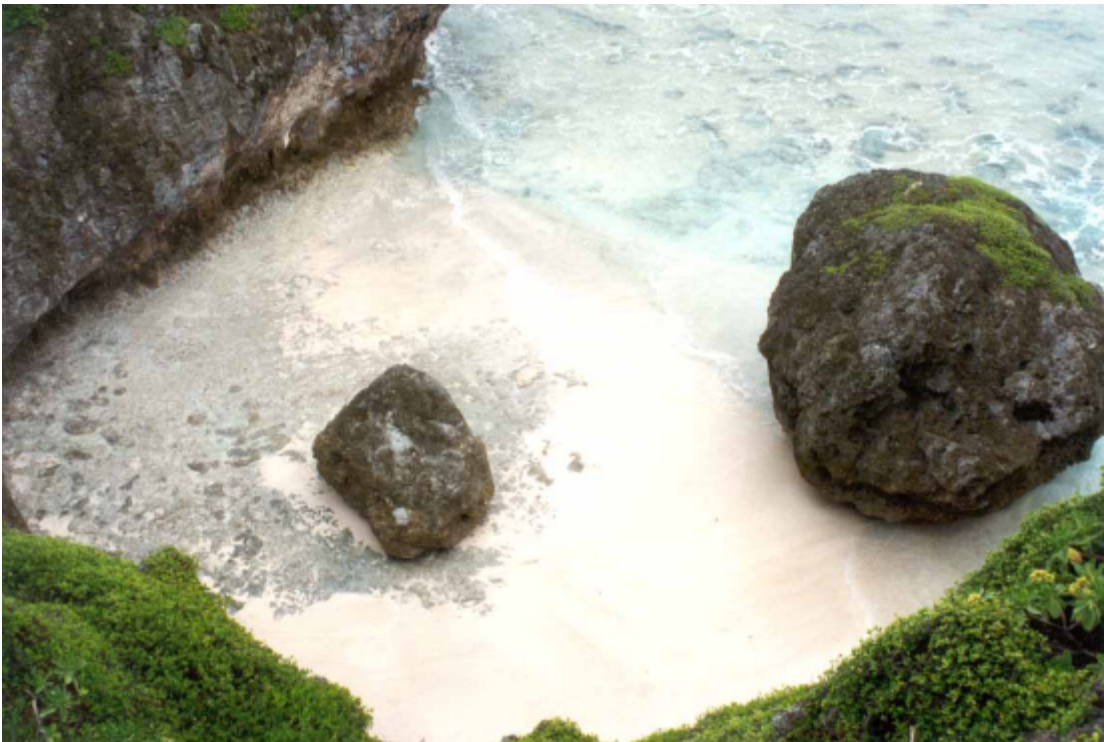
Figure 45. Top: North side Tauta Beach and overhanging cliff beyond. Bottom: Looking down into Tauta Beach embayment from top of cliff. (DLF/ 10 Nov 1995).

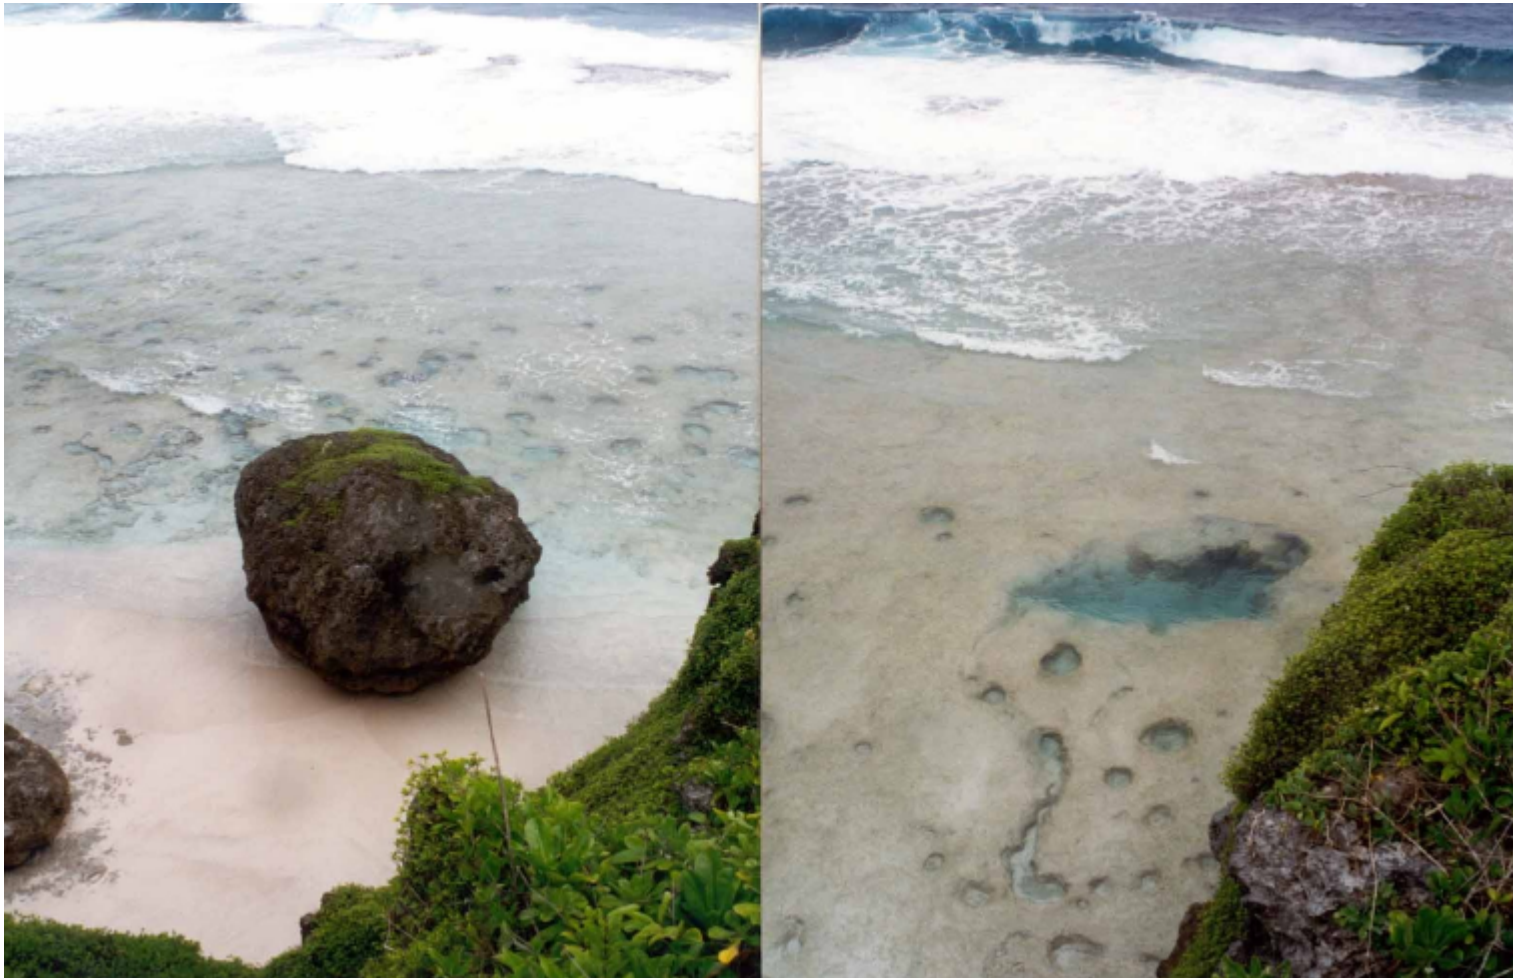
Figure 46. Left: Tauta Beach from top of cliff at head of embayment. Sample 7 from nearshore seaward and to right of block. Sample 8 from beachface on near side of block. Right: Detail of pits and channels on platform surface off south side of Tauta Beach (DLF/ 10 Nov 1995).

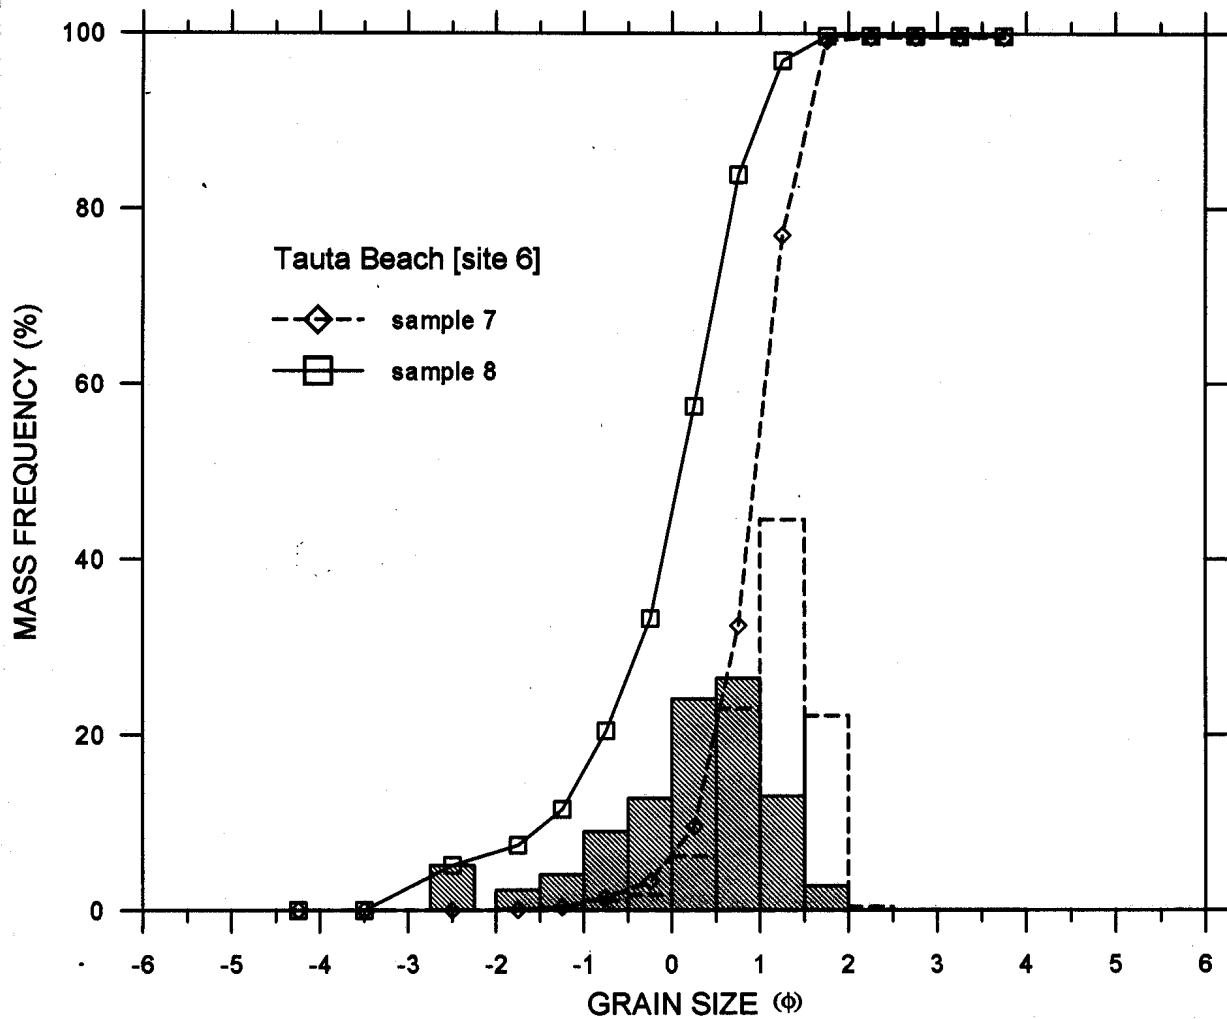
Figure 47. Grain-size distributions of samples 7 and 8 from Tauta Beach.

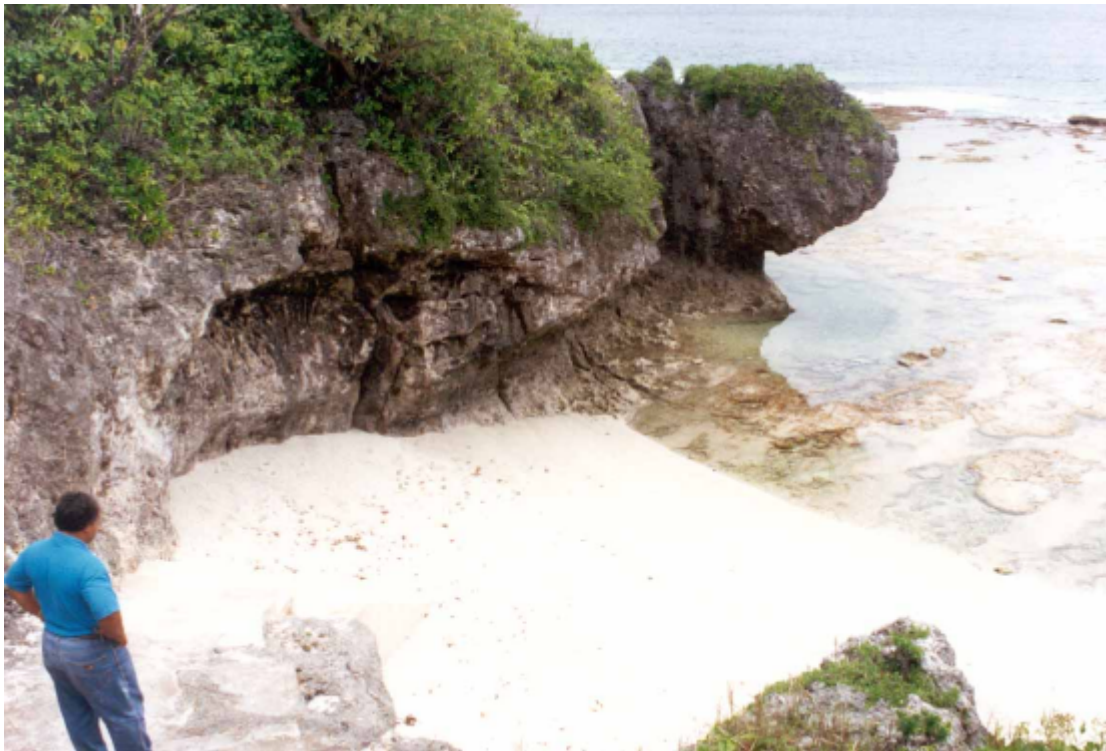
Figure 48. Tamakautoga Landing beach from top of steps, with Molese Tamate in foreground. Note blasted pool at base of overhanging cliff. (DLF/ 6 Nov 1995).

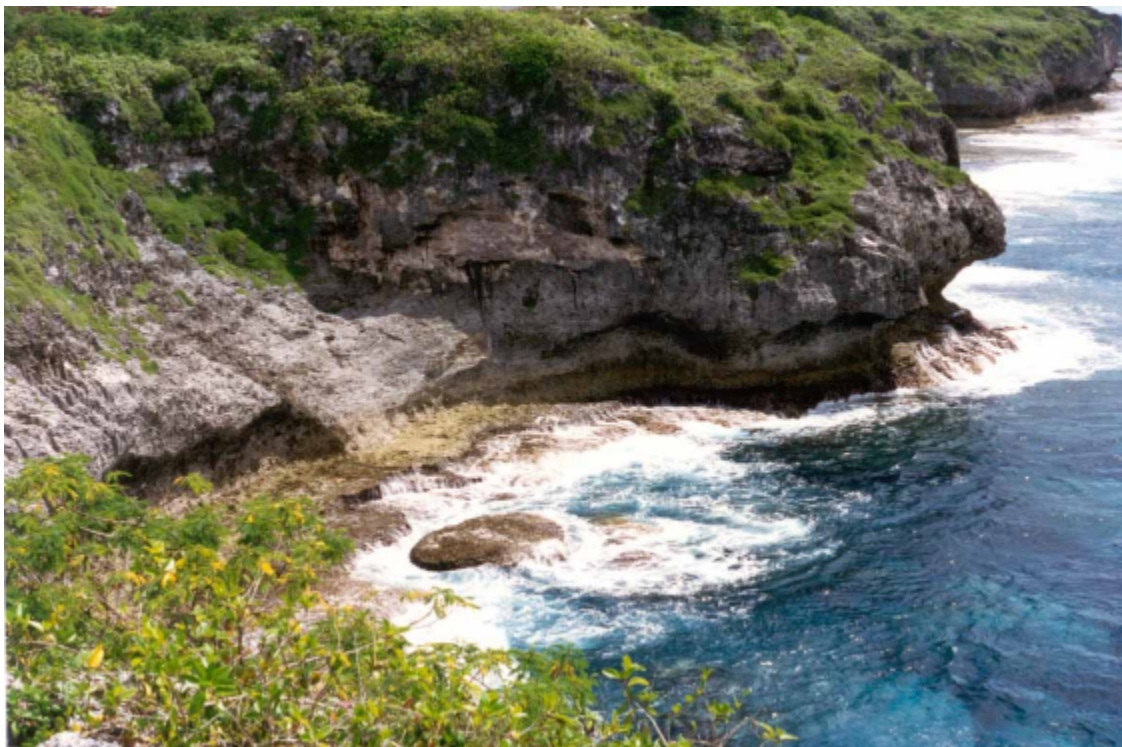
Figure 50. Narrow platform, notched cliff, and ramping backshore rock face, partly stripped of vegetation by wave runup during Cyclone Ofa, south side of Niue Hotel, Alofi South (DLF/ 5 Nov 1995).

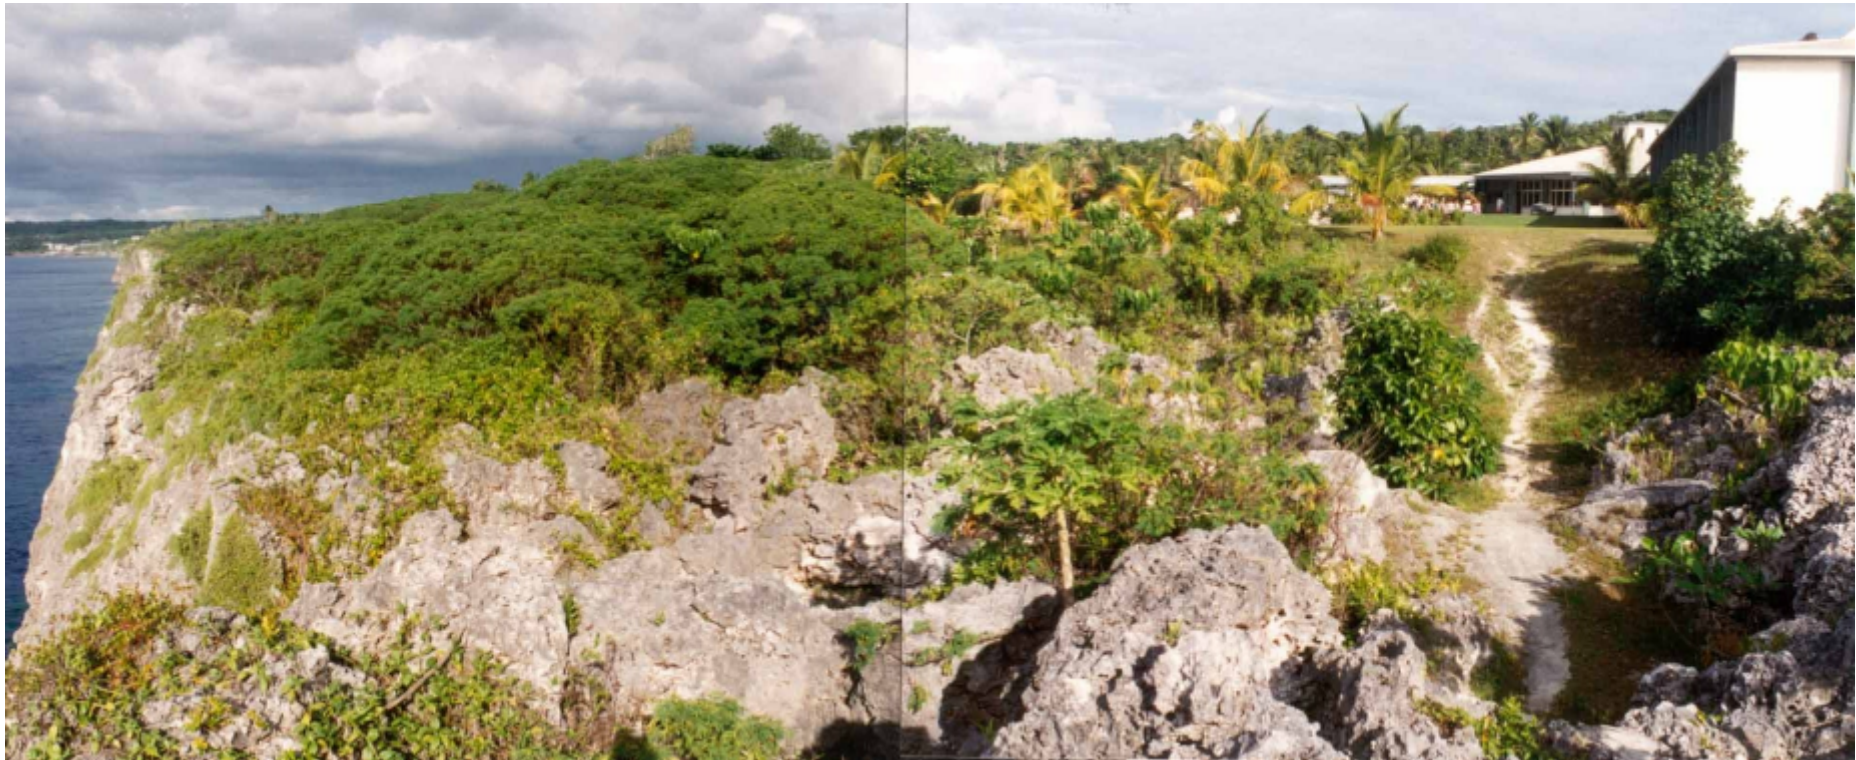
Figure 52. Composite panorama showing cliff and site of Niue Hotel. Note bedroom wing at extreme right, severely damaged during Cyclone Ofa, lawn that was covered with coarse gravel, and main building with bar that was damaged by a very large boulder, on slight topographic rise in distance. (DLF/ 6 Nov 1995).
