**COASTAL SEDIMENTATION AND COASTAL MANAGEMENT  
OF FONGAFALE, FUNAFUTI ATOLL  
TUVALU**

***September 1995***

***SOPAC Technical Report 221***

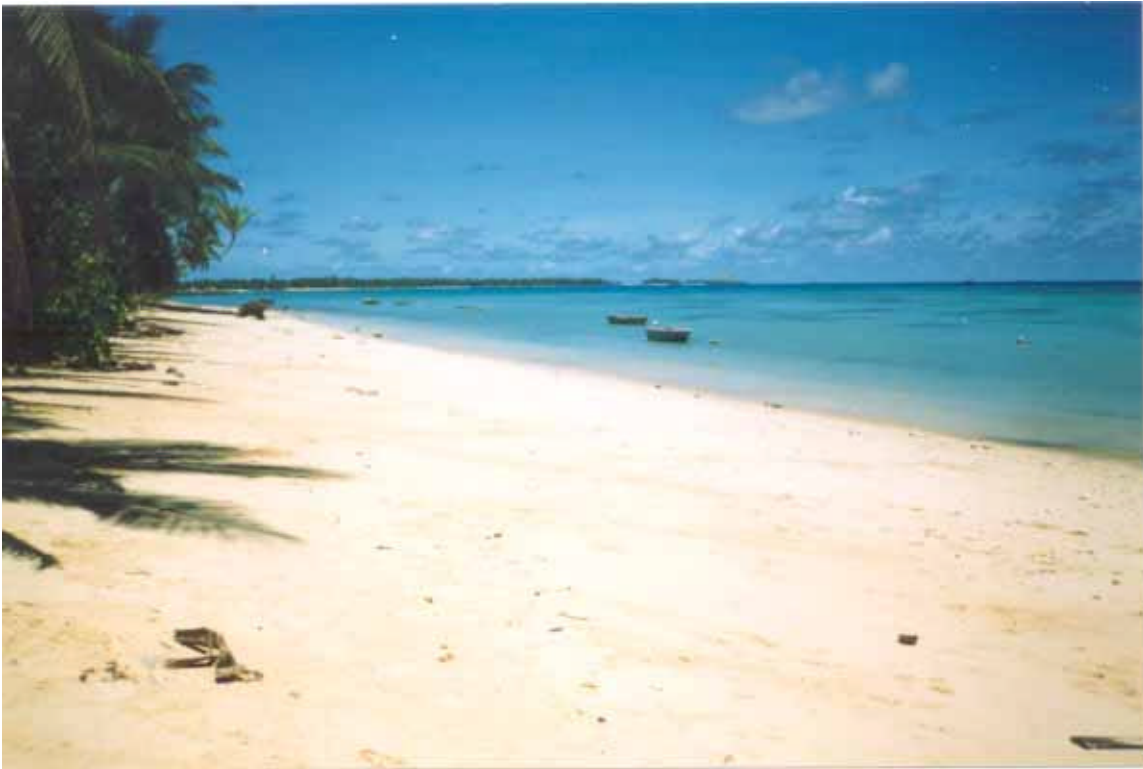
*Figure 9. The lagoon-side sand beach, with sand covered (light) and patch-reef (dark) coral flat in the central coral flat province of Fongafale.*

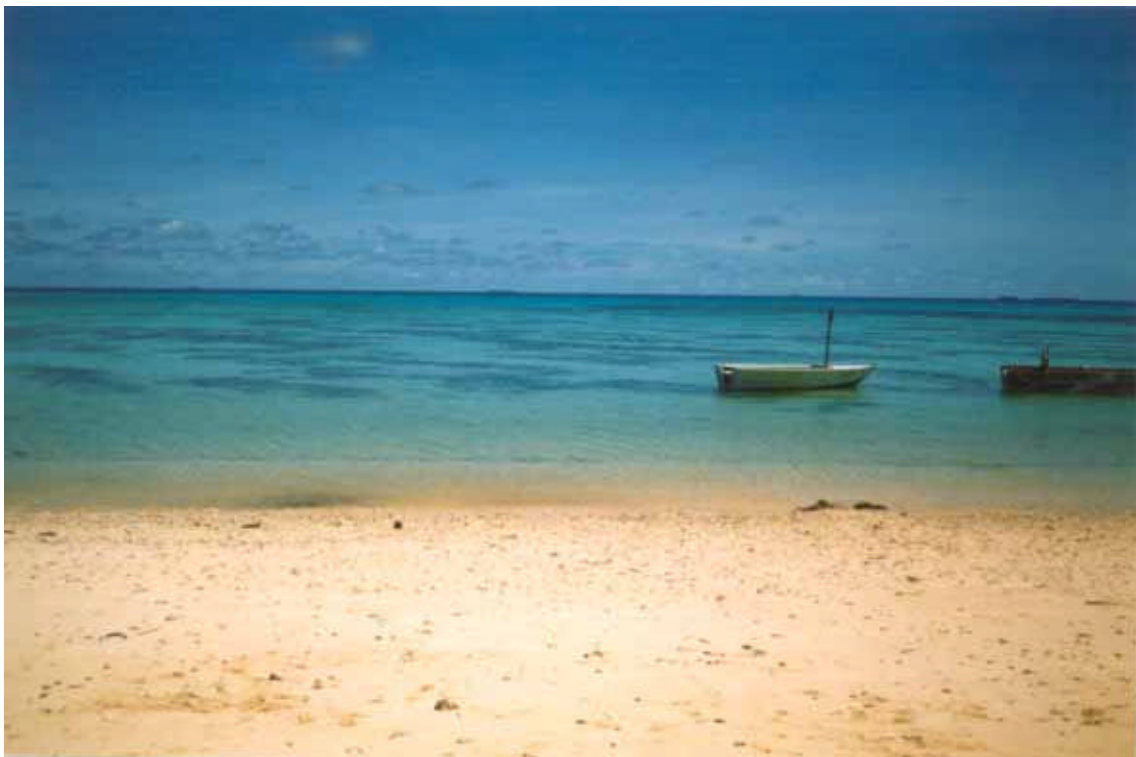
*Figure 10. Sand (light) and patch reef (dark) in the central coral flat province, with sand beach in the foreground.*

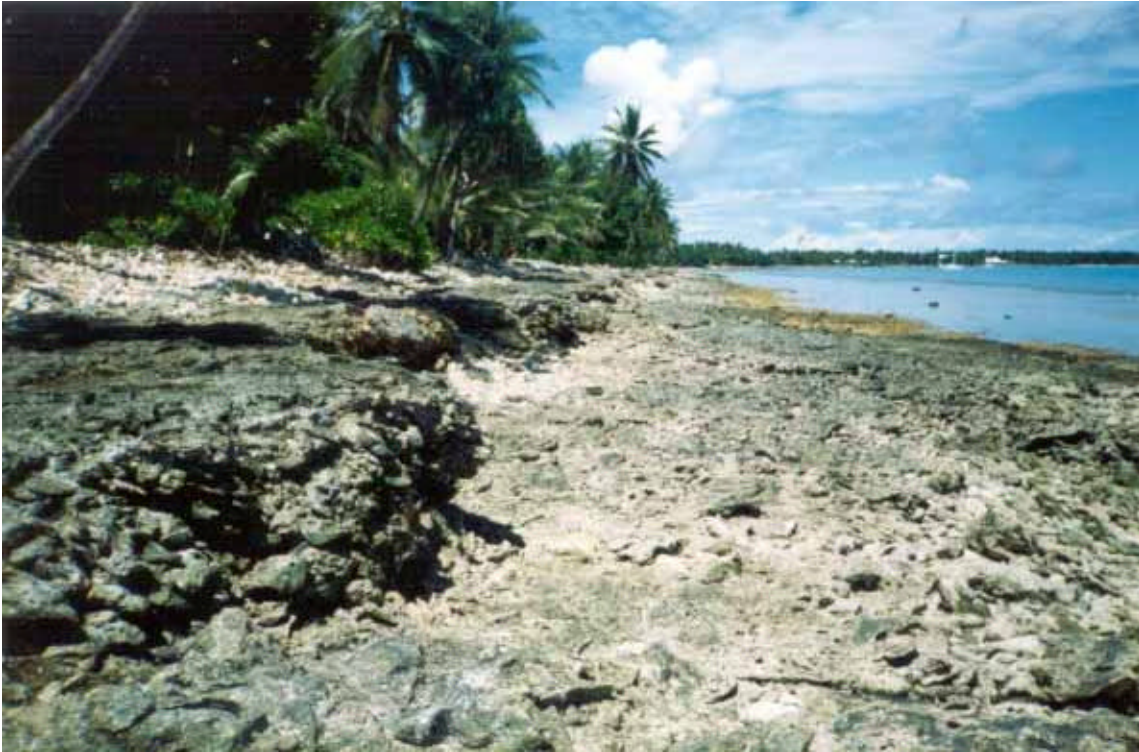
*Figure 11. The beachrock with erosion scarp in the north beach region.*

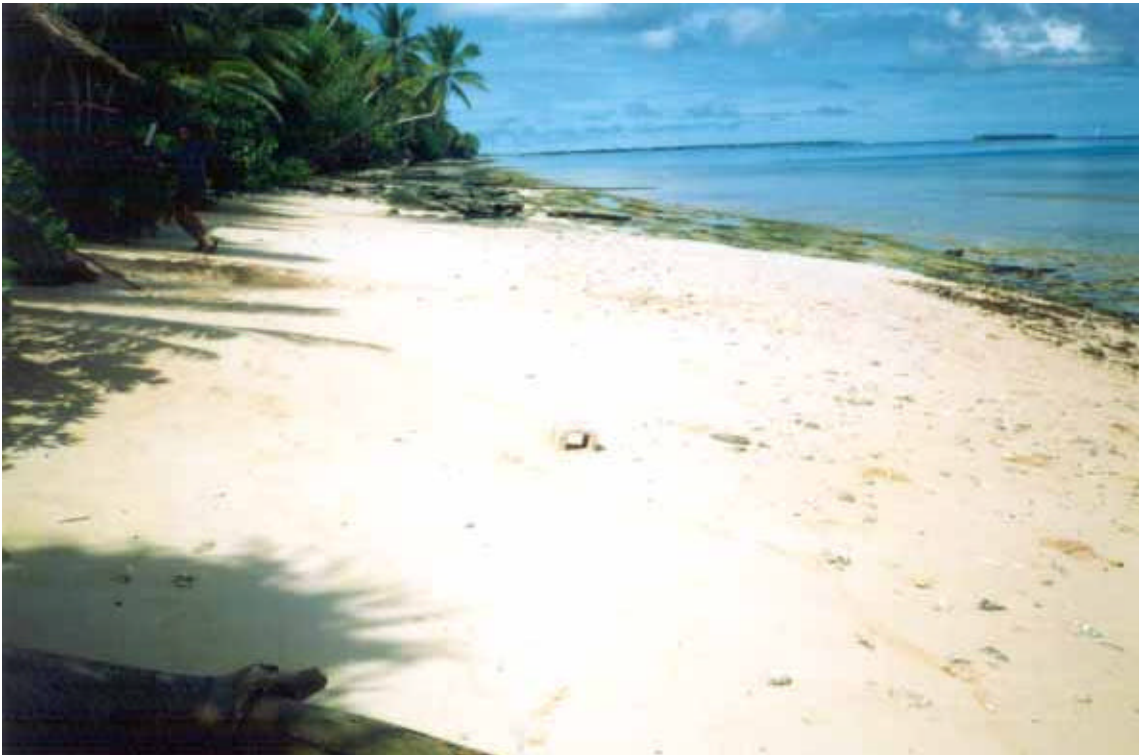
*Figure 12. The sand beach in the north beach region. A thin sand layer covers the beachrock.*

Form 4 : Most parts of the beach are covered with gravel (mostly cobbles), rarely with sand (Figure 12) and very little of the beachrock is exposed. This form has evolved from Forms 1 or 2 or 3.

Thicker sand (tens of centimeters thick) accumulates on the beachrock only under special conditions, such as near the High School in the north arm. The underlying beachrock is easily eroded, forming a shallow basin, in which sand is deposited (Figures 5 and 12).

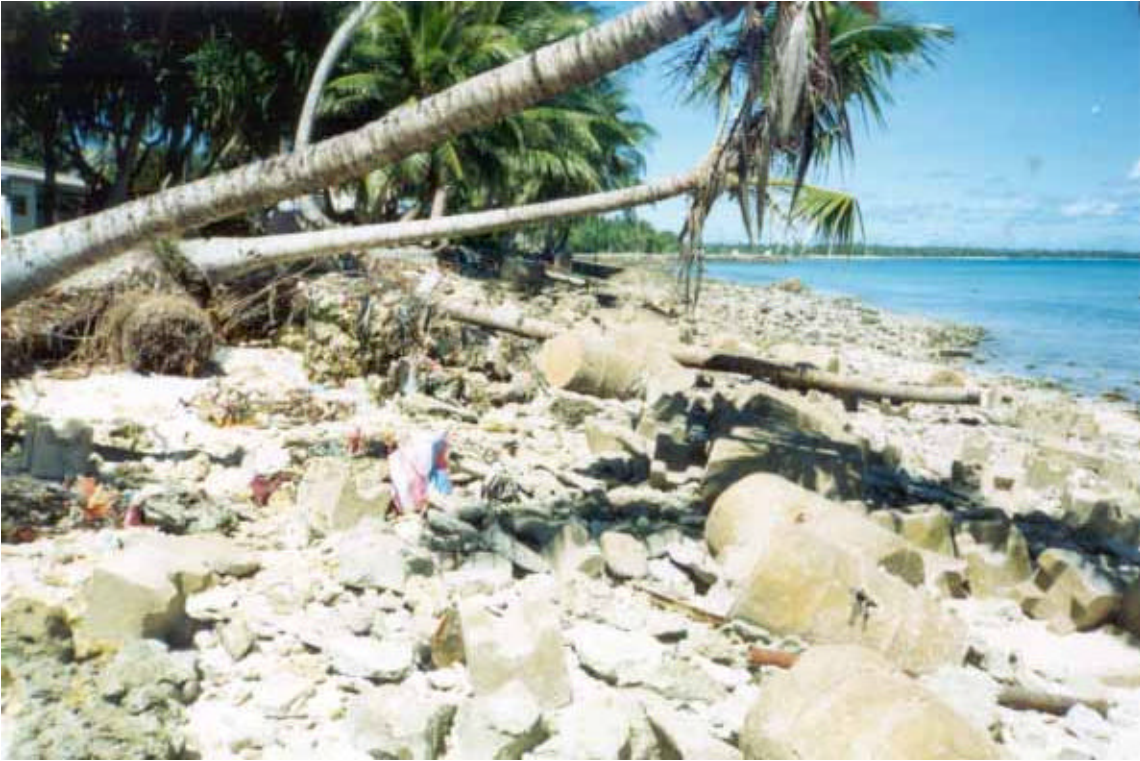
*Figure 20. Coastal erosion to northeast of BS3. The shoreline of the reclaimed land in World War II is shown by the cemented coral stone cylinders, which were put in gasoline drums. The remains of a gabion basket seawall lie between the eroded coast and the cylinders.*

- (v) The section extending 125 m northeast from BS3: the coastline of the reclaimed land in the Second World War is marked by large cemented coral-stone cylinders. These coral stones were placed in gasoline drums (now the drums have disappeared and only fragments of rusted iron remain). These cylinders lie 5.5 m from the present vegetation line (Figure 20). The remains of a later seawall of gabion baskets, behind the Second World War seawall, are now 3 m from the present vegetation line. This shore is poorly protected relative to adjoining sections of the coast and is therefore suffering more intense erosion (Figures 20 and 21).

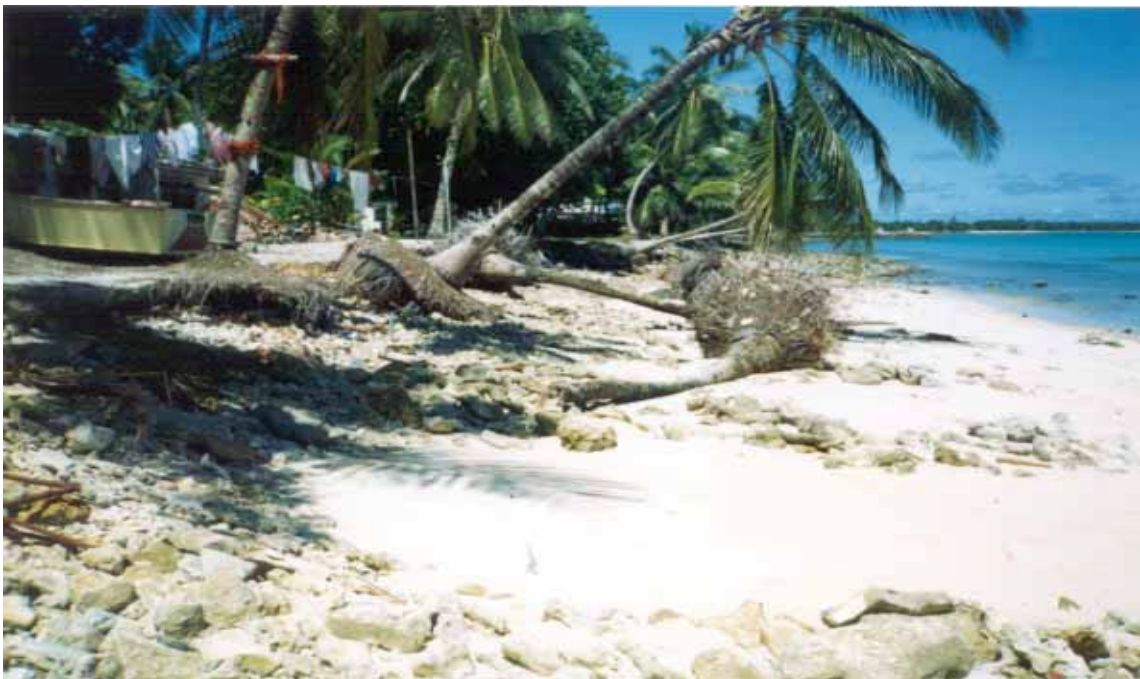
*Figure 21. Coastal erosion to northeast of BS3.*

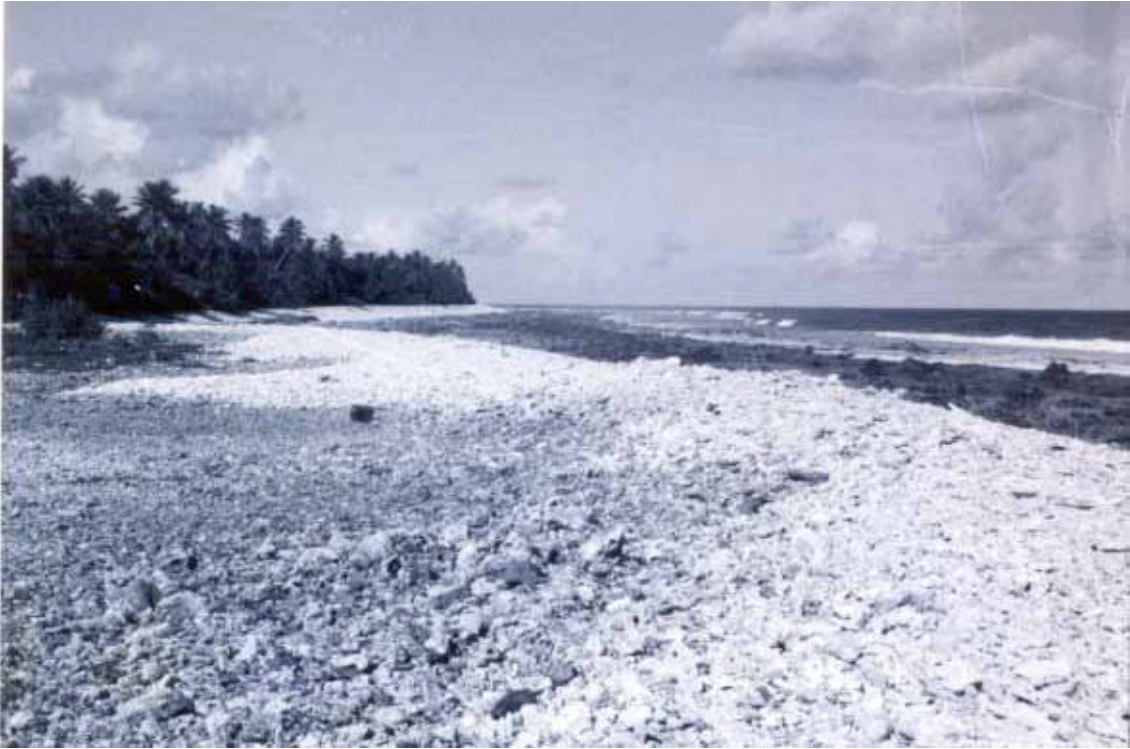
*Figure 25. The oceanside of the gravel accumulation at the south end of Fongafale Island.*

the ocean side, as result of southwestward longshore transport on the outer (ocean side) coast (Figures 23-25). A 10 m wide gravel beach accumulated on the lagoon side (Figures 23 and 26). Some gravel was transported into the lagoon and then moved northeast by longshore currents to be deposited on beachrock.

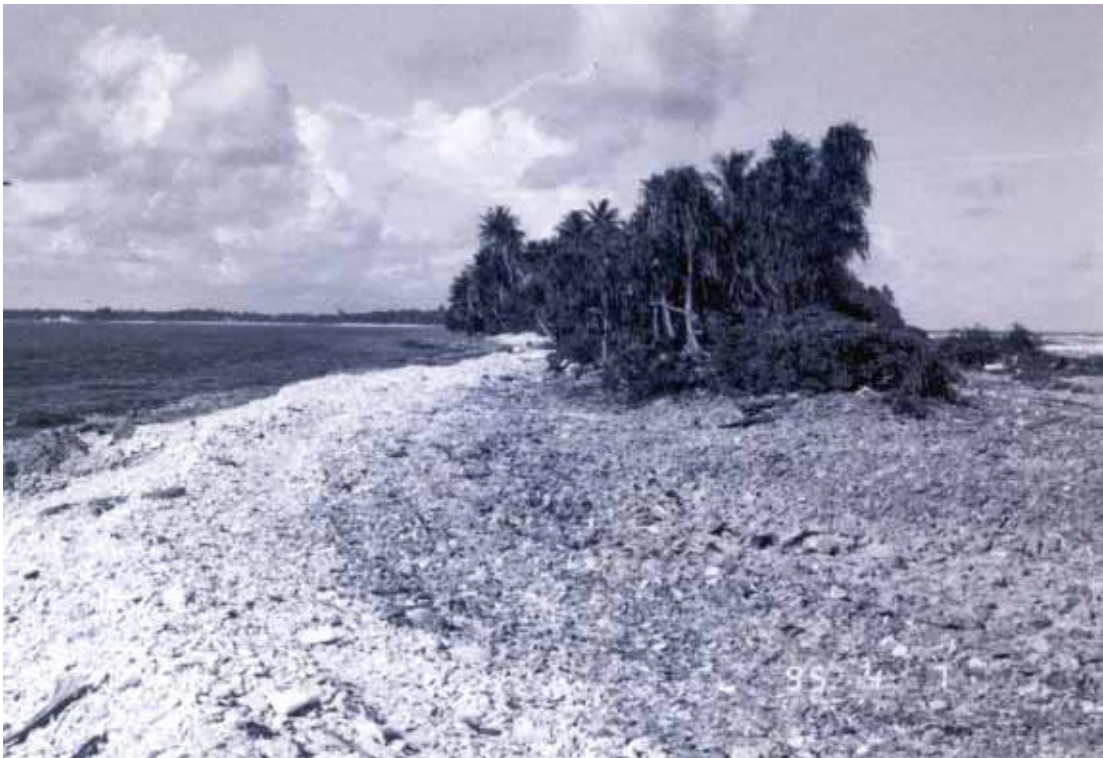
*Figure 26. The lagoonside of the gravel accumulation and the recent accretion with vegetation cover at the south end of Fongafale.*

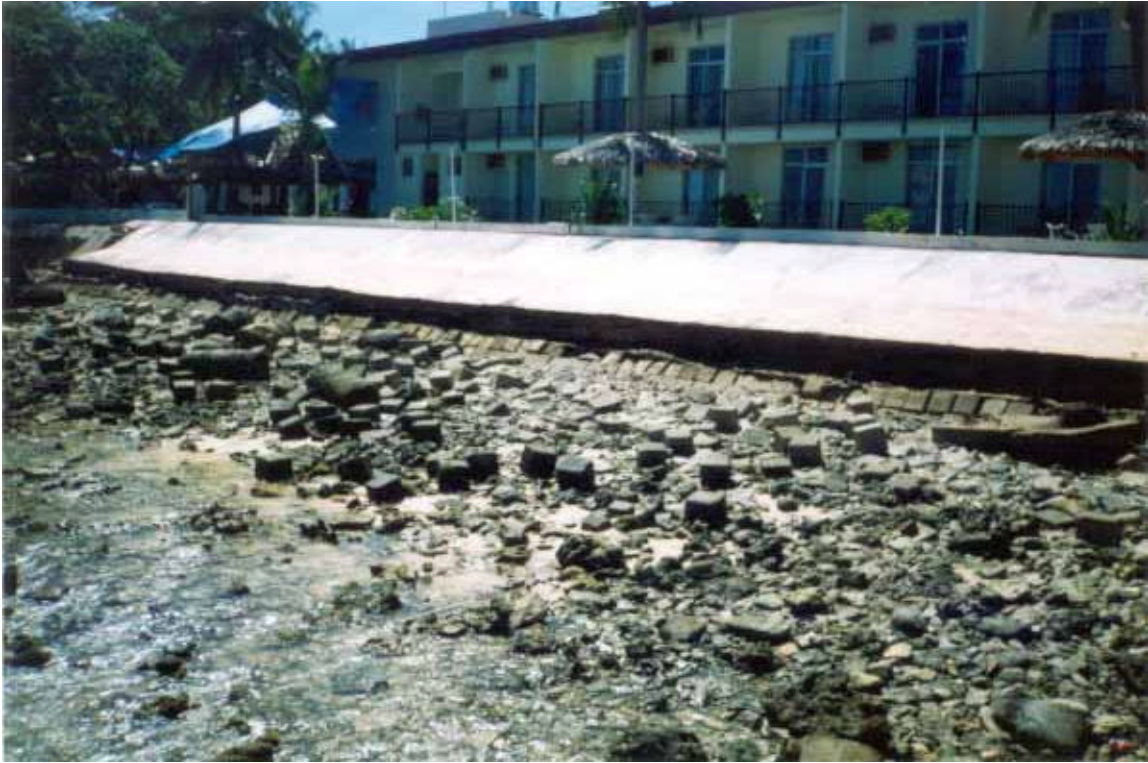
*Figure 30. The concrete seawall and boulders on the beach in front of Vaiaku Lagi Hotel.*

The seawall has helped to protect the coast, but it is aesthetically displeasing and prevents the sand beach from recovering (Figures 30, 31 and 32), hindering the development of tourism. Coastal management and coastal protection efforts should therefore aim to recover the natural scene if possible.

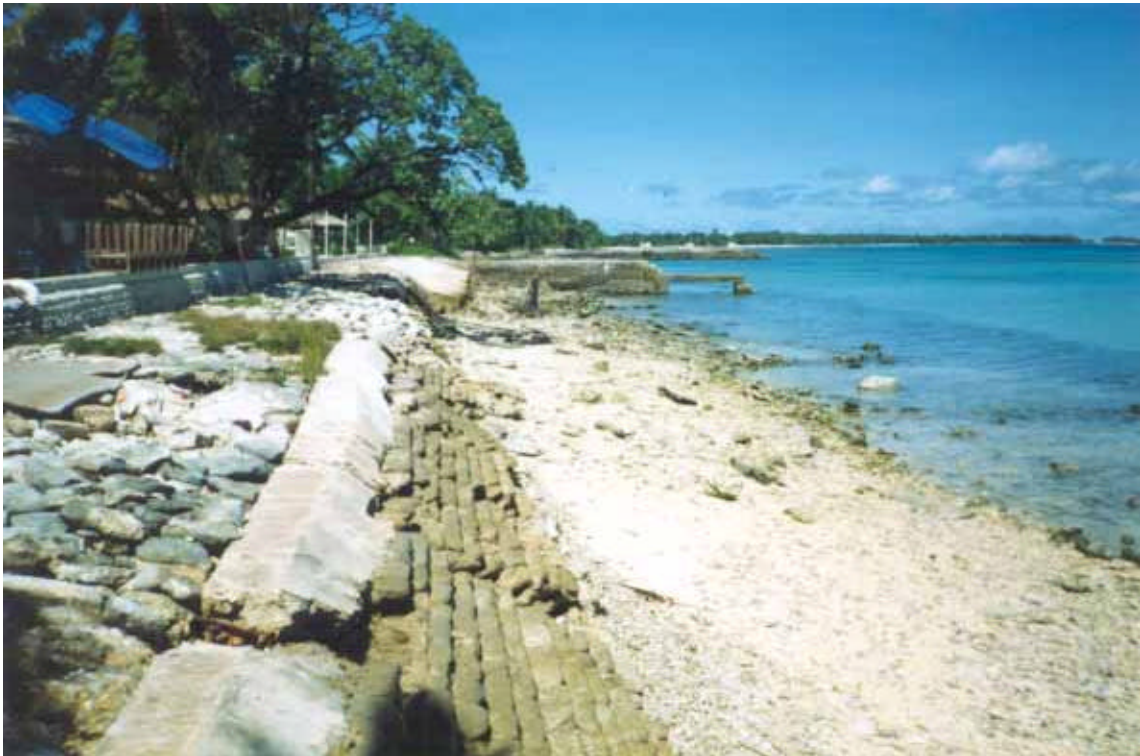
*Figure 31. The cemented boulder seawall and boulders on the beach in front of Vaiaku Lagi Hotel.*

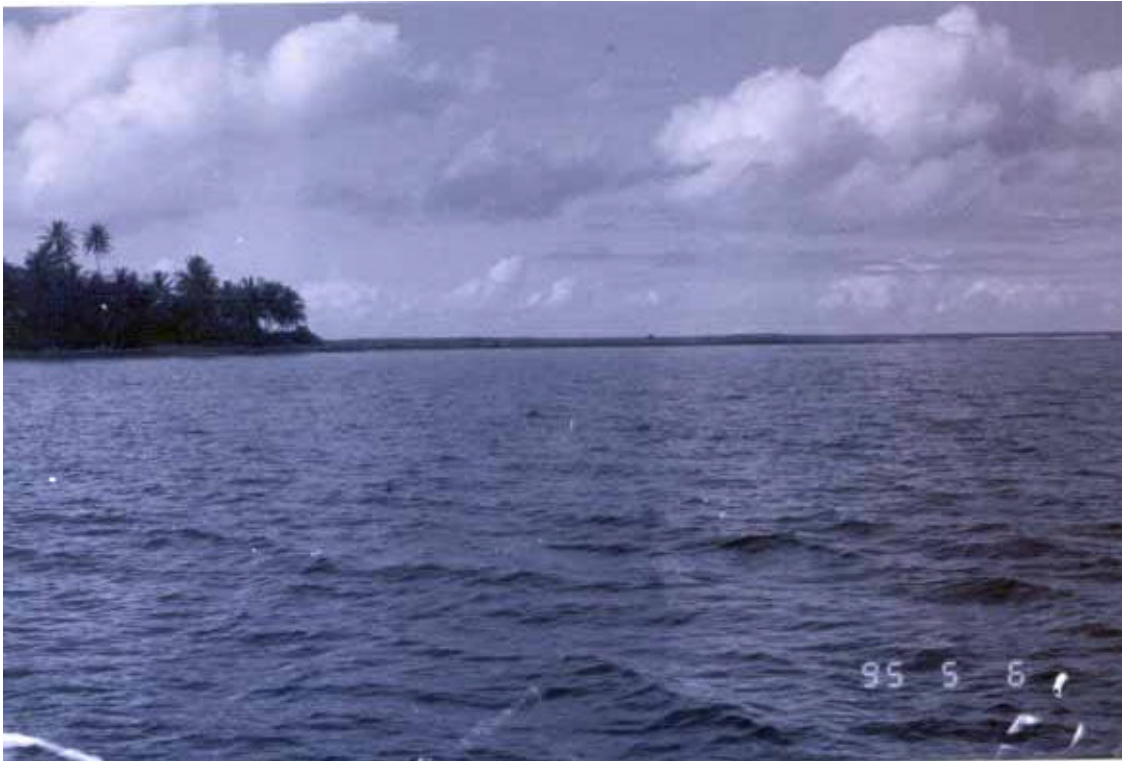
*Figure 35. Accumulation of gravel without vegetation cover at the south end of Funangongo Island.*

In recent years gravel has accumulated at both ends of the islands south of Fongafale, such as Futato, Funangongo and Funamanu (Figure 35). Removing the gravel would not produce a significant environmental impact, except at the southwest end of Funamanu. Taking this gravel would be more expensive than taking from the southwest end of Fongafale. The jetty close to Vaiaku Lagi Hotel (at the southwest corner of the hotel) should be demolished or changed to a pier-type wharf. Otherwise erosion will continue on the downdrift side of the jetty, just in front of the hotel.
