# **COASTAL SEDIMENTATION AND SHORE PROCESSES NATADOLA BEACH, VITI LEVU, FIJI**

Donald L. Forbes, Jens Kruger  
Sekove Motuiwaca & Niko Naibitakele  
SOPAC Secretariat

*SOPAC Preliminary Report 83*

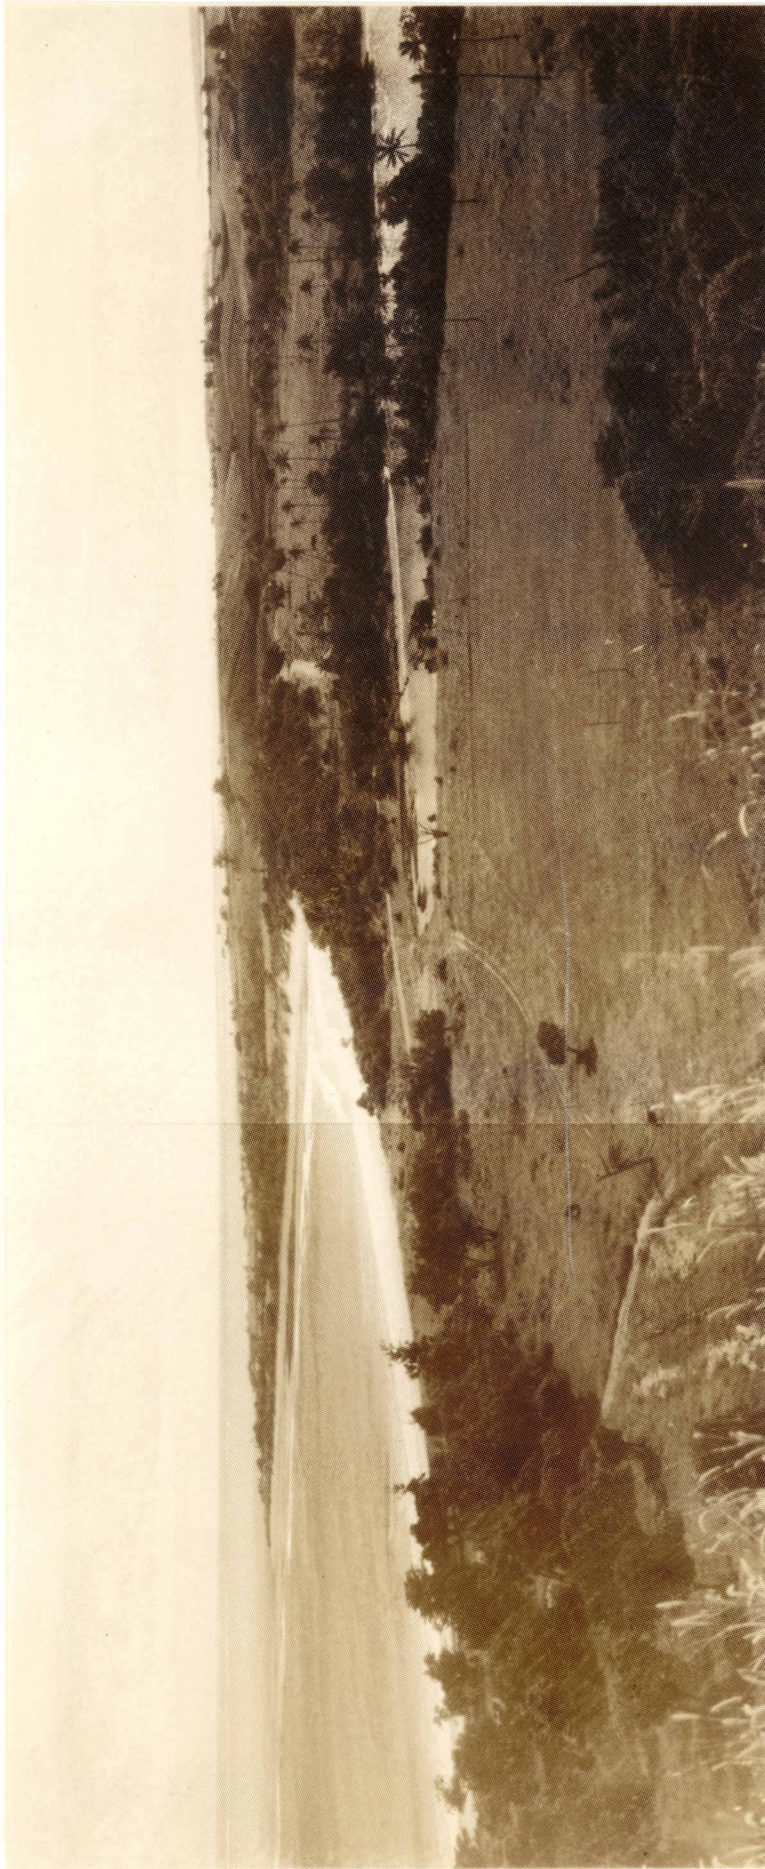
*Figure 5. Panorama looking northwest to beach and beach-ridge plain with Natadola River and western dune ridges in the distance.*

Rip currents are a common feature of the nearshore dynamics at Natadola Beach. Several rip plumes can be seen along the beach in Figure 5 and another, at the end of the reef platform at line 2, is shown in Figure 6. A slight protrusion of the beach close to line 7, visible both in the

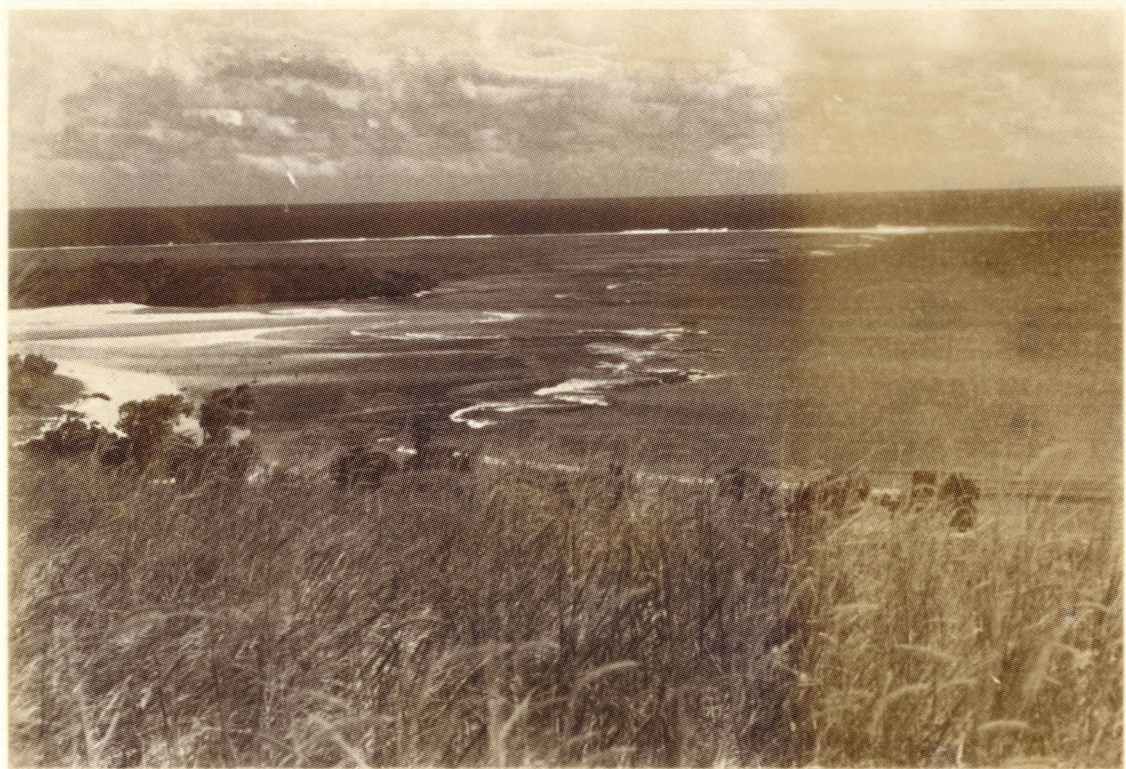
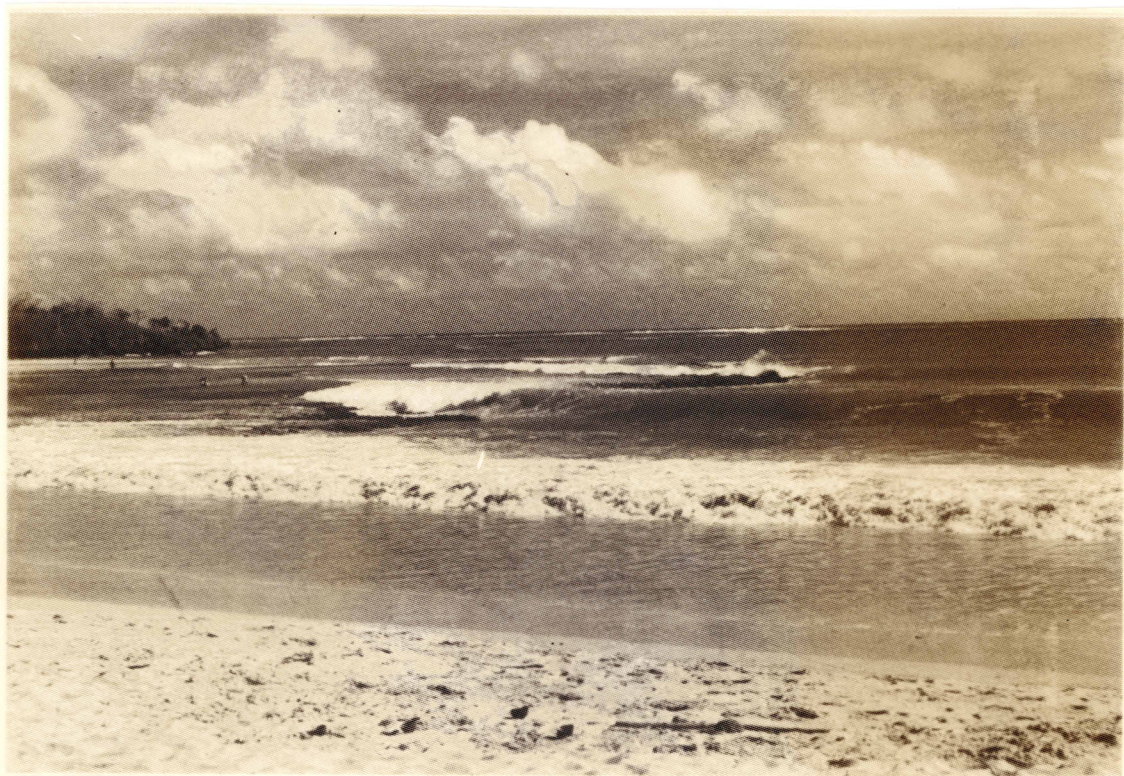
*Figure 6. A: South end of Natadola Beach, with line 1 at far left, marginal reef flat, and passage inside Navo Island. B: Close-up of surf at inner end of reef flat near line 2, with turbid rip current.*

- 1 - a short, west-facing, drift-aligned segment extending about 400 m from the tidal channel inside Navo Island to the end of the marginal reef at the beach (Figure 6);
- 2 - a central, southwest-facing, swash-aligned segment about 900 m long with a sandy nearshore profile (Figure 7);
- 3 - a flanking, south-facing, drift-aligned segment approximately 700 m long on the west, terminating at Dubua Point (Figure 8).

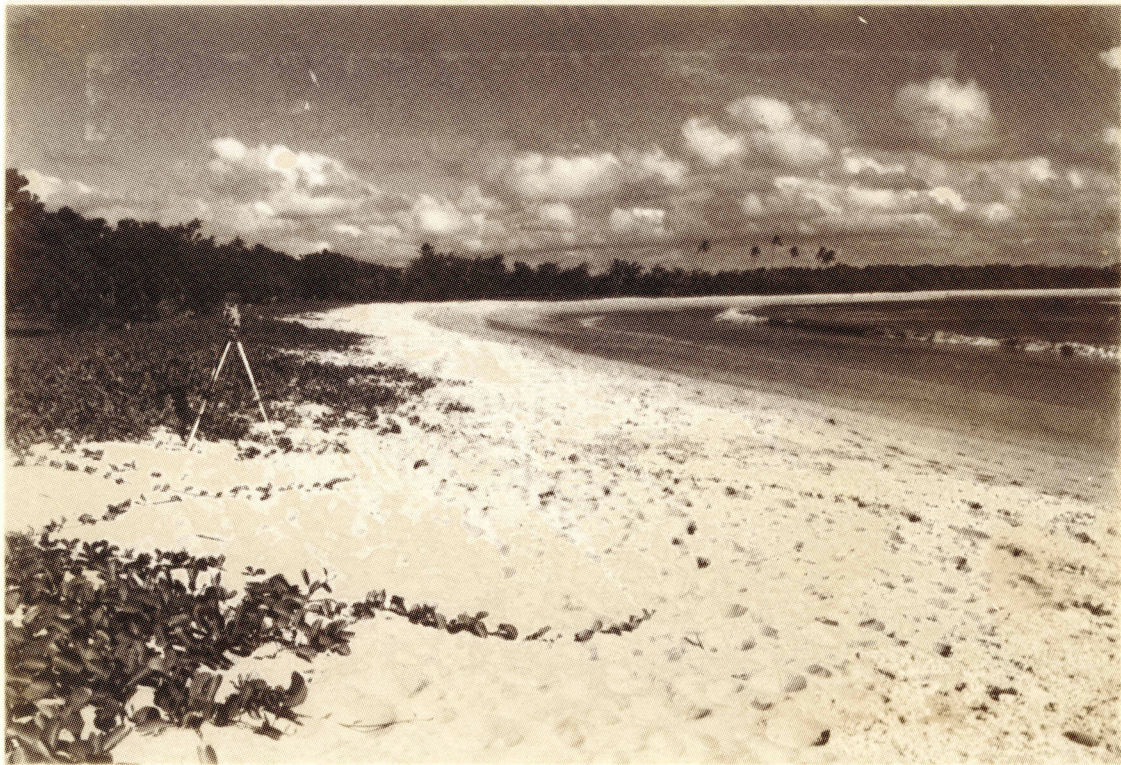
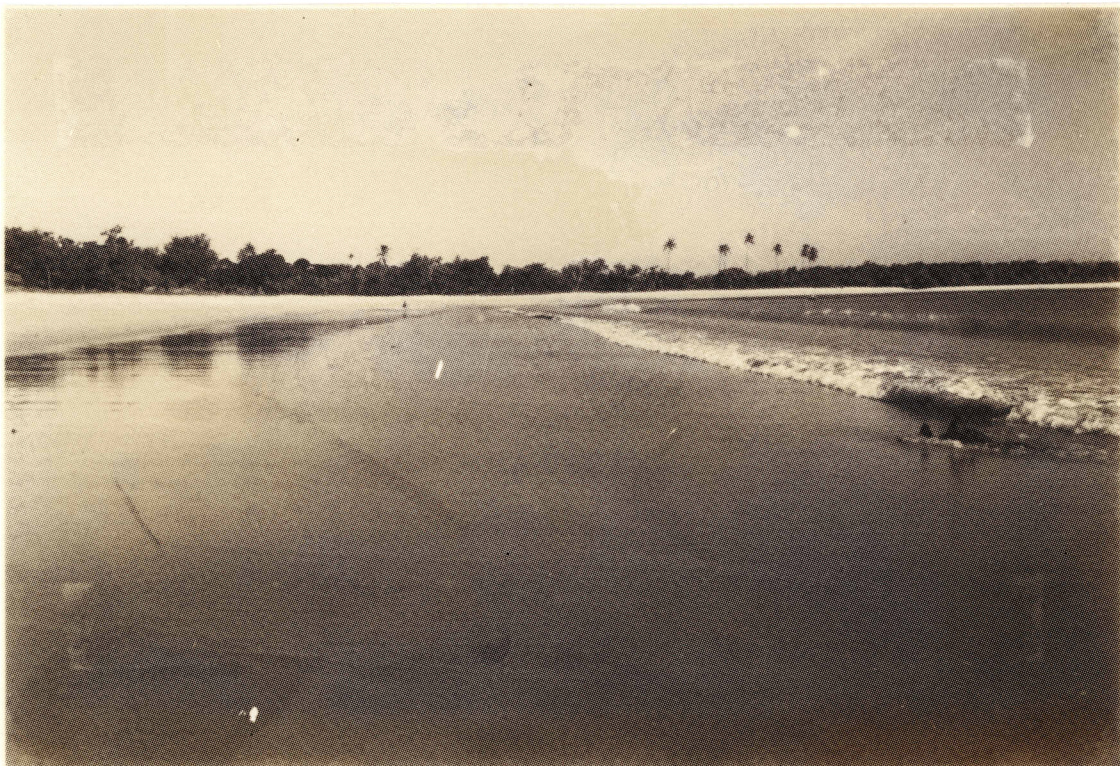
*Figure 7. A: Total station survey instrument at back of berm on line 4, looking east along the top of the beach. B: Low-tide terrace, looking southeast between lines 4 and 5, with rooted stump embedded in beach.*

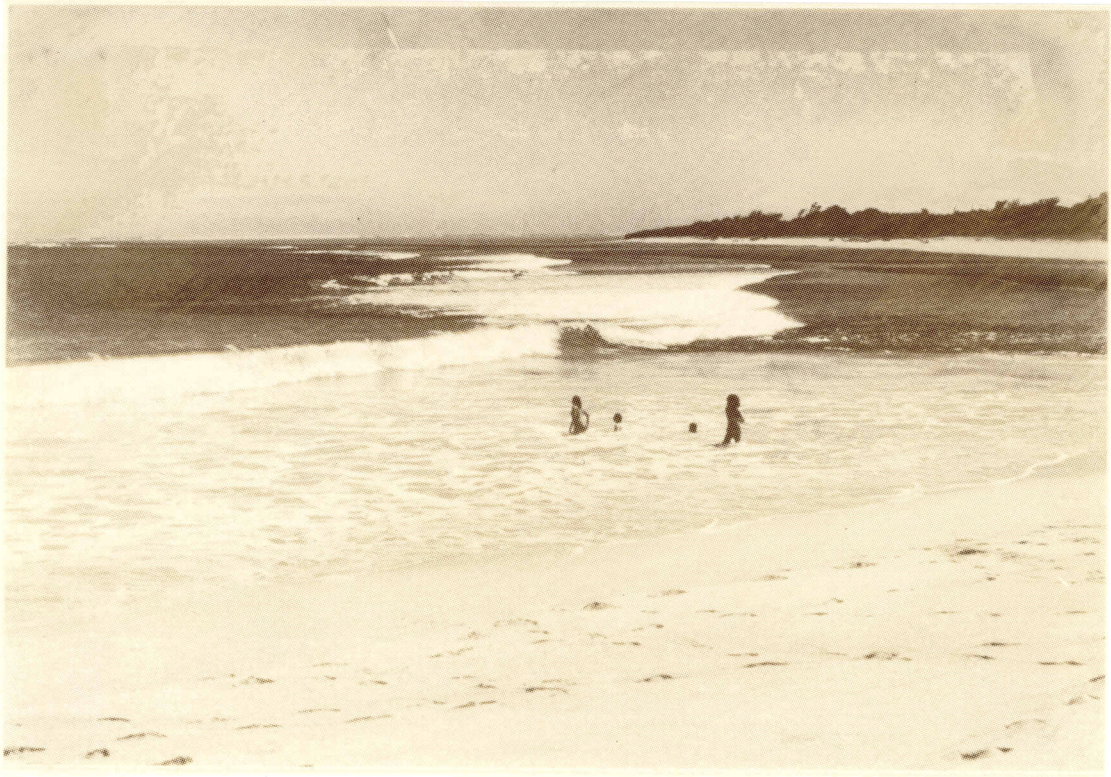
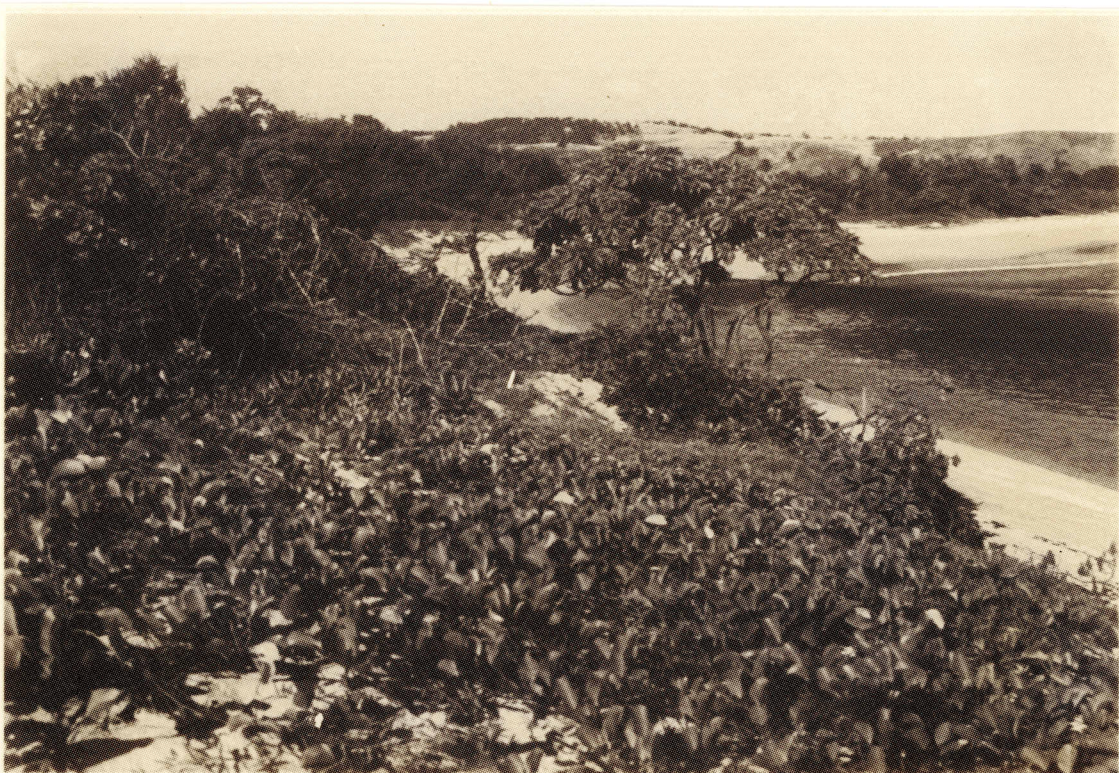
*Figure 8. A: Northwestern marginal reef flat at mid-tide, looking southwest from line 8. B: View from top of the dune at line 9, looking back to line 8.*

Each of the flanking segments is fronted by a reef platform. They are described as 'drift-aligned' because refracting waves break at an angle to the beach and set up longshore currents and associated sediment transport ("longshore drift"). The central section is described as 'swash-aligned' because incoming waves break almost simultaneously along its length. Low dunes are developed behind the western segment of the beach (Figure 8).

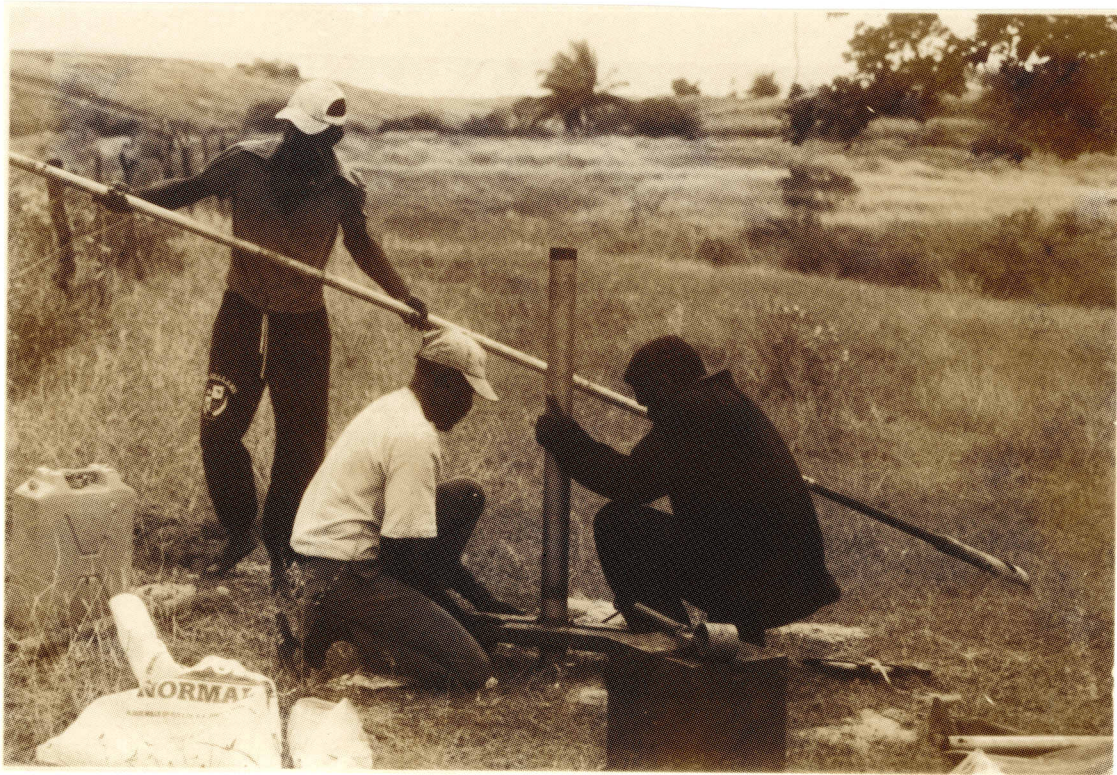
Figure 13. Coring operations in beach- and dune-ridge complex along line 8. From left: Maika Tukana, Leke Nacanieli, and Sekove Motuiwaca at core site 8/1.

Nine cores were obtained using a hand-operated auger and bailer system (Figures 9 & 13). Core lengths varied from 2 to 7 m (Figures 12 & 14). Samples of representative sections were bagged (Appendix 2) and the remainder of the core material was described and discarded in the field.
