## Recovering FADs lost at a depth of 2000 m

*by Marc Taquet<sup>1</sup>, Paul Gervain<sup>2</sup> & Alain Lagin<sup>1</sup>*

## Safety system developed for light FADs<sup>1</sup>

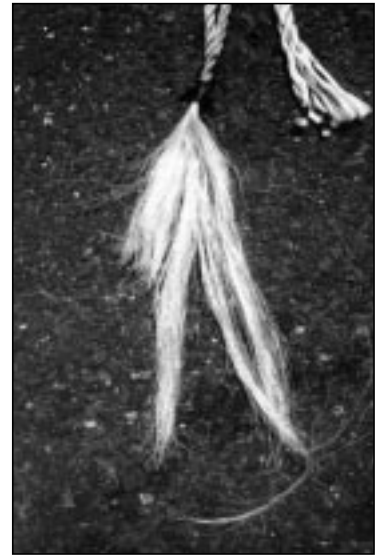
Photo 1

resulted in the causes of failure being identified. One FAD had been torn away from its mooring by a boat as the stretching of its rope was characteristic of very strong traction (Photo 1). The stainless steel wire leaders from fishing lines tangled at the exact location of the breakage point of the other two devices, leave no doubt about the reason for their loss (Photo 2).

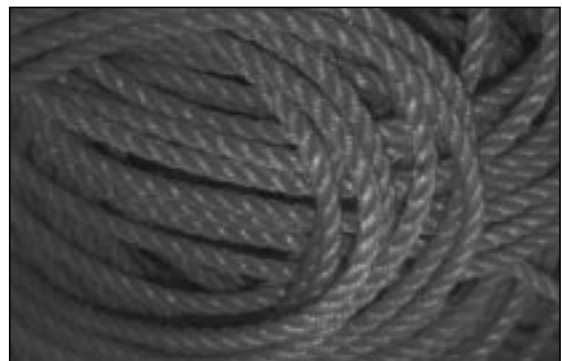
Photo 3

On one of the FADs recovered (deployed in 1995 and lost in 1996), we were able to examine in detail the deep-water components. The ropes had not been subjected to any damage (Photo 3). Below the first 200 metres (from the surface), no sign of aging, fouling or kinking was observed. The splices were in perfect condition and the whippings were in place. The shackles and swivels located on the deep part showed little corrosion and were in very good condition. The anchor was in its original condition (Photo 4). The thimbles which had not been secured by whipping were, however, badly damaged, but part of the damage was due to the strain exercised during recovery because of the weight of the anchor. Galvanised thimbles, nevertheless, constitute the weak point of every connection, and a simple alternative must be implemented without delay.
