CASE STUDY – MV ENCHANTER

20 March 2022

Rescue Coordination Centre New Zealand (RCCNZ)

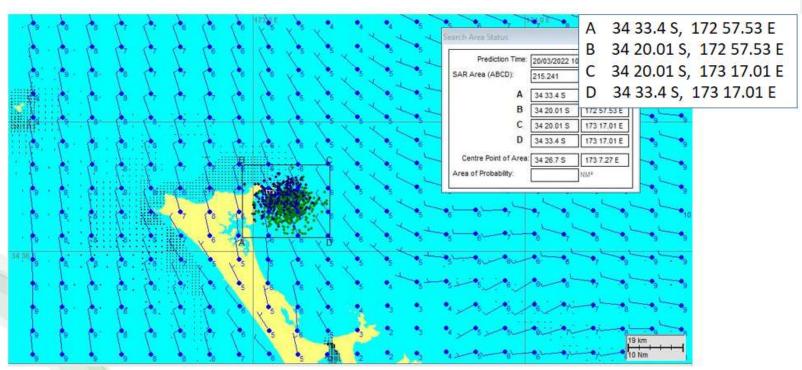
SAR Area At 10:18:00 PM 20/03/2022 (GMT)

Drift start position based on EPIRB position – Drift start time 202018 Local time, valid until datum 201018 Local. Targets: PIW (blue dots) and life raft (green dots).
