A Technical Appraisal of the Auki Water Supply System

Malaita Island, Solomon Islands

Technical Report 261

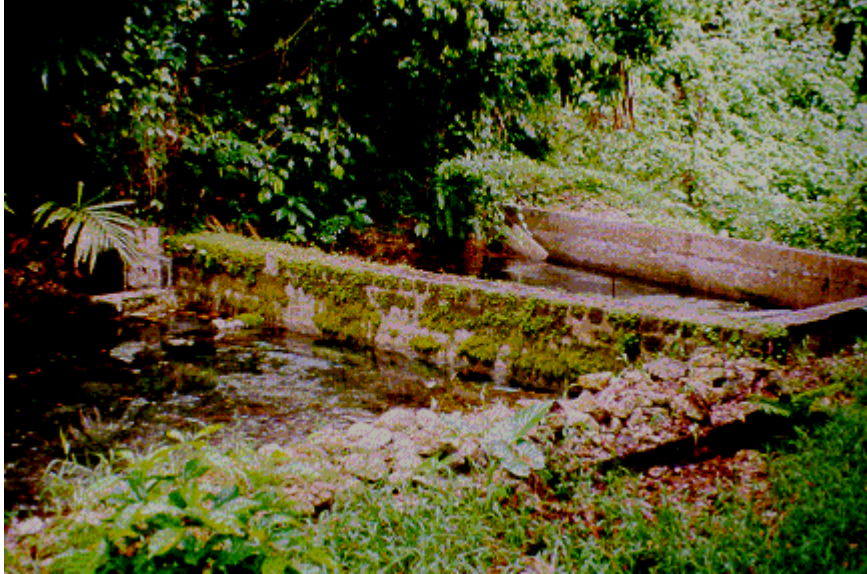
Photo A1.1: Auki Kwaibala Source, View of Basin 1 and Basin 2.

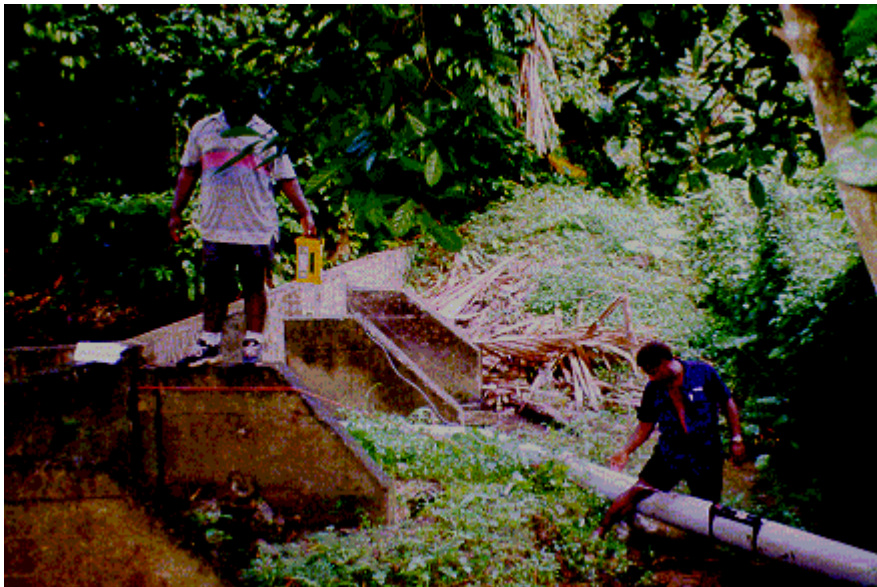
Photo A1.2: Auki Kwaibala Source, View of retaining wall In Basin 1 and PVC 200mm suction pipe.

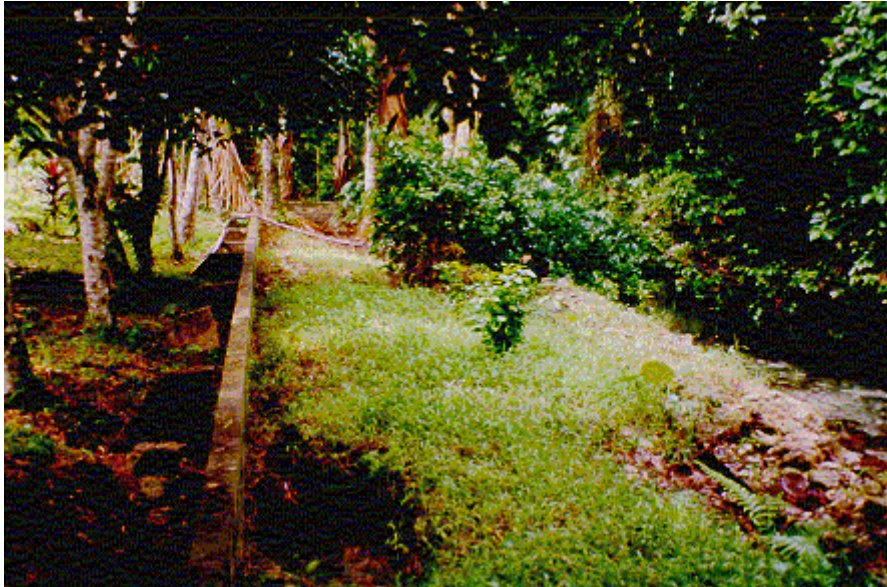
Photo A1.3: Auki Kwaibala Source, View of Basin 3 showing both new and old retaining structure.

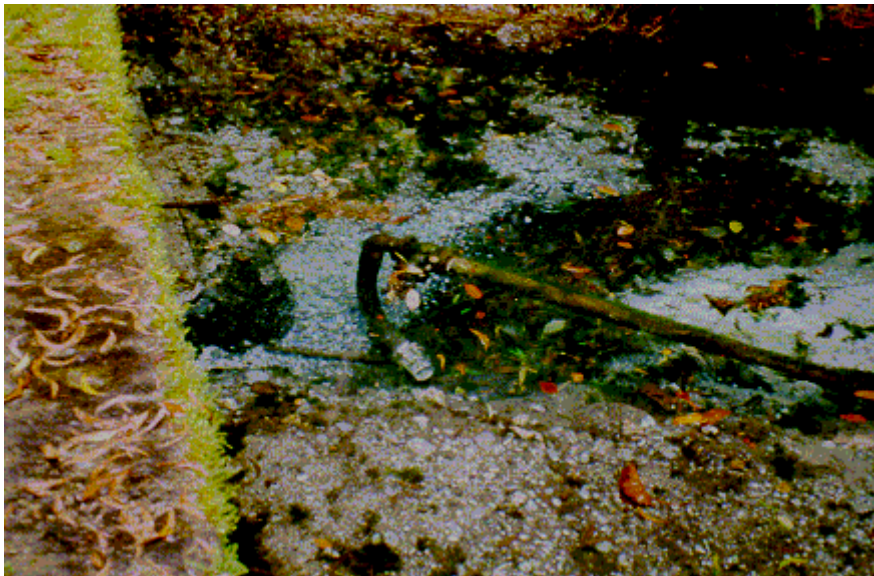
Photo A1.4: Auki Kwaibala Source, View into Basin 1 showing the old suction pipe and gravel spots indicating water entry.

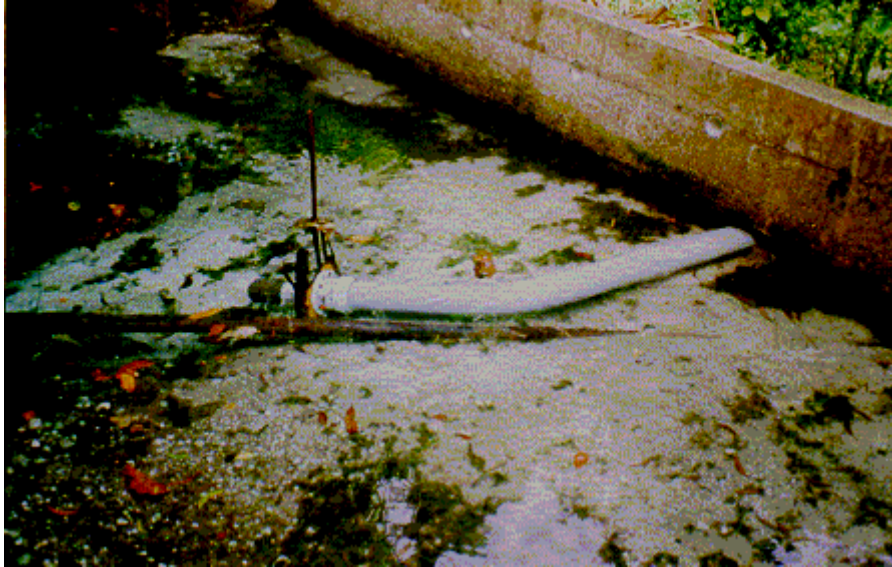
Photo A1.5: Auki Kwaibala Source, View into Basin 1 showing the new PVC 200mm suction sipe and gravel spots indicating water entry.

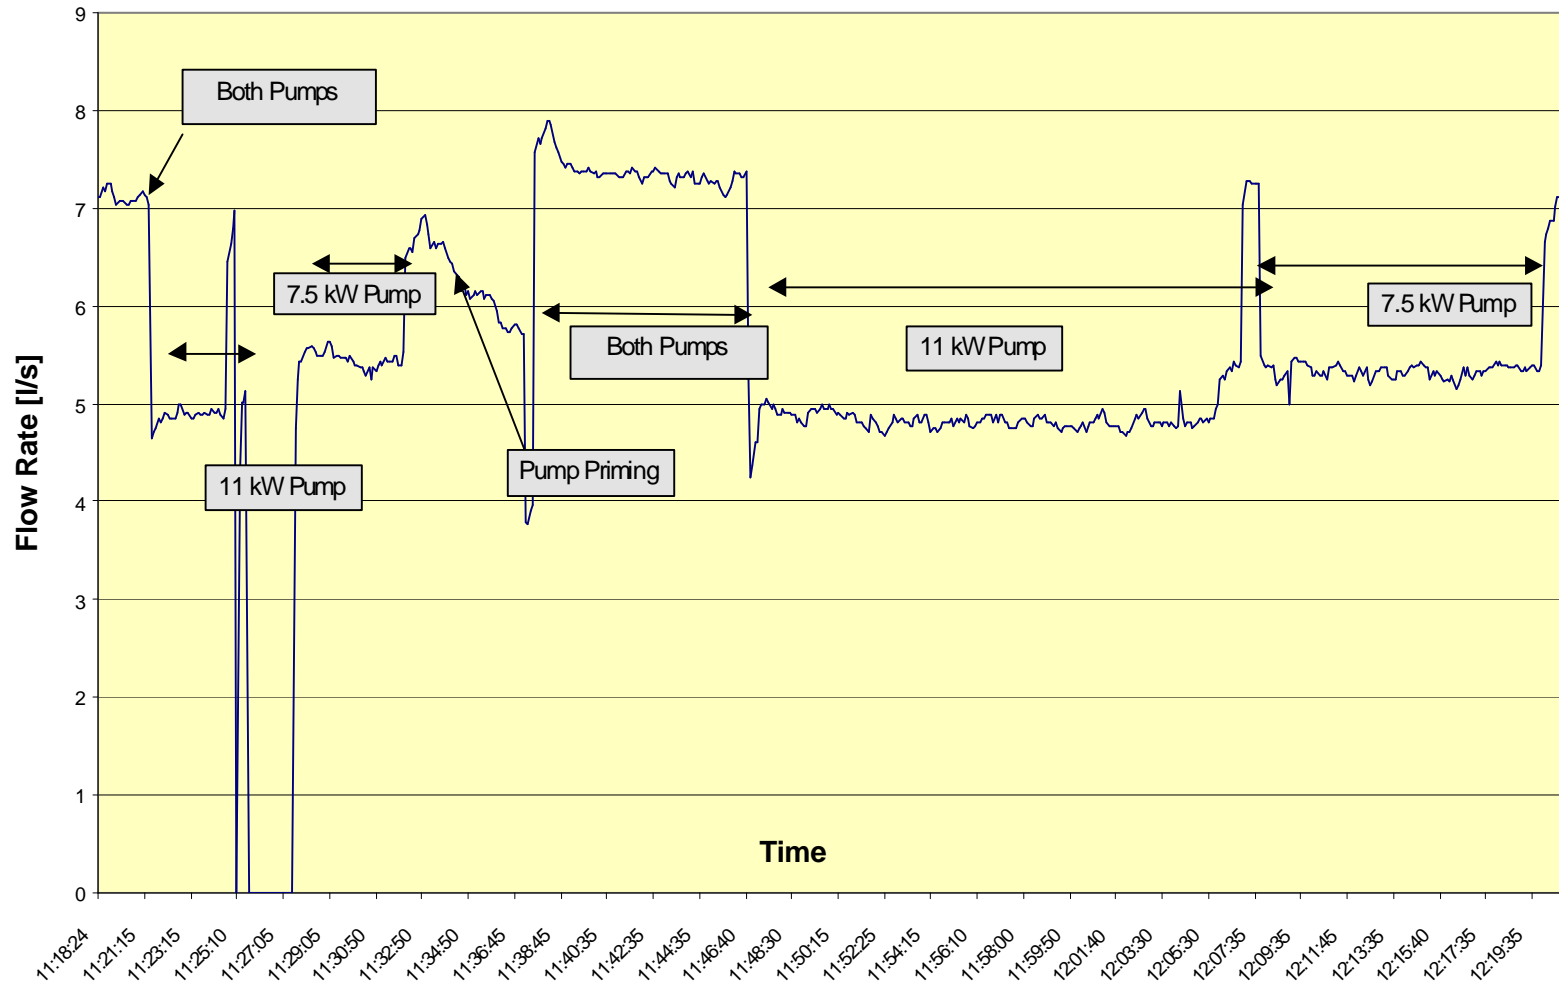
Figure A2.1: Pump Performance test at Kwaibala Source, 28 of May 1998

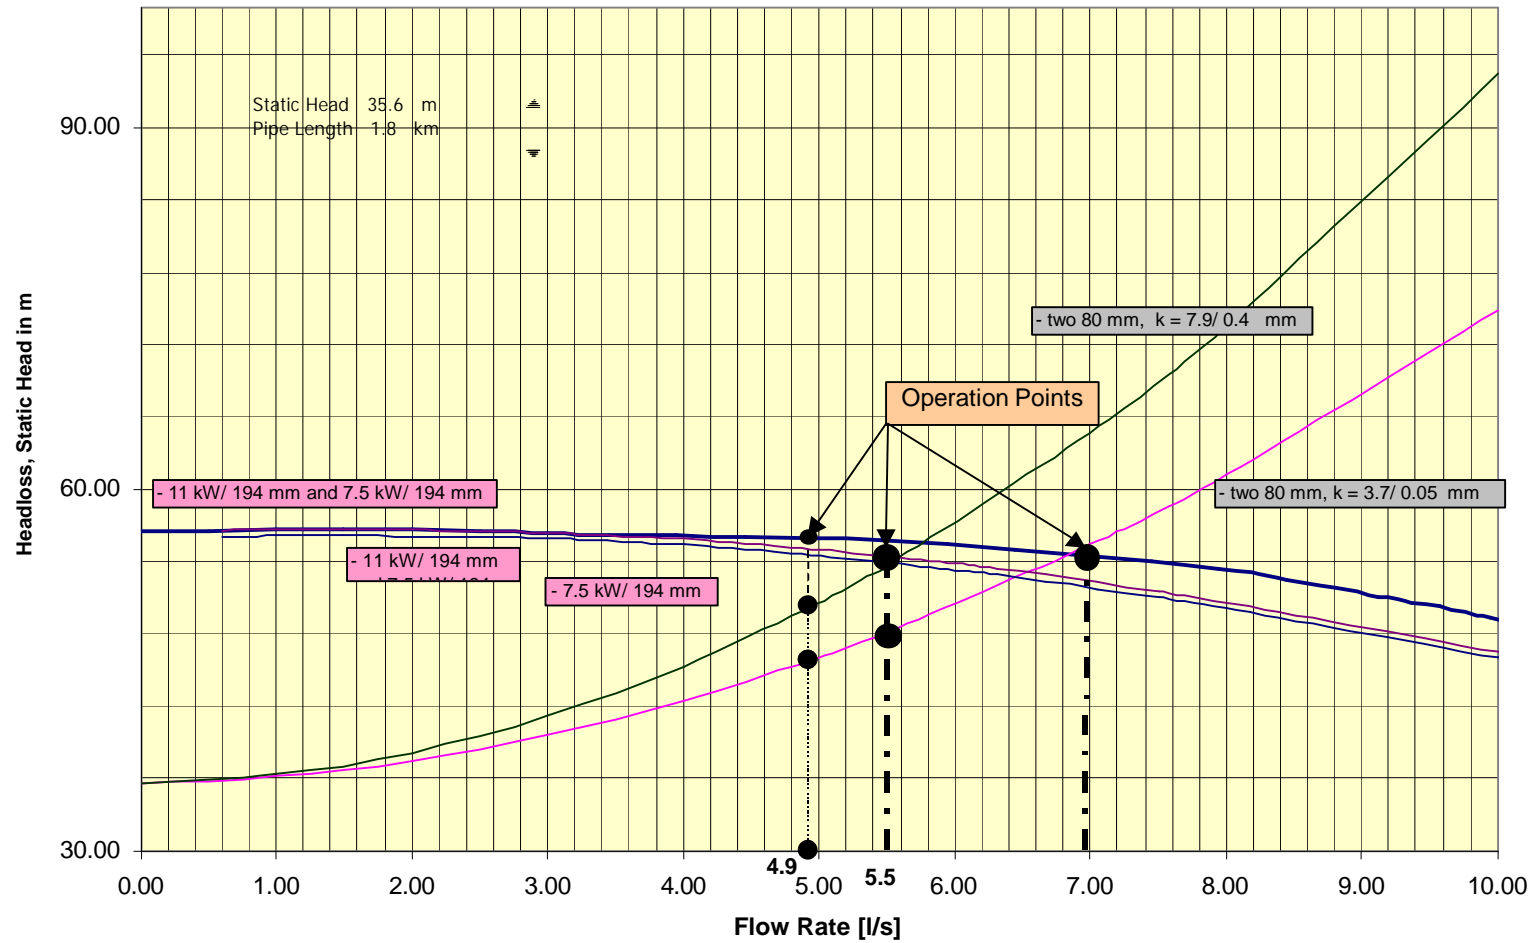
Which one exactly, is hard to decide. Figure A2.4 shows the attempt to model the actual situation assuming very different pipes resistance. As can be seen the parallel pumping (assuming normal pump performance) can be simulated through a two-pipe system with two very different k factors, though each pump alone would be supposed to pump a higher rate.

Figure A2.4: Final Analysis at Kwaibala Source

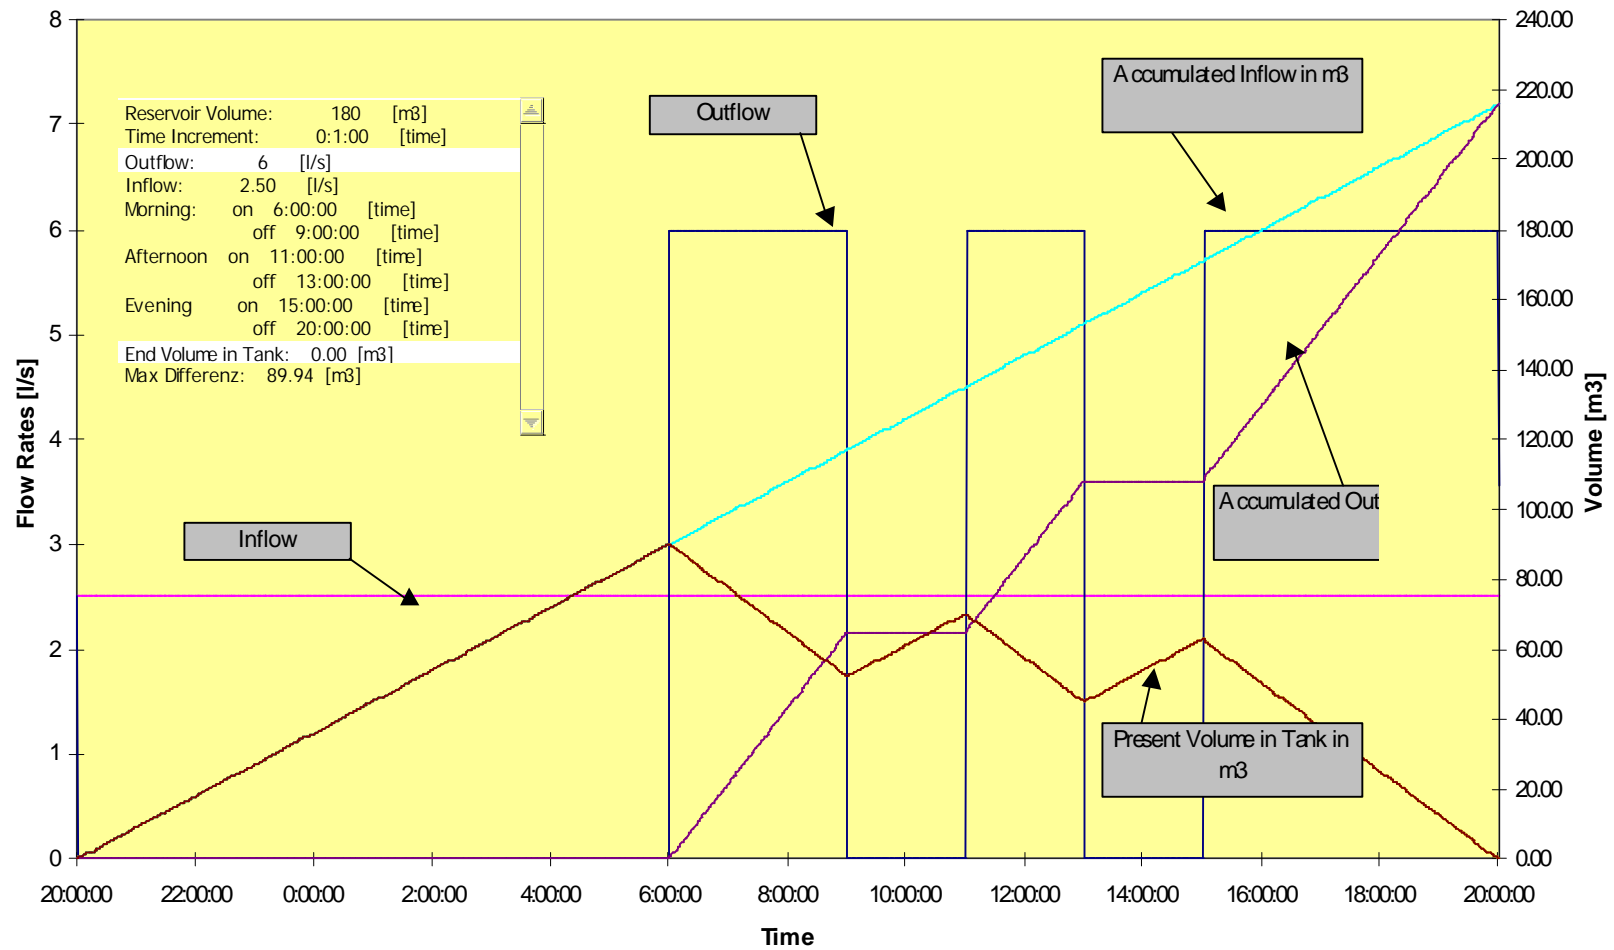
Figure A2.5 shows the inflow-outflow analysis for the low-level storage tank applying the measured inflow rate of 2.5 l/s and a constant outflow rate during water hours of 6 l/s. Water hours (when water is available) are applied from 6.00 AM to 9.00 AM, 11.00 AM to 1.00 PM and 3.00 PM to 8.00 PM. Figure A2.6 shows the same analysis for a 12-day period.

Figure A2.5: Analysis for the low-level storage tank assuming a constant inflow of 2.5 l/s and a constant outflow of 6 l/s

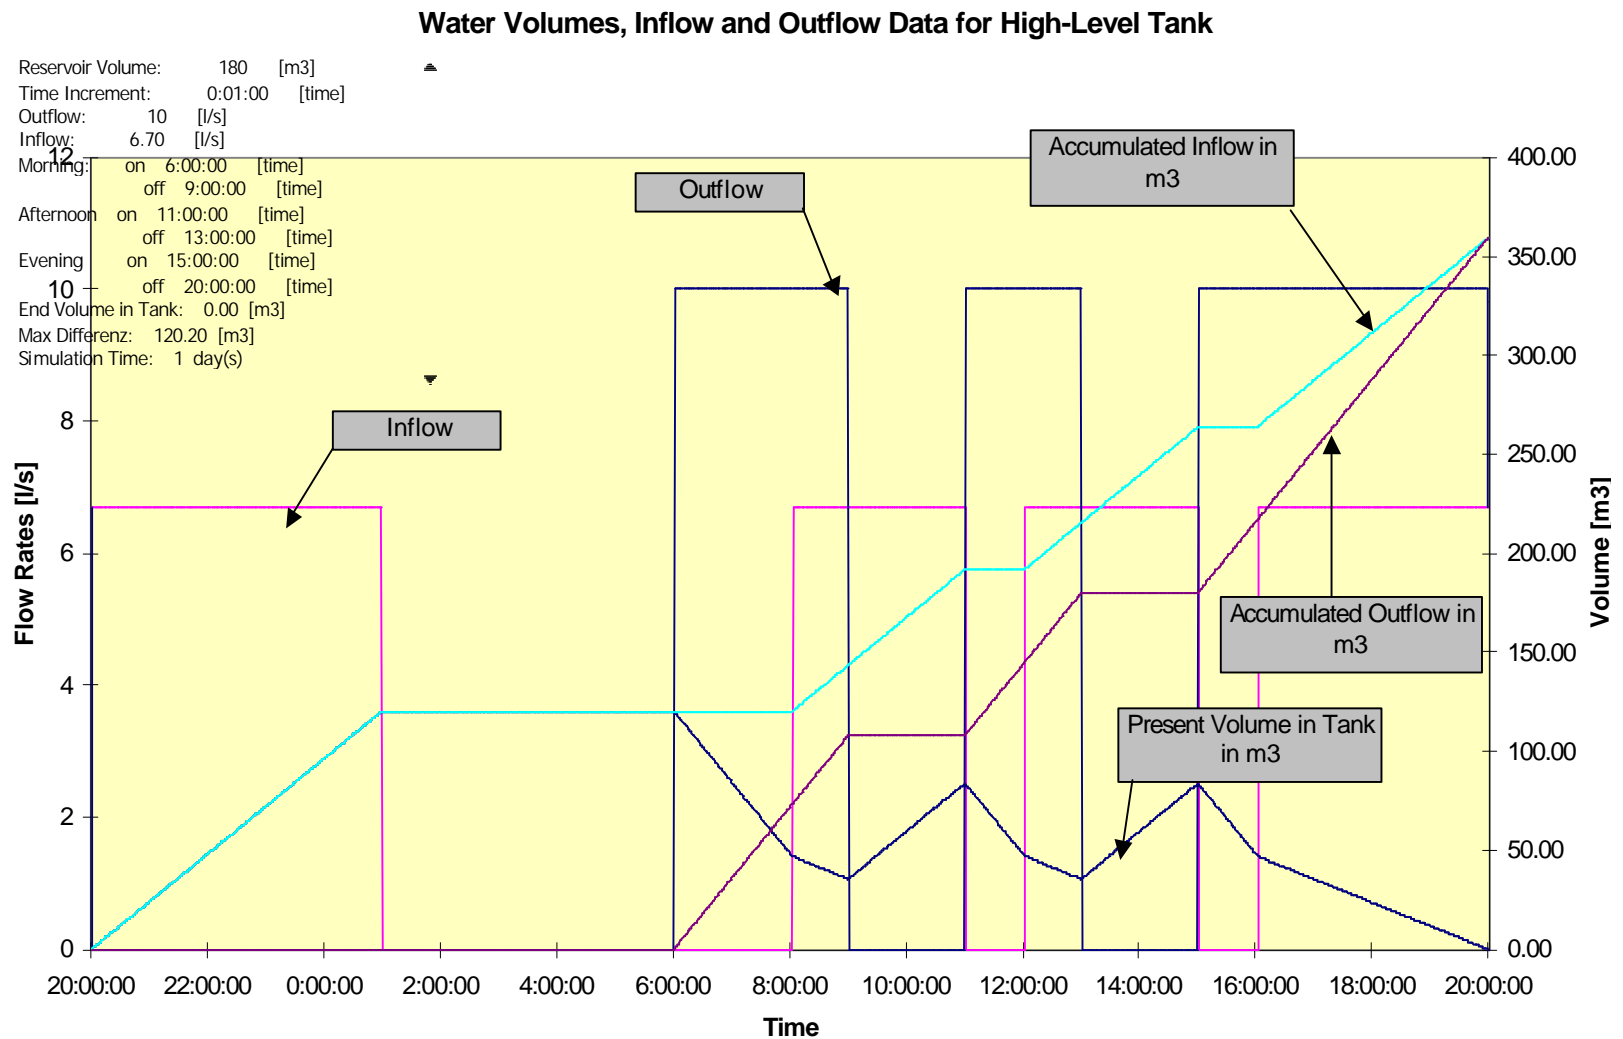
Figure A3.3 (Appendix 3) displays one example of how the required pumping time of 14.9 hours ($10/6.7 \times 10$ [hours]) can be distributed so that the full flow rate of 10 l/s is delivered during the imposed water hours. Please note that this result was achieved by assuming a pump operator (or a control switch) would shut the pump off and on if a certain condition is matched, e.g. a certain level in the tank. Possible variation of the pumping hours into the high-level tank can be also derived from Figure A3.3 (Appendix 3). The fluctuating water body for the high-level tank amounts to 120 m³ or 33 % of the water reticulated into this particular pressure zone.

Figure A3.3: One-day simulation for the high-level tank (pumping time into the tank optimised).

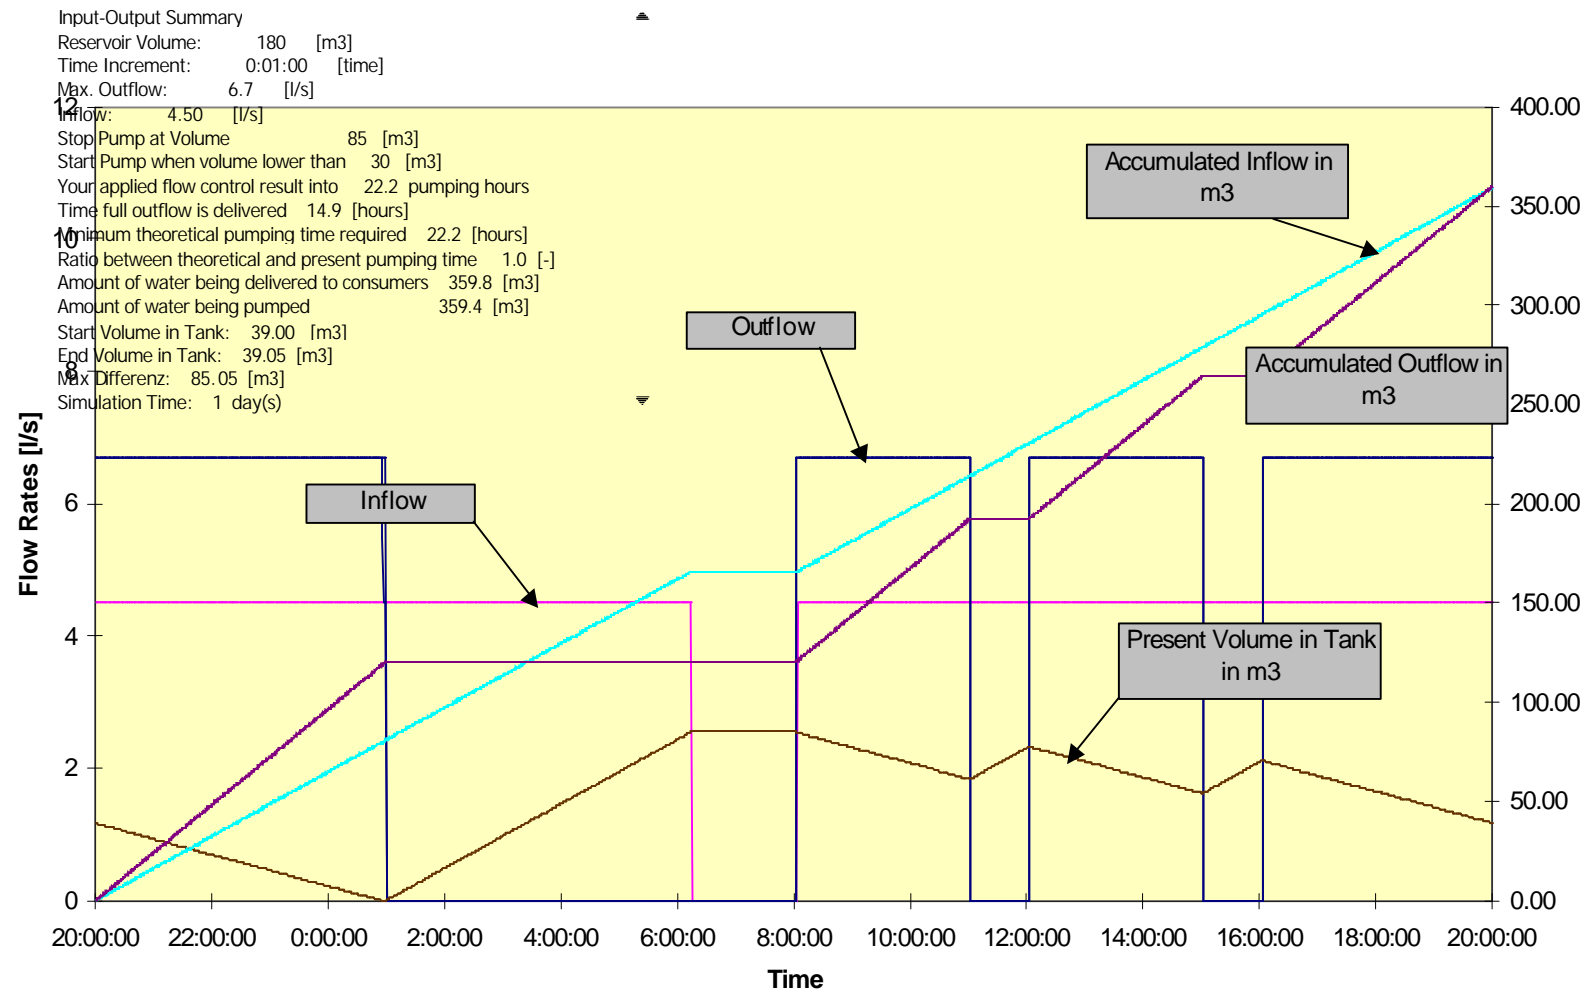
The graph in Figure A3.4 (Appendix 3) shows the tank simulation for the intermediate tank and has been computed using an inflow of 4.5 l/s from the Kwaibala source and an outflow of 6.7 l/s into the high-level tank. The required pumping time is 22.2 ($6.7/4.5 \times 14.9$ [hours]) and the fluctuating water body for the intermediate tank amounts to 85 m³ or 24 % of the water boosted into the high-level tank. This figure is high considering that the tank is used only to store water to boost it from the main source into the high-level tank. This reflects the difference in performance of the pumps.

Figure A3.4: One-day simulation for the intermediate tank (pumping time into the tank opti-

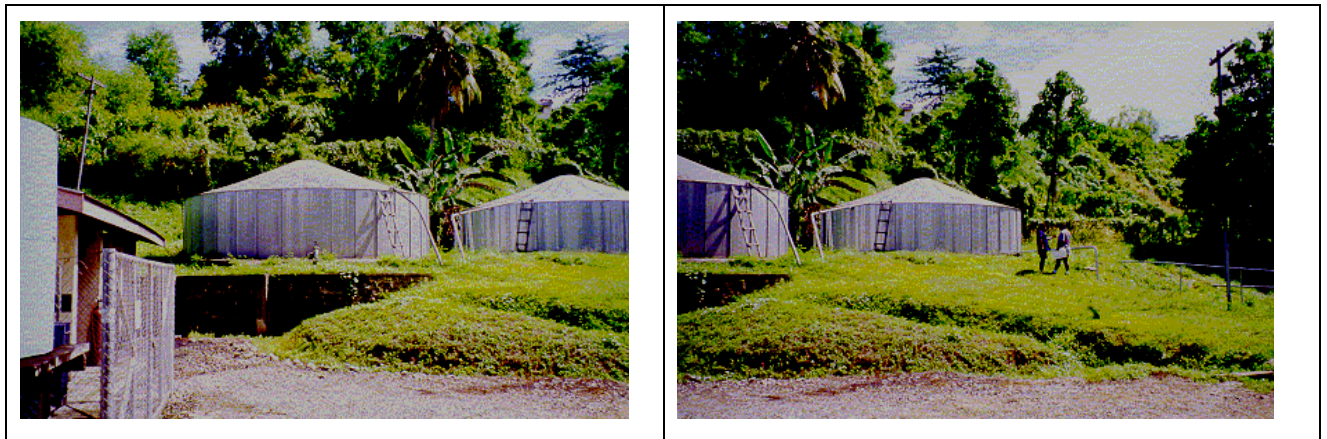
Photo A3.3: Storage facilities, the left tank is serving the low-level tank, the right one is the intermediate tank

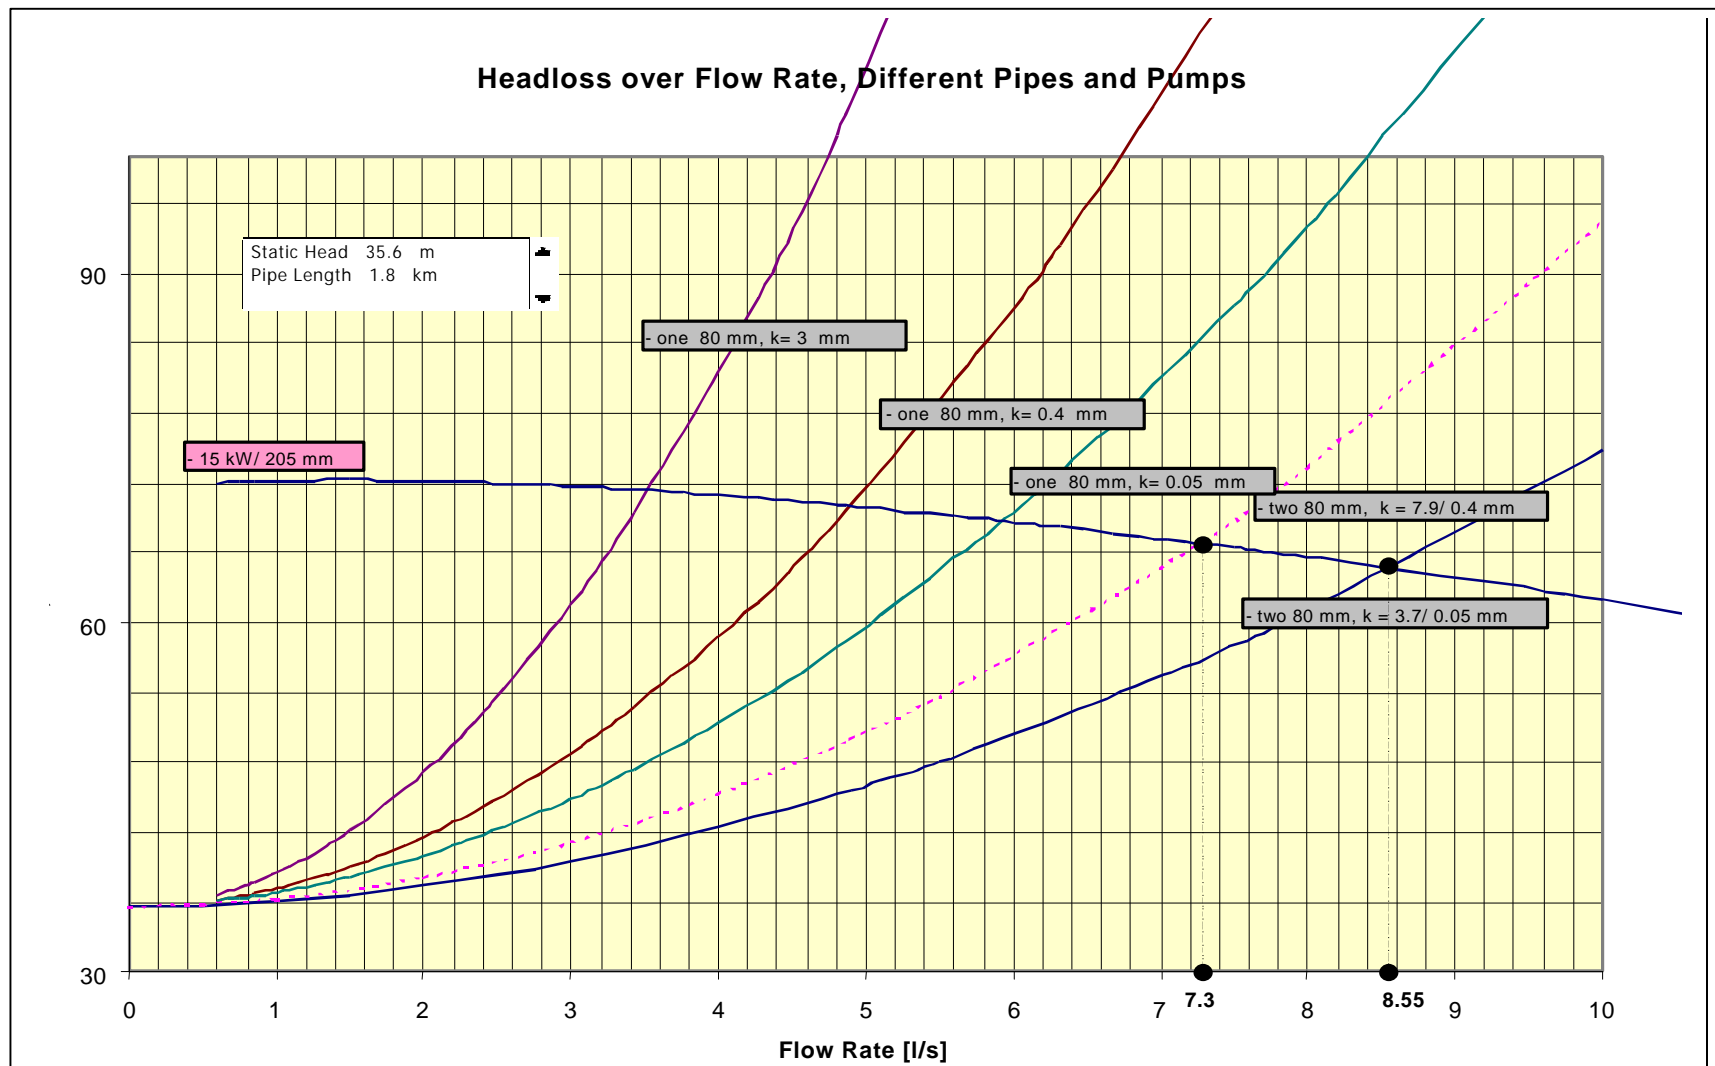
Figure A4.1: Impact of relocating the 15 kW pump from the gallery to the Kwaibala source
