Coastal Erosion in South Tarawa, Kiribati

Coastal Sedimentation and Coastal Management of Fongafale, Funafuti Atoll, Tuvalu

Coastal Stability and Sand Transport Aitutaki, Southern Cook Islands

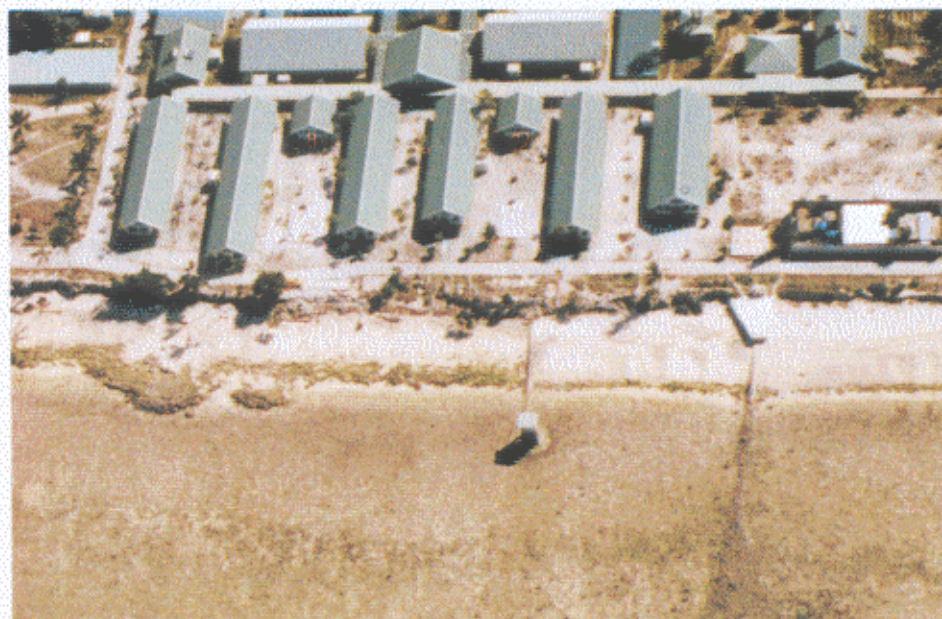
Oblique airphoto of Tungaru Central Hospital (24 June 1995) showing details of shore morphology and structures.

This facility, completed in 1991, is situated along the ocean shore to the east of Bikenibeu close to the southeast corner of the atoll. This section of the coast faces slightly west of south. Although reasonably straight, it is marked by a succession of embayments on the west sides of conglomerate outcrops and platform headlands projecting onto the reef flat. In retrospect, it is most unfortunate that this important facility was constructed so close to the coast. The distance from the backshore scarp to the emergency access now ranges from 0 to 8 m, except at the east end of the property, where the road turns away from the shore. Damage to the road foundation has already begun at the west end, where partial loss is imminent.

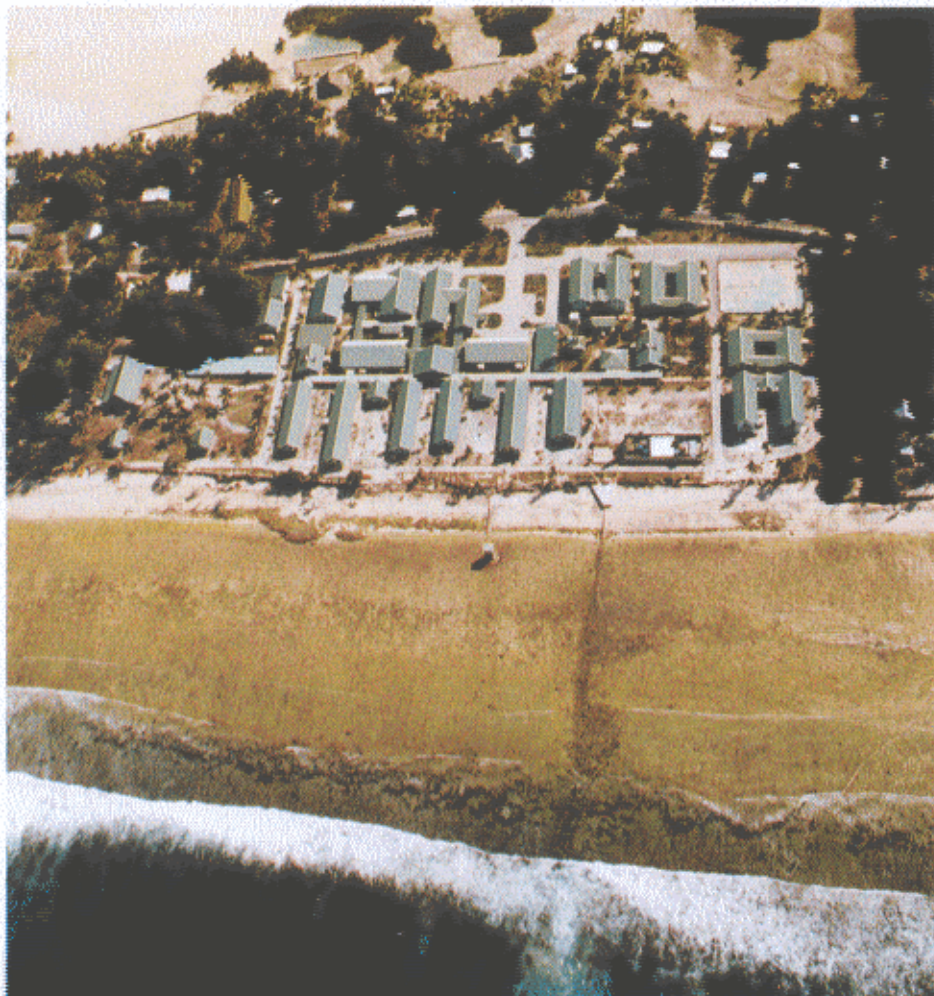
Airphoto showing Tungaru Central Hospital.

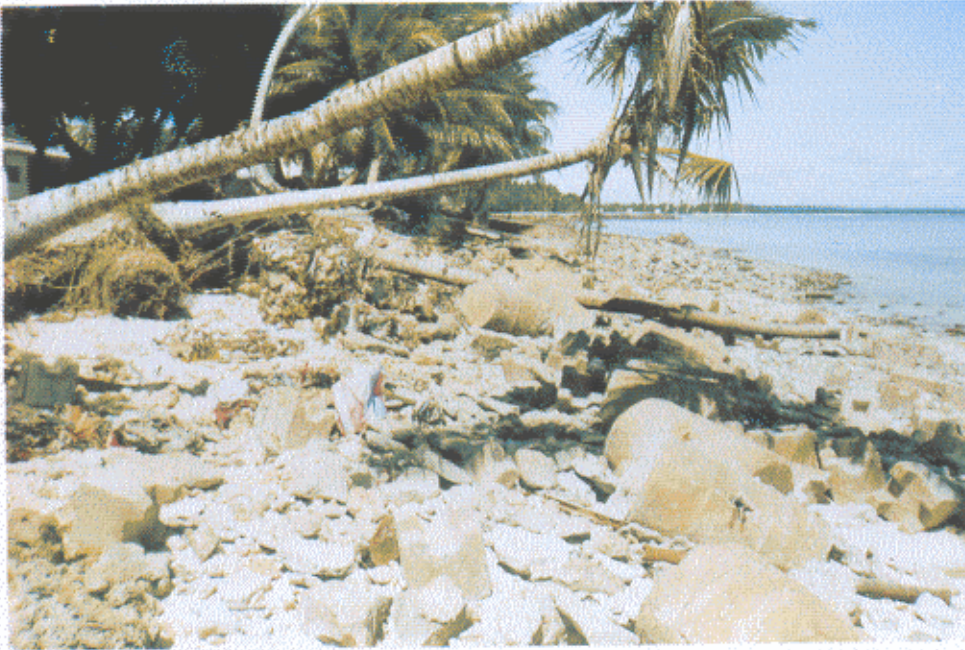
The shoreline of the reclaimed land in World War II is shown by the cemented coral stone cylinders, which were put in gasoline drums. The remains of a gabion basket seawall lie between the eroded coast and the cylinders.

processes and the desires of the people. After destruction of the coral stone seawall built in the Second World War, gabion basket seawalls were built. Only small parts of these have survived. In recent years, seawalls of concrete cubes have been built from Teuaea Road south to the disused Vaiaku Wharf, along with a vertical stone-cemented seawall and concrete seawall in the front of the new Vaiaku Lagi Hotel.

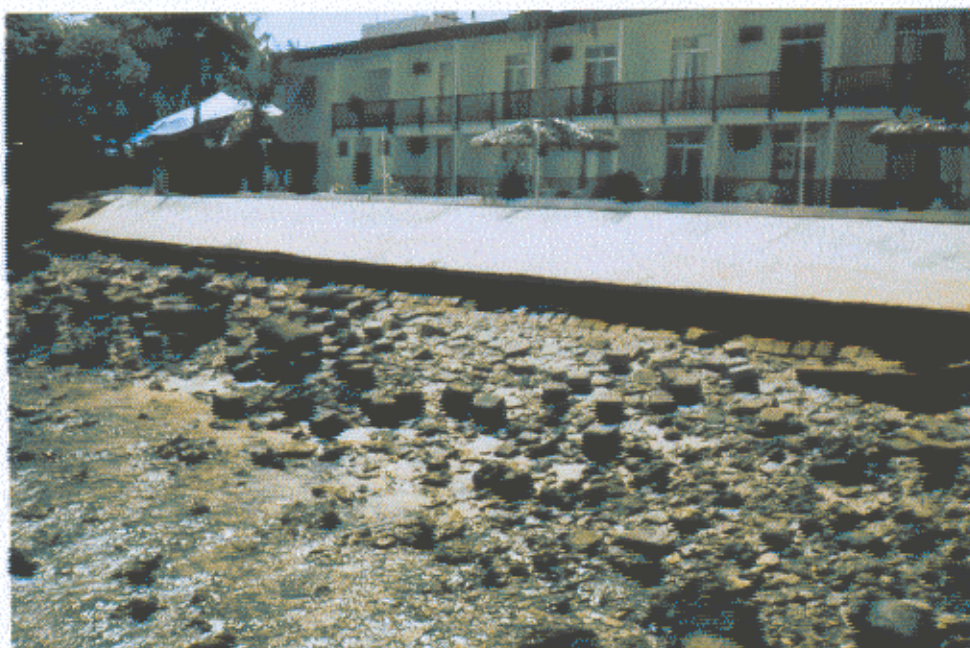
The concrete seawall and boulders on the beach in front of Vaiaku Lagi Hotel.

Construction of seawalls should be avoided, as they promote beach erosion. The jetty close to the Vaiaku Lagi Hotel should be demolished or changed to a pier-type wharf. Otherwise erosion will continue on the downdrift side of the jetty, just in front of the hotel.

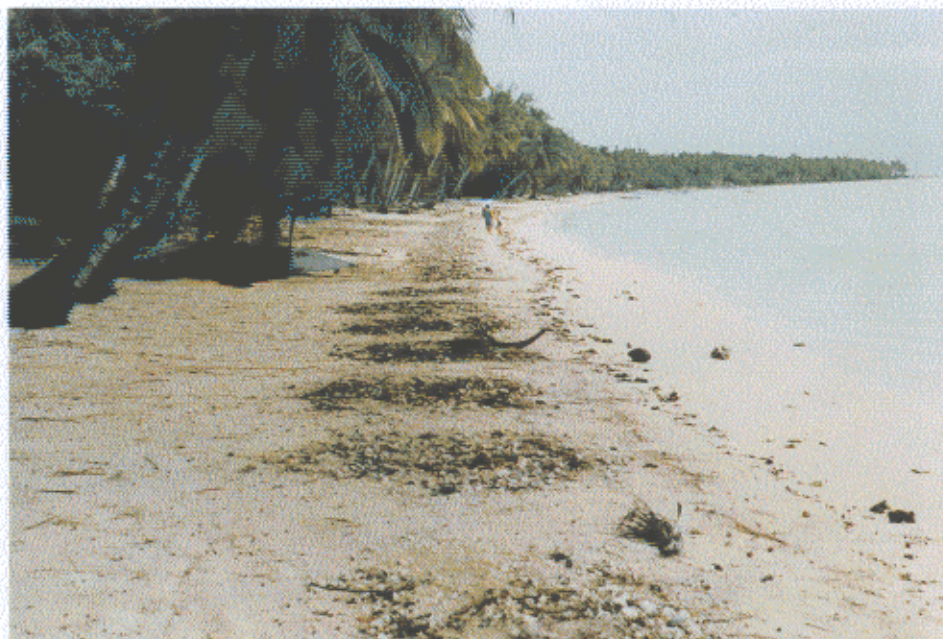
Looking south along the western shore of the main island toward Arutanga. Seaward-leaning coconuts attest to an earlier erosion event, while the cusped gravel swash bar points to more recent accretion of material from the reef flat.
