EU-SOPAC (EDF9) Project Report 105
Reducing Vulnerability of Pacific ACP States

REPUBLIC OF THE MARSHALL ISLANDS TECHNICAL REPORT

Rapid Biological Marine Assessment of the Proposed RMI-EPA Sand and Aggregate
Dredging Site Locations within Majuro Lagoon, Republic of the Marshall Islands

May 2008

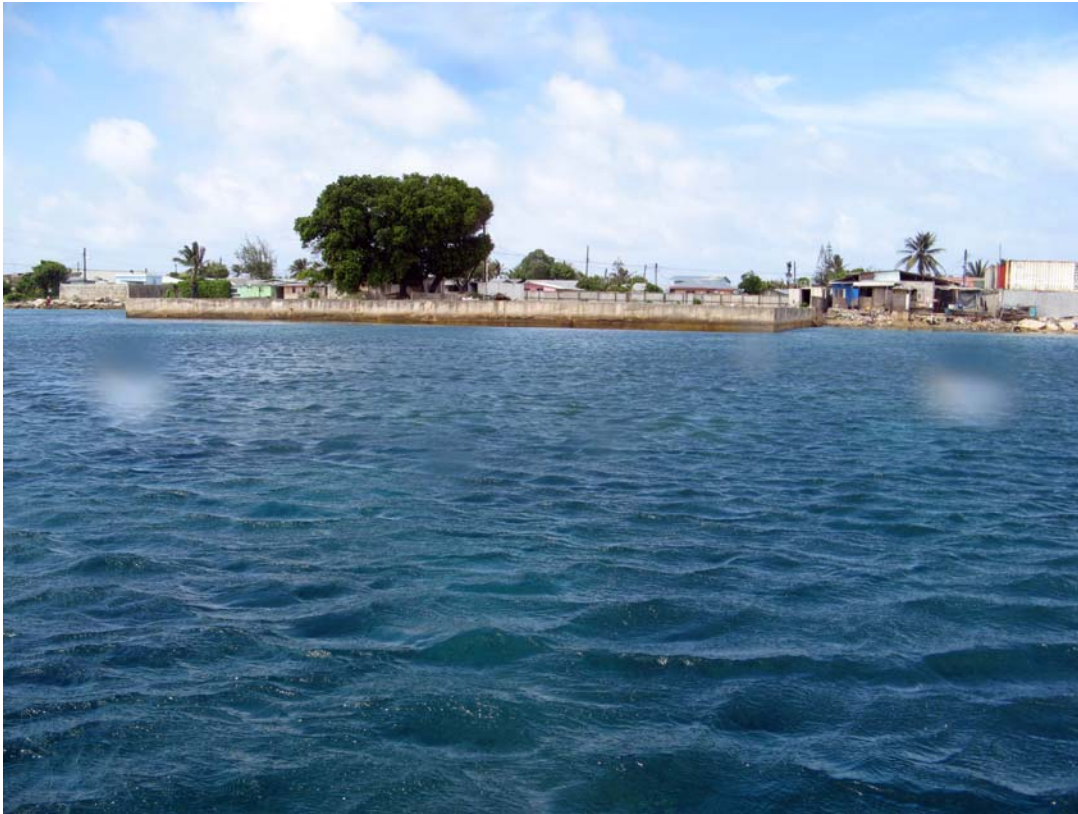
Figure 3. Land reclamation site, Majuro Lagoon.

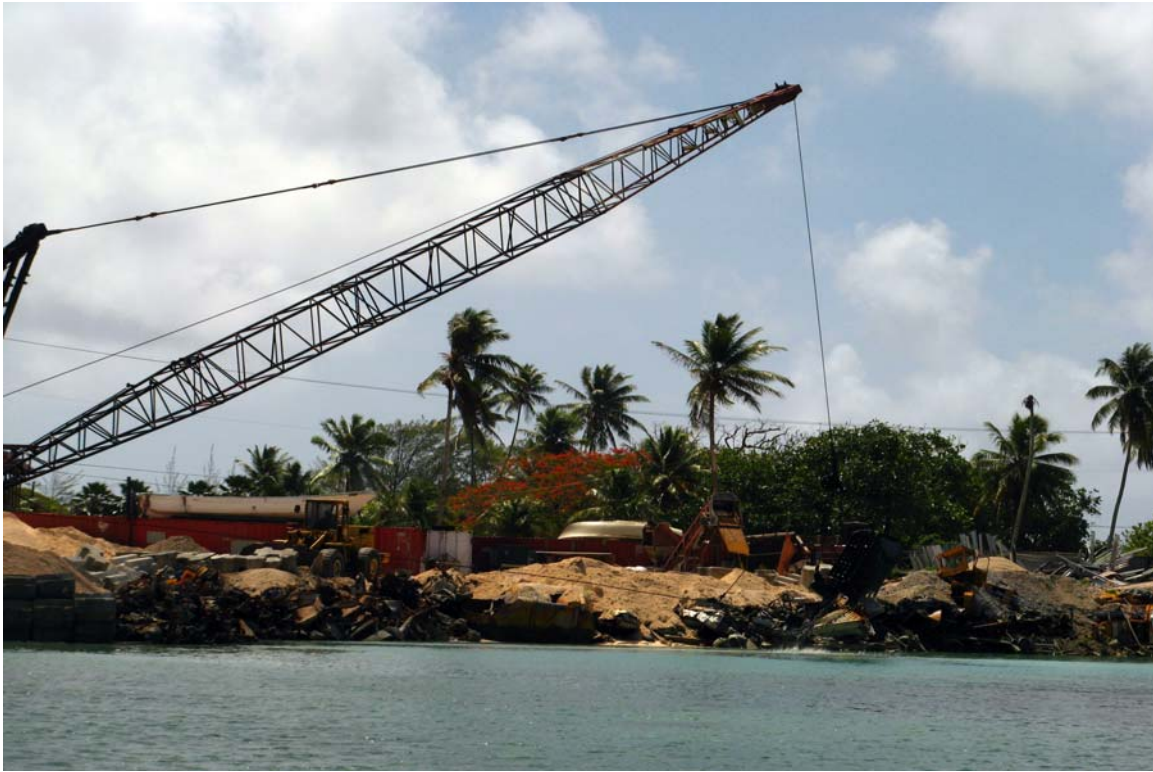
Figure 4. Shoreline based dragline scraper and crane system extracting sand and gravel from the Majuro Lagoon.

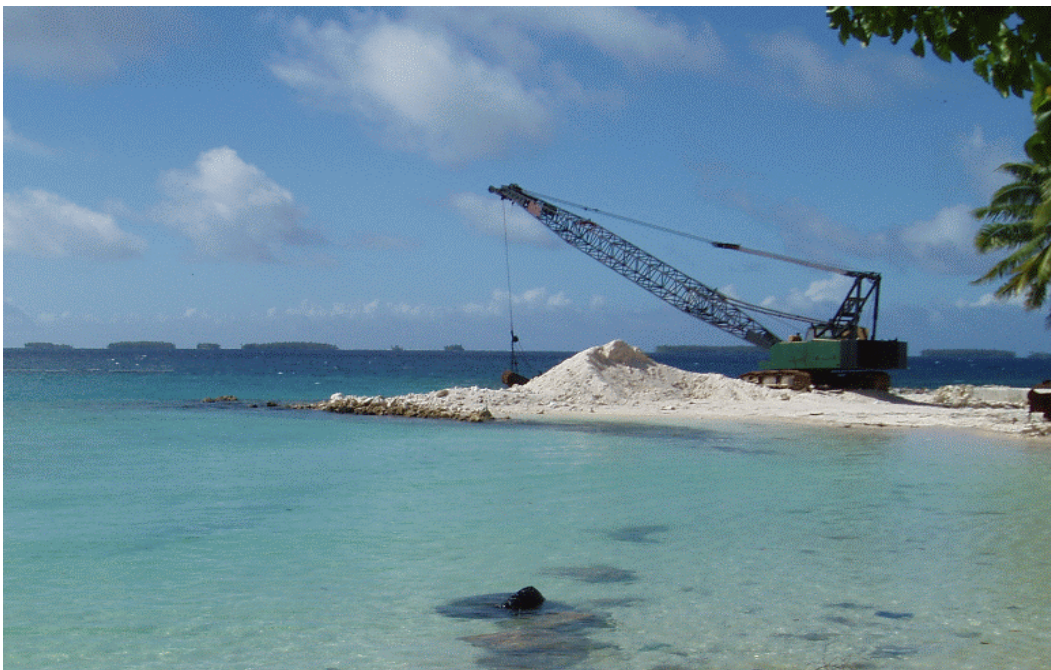
Figure 5. Shoreline based hydraulic excavator extracting sand and gravel from the Majuro Lagoon.

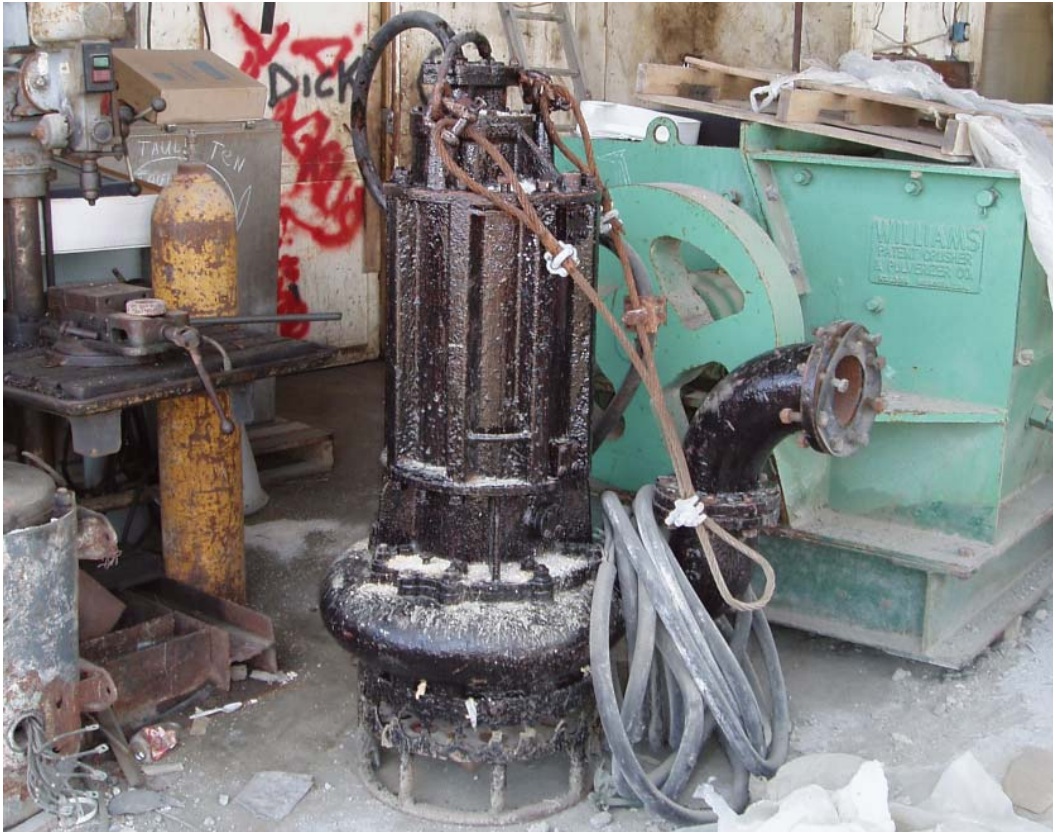
Figure 6. Suction dredge pump to extract sand and gravel from the lagoon bed.

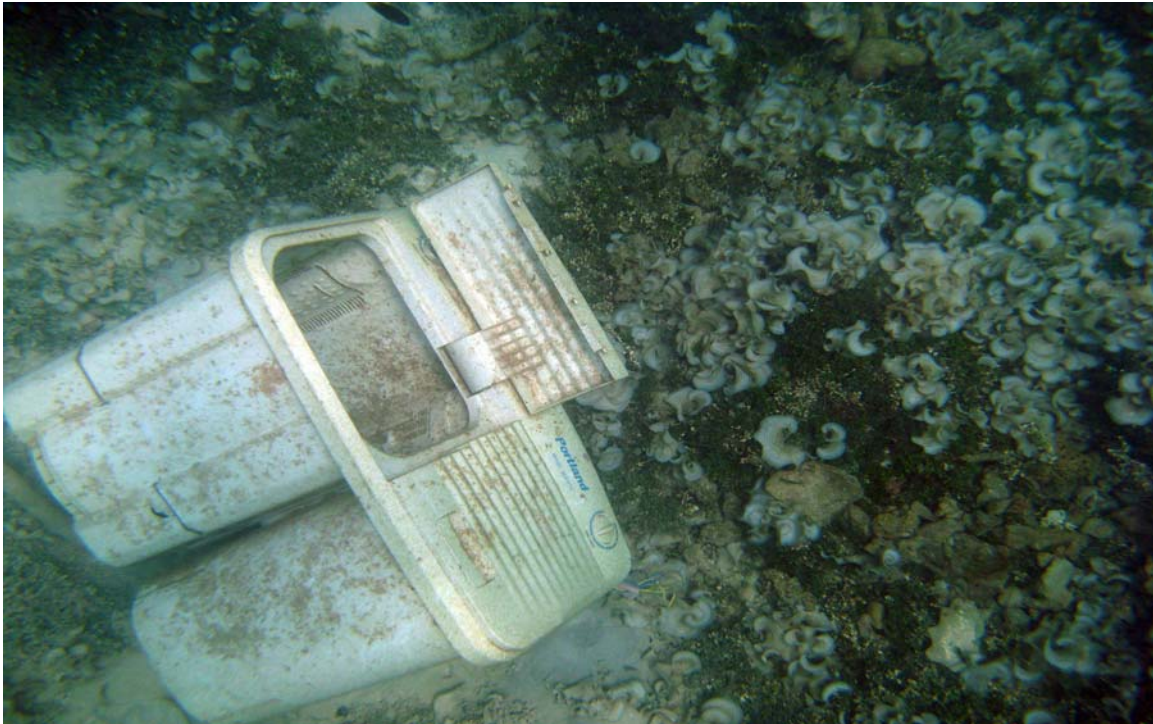
Figure 7. An example of residential garbage commonly found during the assessment (reef flat in front of Rita, Majuro Atoll).

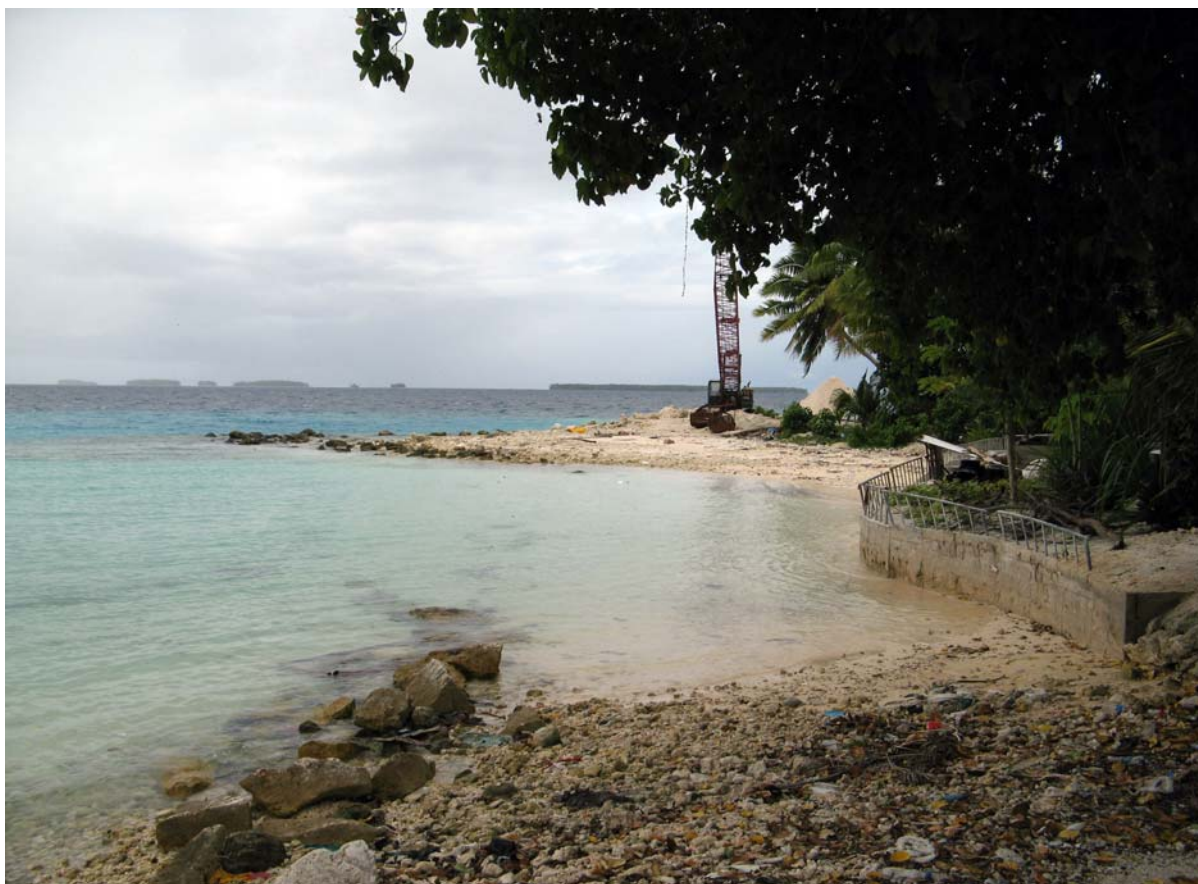
Figure 9. Coral reef subjected to high suspended sediment load associated with coastal mining.

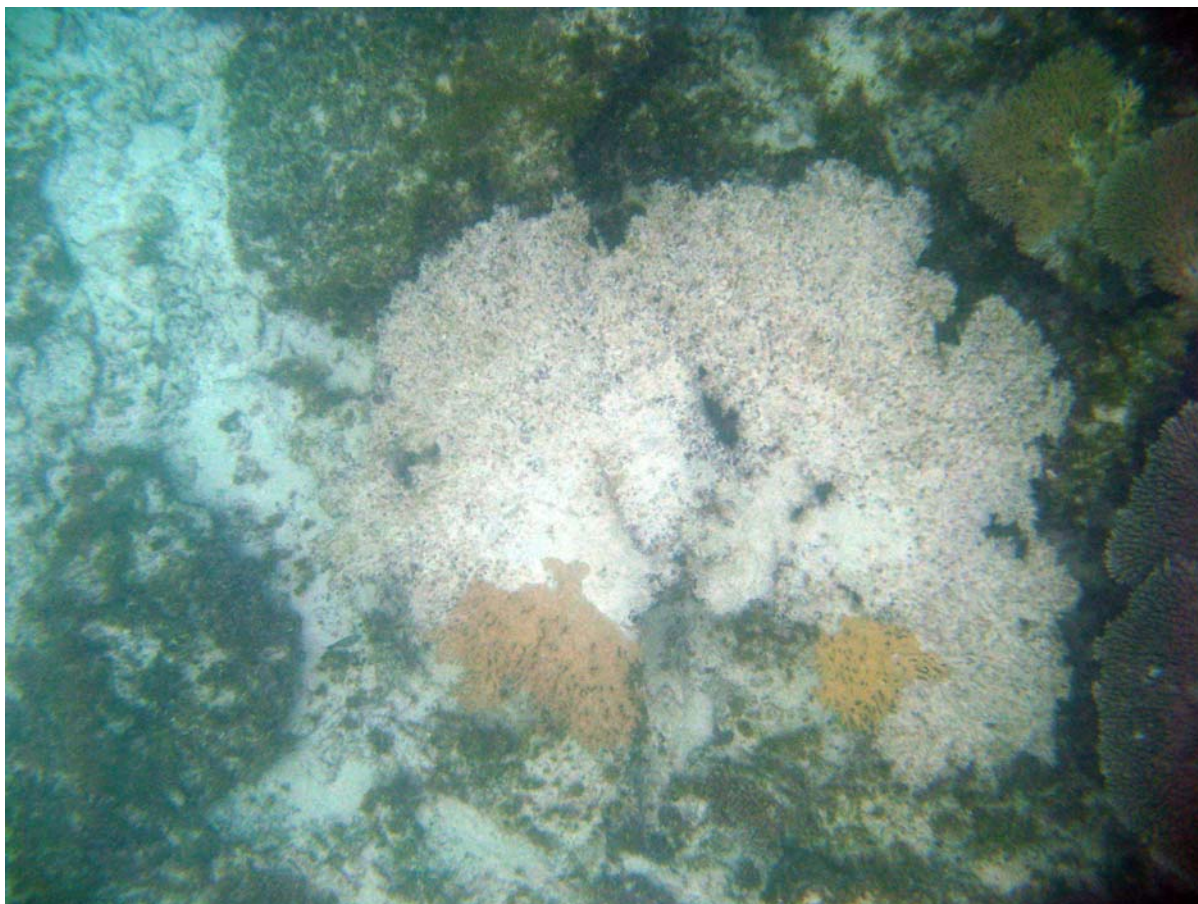
Crown of thorns starfish – COTS (*Acanthaster planci*) outbreaks have been recorded over the past 4 – 5 years in the western half of the lagoon and were reported to have caused considerable mortality (personal observations, Jacobson, 2007). Dead table corals (*Acropora* sp. – 2 – 3 meters diameter) with COTS feeding scars were seen during the assessment at Site AJT, Location 2. Several small adult COTS specimens were located during the assessment (e.g. Site JT, Tow 6 and Site JB, Tow 22) however recent feeding scars seen on hard coral communities at these assessment sites were minimal. The number of COTS recorded during this assessment does not indicate these animals are a threat to reefs at these sites at the present time.

Figure 10. Coral damage due to Crown of thorns starfish, Site AJT, location 2.

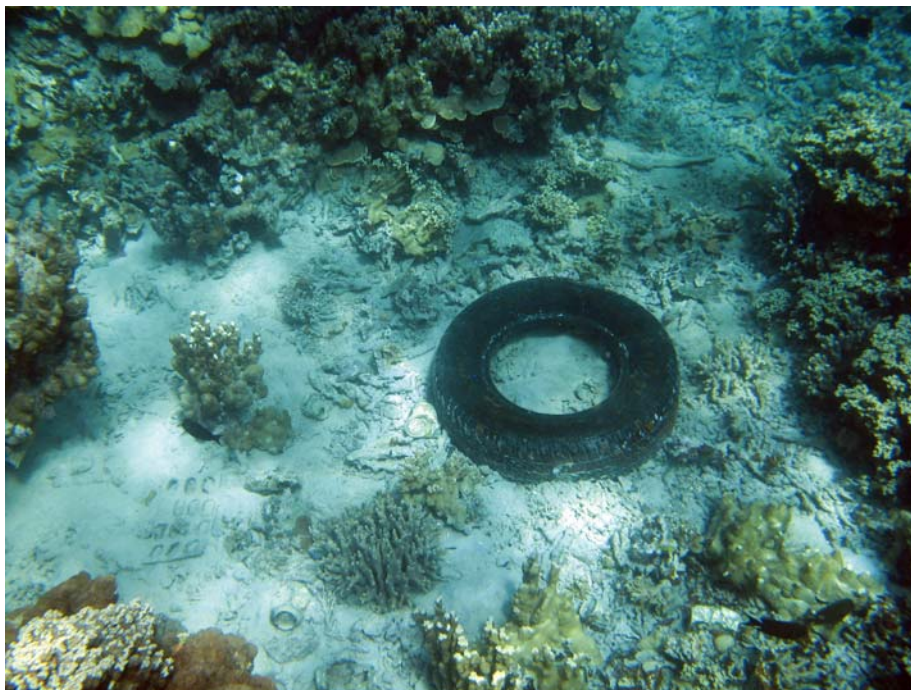
Again, household and commercial garbage was a common feature on the reef edges and slopes at all sites and Sites RT, JT, and DL showed the highest levels of garbage.

Figure 15. Garbage located on the reef slope at Site DL.

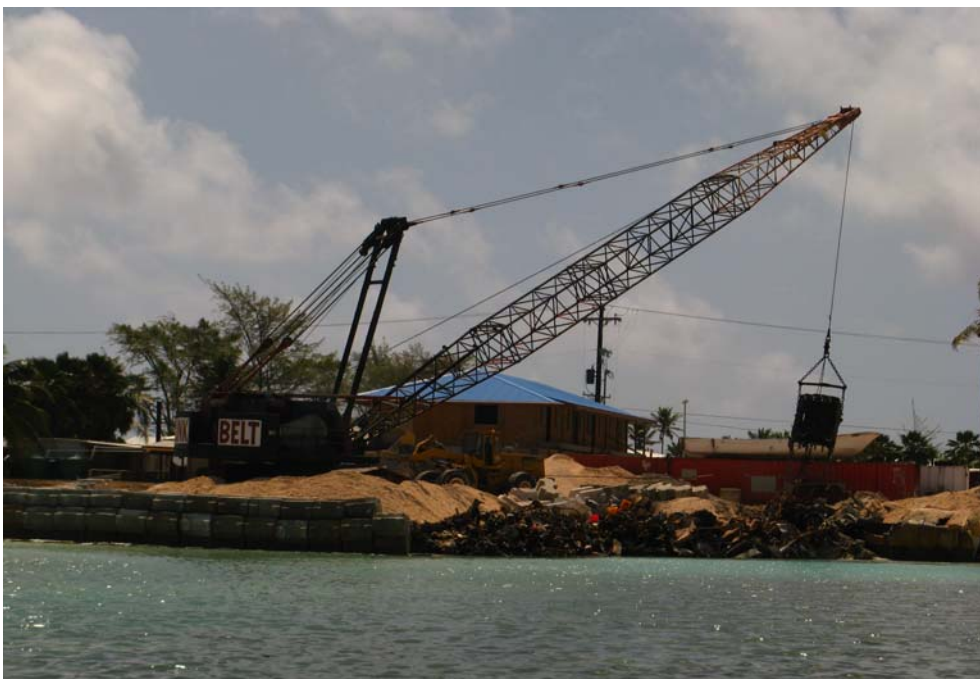
Various areas of the reef flat have been previously and are currently dredged to provide material for reclamation activities and to widen and deepen water access to several commercial facilities fill (e.g. Mr Dominic's dredging site). Considerable sedimentation has occurred on reefs downstream of the present dredging operation, which has resulted in hard coral mortality. Improvements in the deployment, location and use of sediment curtains to prevent sedimentation and smothering are urgently required during all dredging activities. Domestic and commercial rubbish dumping was prevalent throughout the Site and included a wide range of items.

Figure 23. Photo of the present shore based dredging operation at Site DL.

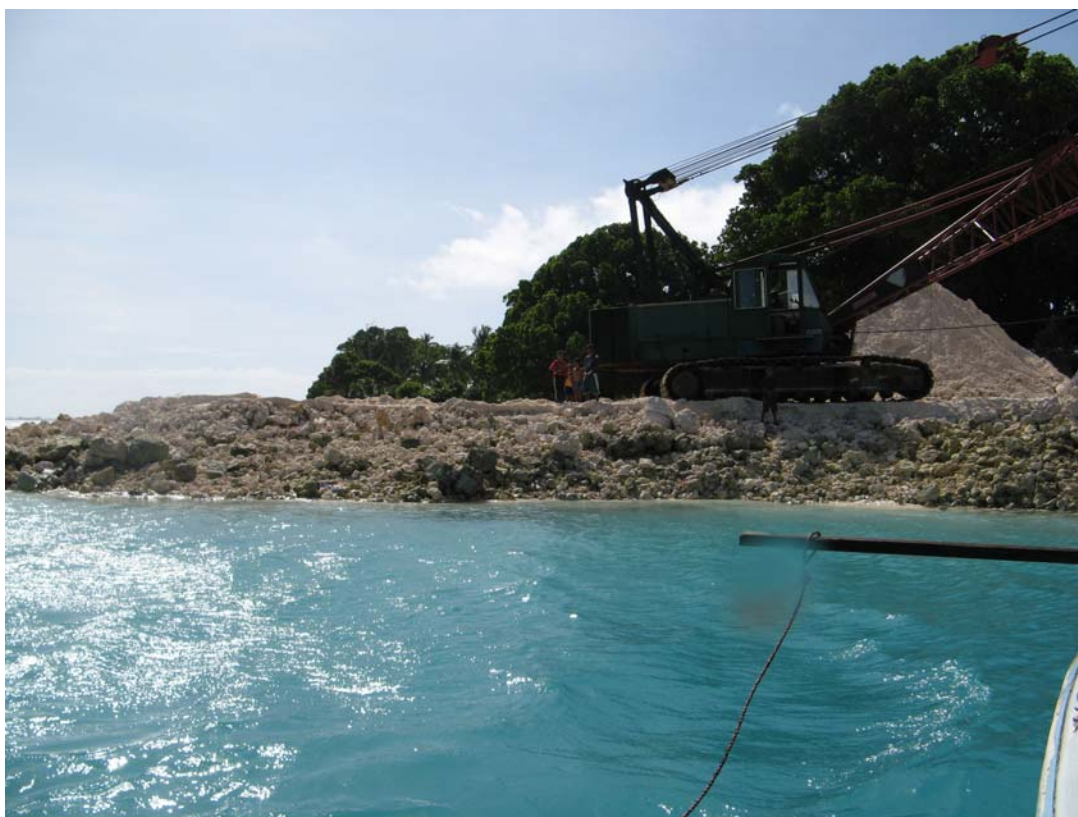
Sections of the reef flat have been previously and are currently dredged to provide a source of material for capping the public dump, land reclamation activities and to widen and deepen access channels (Figure 25). Considerable sedimentation has occurred on reefs downstream of the current dredging operation, which has resulted in hard coral mortality. Improvements in the deployment and use of sediment curtains are urgently required. Domestic and commercial rubbish was less frequently seen on this site. It is important to note that no chemical analysis to determine possible impacts of the Majuro dump was undertaken however it very likely that leachates from the dump would drain into neighbouring lagoon and ocean side waters.

Figure 25. Photo of the shore line hydraulic dredging operation at Site JB.
