Climate and Abstraction Impacts in Atoll Environments (CAIA)

Groundwater Field Investigations Vaitupu, Tuvalu

Geoscience Division of the Pacific Community

(SPC Technical Report SPC00052)

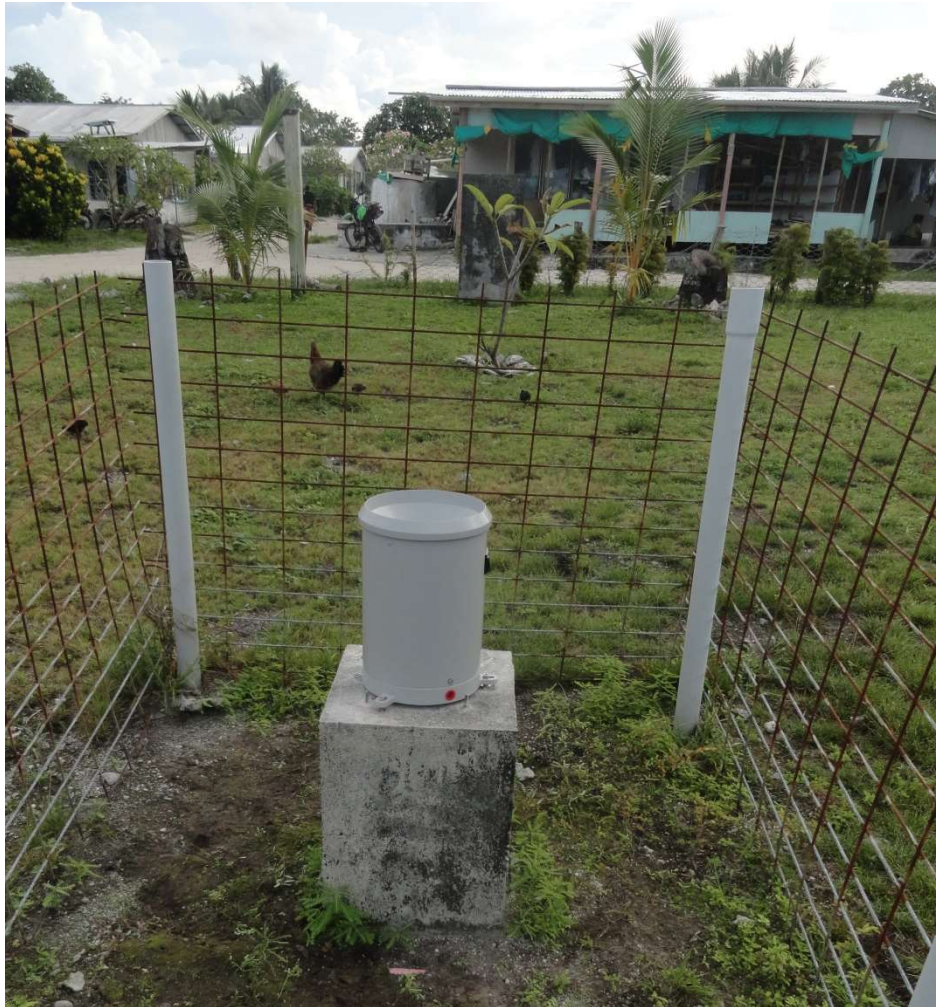
Figure 8: TB3 rain gauge installed near *kaupule* office on Vaitupu.

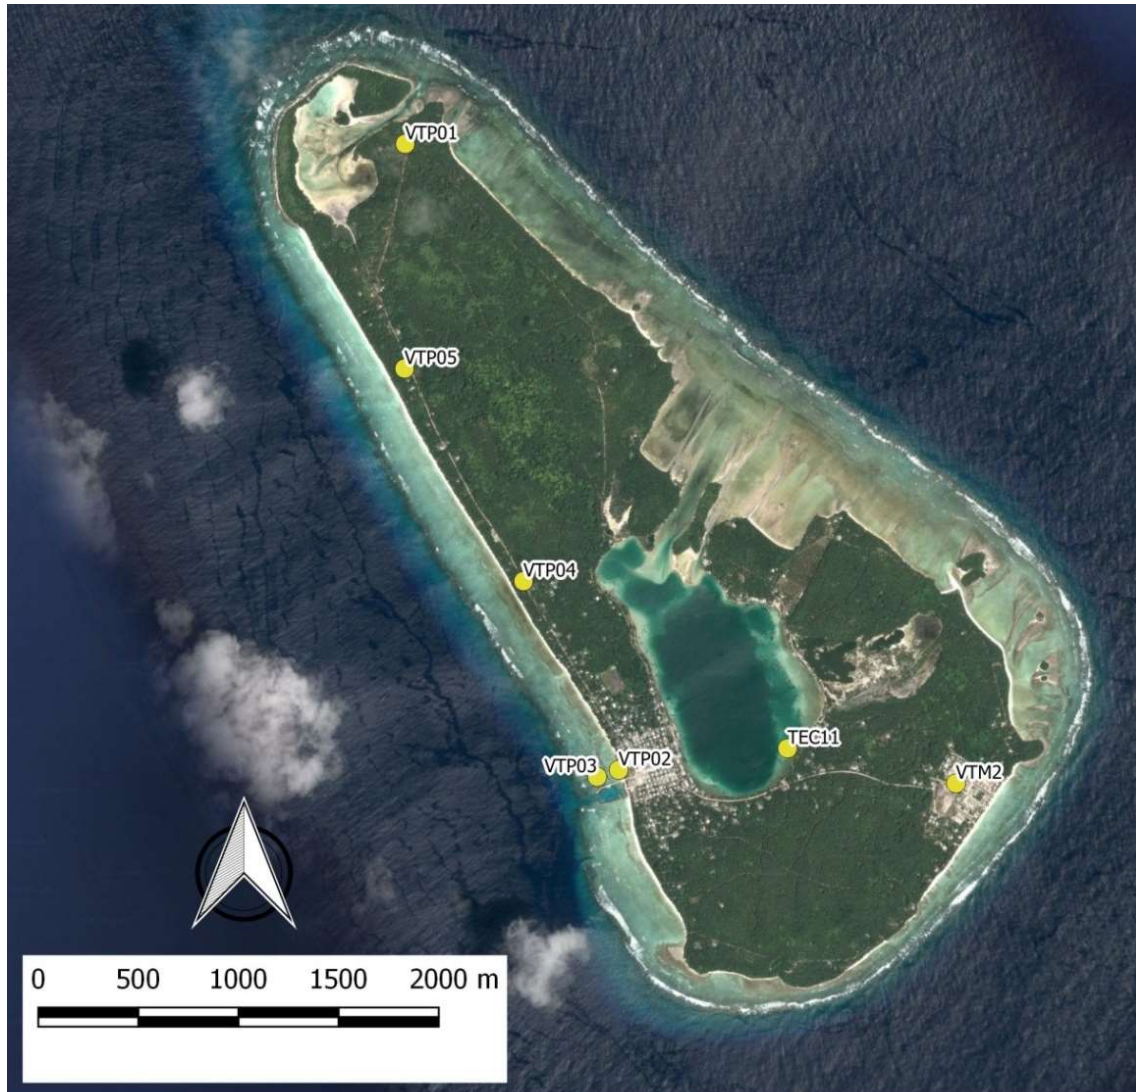
Figure 9: Location of benchmarks established as part of the survey. Benchmark elevation corrected from the continuous GPS (CGPS), TUVA based in Funafuti. Source: Google Earth 2015

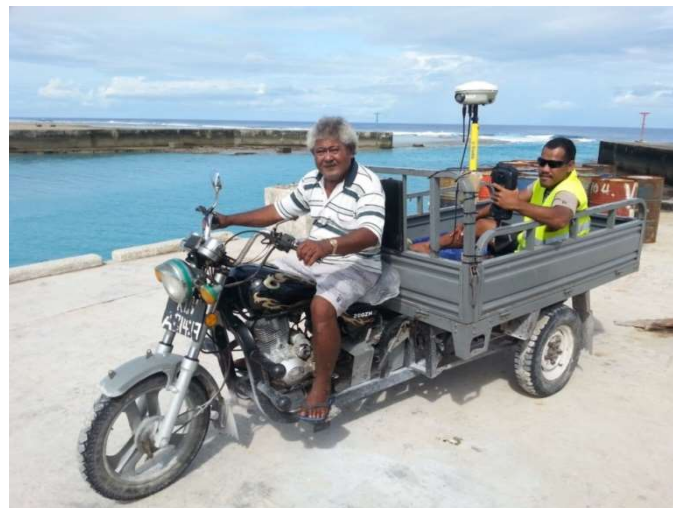
Figure 11: Continuous mode of RTK survey with the rover mounted on a trailer pulled by a motorbike.

The RTK survey was completed on foot and on a bike trailer (Figure 11). In total, 1,200 points were collected as part of the survey. The RTK survey was limited in certain areas due to dense vegetation, unfavourable weather conditions, and inaccessible sites (Figure 12).

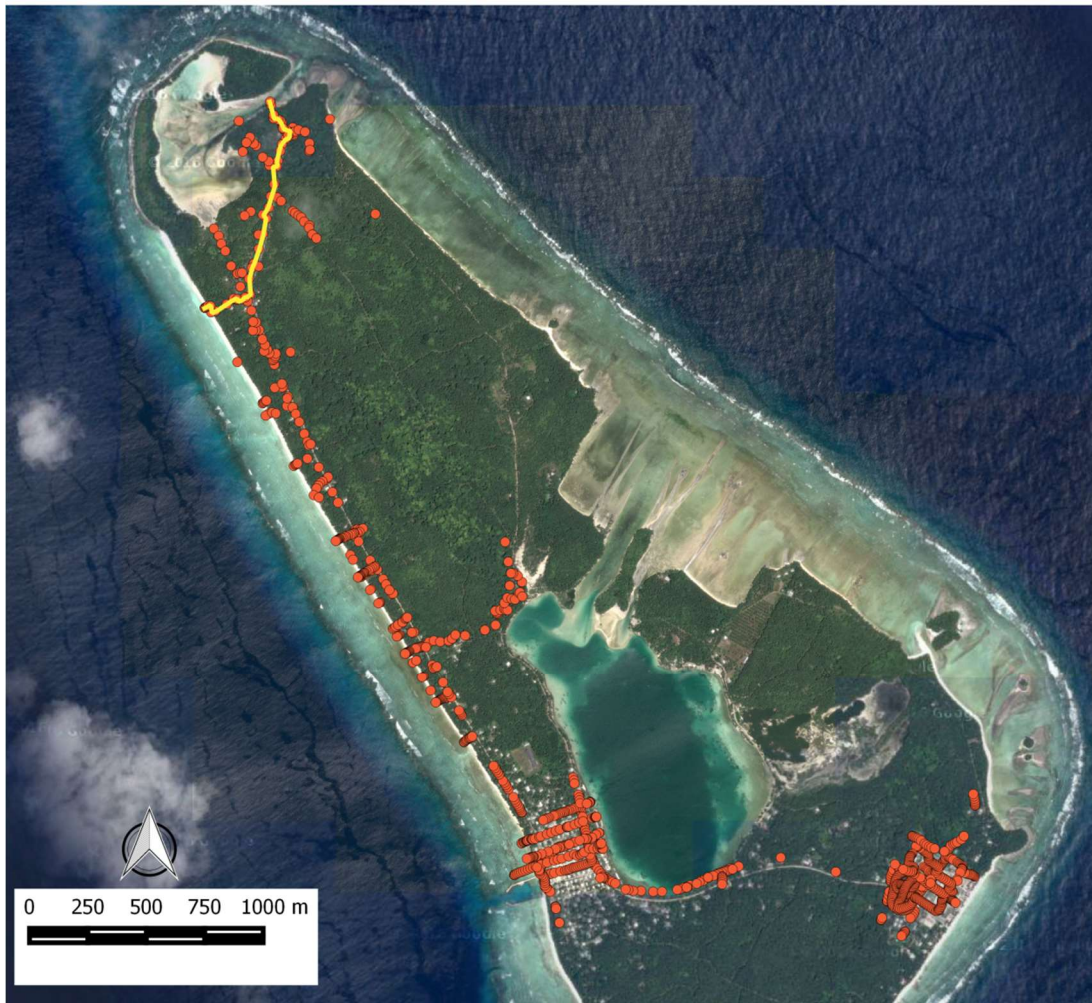
Figure 12: Satellite image of Vaitupu showing the area cover during the RTK survey (red points) and the transect (yellow) from which the cross section was derived. Source: Google Earth 2015.

With the available RTK dataset, a cross section (presented in Annex 3) was derived across northern Vaitupu to understand the atoll's geomorphology.

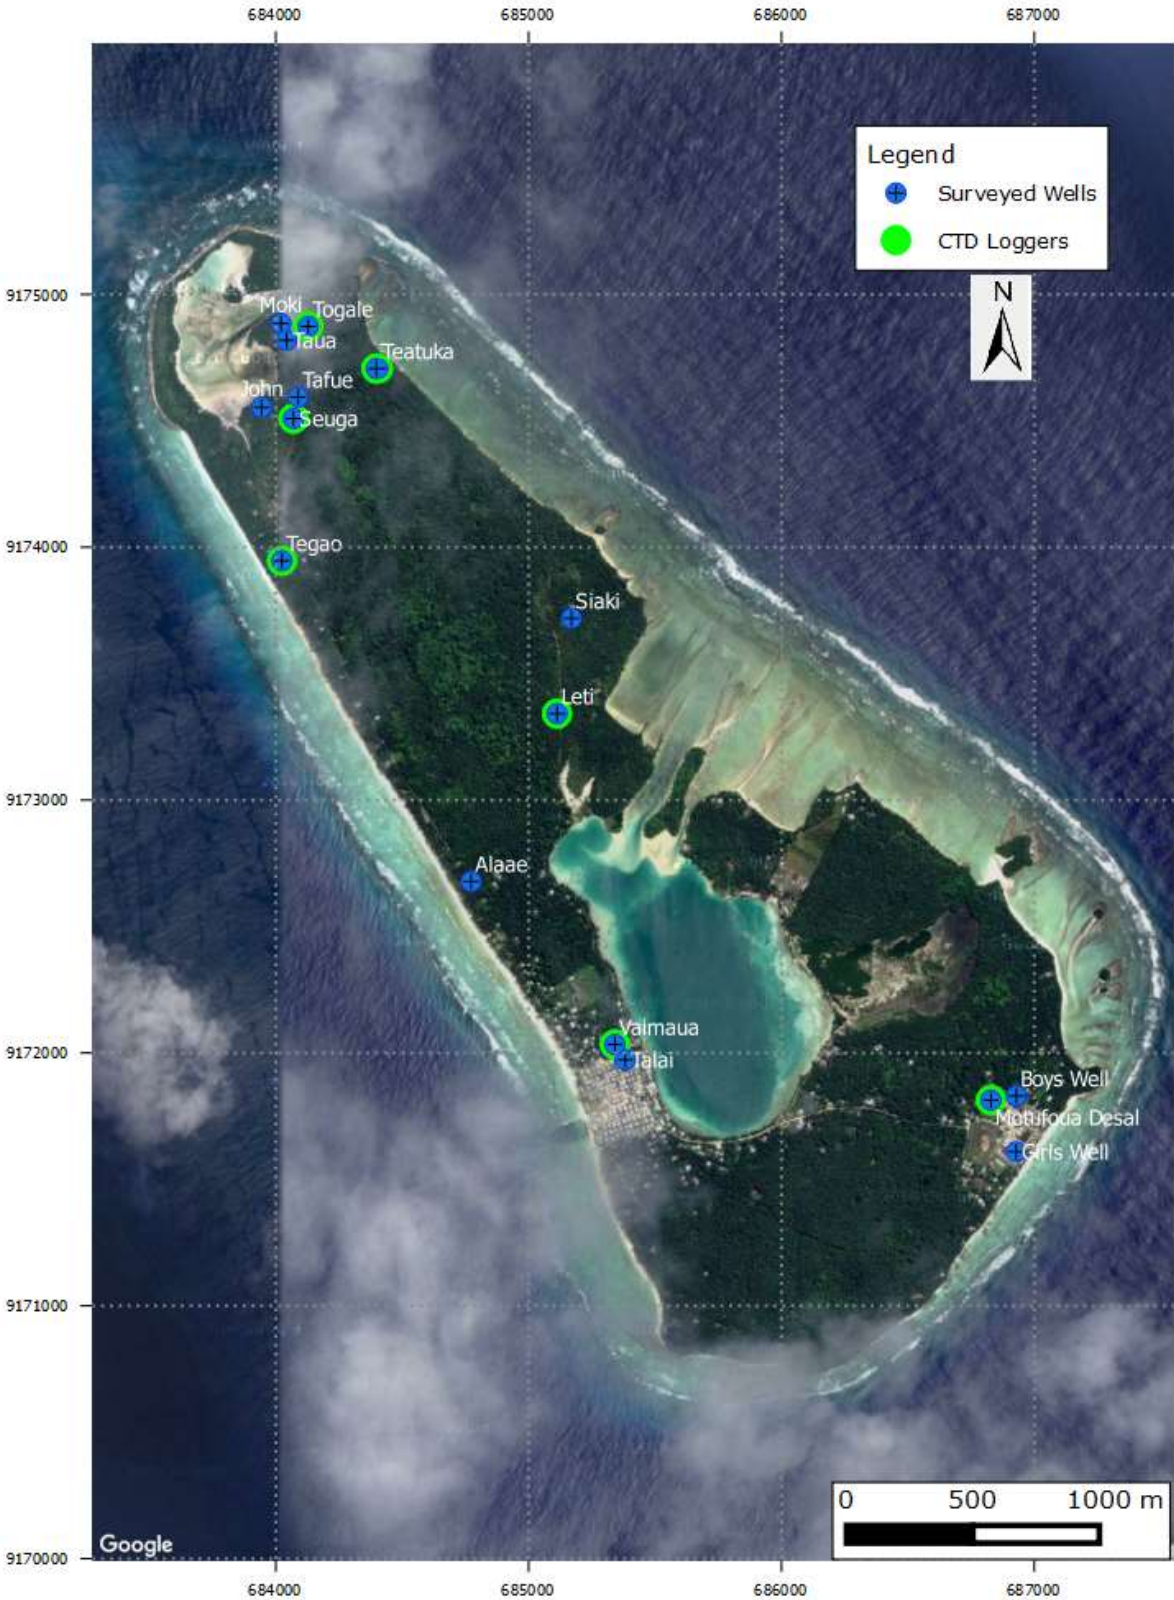
Figure 13. Location of surveyed wells on Vaitupu. Source: Google Earth 2015

Sixteen wells were assessed. The summary of the current conditions of the groundwater wells is presented in Annex 4, and the location of the wells is shown in Figure 13.

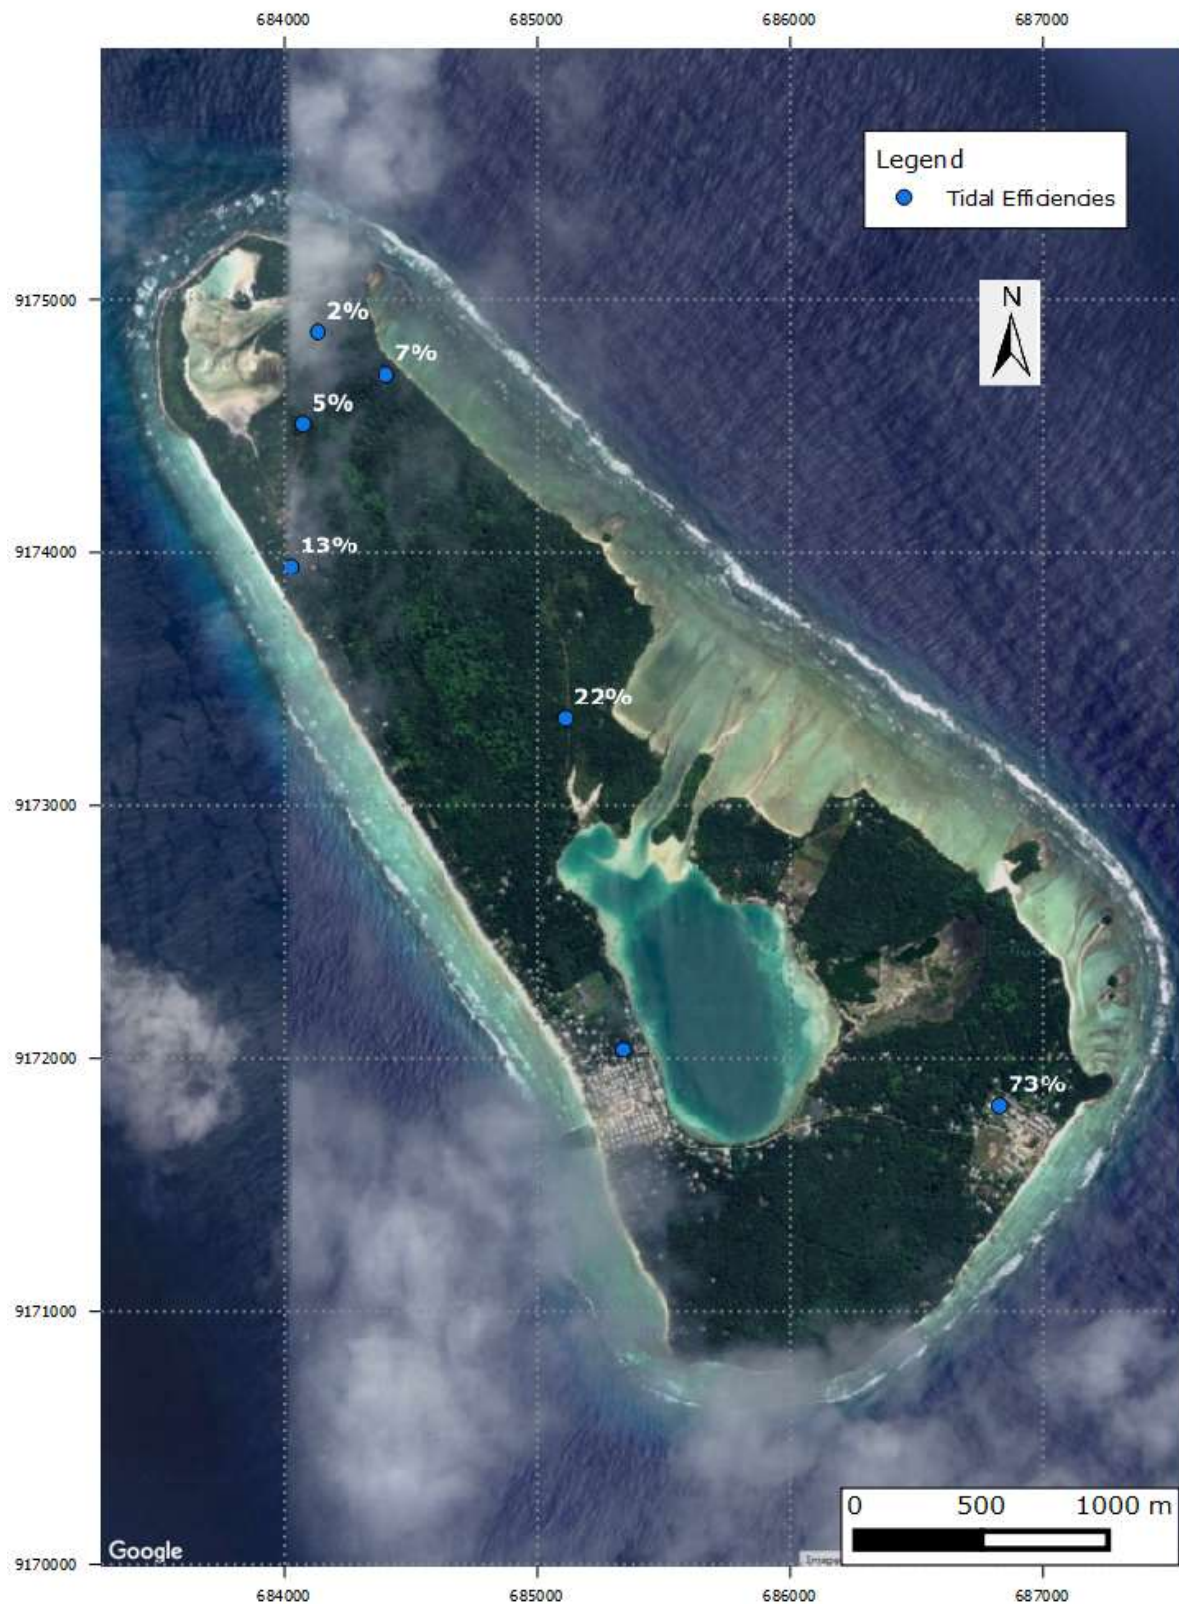
Figure 15. Estimated tidal efficiencies at Vaitupu. Source Google Earth 2015

The lowest tidal efficiencies, and longest tidal lags, were identified in the wells located on the northwest end of Vaitupu, with efficiencies between 2.3% and 7.5%. The low connectivity with the ocean signal is correlated with fresher groundwater, whereby lower salinities are found at the wells located in this area of lower tidal efficiency. The area of low connectivity to the tidal ocean signal is restricted to the northwest end of Vaitupu. Tegao well, located farther south, has a slightly higher efficiency of 12.6% than those wells located in the northern end of Vaitupu (Figure 15).

Towards the central part of Vaitupu, in the well Leti, the efficiency is intermediate, 22.5% and 2.7 hr of tidal lag, suggesting a higher connectivity with the ocean than the northwest end of Vaitupu. These results correspond with the higher salinities measured at Leti and Siaki wells. Unfortunately, the CTD logger located at the village at Vaimaua well, was removed from the well by unknown persons a few hours after its installation. The equipment was recovered by the community and returned to project staff at the end of the field campaign, however the returned logger was damaged and it was not possible to estimate the tidal efficiency and lag for this well.

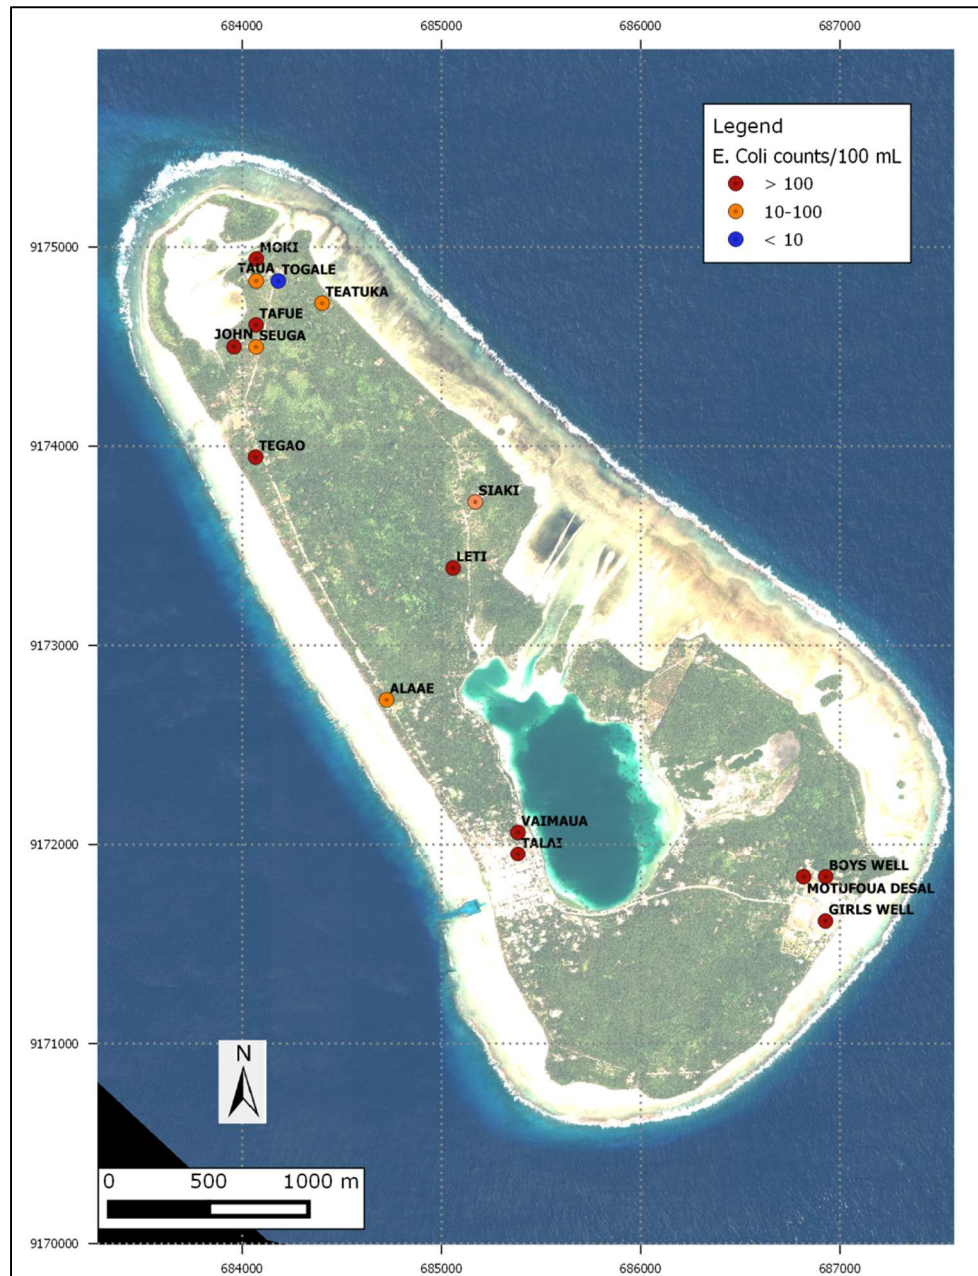
Figure 16: Groundwater bacteriological sampling and *E. coli* positive test at Vaitupu, Tuvalu in June 2015.
Source: Google Earth 2015

In total, 16 groundwater samples were collected and analysed during field activities. Results from the sampling are provided in Annex 6, with a summary of the results presented in Table 6 and Figure 16. Freshwater lenses in atoll environments are susceptible to contamination due to the shallow depth of the water table. The commonly observed contamination sources include human graves, agriculture (*pulaka* pits), pig pens, poorly sited and constructed sanitation systems, and general household activities such as washing, gardening and waste disposal.

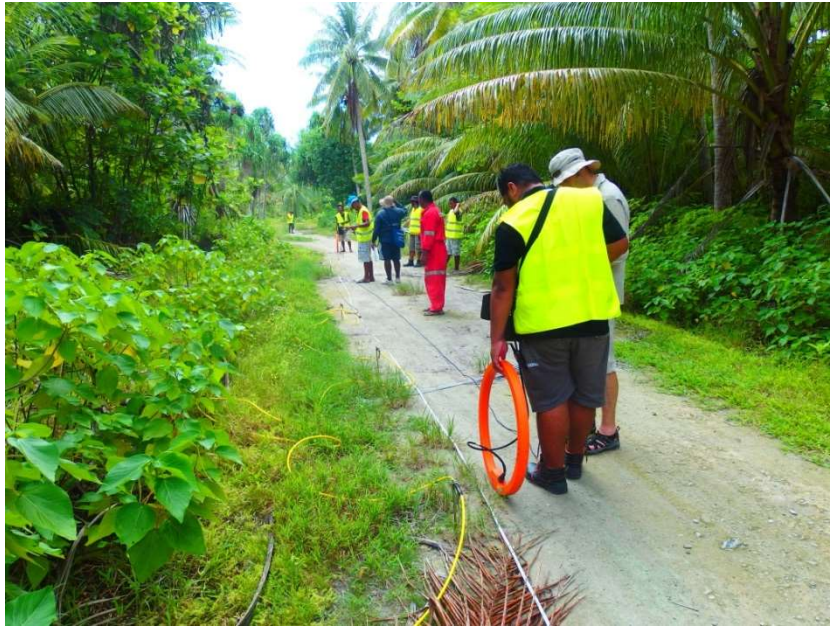
Figure 18: EM34 survey on Vaitupu.

The portability of the equipment allows an experienced team to undertake rapid surveys, with 2 km or more of non-invasive surveys able to be achieved per day. The EM-34 is used mainly as a reconnaissance tool to identify areas of greater fresh groundwater potential, which can be further investigated with other investigation techniques such as resistivity to indicate the likely thickness and extent of the fresh groundwater.

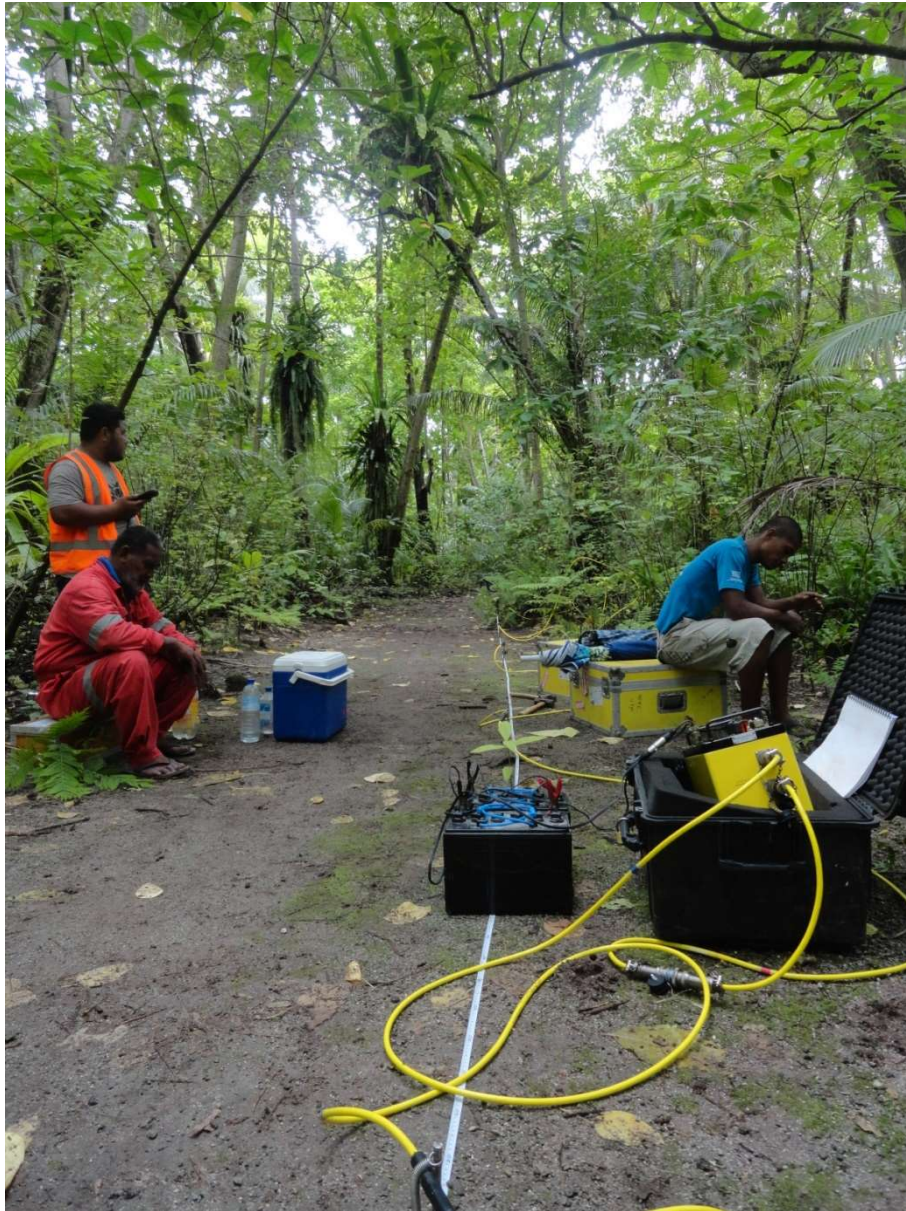
Figure 20: The resistivity survey lines along established tracks on Vaitupu.

Electrical current is injected into the ground through the use of stainless steel current electrodes, and then measured as a voltage in the potential electrode. Different spacing and sequencing of injection and measurement electrodes result in different arrays that are used for different investigations, depending on the depth and resolution of interest. On Vaitupu, dipole–dipole, Wenner, and trimmed Wenner arrays were trialled to determine which surveys would yield the best results for the available survey time.

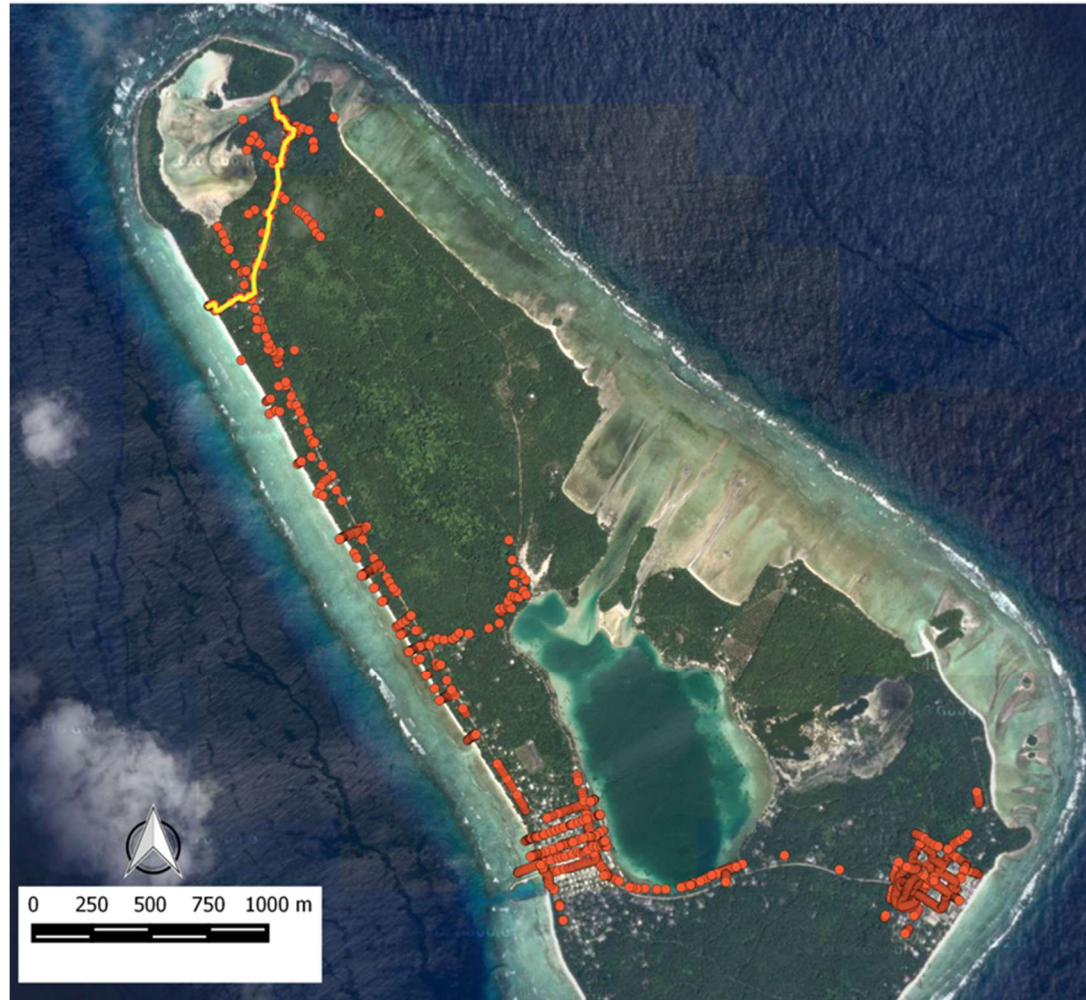
Topographical cross section location, Vaitupu.
