Household Survey to Assess Vulnerabilities to Water Resources and Coastal Erosion and Inundation

Lifuka, Ha'apai, Tonga

SPC SOPAC DIVISION TECHNICAL REPORT

Secretariat of the Pacific Community
Suva, Fiji
March 2013

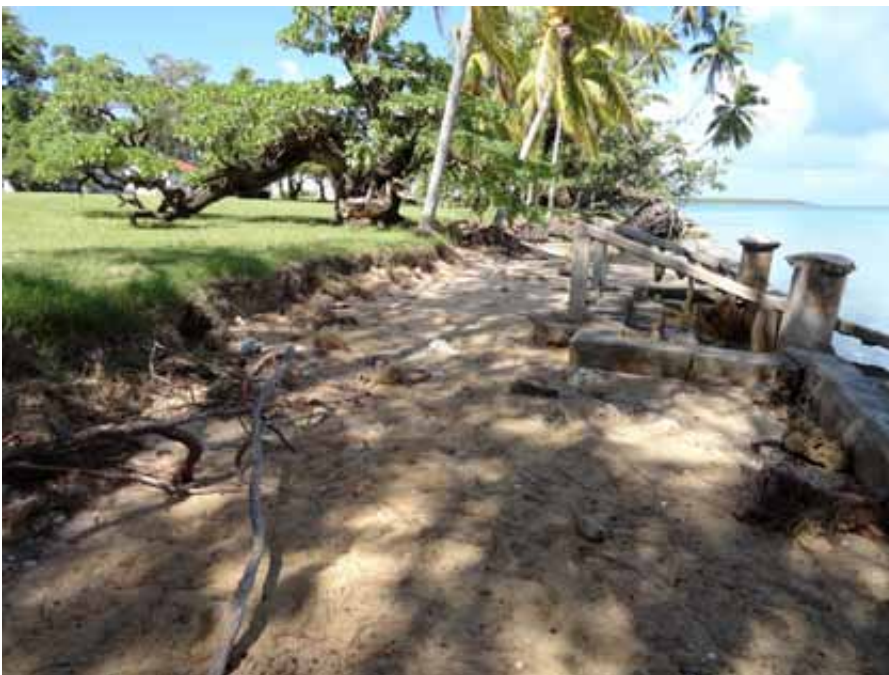
Figure 4. Coastal erosion in front of the Lifuka Royal Palace

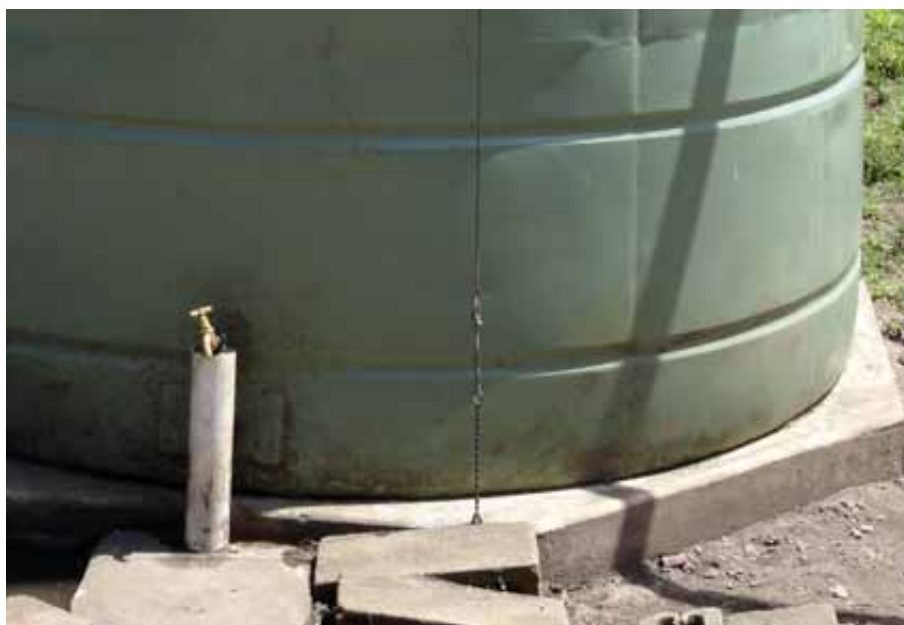
A total of 96% of all households took their drinking water from an external tap connected to a rainwater collection tank. Refer to Figure 17.

Figure 17. External tap on a plastic tank

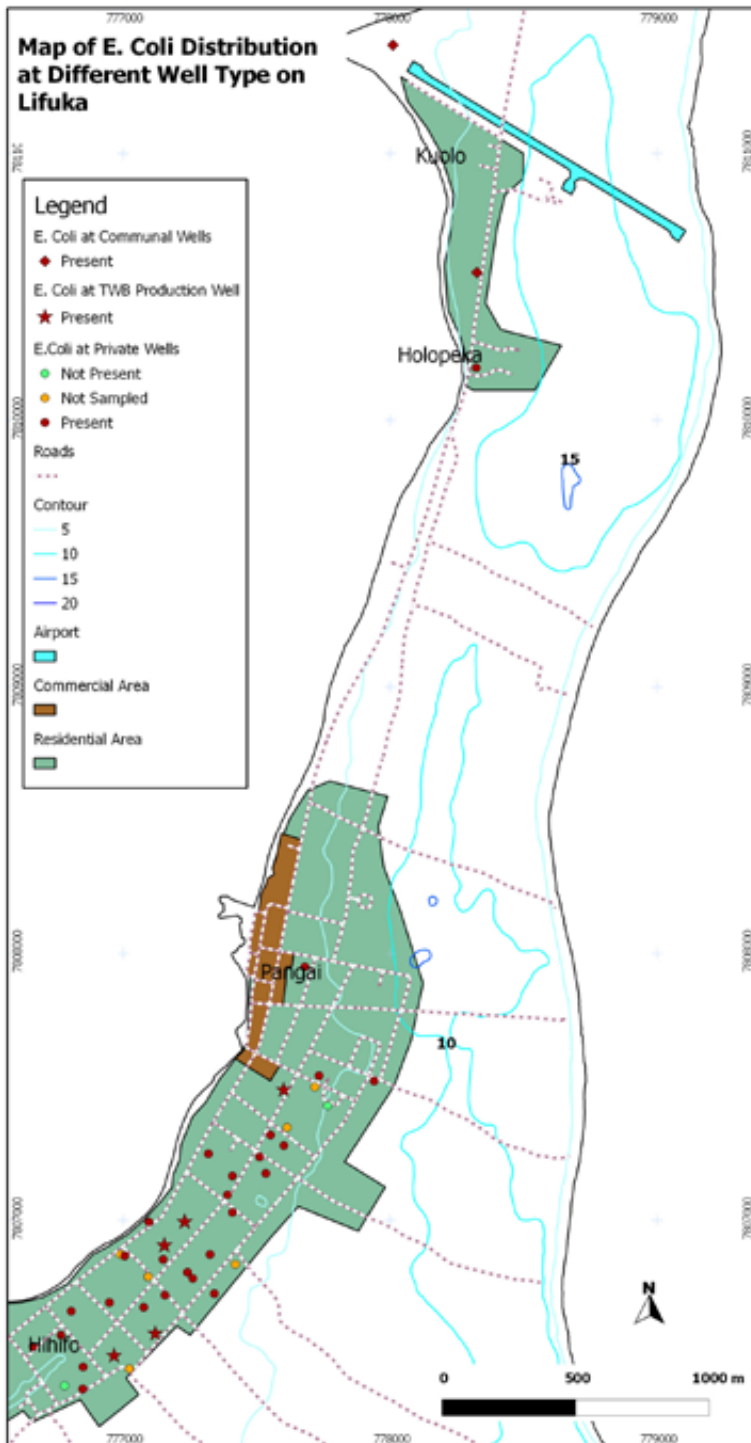
The results indicate that all groundwater on Lifuka should be considered contaminated by faecal matter. It is strongly advised that the people of Lifuka be made aware of this situation, and that adequate treatment of groundwater be undertaken at both the TWB treatment plant and at households prior to drinking. Treatment involving boiling or chlorination should be sufficient to reduce the risk to public health. Care should be taken not to ingest untreated water used for non-drinking purposes such as bathing.

Figure 24. Map of sample points and *E. coli* distribution
(P – present; N – not present; NA – not available)

No sampling of rainwater from tanks was undertaken. Household water safety planning is the recommended approach for assessing the risk potential, and boiling of water is recommended where water is used for drinking.

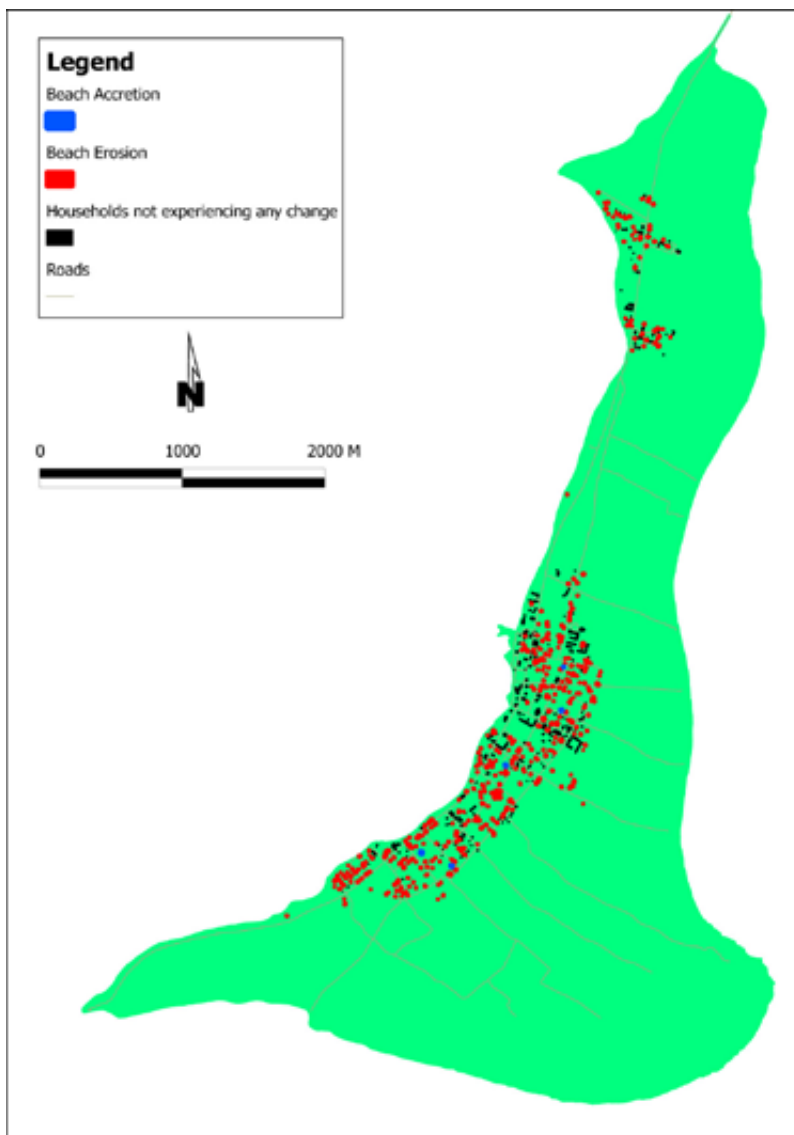
Results of the household survey questionnaire suggest that the community of Lifuka strongly believed that the coastline is eroding. In total, 98% said the width of the beach was decreasing. This showed a strong consensus within the population that coastal erosion was a serious concern. Only 1% of respondents said the width of the beach was either increasing or not changing (Figure 27). Another 1% of households did not want to respond as they were recent arrivals to Lifuka.

Figure 27. Location of households reporting accretion, erosion, or no change of beach width

Although the main purpose behind this question was to understand the community's opinions on coastal changes on Lifuka, the almost uniform answer that the width of the beach had decreased gave solid support to calls that coastal erosion was a grave concern.

It was also interesting to compare these community views with a preliminary analysis of satellite imagery by the SOPAC/SPC Oceanography team, which suggested that the beach in Pangai had receded up to 40 m over the last 44 years (Jens Kruger, Team Leader, Oceanography team, SOPAC/SPC, personal communication, 5 June 2012).

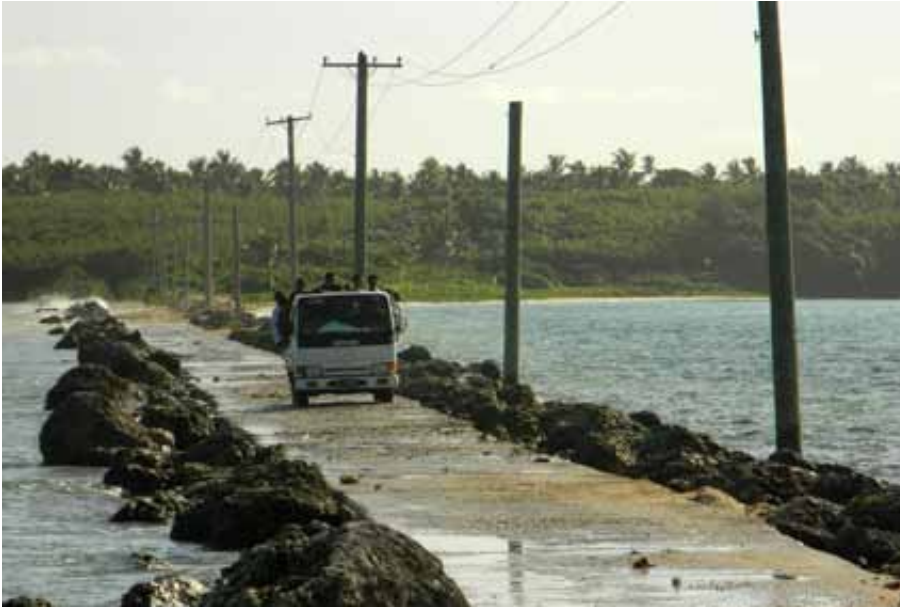
The majority of households did not link coastal erosion with human activities on the island. Though roughly half of Lifuka's households reported mining aggregates from the beach (see section 7 on aggregate mining), just 17 households (4%) believed that stopping sand mining would halt coastal erosion. Similarly, only a small percentage of respondents believed the causeway connecting Lifuka and Foa to be responsible for coastal erosion, with only eight households (2%) suggesting it should be redesigned to prevent sand sedimentation on the Lifuka shoreline.

Figure 31. Photo of the causeway connecting Lifuka and Foa

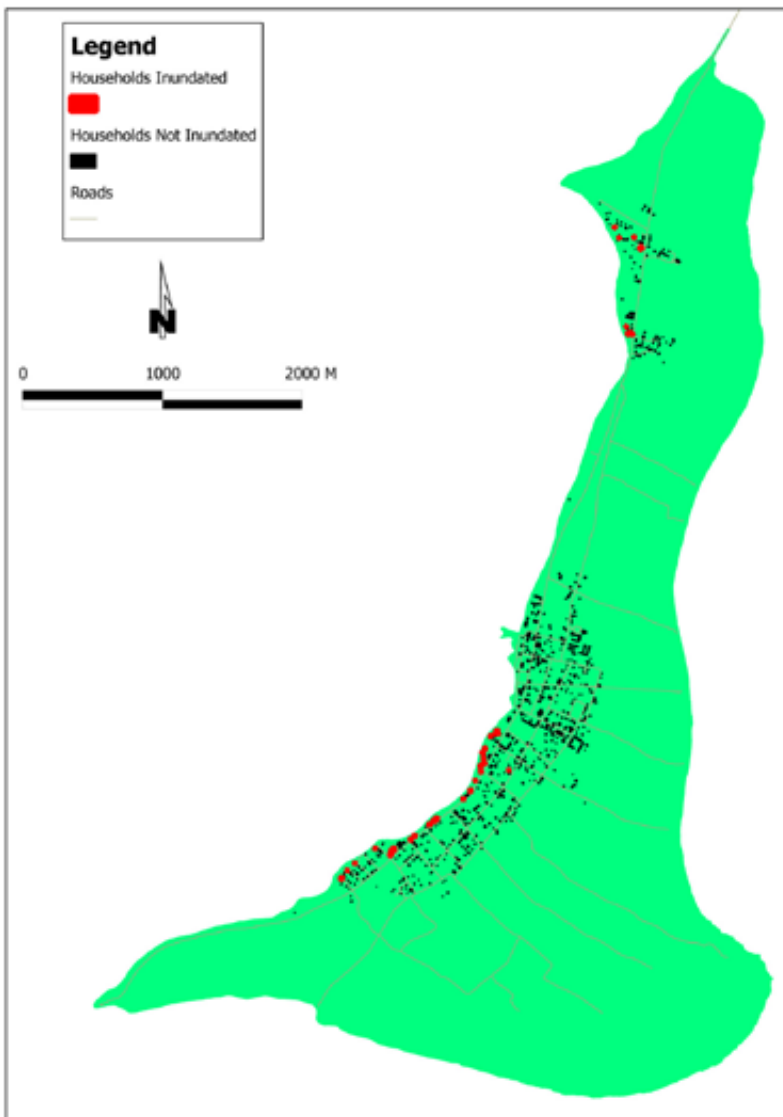
Coastal inundation appeared to affect a very small percentage of people in the Lifuka community. Of the 392 households interviewed, 92% (362 households) claimed that their land had never been inundated by ocean water. As the following discussion will show, inundation affected just a small percentage of households (8%) as most of the households (private infrastructure) are located further inland (Figure 32). Figure 33 shows the distribution of responses regarding how many times the land belonging to interviewed households has been inundated by ocean water or hit by waves.

Figure 32. Location of households reporting inundation either due to tropical cyclone waves or tsunami

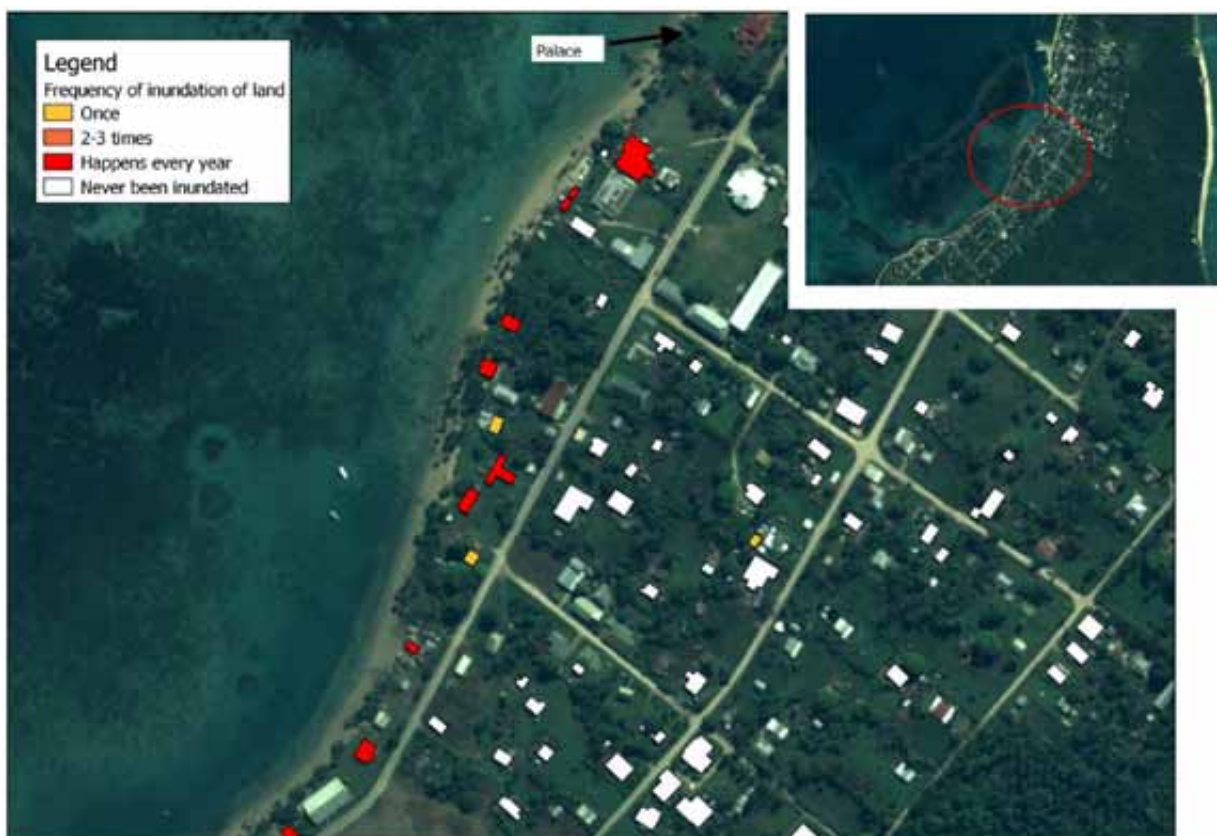
Figure 34 provides a map of Pangai showing which households reported inundation in the past. Houses coloured in red on the map reported having their land inundated every year. Those in orange reported that their land had been inundated two or three times, while those households in yellow reported that inundation had occurred just once. Households in white said their land had never been inundated. For the uncoloured houses, data are not available.

Figure 34. Map of Pangai with households that reported land inundation by ocean water marked

As can be seen from the map in Figure 34, the infrastructure alongside Pangai's coast is under great risk from coastal inundation and erosion. Though the map shows the frequency of inundation of private households, infrastructure is also under threat. Amongst the households in Pangai reporting that their land had been inundated, 29% said that the water level had risen higher than the living room floor on at least one occasion.

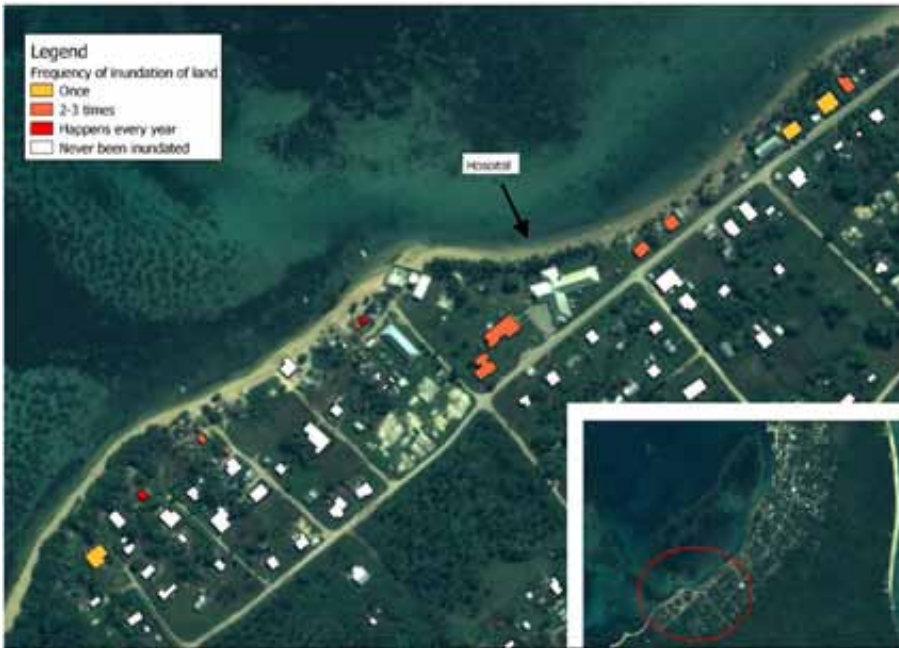
Figure 35 contains the corresponding map of Hihifo. As can be seen from the colours, coastal inundation was not as frequent as in Pangai. Most of the households here reported having had their land inundated two or three times in the past, but indicated that this was not an annual event. The hospital, one of the major pieces of infrastructure at risk, recently had a foreshore constructed to prevent coastal erosion. Nevertheless, hospital staff said that the land surrounding the hospital had been hit by waves several times, although the building itself has never been inundated.

Figure 35. Map of Hihifo with households that reported inundation by ocean water marked

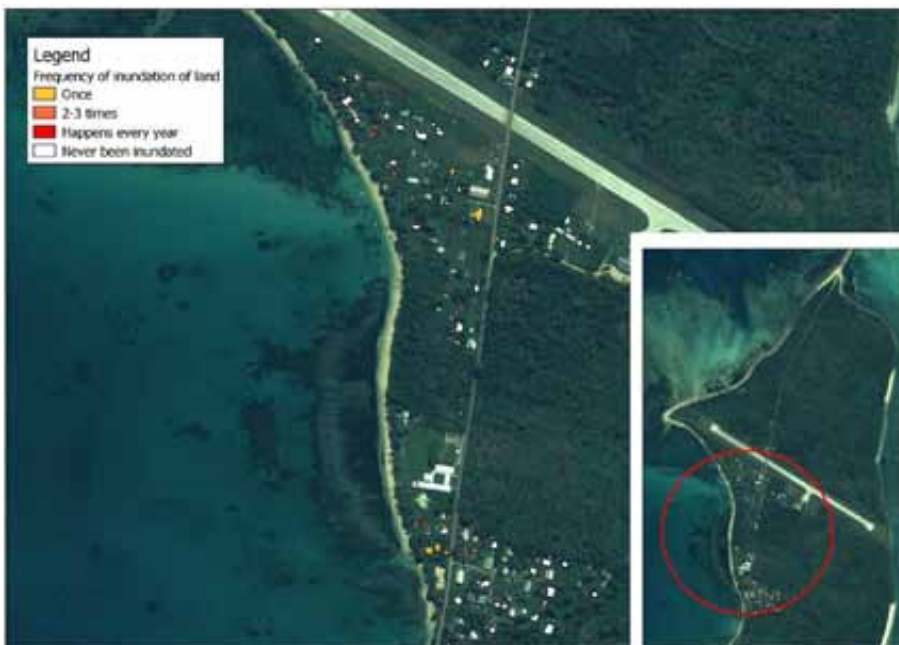
Koulo and Holopeka appeared to be least affected by coastal erosion and inundation, as can be seen from Figure 36. A total of 17 households reported that their land had been inundated, although most households said that this had occurred just once in the past. Some of the households further inland indicated that their land had been inundated, and it was assumed that the land under that household's ownership stretched closer to the coast. Further north in the area around the airport, inundation seemed to be more frequent, with households reporting recurrent inundation of their land.

Figure 36. Map of Koulo and Holopeka with households that reported land inundated by ocean water marked

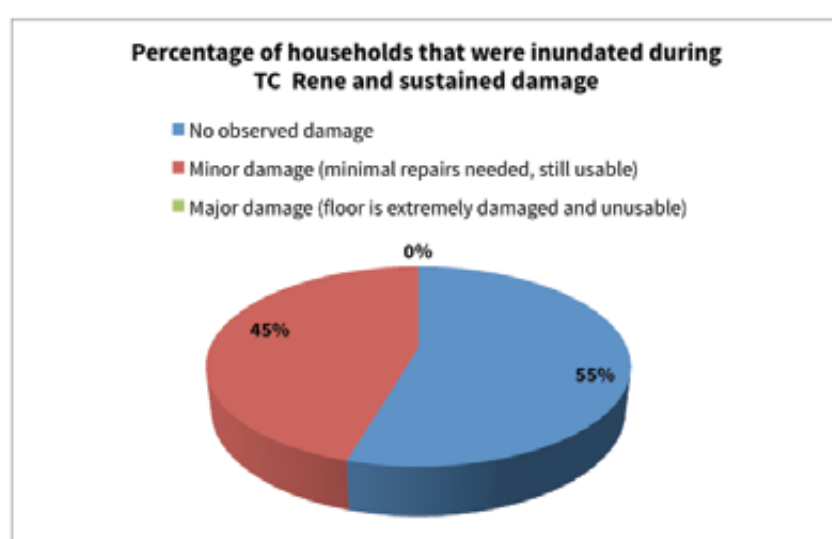
For those households that indicated inundation by TC Rene, six indicated that there was no observed physical damage to the foundation of their house. Five households recalled minor damage – a foundation that needed repairs but was still useable. None of the households reported major damage, which would have meant a foundation that had been extremely damaged and made unusable (Figure 39).

Figure 39. Damage to house foundations due to TC Rene, for households that reported inundation

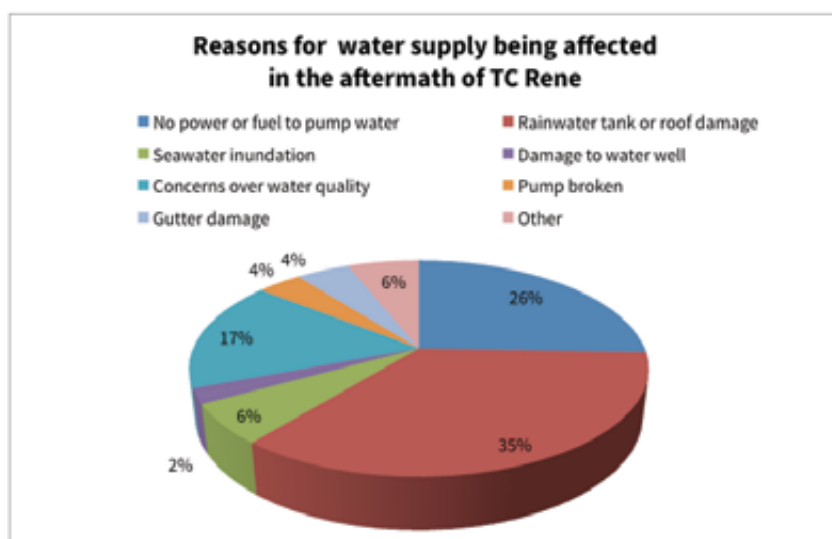
In the aftermath of TC Rene, 31% of households in Lifuka reported that their water supply had been affected. For those 122 households, the main causes were rainwater tank or roof damage (35%), a lack of power or fuel to pump water (26%) and concern over water quality (17%) (Figure 40). Many households reporting concerns over water quality stated that the water tasted salty for several days after the cyclone as strong winds blew ocean mist into the rainwater tanks.

Figure 40. Reasons for water supply becoming affected in the aftermath of TC Rene

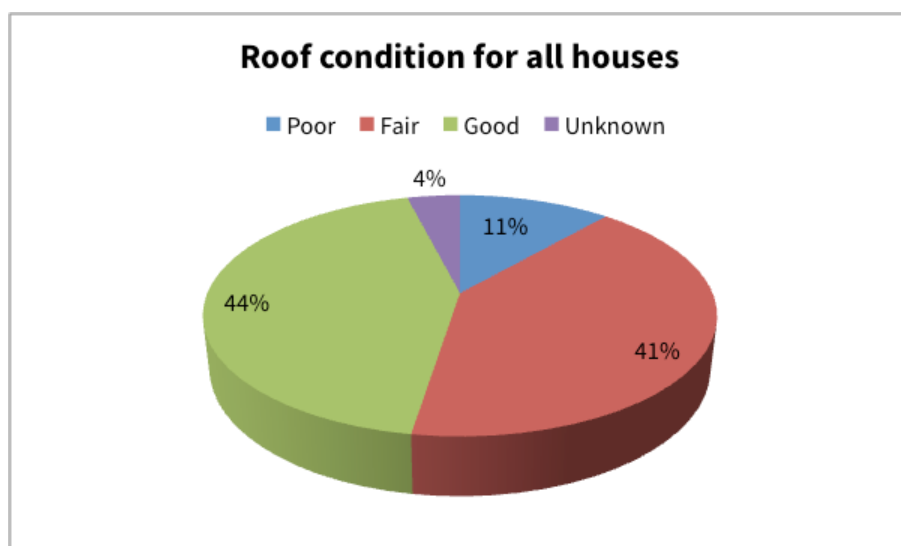
Figure 47. Condition of house roofs – physical survey

A visual assessment showed that 11% of the house roofs surveyed were unsuitable for rainwater harvesting, and replacement was recommended. Of the remainder, 85% of roofs appeared suitable for harvesting rainwater, and the condition of 4% was unknown (Figure 47).

Roof deterioration, predominantly from rust, was common. It was estimated that some 52% of all houses required some roof maintenance, and, in some cases, replacement was required to improve the effectiveness and quality of rainwater harvesting systems.

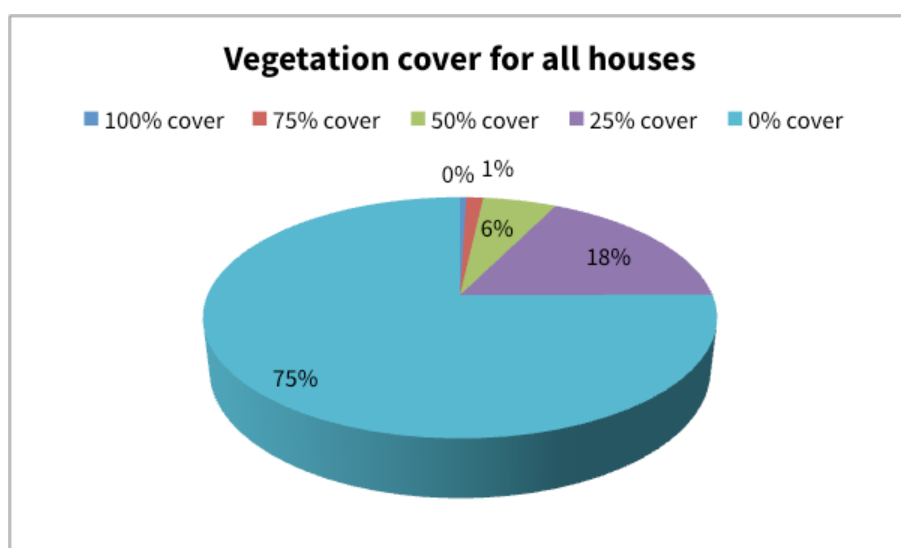
Figure 48. Vegetation cover over roofs

The survey indicates that vegetation overhanging homes did not appear to be a significant problem on Lifuka (Figure 48). Some 75% of households surveyed had minimal, if any, vegetation overhanging the roof catchment, significantly reducing the risk of contamination to stored rainwater.

We recommend that those surveyed households with some vegetation cover (25%) clear it to improve their water quality.

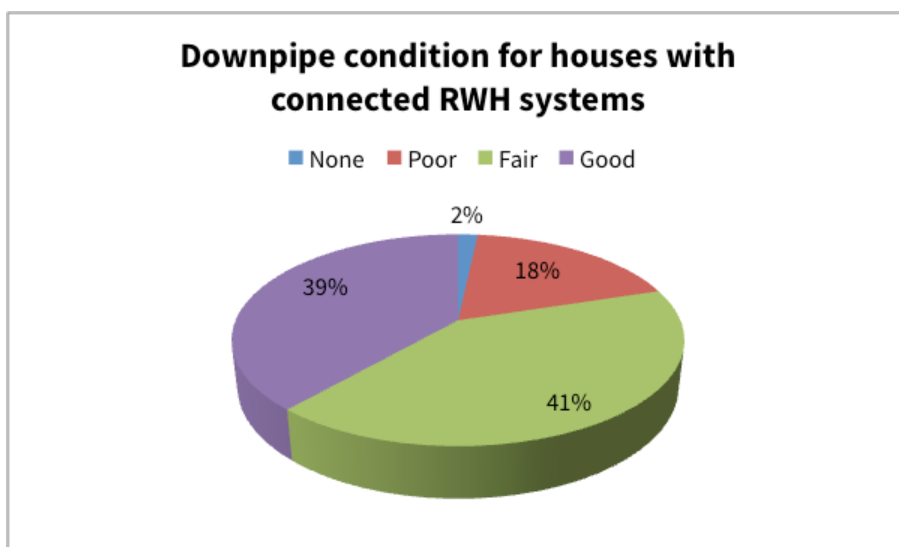
Figure 49. Downpipe condition for houses with connected rainwater harvesting systems

Figure 49 indicates the condition of downpipes for houses at the time of the survey. Less than 40% of all houses had efficient downpipes installed. An estimated 20% of all houses required downpipes to be replaced, while more than 40% of houses required minor repairs to downpipes.

We recommend that repair and replacement of downpipes and gutters be considered in future infrastructure improvement projects in conjunction with the development of a sustainable, community-led maintenance incentive programme.

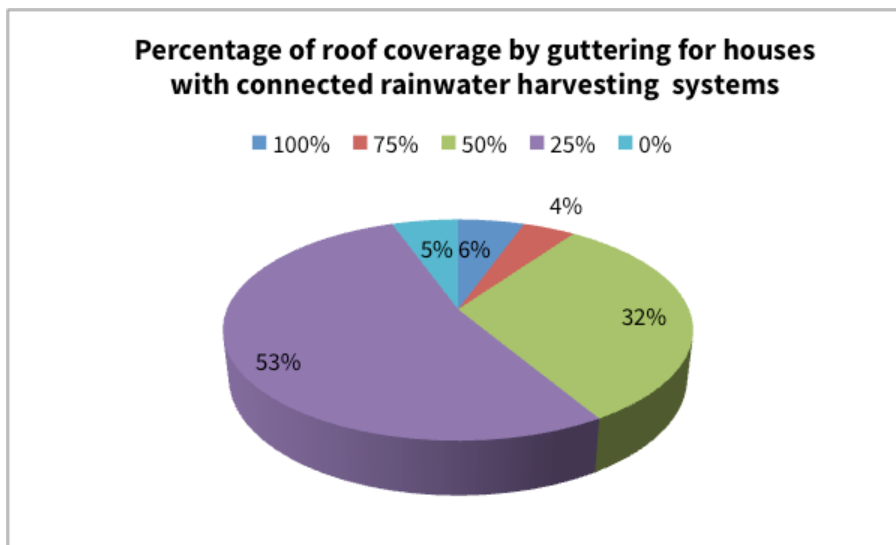
Figure 50. Gutter coverage of rainwater harvesting buildings

It is apparent from Figure 50 that significant improvement in the quantity of rainfall collected can be made with increased coverage by gutters. Just 6% of households were collecting the maximum amount of rainfall, whilst 94% of all households were collecting from 50% of the roof area or less.

Increasing the gutter coverage on houses would improve access to rainwater for most households. Future adaptation options to improve water supply should include increased guttering as an achievable solution that can be undertaken by householders and through a donor and community participation scheme.

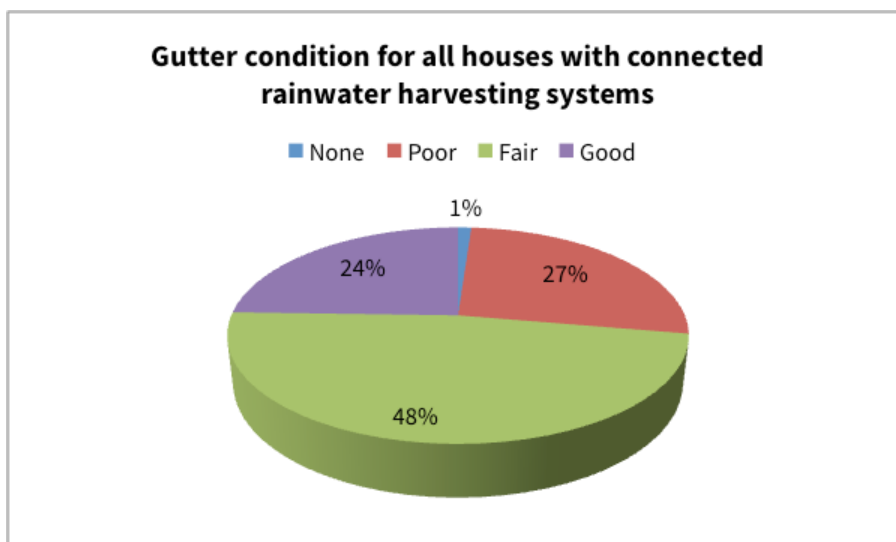
Figure 51. Gutter condition for all houses with connected rainwater harvesting systems

More than 75% of all houses had gutters that were improperly fitted, had sections missing or broken, or lost some water (Figure 51).

There was significant scope for improving rainwater harvesting yields through increased coverage and properly installed guttering. We recommend that adaptation options to improve water supply include increased guttering to maximise the available roof catchment area, as well as incentive schemes that actively encourage the maintenance of guttering to support sustainability and efficiency of rainwater harvesting.

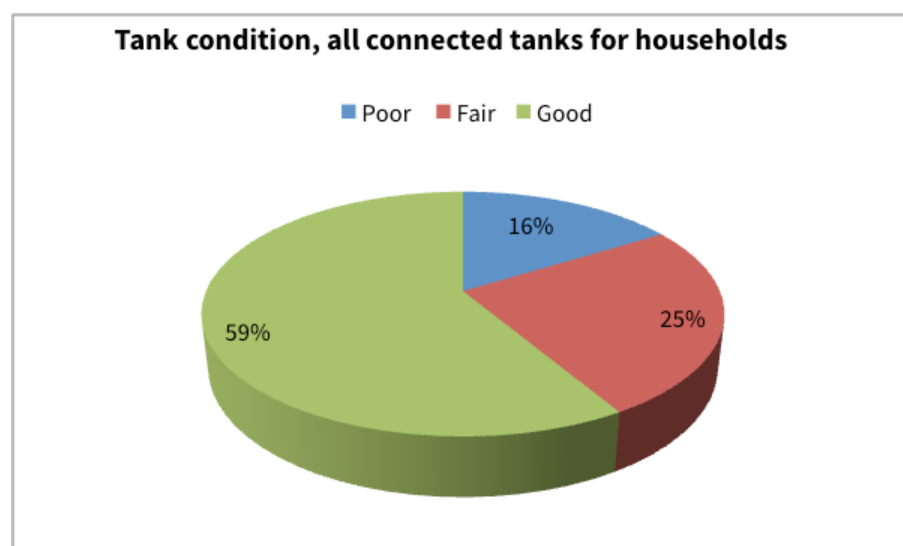
Figure 53. Condition of all connected tanks for households

Nearly 60% of all connected household tanks were considered to be in good condition and free of any observed leaks. An estimated 16% of connected household tanks were observed to be leaking and in need of repair or replacement (Figure 53).

Overall, 40% of storage tanks observed required repairs, ranging from minor to complete replacement. We recommend regular tank inspections in combination with a gutter-maintenance incentive scheme to help identify cracks and leaks early and provide more time and resources for maintenance and rehabilitation.

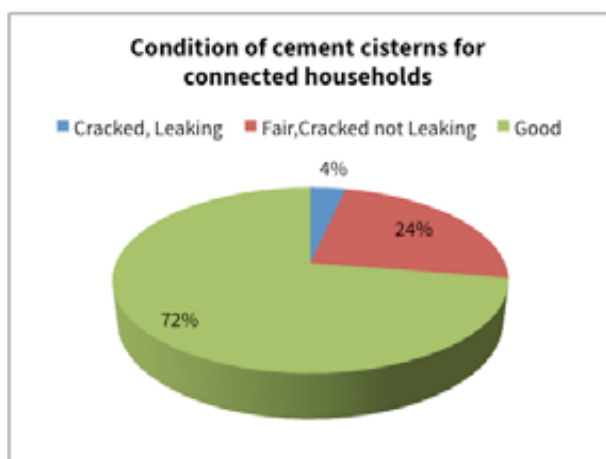
Figure 54. Condition of connected cement cisterns

It is more difficult to determine if cement cisterns are leaking, as much of their structure is below ground. Based on observation, 72% of cisterns appeared to be in good condition, free of any visible cracks or leaks. An estimated 4% of the connected cement cisterns were observed to leak, and required immediate repair or replacement.

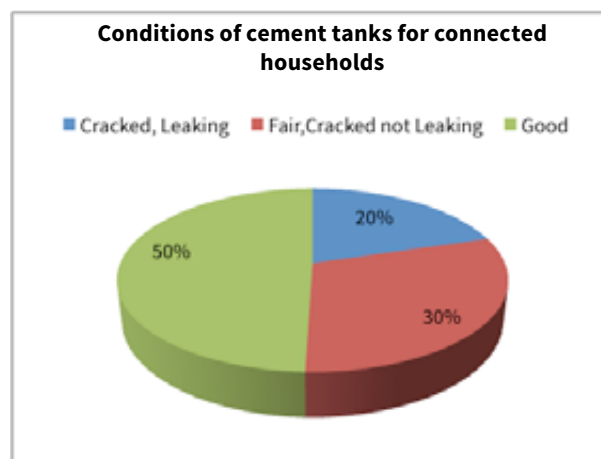
Figure 55. Condition of connected cement tanks

A similar analysis was done for the different types of tanks, and the results are presented in Figures 54–56. Figure 55 indicates that 50% of the connected cement tanks were considered free of any external visible cracks or leaks.

An estimated 20% of the connected cement tanks were observed to be cracked and leaking, requiring immediate repair or replacement. The remaining 30% of connected cement tanks had external visible cracks and were likely to require repairs.

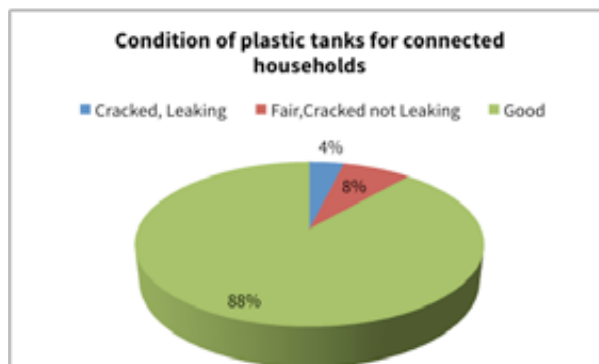
Figure 56. Condition of connected plastic tanks

Plastics tanks were generally well maintained, with 88% of the connected plastic tanks considered to be in good condition. An estimated 4% of the connected plastic tanks were observed to be leaking at the time of the survey. This relatively high rate of plastic tanks in good condition may reflect the fact that they are generally newer than the cement tanks.

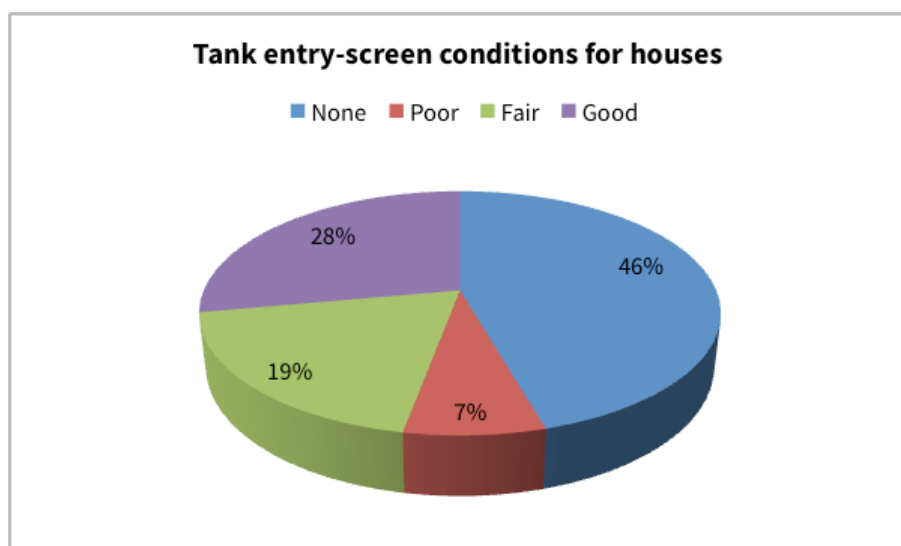
Figure 58. Condition of screens at tank entry points for connected household tanks

Some 46% of connected household tanks did not have any screens to filter debris. An estimated 72% of all connected household tanks required screens to be installed, repaired or replaced (Figure 58). A similar analysis was done for the different types of connected tanks (Table 23).

We recommend a community maintenance incentive programme that runs every six months, and supports householders with basic tools, materials, and technical knowledge regarding the importance of maintaining clean tanks and gutters, to improve water quality and security of supply.

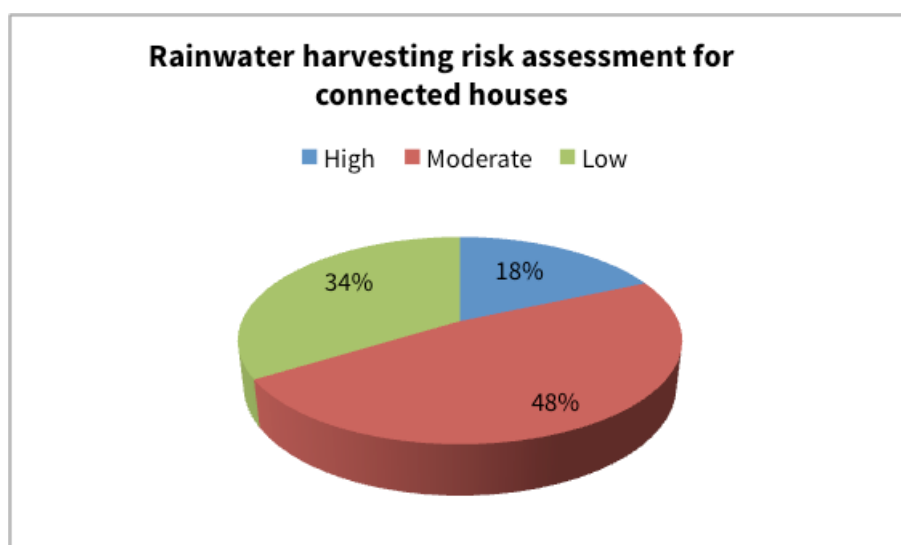
Figure 59. Assessment of risks to water quality of rainwater harvesting systems for connected households

Two-thirds of all household rainwater tanks in Lifuka were classified as having a moderate to high risk of contamination (Figure 59).

Boiling of water and safe storage in households prior to consumption is recommended.

Additionally, improvements to tank-water quality can be expected where first flush diverters (WHO 2004) are in use to divert the ‘first flush’ of rainfall, which can contain dirt and contaminants from the roof, along with basic screening and gutter maintenance programmes. It is recommended that first flush diverters be considered for future rain tank installations and form part of the building code for new buildings and extensions.

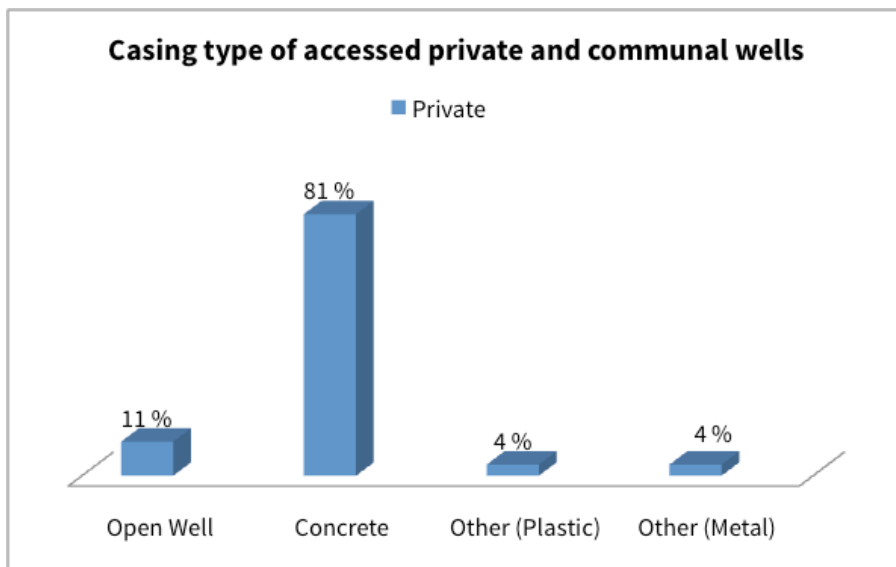
Figure 63. Private wells by casing type

A total of 89% of the private wells were cased, offering some protection against collapsed well walls and ingress of surface waters (Figure 63). Approximately 11% of the surveyed private wells did not have any casing and were at higher risk of contamination. Households with open wells could minimise contamination risks by casing wells, constructing a concrete apron, and restricting the access of animals.

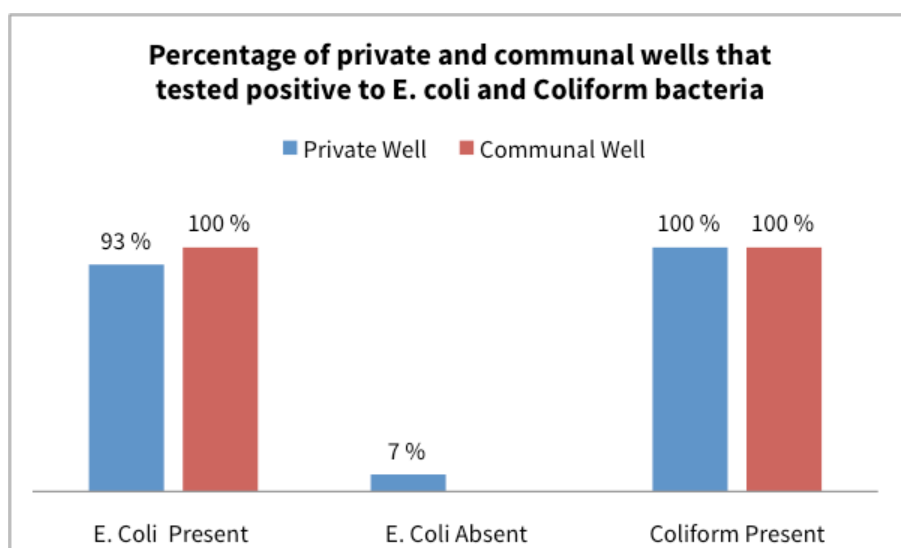
Figure 65. Percentage of private and communal wells that tested positive for *E. coli* and coliform bacteria

A total of 93% of private wells and both communal wells tested positive for the presence of *E. coli*, and all were positive for coliform bacteria (Figure 65). Evidently, there is a high risk of groundwater faecal contamination from current land activities and practices. Previous studies (Crennan 2001) have also indicated high levels of bacteriological contamination of groundwater.

It is recommended that communities on Lifuka be informed about the level of groundwater contamination and the risks this poses to public health. Similarly, it is important for the community to recognise that water quality will not improve whilst current wastewater practices remain, and while large numbers of pigs and dogs are allowed to roam.

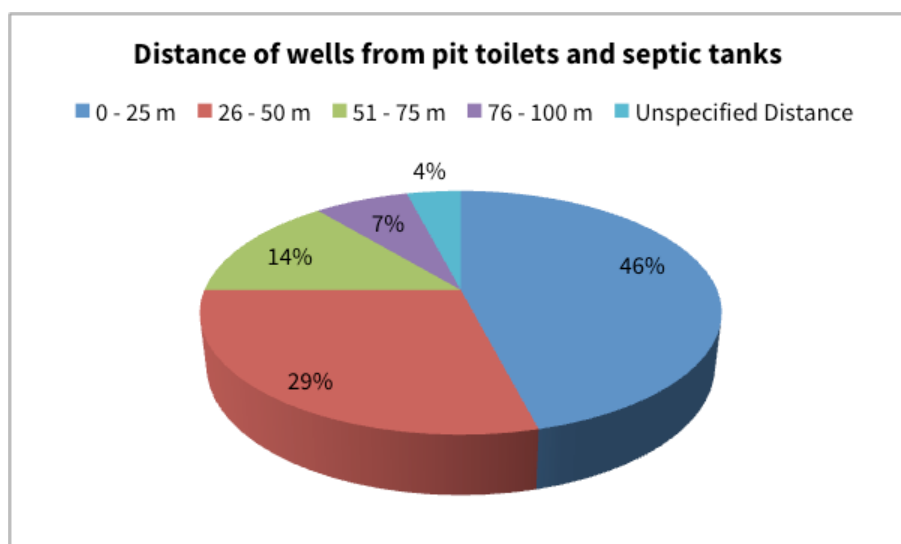
Figure 67. Distance of wells from pit toilets and septic tanks

The threat of contamination is significantly increased where the bases of septic tanks or soakaway pits and pit latrines are unsealed (as is the case for the majority of septic pits/soakaway pits on Lifuka) and are also in close proximity to wells.

The distance from wells to the closest septic tank/pit latrine was observed. Results indicated that approximately 46% of private wells were less than 25 m away from pit toilets and latrines (Figure 67). A total of 90% of wells were within 75 m of pit toilets and latrines.

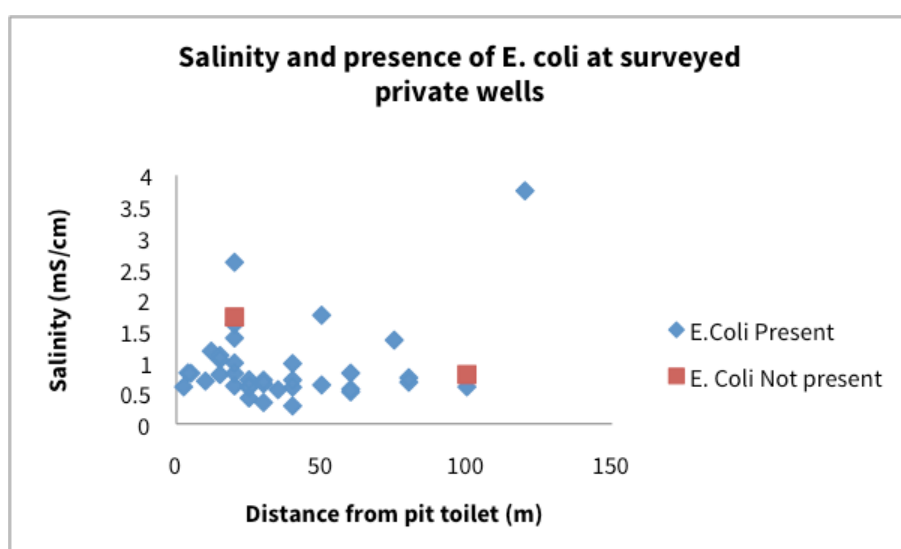
An attempt was made to establish a relationship between the distance of a well from the closest septic tank or pit toilet and the presence of *E. coli* in the groundwater. No obvious relationship was established (see Figure 68). A UNESCO-funded groundwater pollution study in Lifuka in 2001 (Crennan 2001) suggested that there was no safe distance for construction of wells in relation to toilet facilities in the villages of Pangai and Hihifo.

Figure 68. Salinity and *E. coli* values for wells

No obvious relationship was observed between the distance of a well from a septic tank or pit toilet and the presence or absence of *E. coli* or salinity.

It is recommended that an alternate waste disposal option, such as composting toilets, be considered for Lifuka. Composting toilets were piloted in 2001, but many of the 15 original composting toilets were no longer operational at the time of this survey. Improved designs in conjunction with a structured and supported implementation programme would improve the success rate for longer-term acceptance of this appropriate technology.

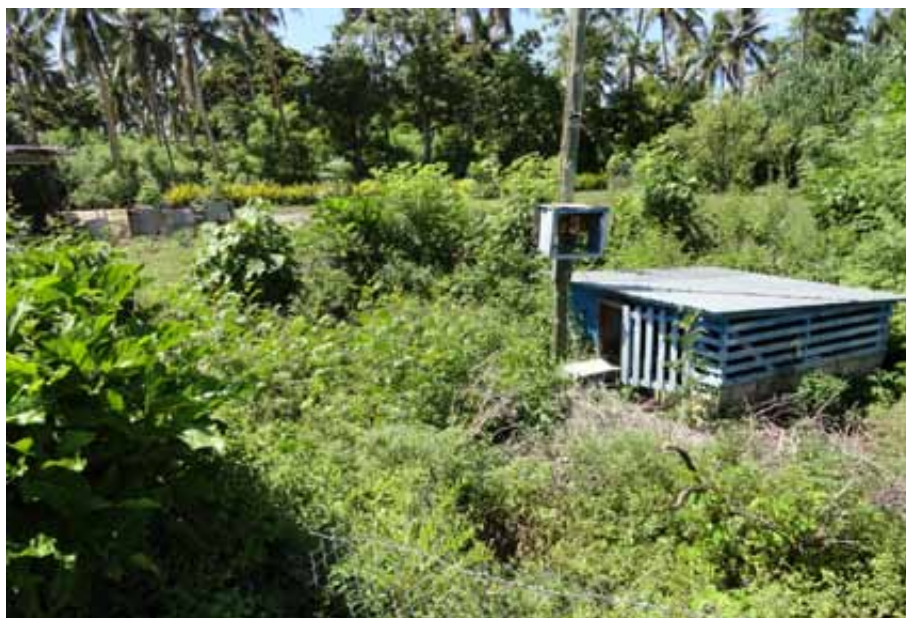
A diesel pump is used for abstraction from Hihifo East and an electric pump is used for abstraction at TWB4. Only one production well site, TWB4, has a working water flow meter attached for measuring abstraction. Instantaneous abstraction rates from the working meter for TWB4 have been measured at 0.46 L/sec. or an estimated 39.7 KL/day. Water-flow meters purchased under the PASAP project are to be attached to the three unmetered raw groundwater abstraction points (TWB Hif East, TWB Hif North Electric, and TWB Pangai North Solar). An additional meter was purchased and installed to measure flow from the treatment plant to the main pipeline to consumers. Information from the flow meters will allow improved abstraction management and better understanding of the relationship between abstraction rates and water quality. The flow meter attached to the outflow from the treatment plant will measure the volume of water leaving the treatment plant towards the households, helping improve water supply budgeting and assisting in leak detection.

Figure 3. TWB production well in Hihifo

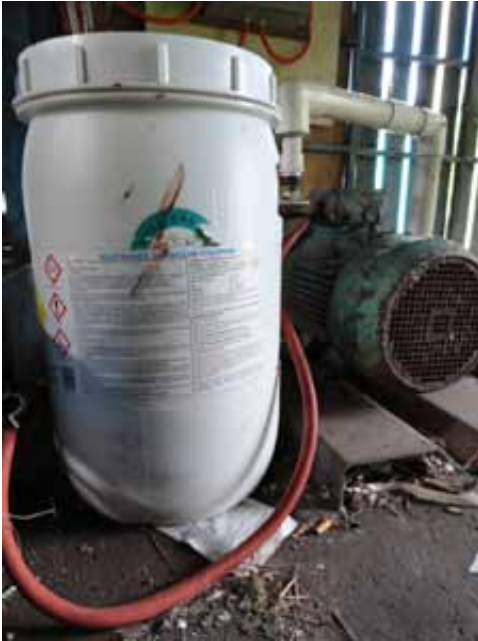
Figure 4. Inside the TWB treatment plant – addition of chlorine to treat water

The standard operational procedure for water treatment on Lifuka is for 500 ml of chlorine granules to be mixed into each of the three 45,000 L raw water storage tanks every day. There are times when this procedure fails and/or treatment of the water with this volume of chlorine is insufficient, as was the case during the March 2012 water-quality sampling.

Testing of water samples taken at the treatment plant and along the distribution line revealed all samples tested positive for bacteria, both coliforms and *E. Coli*. TWB's water treatment at the time of the survey was found to ineffective in removing these contaminants, suggesting that better enforcement of standard operating procedures or improved treatment is required.

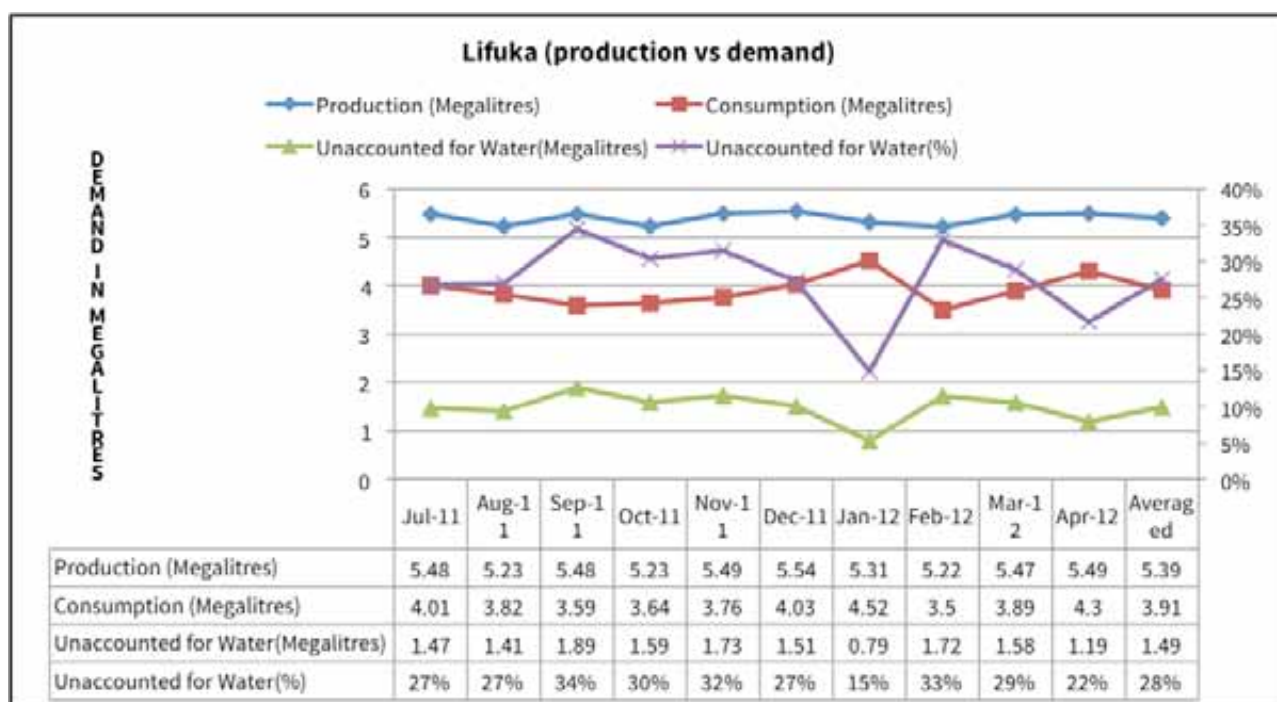
Figure 6. Monthly water abstraction and usage data (Source: Tonga Water Board, 2012)

The fluctuations observed in the unaccounted-for water for January 2012 appear anomalous. It is suggested that this anomaly is an artefact of the data due to an increase in consumption measured against a relatively stable 'calculated' production volume, resulting in an apparent drop in unaccounted-for water.

It is recommended that TWB undertake weekly recording of the meters installed on all production bores to determine the volumes of water abstracted and daily readings on the distribution outlet line at the treatment plant.

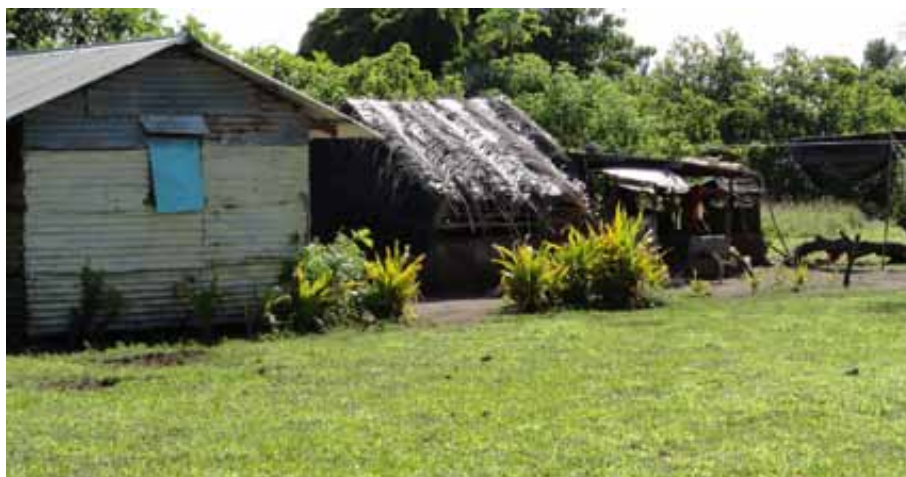
Figure 1. A metal roof (left) and a thatched roof (right)

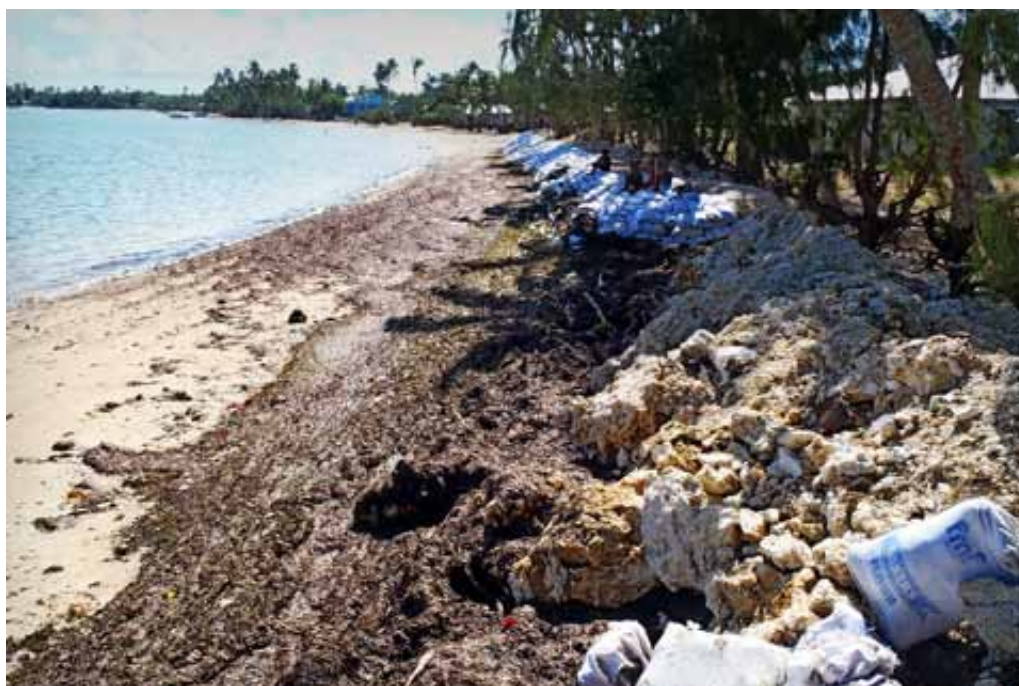
Figure 11. Sea wall in front of Lifuka Hospital
