Household Survey to Assess Vulnerabilities to Water Resources and Coastal Erosion and Inundation

Lifuka, Ha'apai, Tonga

SPC SOPAC DIVISION TECHNICAL REPORT

Secretariat of the Pacific Community
Suva, Fiji
March 2013

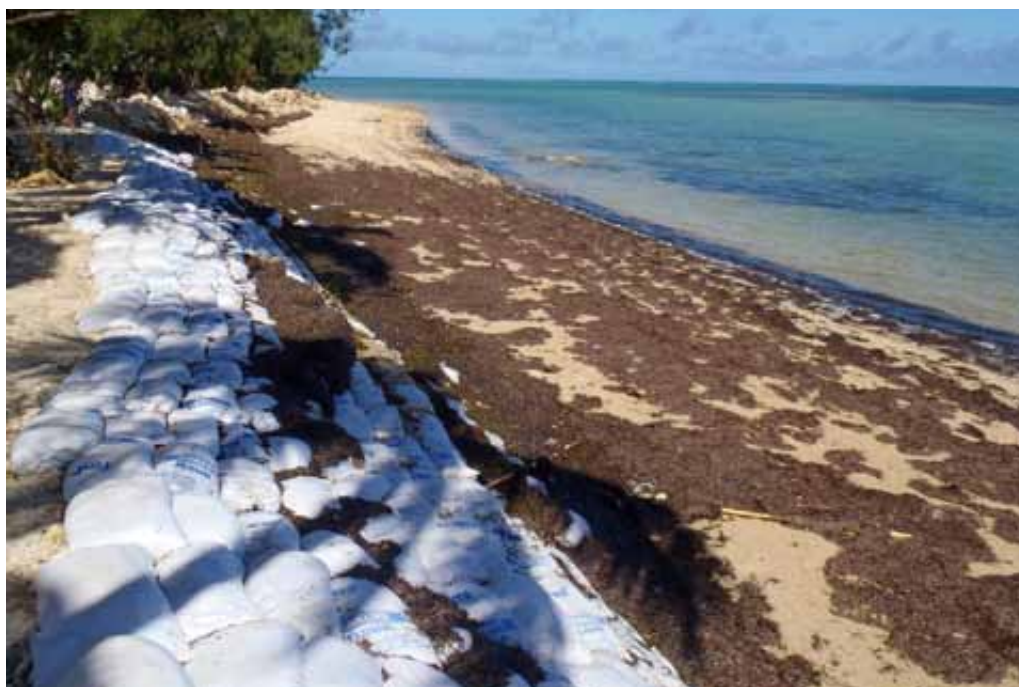
Figure 12. Sea wall in front of Lifuka Hospital
