# Pacific Safety of Navigation Project

## Risk assessment for Luganville harbour, Espiritu Santo, Vanuatu

Francesca Pradelli and Salesh Kumar

Suva, Fiji, 2020

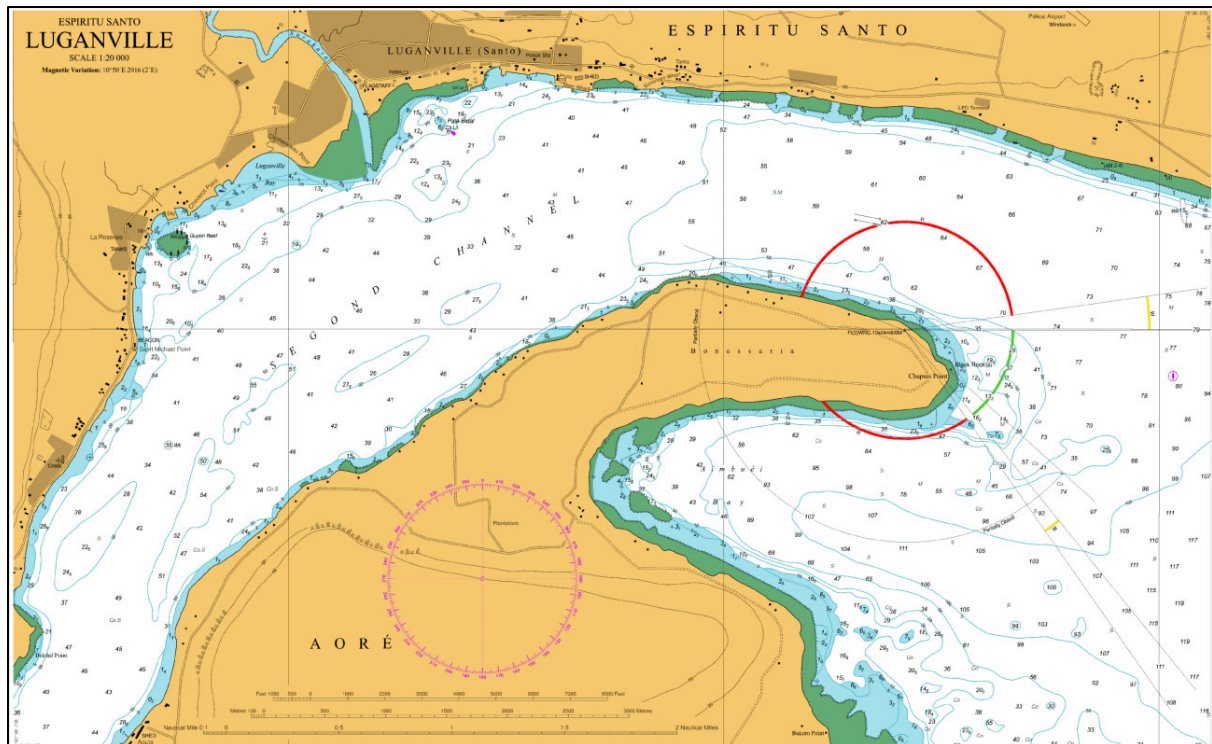
Figure 1: Chart BA 1638\_2 of Luganville harbour at 1:20,000 scale.

Chart BA 1638\_2 covers Luganville harbour at a scale of 1:20,000 (Figure 1).

Recommendation	Amount (vatu)
5. Acquisition by the government of the land title so that trees that obstruct the sector light on Aore east can be cut (Figures 1 and 4).  Latitude: 15-32.004234S; Longitude:167-12.832535E	0
