Pacific Safety of Navigation Project

Risk assessment for Namukulu and Avatele harbours, Niue

November 2019

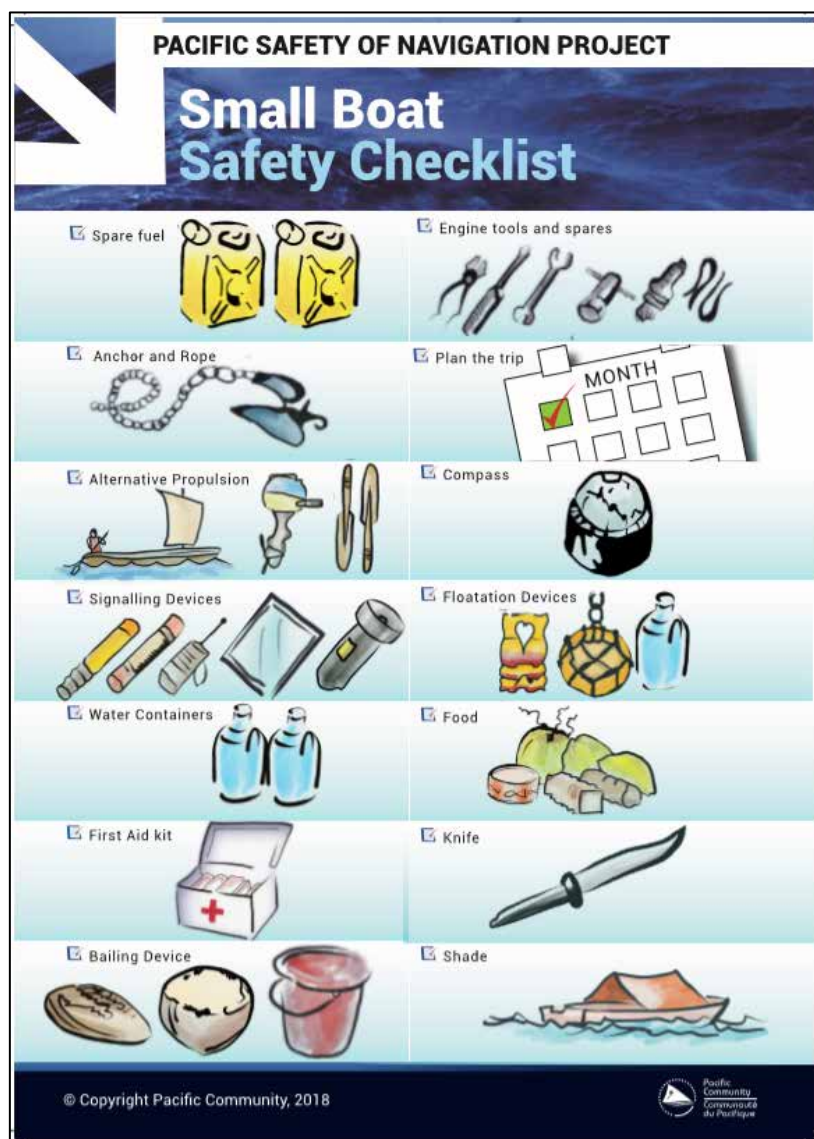
This recommendation addresses the potential grounding of a dinghy or vaka on the reef during the day at the channel entrance to Namukulu while returning to shore. A lack of regular vessel maintenance and proper engine checks and safety equipment before trips is a major concern.

It is recommended that laminated safety checklists or stickers (shown below) be provided to all local fishermen in the Namukulu area. It is also recommended that the small boat safety awareness programme be enhanced, and that the Niue Fisheries Department conduct outboard maintenance programmes and random spot checks. The guidance from the checklist and awareness programme should potentially help locals to reduce the risk to as low as reasonably practicable.

Action	Cost to implement (NZD)
Distribute safety checklists and/or stickers	500
