# RECOMMENDATIONS FOR DESIGN OF A COASTAL PROTECTION SYSTEM FOR SHORELINE PROTECTION YAREN DISTRICT, REPUBLIC OF NAURU (RON)

*May 2001*

*SOPAC Technical Report 317*

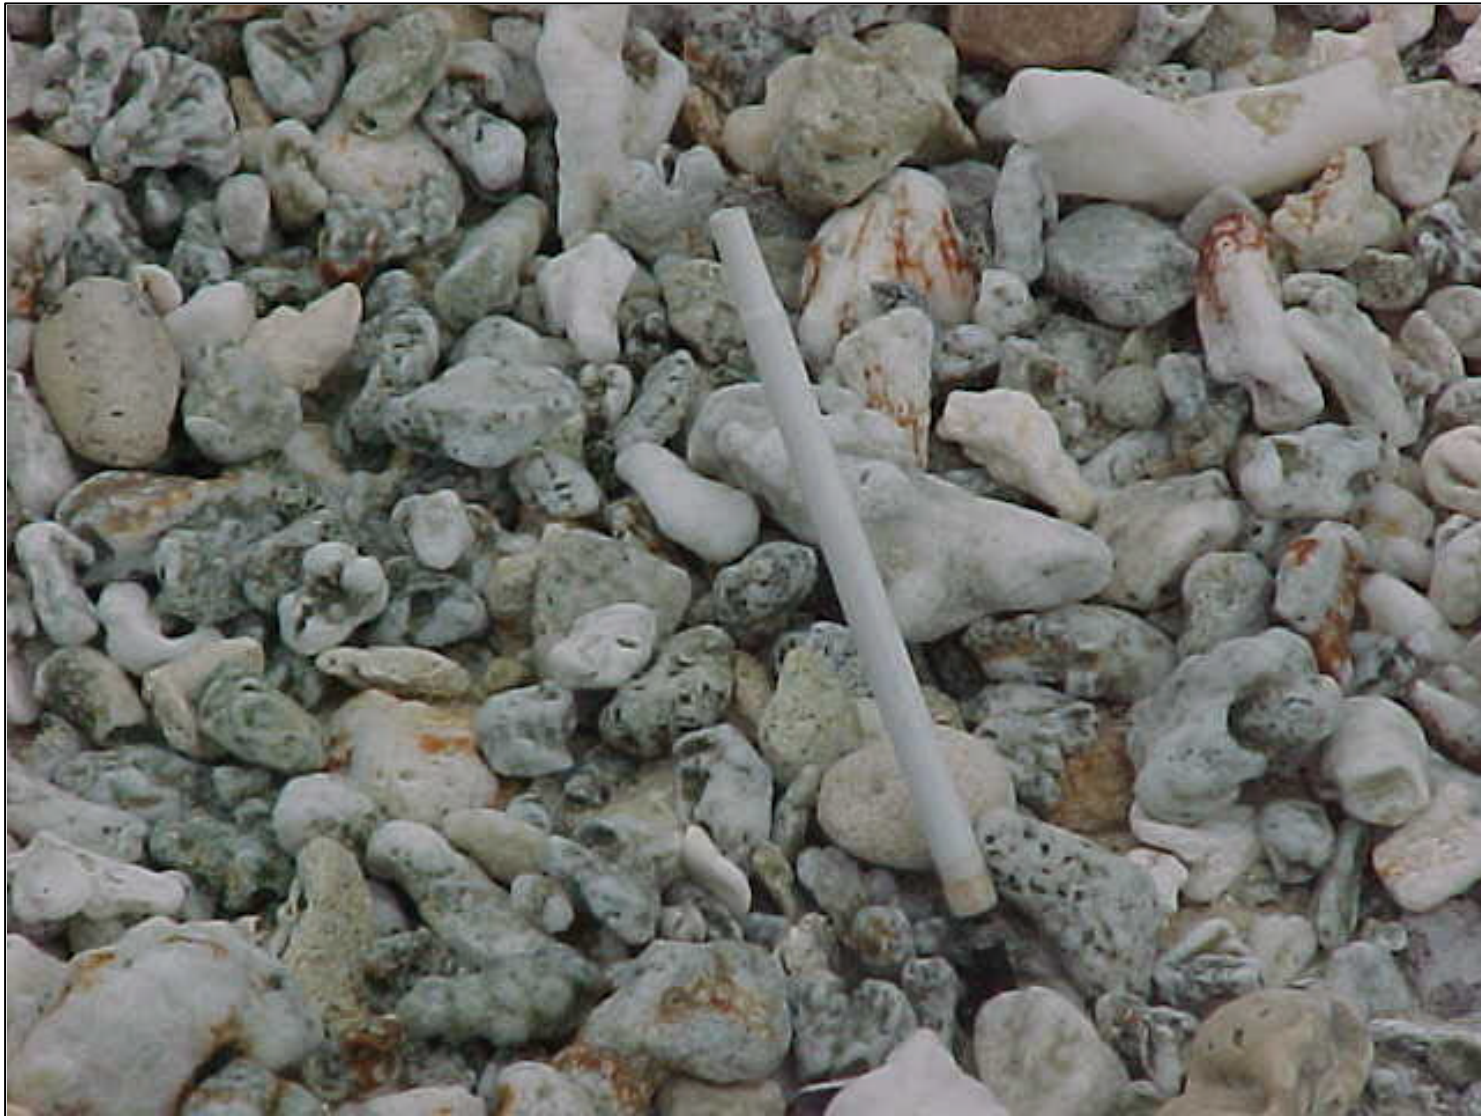
- all of these boulders are typical cavernous, dolomite limestone;
- the interface of the lower beach and backreef area is a depositional site for medium to coarse gravel (Figure 8);

- all gravel fragments have a high aspect ratio (Figure 8).

*Figure 8. Carbonate gravel deposited along the lower beach. Note pen for scale.*

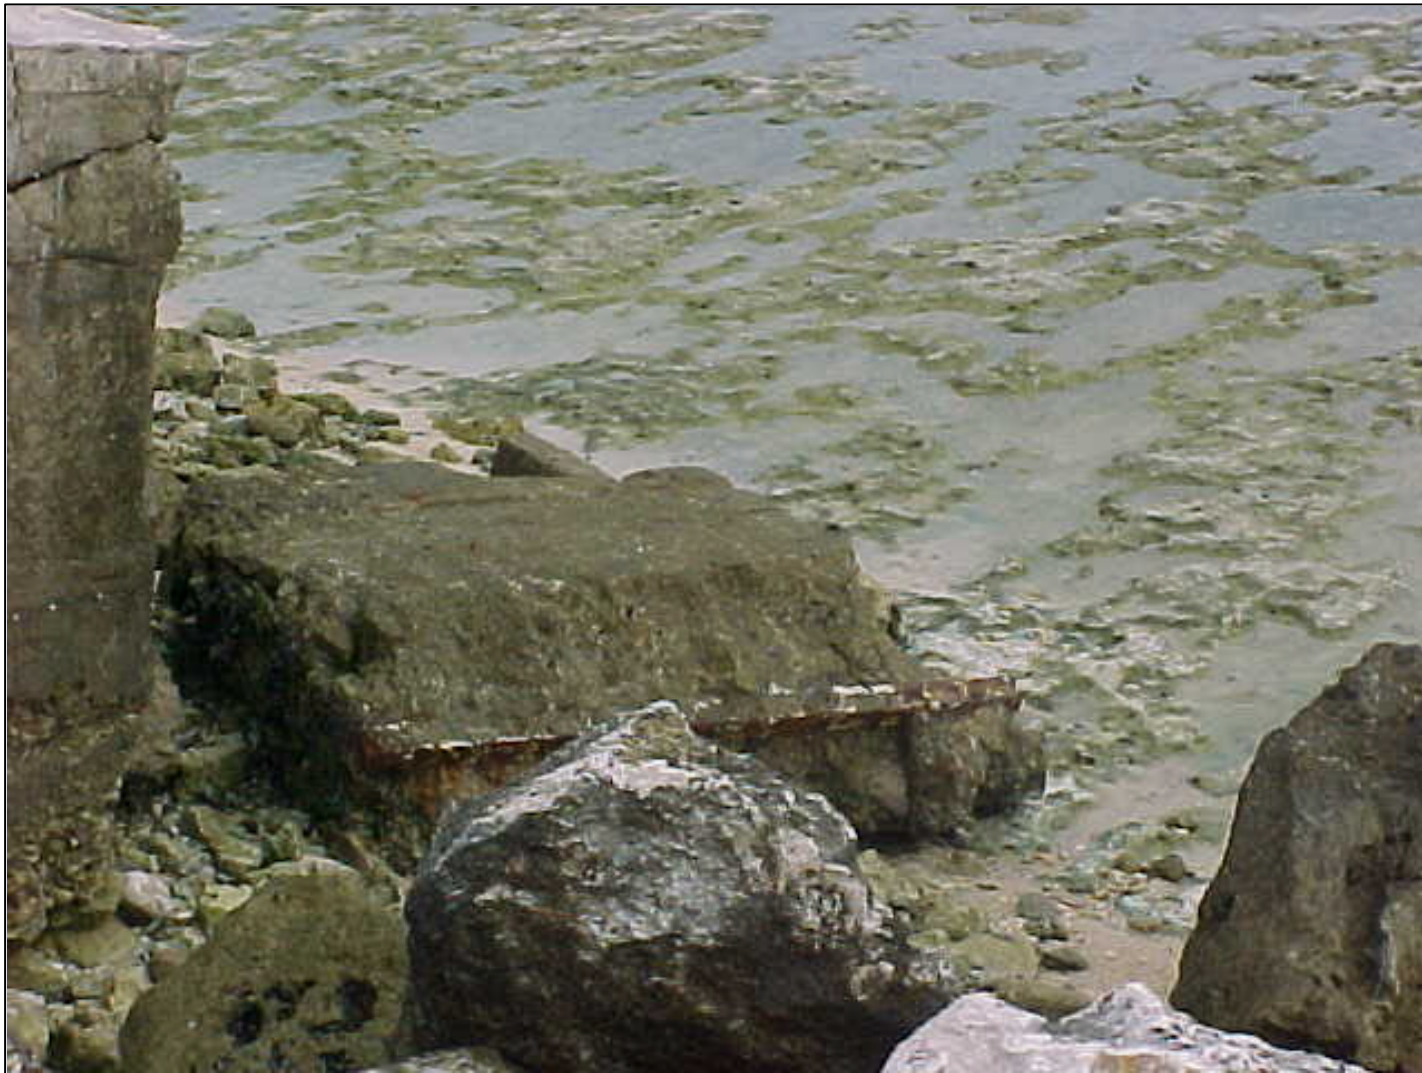
- the lower beach and backreef areas are 50 % covered with green filamentous algae (Figures 9 and 10);
- these indicate polluted and/or eutrophic (nutrient-enriched) waters; and
- macrobenthic species are common on the beach and backreef and include green algae, red algae, sea cucumbers; sea urchins and molluscs (Figure 11) attached to rock substrate.

*Figure 9. Filamentous green algae covering the backreef area.*

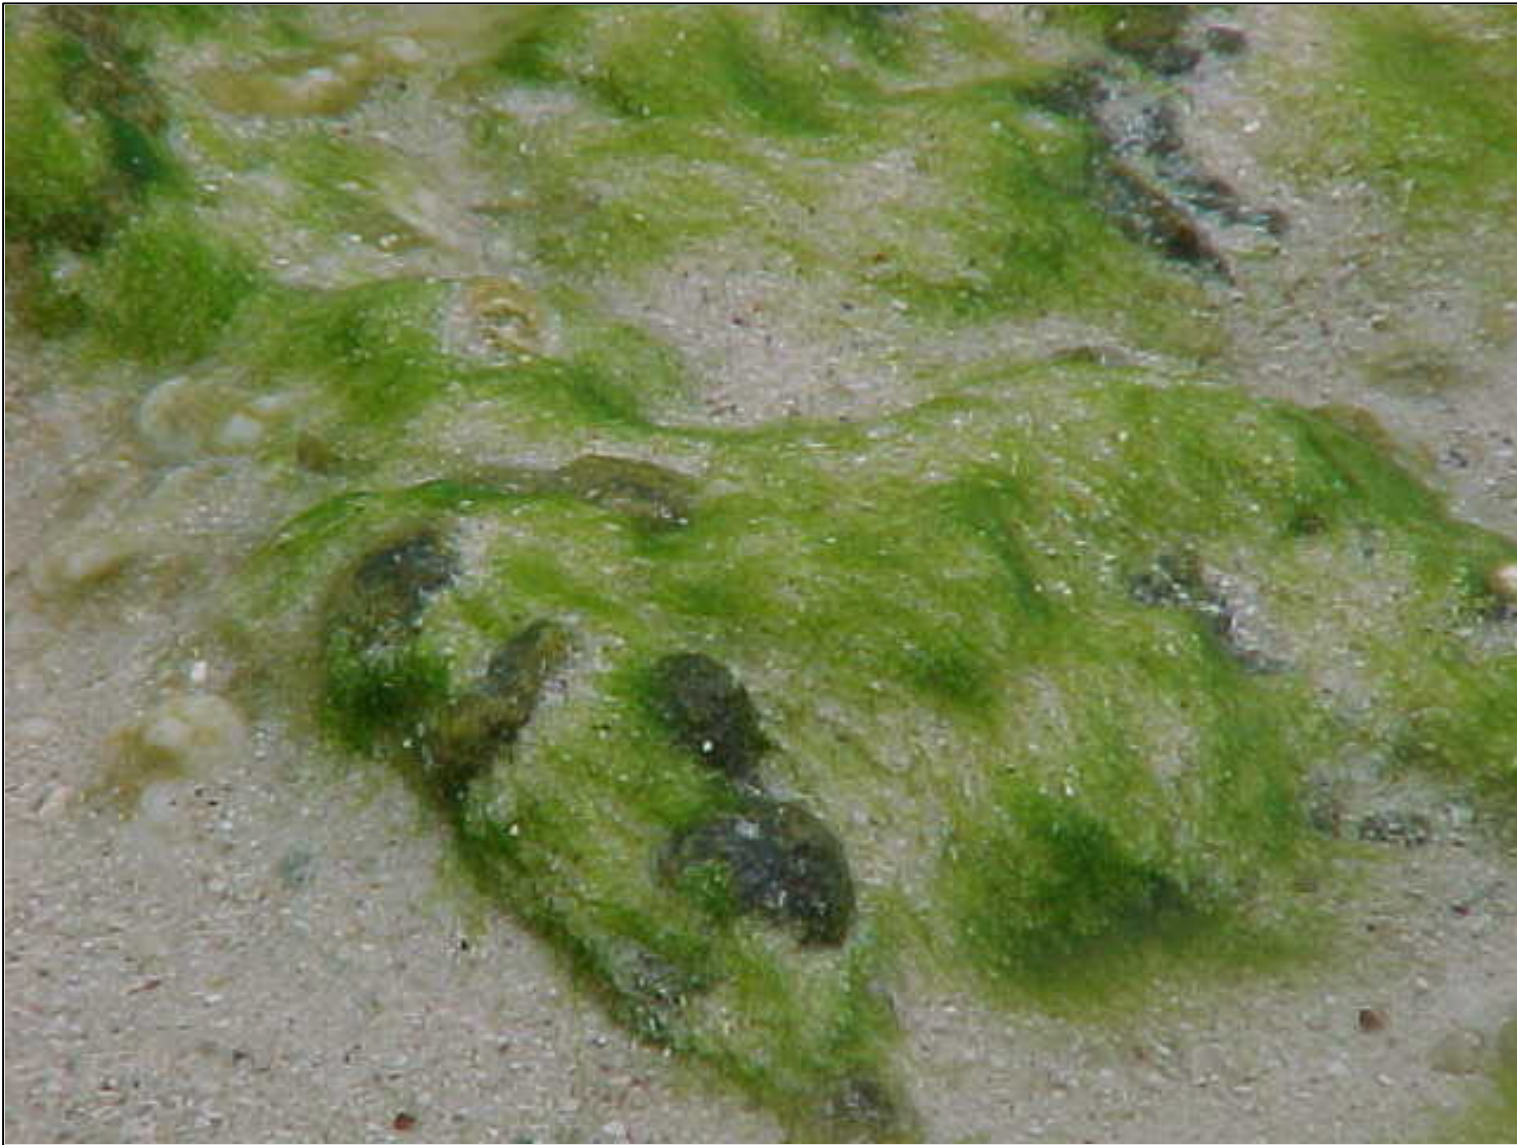
*Figure 10. Filamentous green algae on underlying limestone bedrock.*

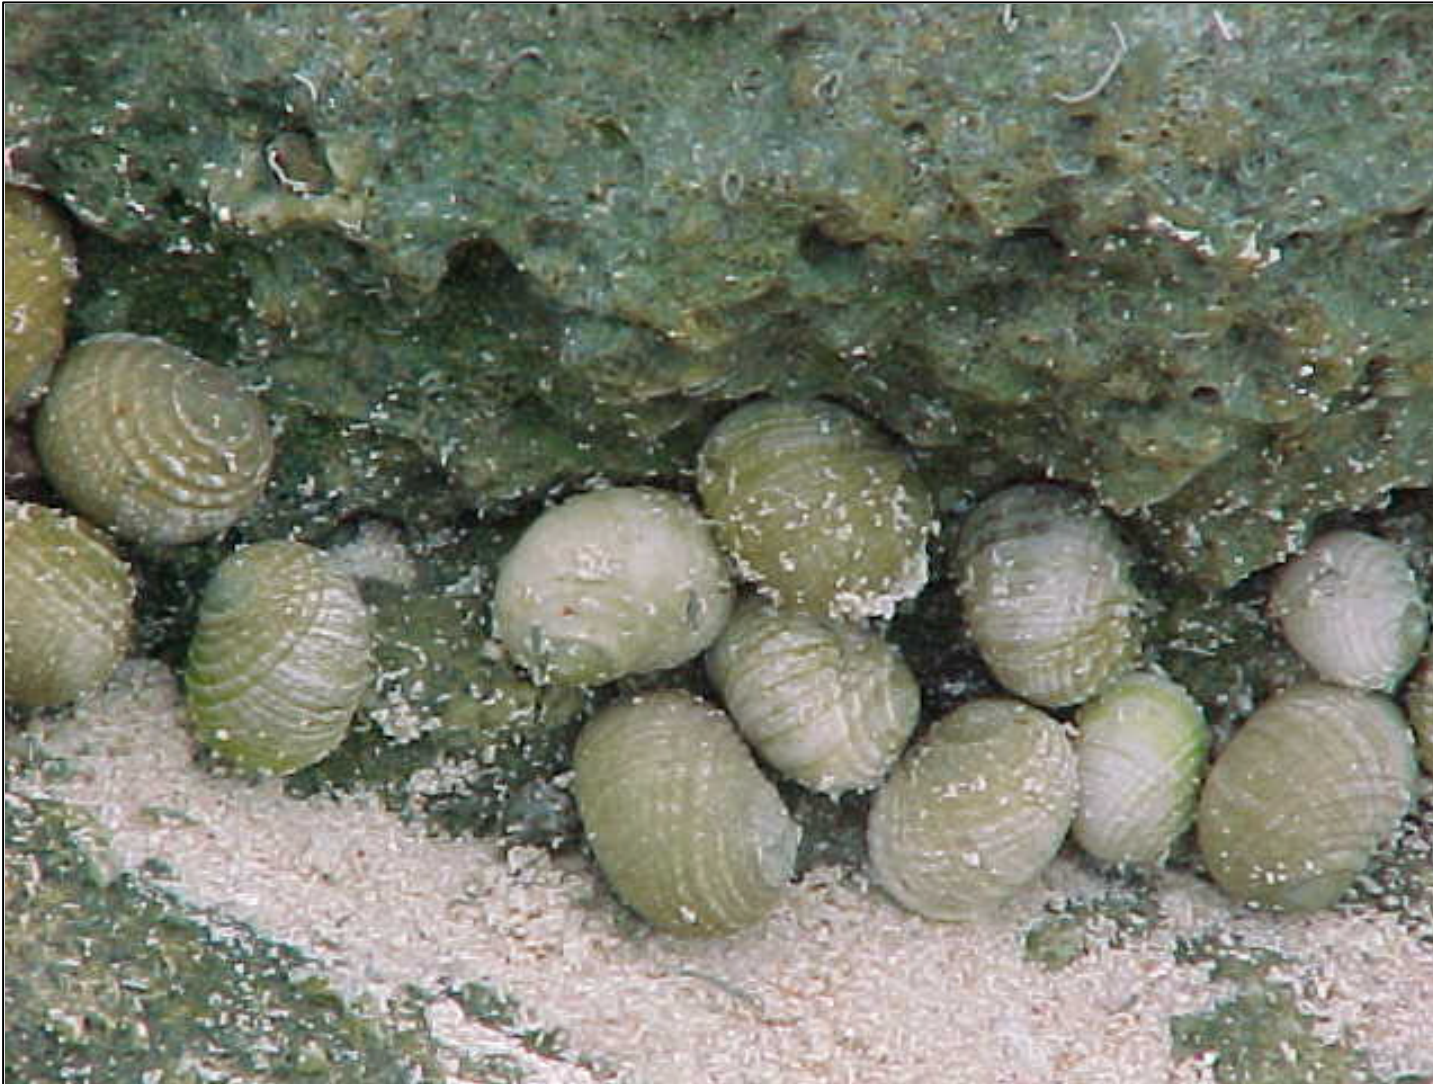
*Figure 11. Molluscan fauna on limestone substrate on the lower beach.*

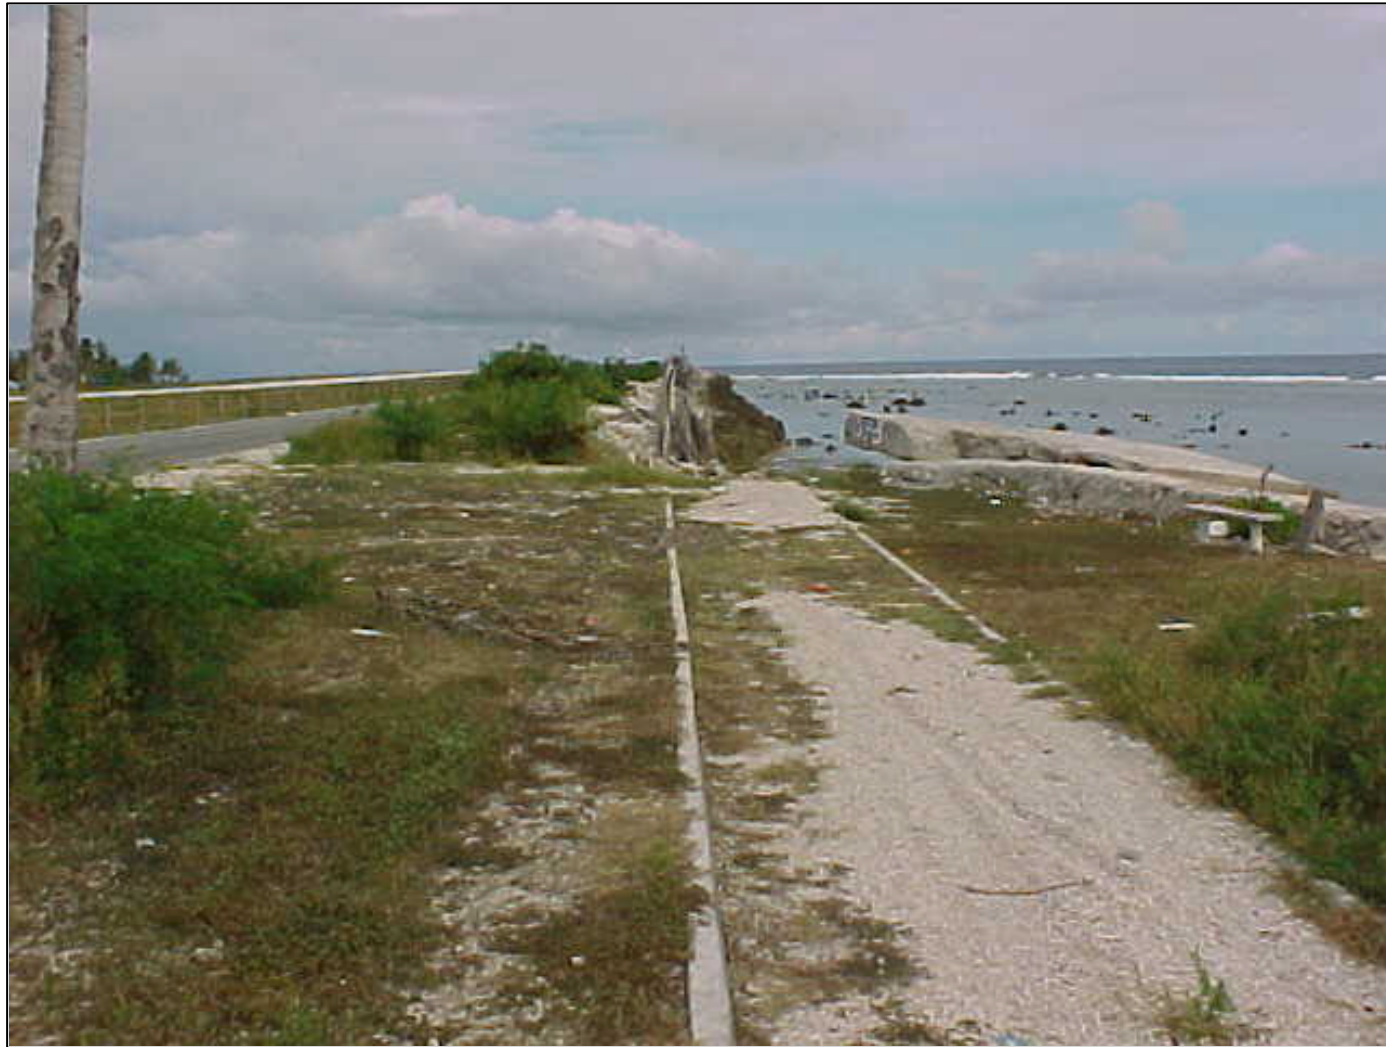
- Figures 13 and 14 show the airport reclamation and fill site;
- note the rip-rap revetment protecting the reclaimed site (Figure 15);
- the rip-rap is made of dolomitic limestone from Nauru;
- note also the green brown algae covering boulders in Figure 15;
- Figure 16 shows part of an old, almost vertical (85°), 1.65 m high and 0.75 m wide (at the top) masonry retaining wall at the problem site. Note strewn 0.30 m diameter, limestone boulders from damaged wall sections (also Figure 17);
- sand and fine gravel are deposited between boulders;

*Figure 13. Location of the airport fill site.*

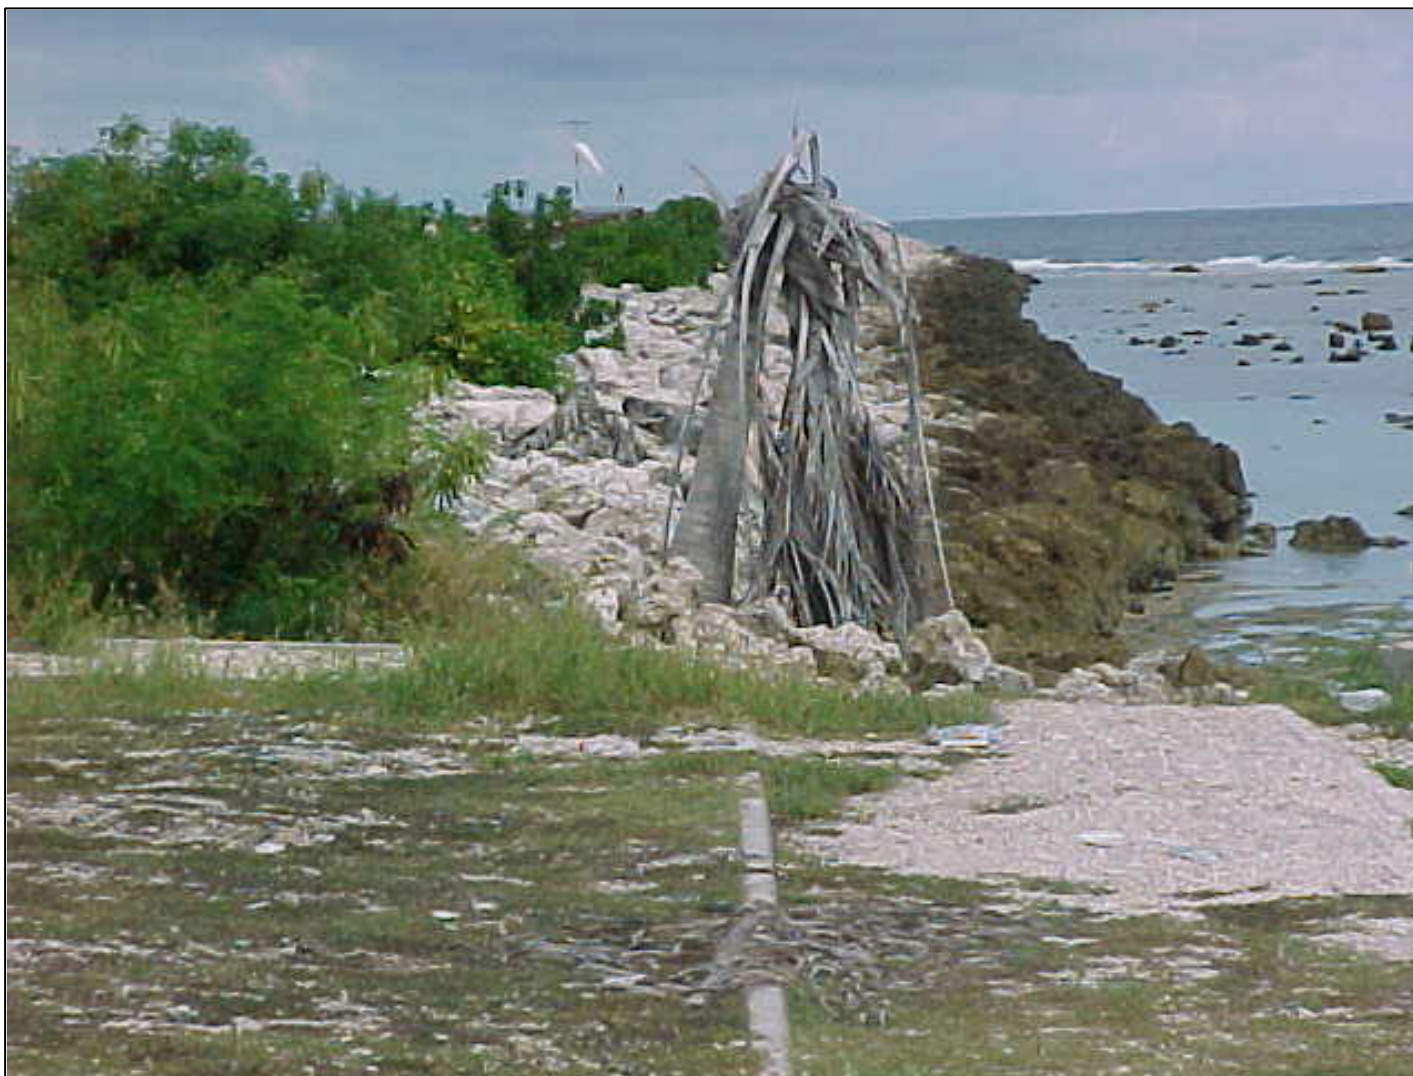
*Figure 14. Details of the fill protection using rip-rap revetment.*

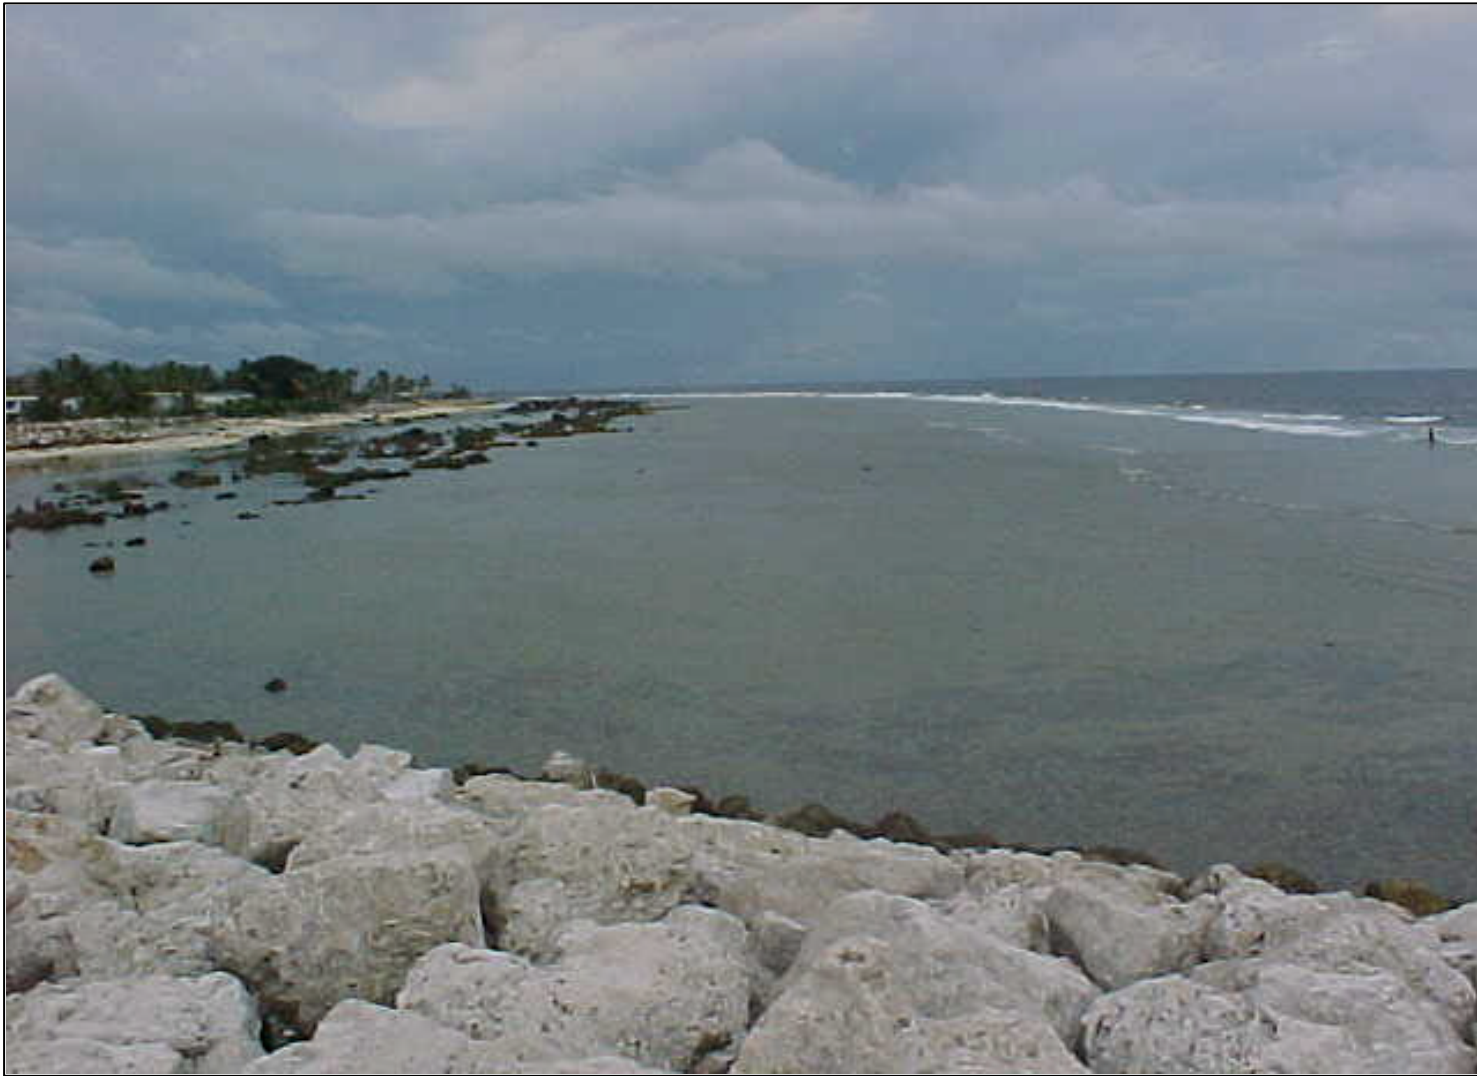
*Figure 28. View looking east of the coastline at the airport fill site. Note rip-rap in foreground.*

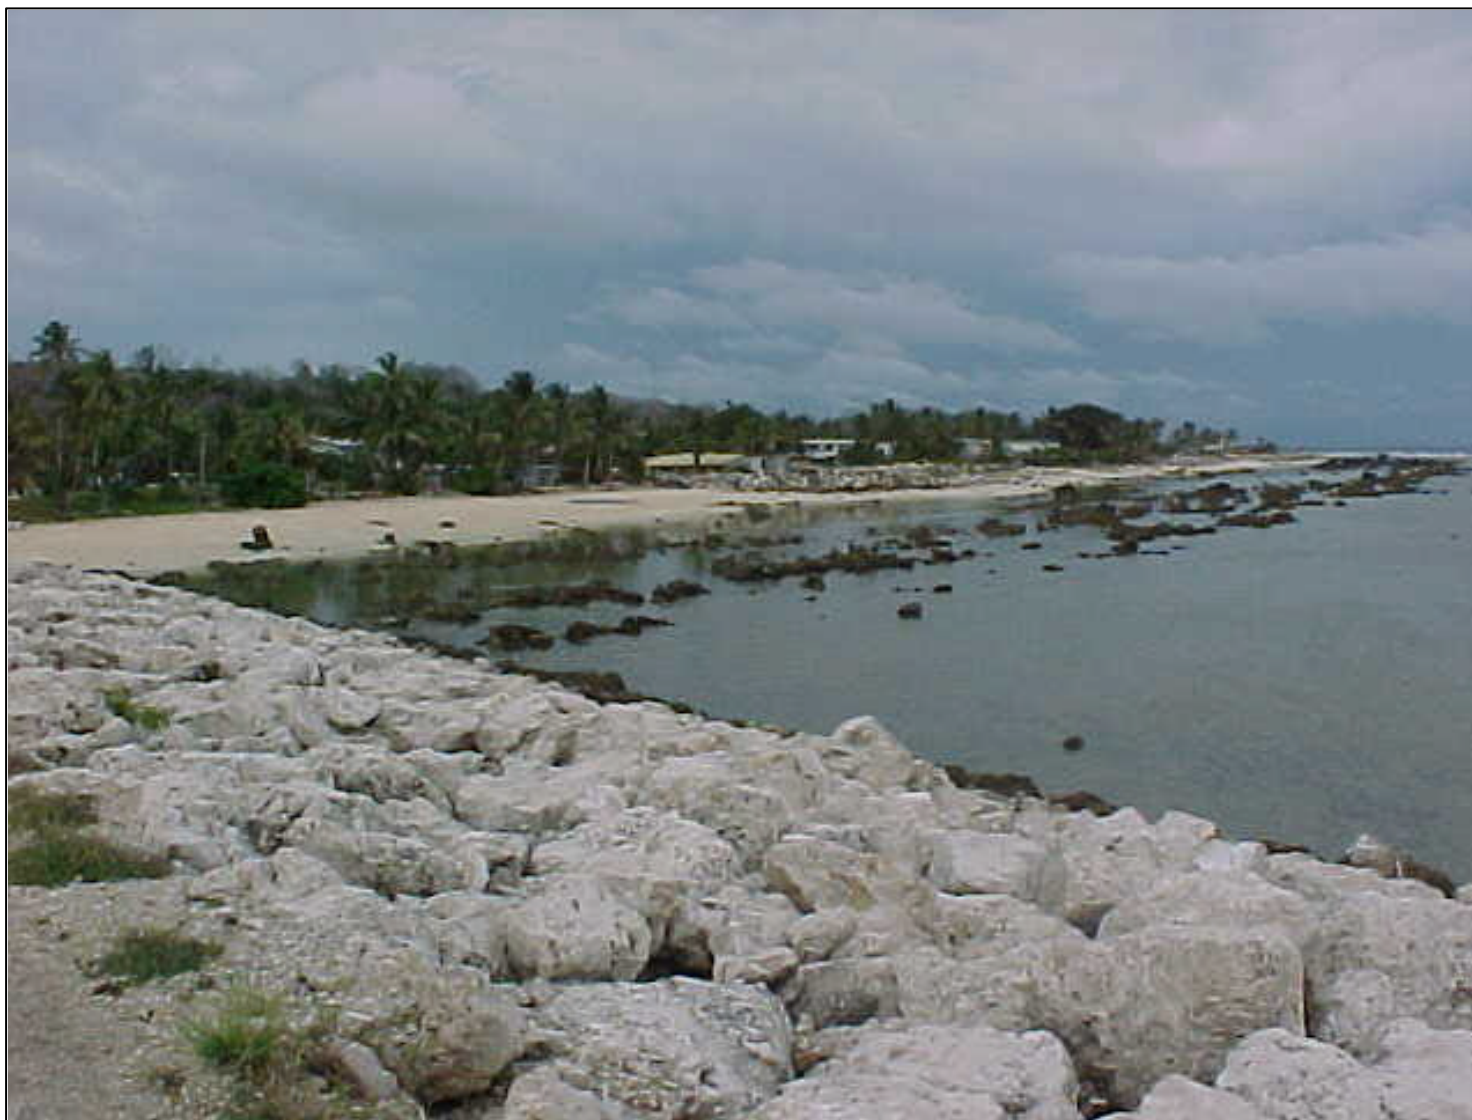
- from Figure 29 one can assess the extent of the reclamation and fill project, into the marine area, is about 175 m at its southern most point/seaward extremity;

*Figure 29. View looking east of the beach at the airport fill site. Note the change in orientation of the natural and built coastline.*

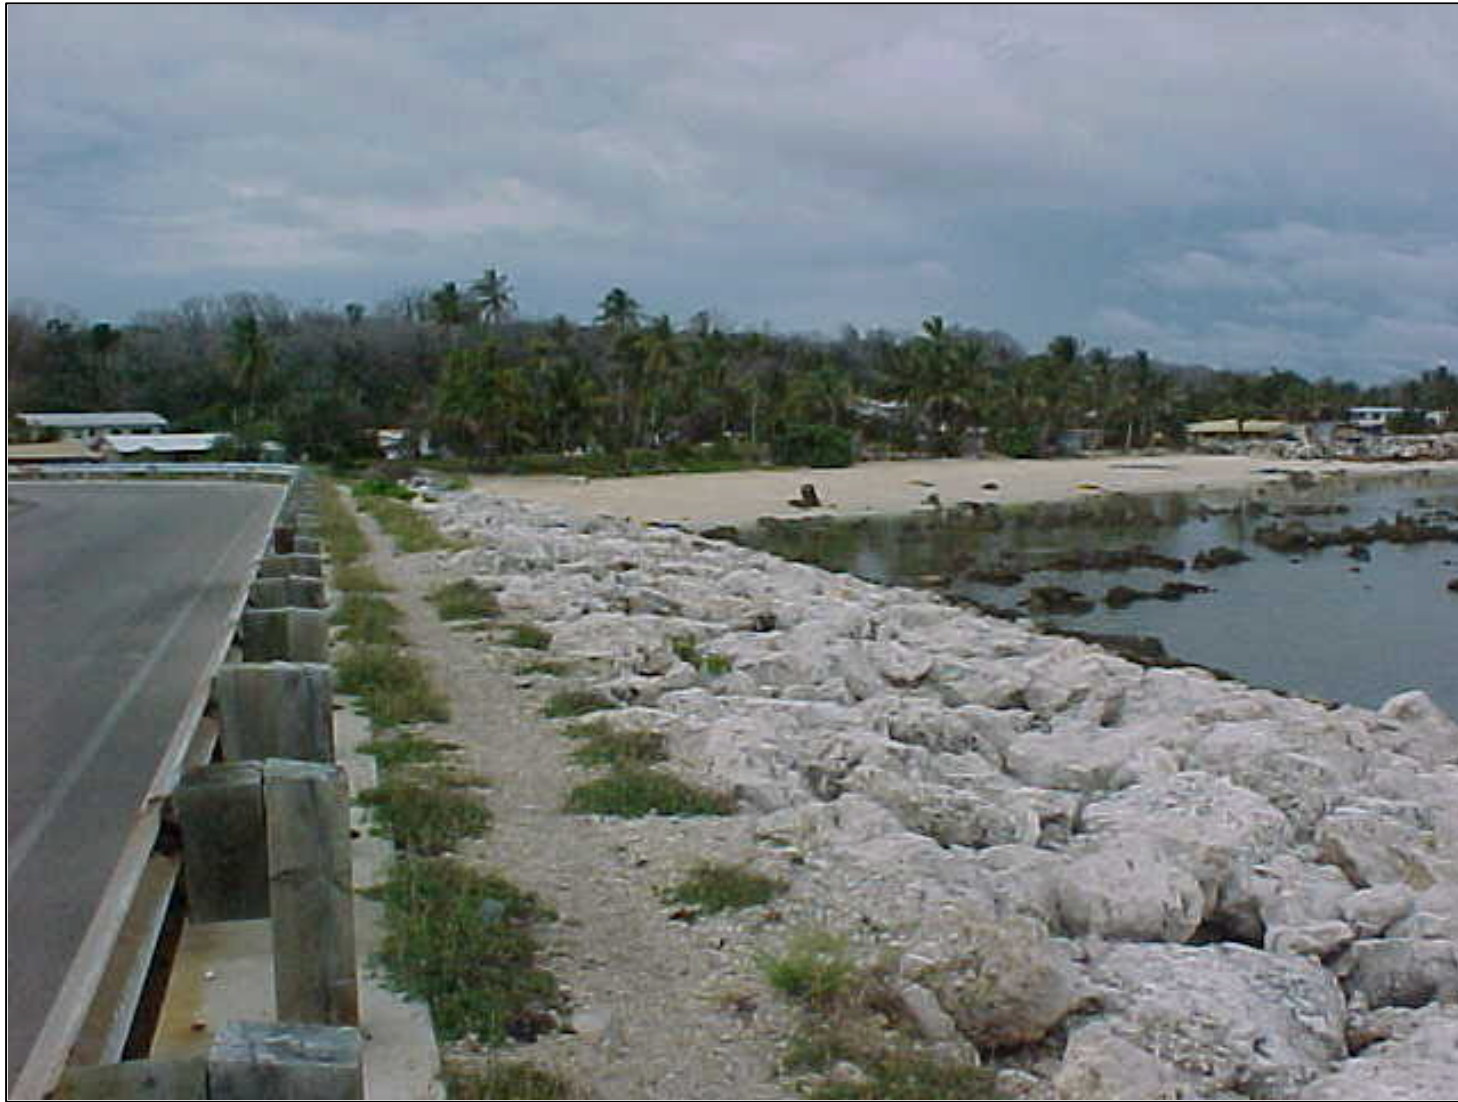
Figure 30. View looking north-northeast showing the rip-rap revetment protecting the airport and coastal roadway. Note limestone pinnacles in the surf zone (to the right).

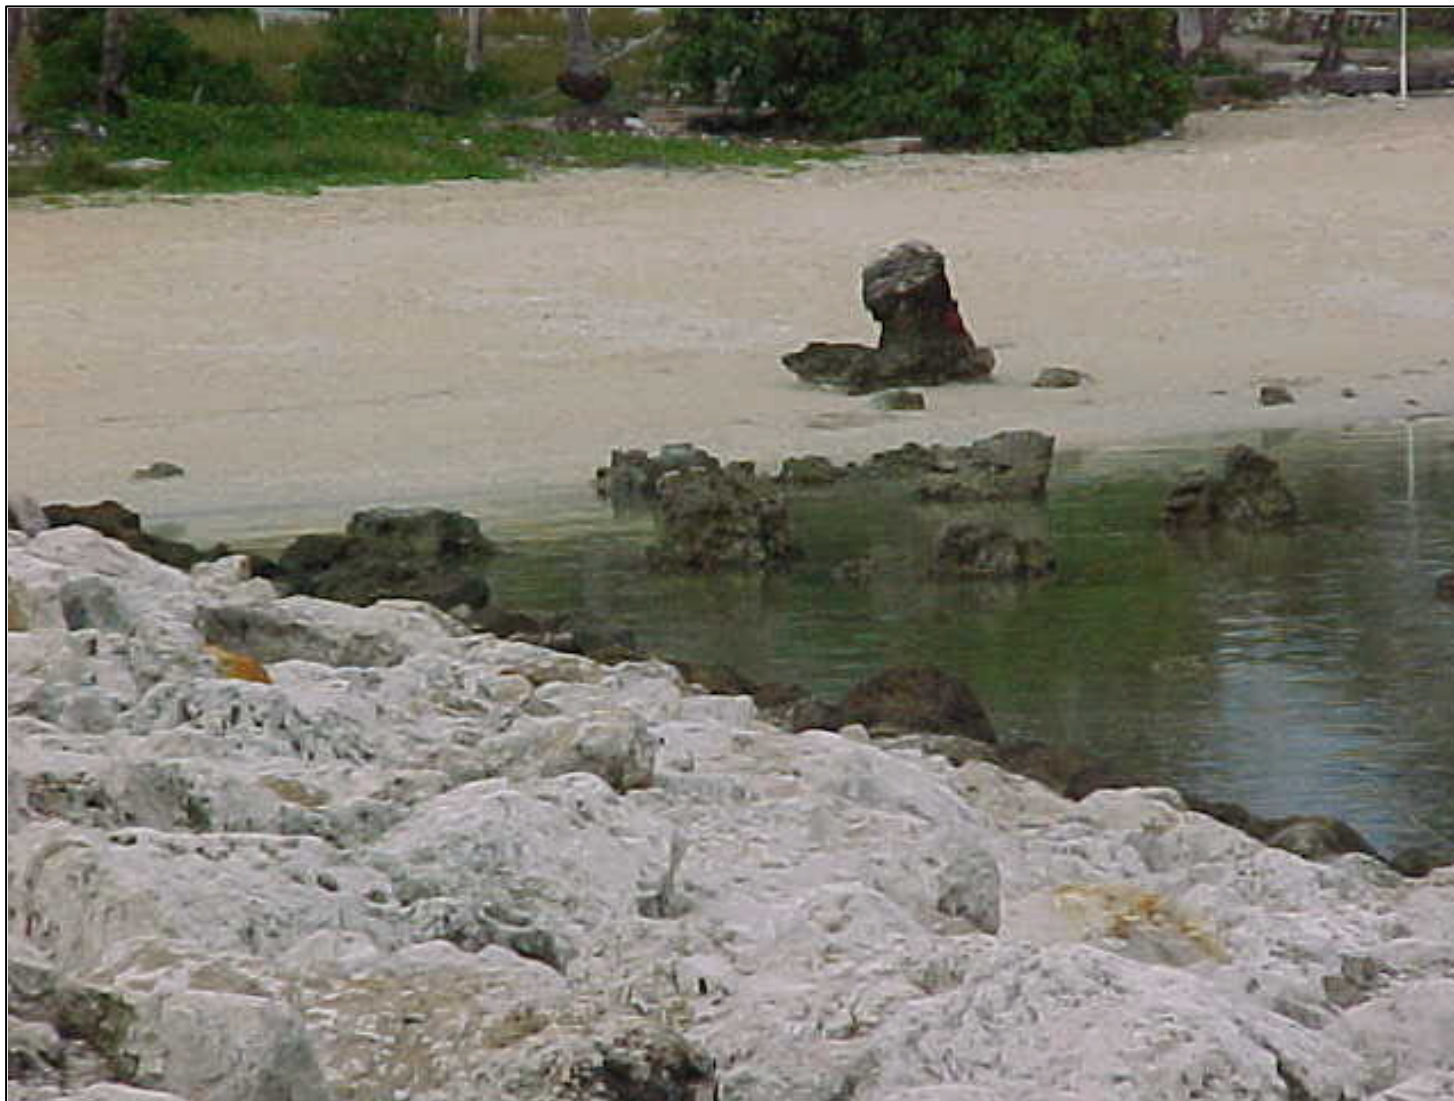
*Figure 31. Details of Figure 30, showing the gentle, carbonate sandy beach and limestone pinnacle.*
