Pacific Safety of Navigation Project

Risk assessment for Port Vila harbour, Vanuatu

March 2019

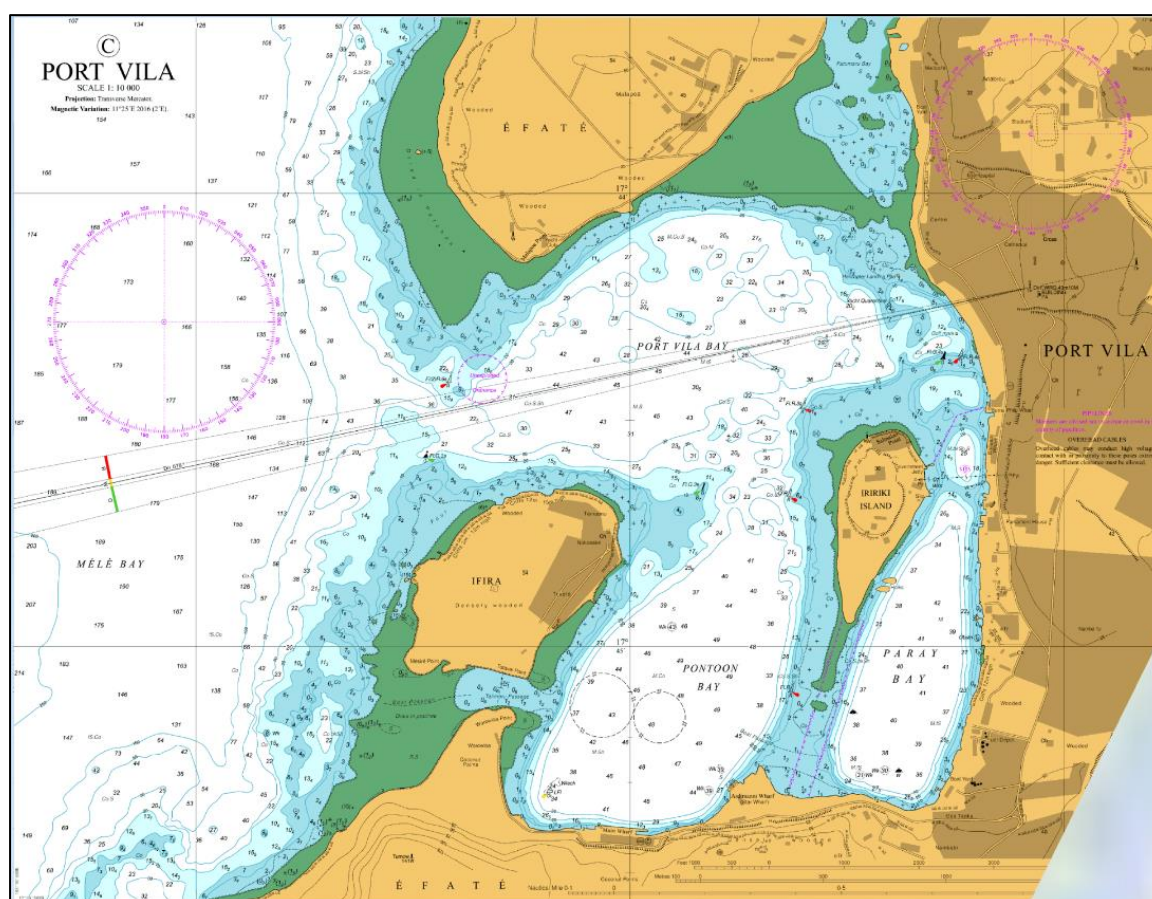
Figure 1. Chart of Port Vila harbour at 1:10,000 scale.

Visibility can be reduced to 0.1 nautical miles in bad weather, which normally occurs between the months of November and April. There are several hazards such as buoys, wrecks, shoals and a narrow and shallow passage that can pose problems for maritime traffic.
