# ESTABLISHMENT OF BEACH PROFILES FOR NAURU

May 2001

SOPAC Preliminary Report 132

This report presents the basic results of only the beach profiling of this project. A detailed discussion and data analysis will be provided in SOPAC Technical Report 323.

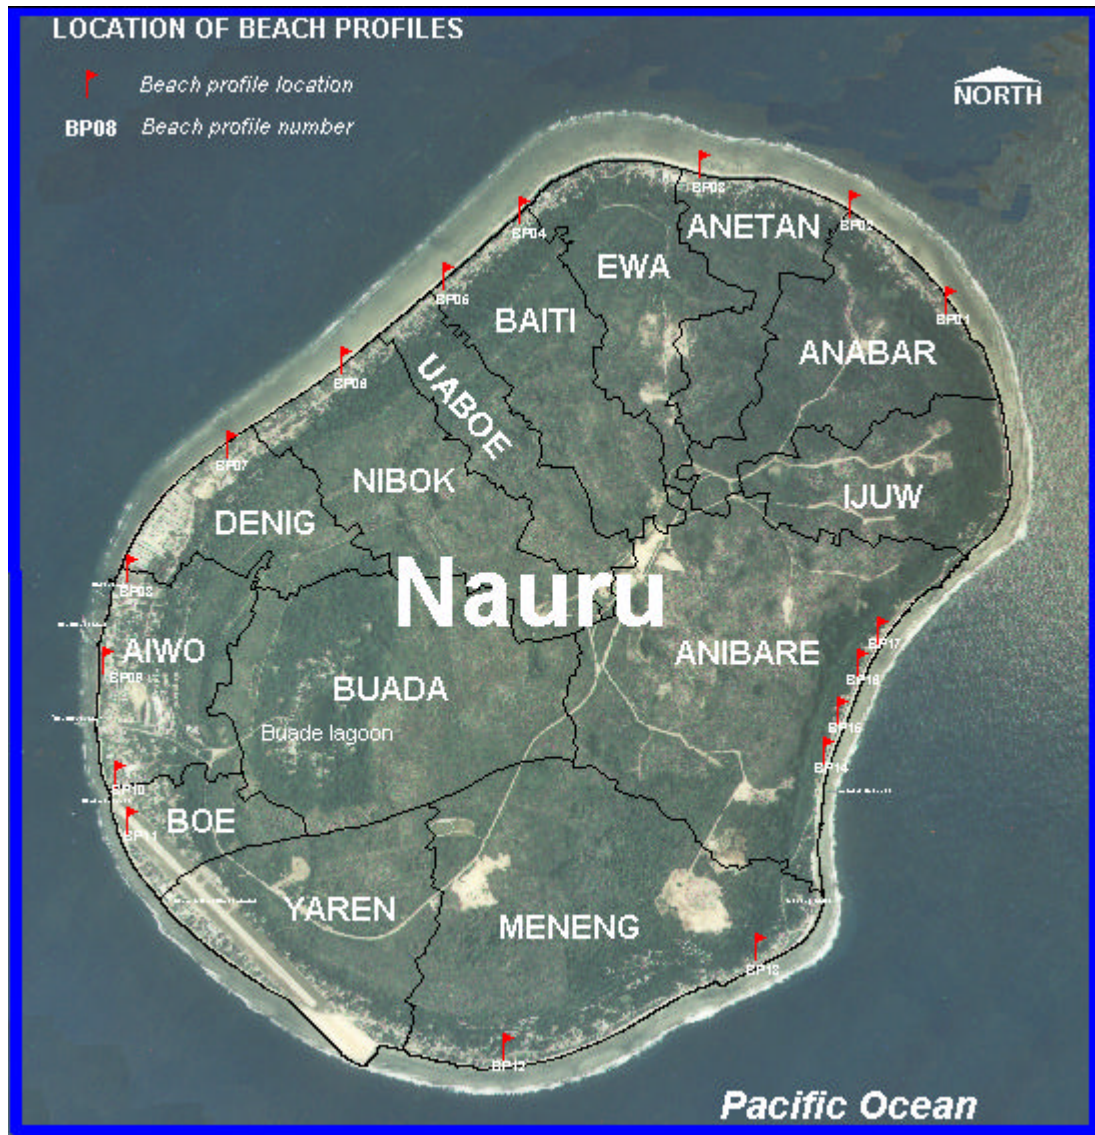
Figure 2. The MapInfo GIS format aerial photography of Nauru, showing the locations of beach profiles.

In developing a coast GIS for Nauru, the 1992 aerial photography was converted into MapInfo GIS format and all control points were geo-coded and plotted on the MapInfo GIS format aerial photography (Figure 2). These data are stored in digital format in SOPAC database.

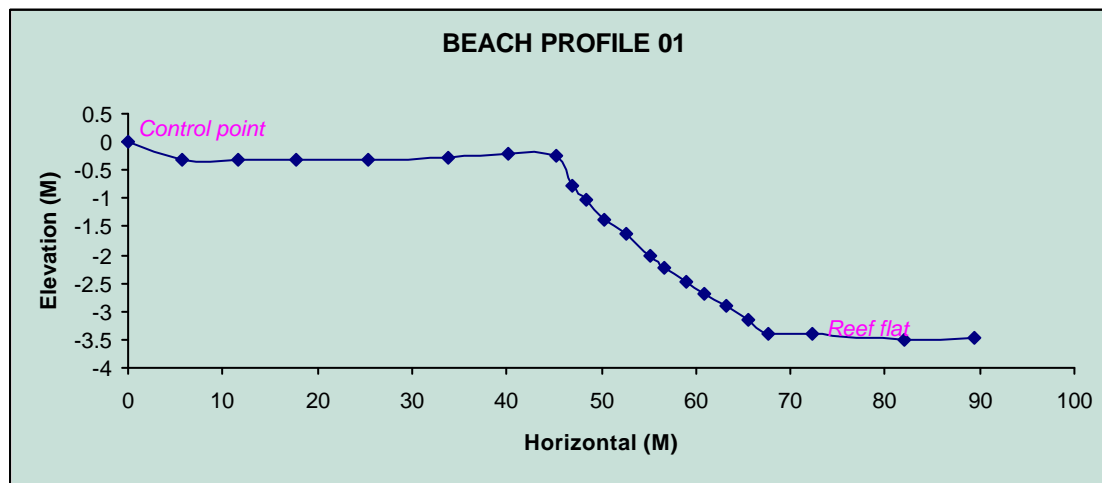
Location: Anabar, Nauru Island  
 Control Point: Basement of Power pole 102  
 Position: 00°30'04"S 166°57'15.5E  
 Bearing: 42°

Horizontal	Elevation
0	0.001
5.771	-0.304
11.642	-0.329
17.729	-0.326
25.4	-0.328
33.905	-0.265
40.071	-0.212
45.156	-0.245
46.876	-0.77
48.454	-1.009
50.333	-1.39
52.72	-1.622
55.207	-2.002
56.66	-2.23
59.037	-2.468
60.874	-2.600
63.11	-2.903
65.527	-3.166
67.598	-3.41
72.377	-3.381
82.061	-3.518
89.443	-3.473

Beach slope: 7.4 °

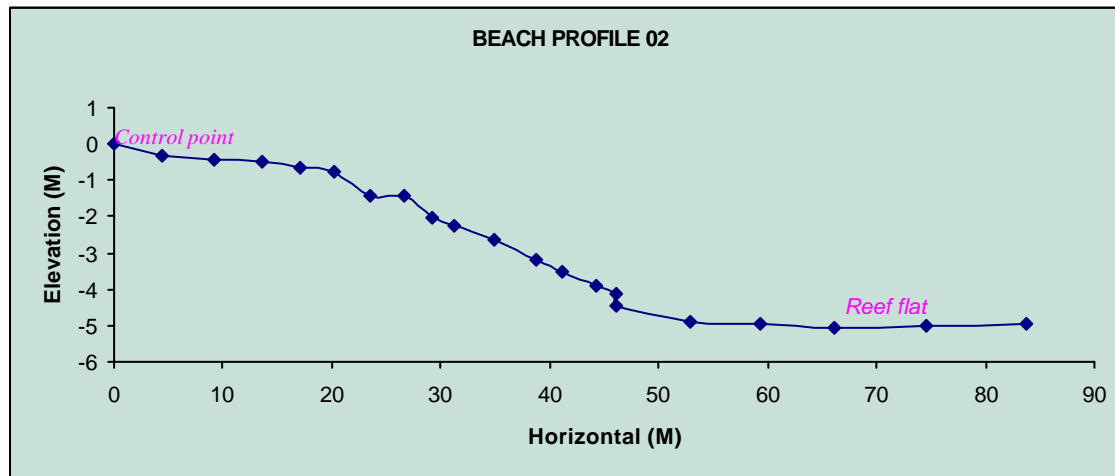
**Location:** Anabar, Nauru Island  
**Control Point:** Basement of Power pole 122  
**Position:** 00°30'17.3"S 166°56'54.9E  
**Bearing:** 26°

Horizontal	Elevation
0.001	0.003
4.357	-0.329
9.195	-0.436
13.648	-0.498
17.007	-0.661
20.286	-0.737
23.484	-1.434
26.607	-1.438
29.147	-2.054
31.171	-2.249
34.872	-2.663
38.747	-3.179
41.067	-3.541
44.348	-3.898
46.149	-4.136
46.187	-4.459
52.937	-4.895
59.364	-4.945
66.138	-5.052
74.621	-5.001
83.757	-4.939

Beach slope:  $8.2^{\circ}$

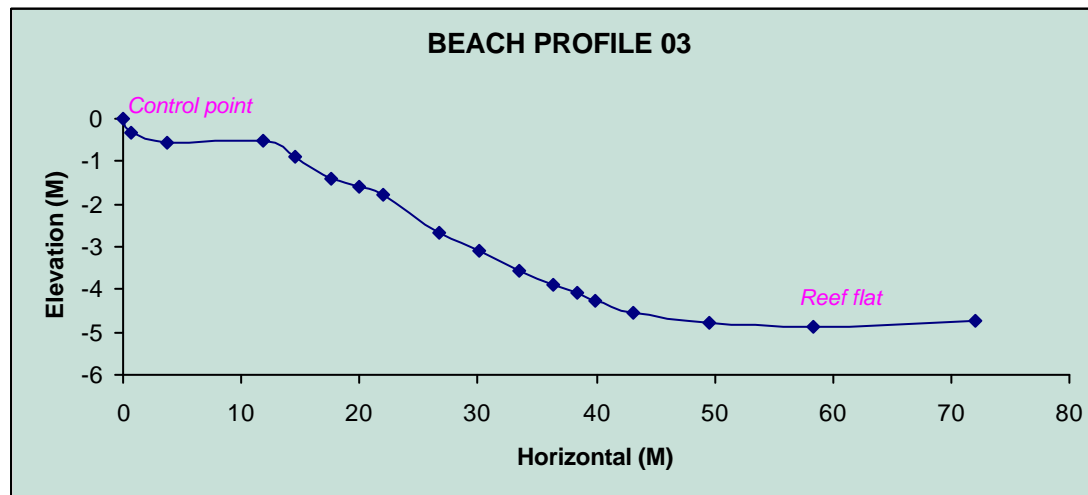
**Location:** Anetan, Nauru Island  
**Control Point:** Basement of Power pole 122  
**Position:** 00°30'12.0"S 166°56'24.8E  
**Bearing:** 358°

Horizontal	Elevation
0.001	0
0.647	-0.347
3.653	-0.585
11.755	-0.539
14.564	-0.9
17.559	-1.384
20	-1.588
22.055	-1.773
26.647	-2.684
30.179	-3.092
33.561	-3.563
36.411	-3.903
38.408	-4.098
39.934	-4.289
43.083	-4.57
49.532	-4.783
58.365	-4.852
72.106	-4.739

Beach slope: 7.3 °

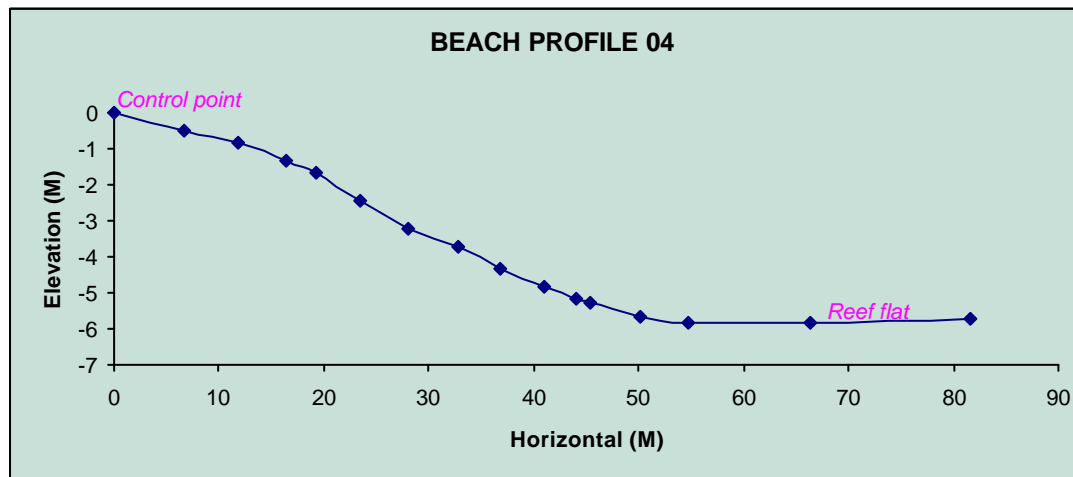
**Location:** Bairi, Nauru Island  
**Control Point:** Western corner of RAD Restaurant  
**Position:** 00°30'24.3"S 166°55'50.0E  
**Bearing:** 292°

Horizontal	Elevation
0.001	0
6.712	-0.479
11.917	-0.833
16.42	-1.316
19.204	-1.673
23.397	-2.431
28.073	-3.233
32.84	-3.736
36.772	-4.313
40.973	-4.816
43.954	-5.147
45.437	-5.257
50.064	-5.658
54.747	-5.812
66.388	-5.842
81.595	-5.706

Beach slope: 7.4 °

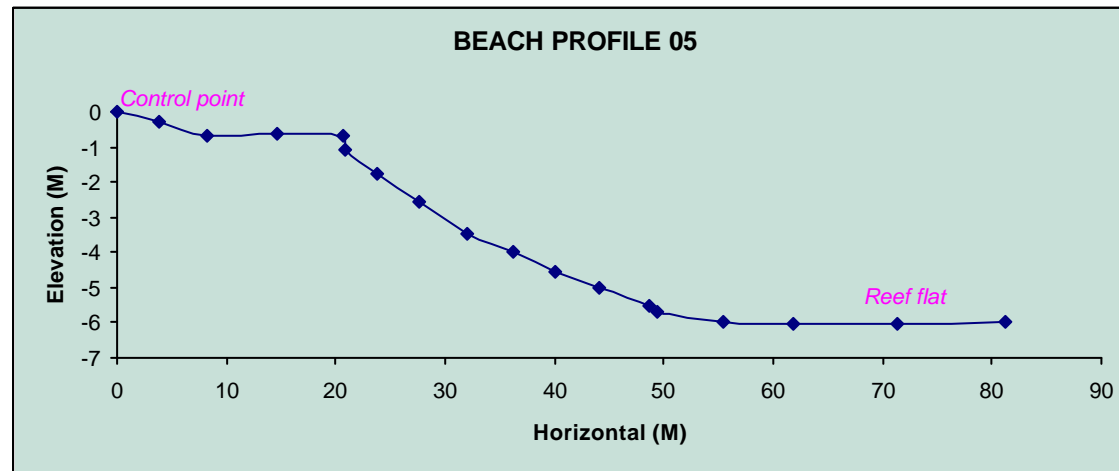
**Location:** Baiti, Nauru Island  
**Control Point:** Western corner of Mr Jezza Dowiyogo's property  
**Position:** 00°30'38.7"S 166°55'36.6E  
**Bearing:** 300°

Horizontal	Elevation
0	0
3.902	-0.26
8.3	-0.669
14.549	-0.606
20.737	-0.666
20.779	-1.079
23.741	-1.777
27.674	-2.572
32.09	-3.484
36.17	-3.994
40.103	-4.561
44.036	-5.014
48.673	-5.534
49.422	-5.687
55.467	-5.994
61.852	-6.015
71.304	-6.04
81.284	-5.977

Beach slope: 9.1 °

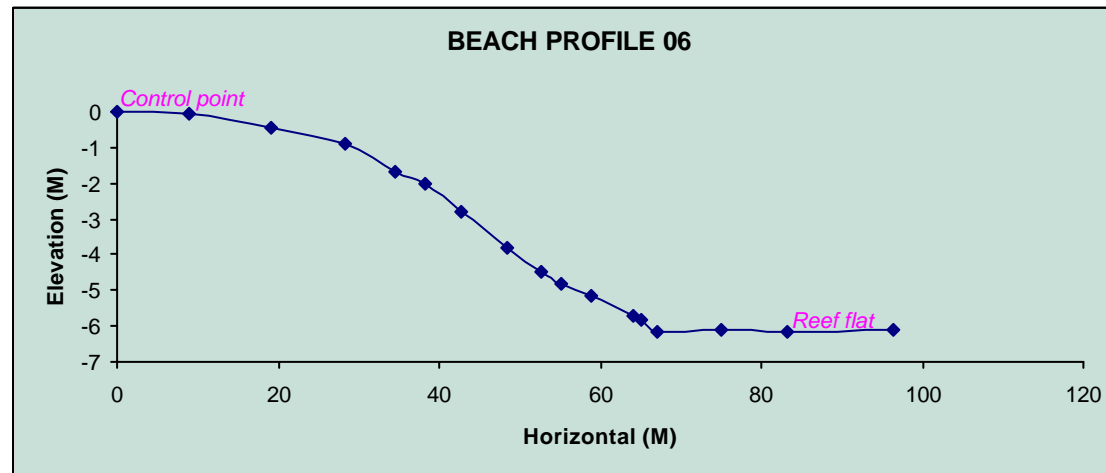
**Location:** Nibok, Nauru Island  
**Control Point:** Southwest corner of Mr Frank Reppaa's proerty  
**Position:** 00°30'58"S 166°55'18.5E  
**Bearing:** 317°

Horizontal	Elevation
0.005	0
9.009	-0.042
19.207	-0.449
28.393	-0.913
34.558	-1.663
38.369	-2.022
42.849	-2.823
48.392	-3.817
52.781	-4.471
55.265	-4.799
58.947	-5.175
64.037	-5.714
65.017	-5.845
67.157	-6.158
75.121	-6.078
83.324	-6.152
96.49	-6.121

Beach slope: 7.7 °

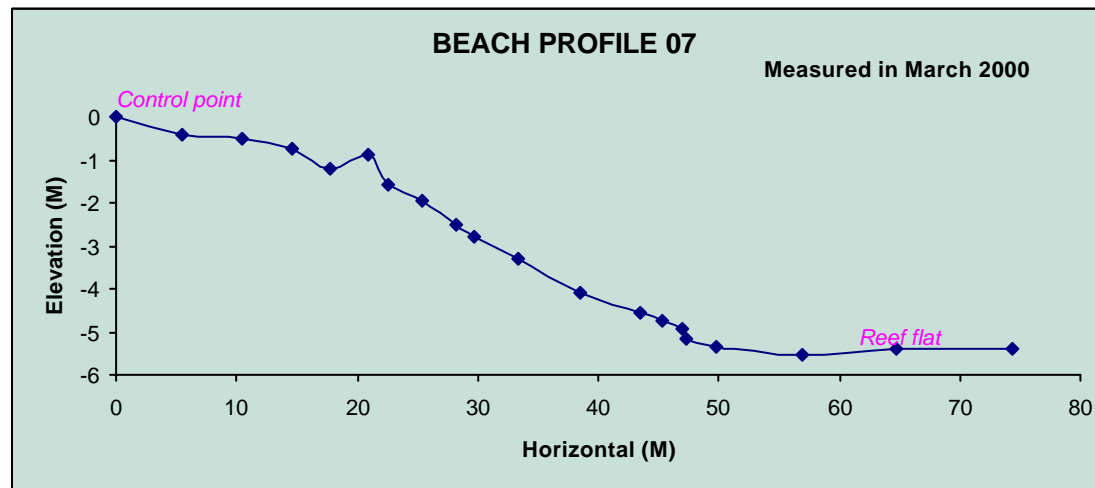
**Location:** Denig, Nauru Island  
**Control Point:** Western corner of CNF building  
**Position:** 00°31'17.1"S 166°54'56.0E  
**Bearing:** 304°

Horizontal	Elevation
0	0
5.425	-0.435
10.413	-0.503
14.577	-0.754
17.805	-1.231
20.934	-0.883
22.603	-1.602
25.339	-1.969
28.167	-2.52
29.719	-2.78
33.283	-3.284
38.528	-4.101
43.548	-4.581
45.317	-4.733
46.92	-4.936
47.241	-5.153
49.798	-5.355
56.864	-5.516
64.749	-5.374
74.281	-5.414

Beach slope: 7.8 °

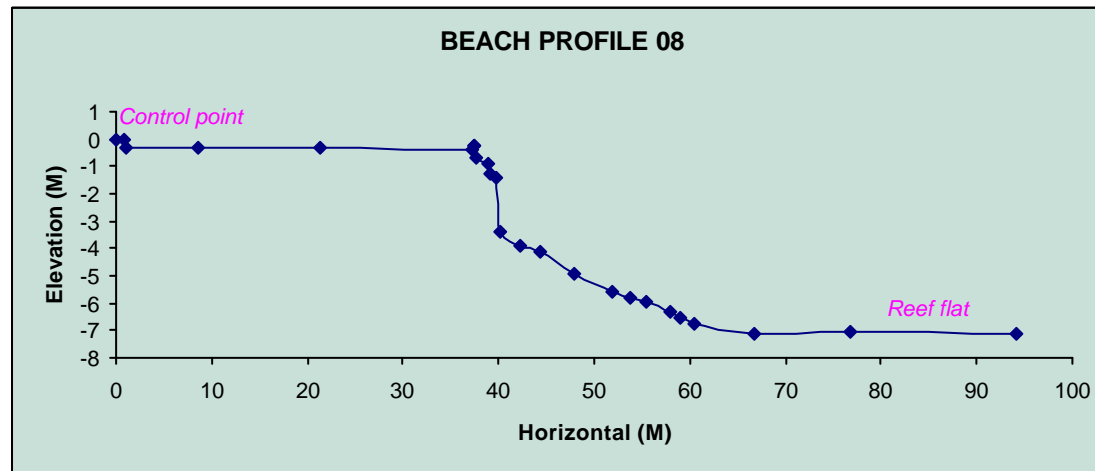
**Location:** Aiwo, Nauru Island  
**Control Point:** Southwest corner of Immigration & Custom Building  
**Position:** 00°31'41.2"S 166°54'38.5"E  
**Bearing:** 273°

Horizontal	Elevation
0.001	0
0.905	0.005
0.964	-0.3
8.515	-0.282
21.405	-0.283
37.337	-0.425
37.348	-0.245
37.518	-0.218
37.616	-0.695
38.972	-0.938
39.135	-1.274
39.797	-1.419
40.247	-3.383
42.327	-3.906
44.389	-4.154
47.976	-4.927
51.885	-5.581
53.8	-5.831
55.411	-5.954
58.014	-6.331
58.936	-6.518
60.366	-6.733
66.762	-7.107
76.787	-7.076
94.222	-7.15

Beach slope: 9.5 °

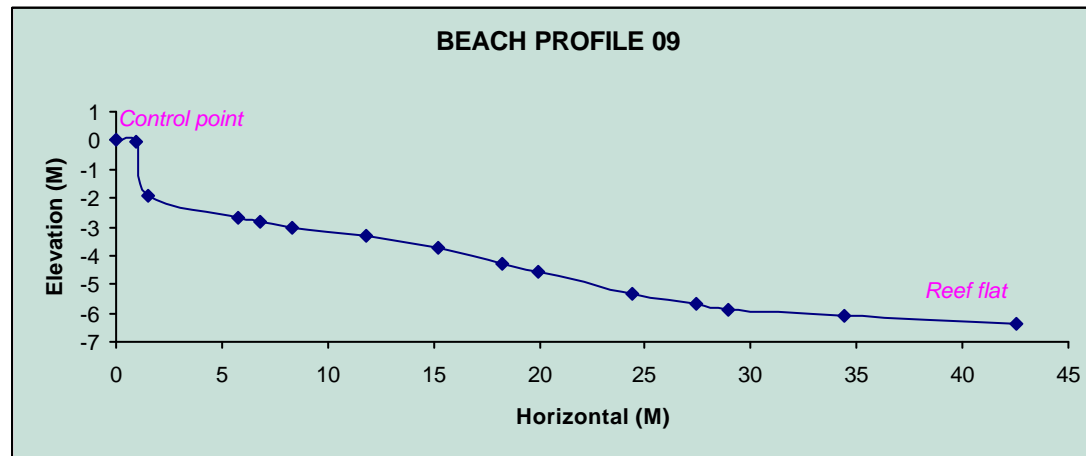
Location: Aiwo, Nauru Island  
Control Point: South end of NPC Club wall  
Position: 00°32'00.0"S 166°54'37.4E  
Bearing: 257°

Horizontal	Elevation
0	0
0.931	-0.042
1.488	-1.911
5.775	-2.7
6.767	-2.846
8.305	-3.029
11.852	-3.297
15.251	-3.722
18.2	-4.277
19.954	-4.587
24.348	-5.3
27.426	-5.7
28.96	-5.903
34.443	-6.126
42.577	-6.358

Beach slope: 7.4 °

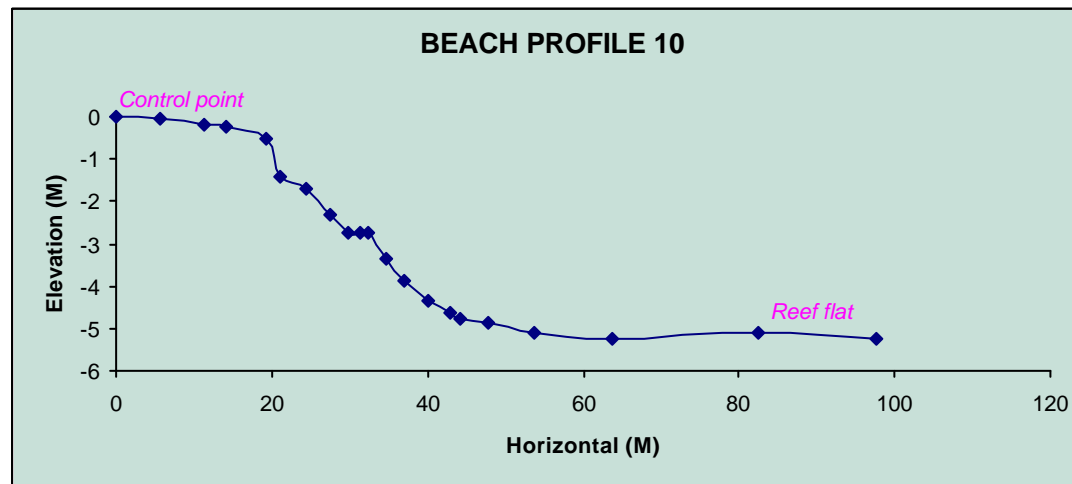
**Location:** Boe, Nauru Island  
**Control Point:** Northwest corner of Gabab Restaurant  
**Position:** 00°32'25.5"S 166°54'40.1"E  
**Bearing:** 232°

Horizontal	Elevation
0.002	0
5.672	-0.06
11.182	-0.2
14.031	-0.224
19.362	-0.528
20.961	-1.436
24.437	-1.706
27.464	-2.32
29.849	-2.762
31.383	-2.745
32.489	-2.75
34.8	-3.343
37.031	-3.854
40.11	-4.327
42.794	-4.627
44.108	-4.794
47.885	-4.85
53.789	-5.101
63.71	-5.236
82.554	-5.111
97.762	-5.267

Beach slope: 9.8°

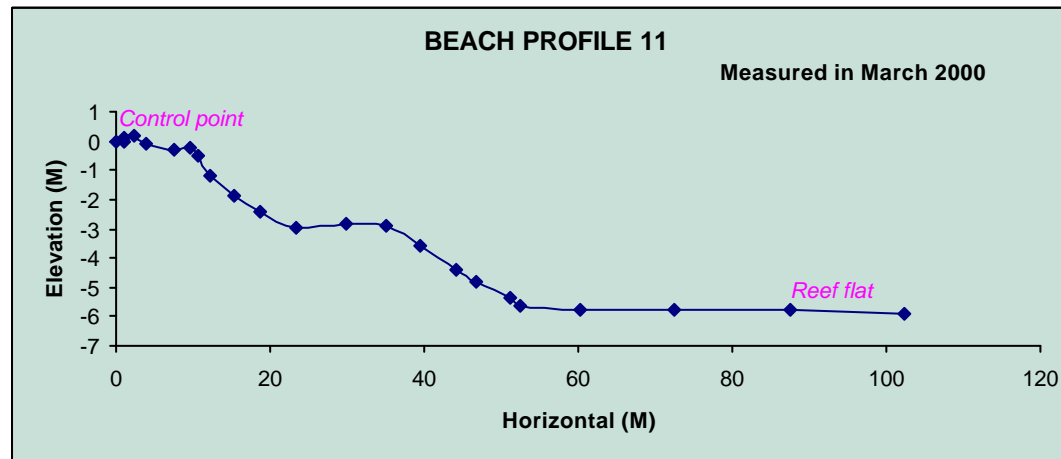
**Location:** Boe, Nauru Island  
**Control Point:** Benchmark on main road  
**Position:** 00°32'32.9"S 166°54'43.6E  
**Bearing:** 230°

Horizontal	Elevation
0.004	-0.001
1.022	-0.016
1.055	0.124
2.419	0.149
3.97	-0.062
7.63	-0.266
9.58	-0.224
10.7	-0.504
12.269	-1.189
15.324	-1.857
18.786	-2.439
23.33	-2.939
29.773	-2.8
35.075	-2.88
39.513	-3.594
44.046	-4.368
46.78	-4.779
51.088	-5.373
52.525	-5.646
60.292	-5.759
72.37	-5.736
87.433	-5.79
102.255	-5.875

Beach slope: 9.0°

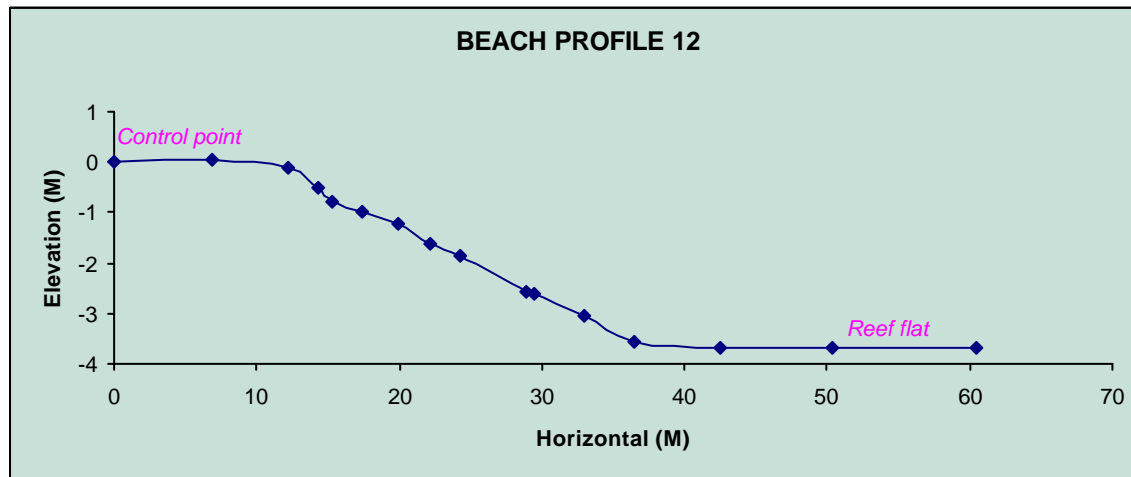
**Location:** Meneng, Nauru Island  
**Control Point:** Eastern corner of Mr. Hedmon Kam's house extension  
**Position:** 00°33'12.0"S 166°56'02.0E  
**Bearing:** 162°

Horizontal	Elevation
0	0
6.865	0.06
12.213	-0.117
14.377	-0.494
15.226	-0.793
17.455	-0.984
19.928	-1.212
22.167	-1.631
24.256	-1.87
28.847	-2.552
29.519	-2.597
32.974	-3.052
36.528	-3.579
42.478	-3.697
50.417	-3.7
60.433	-3.695

Beach slope: 8.1°

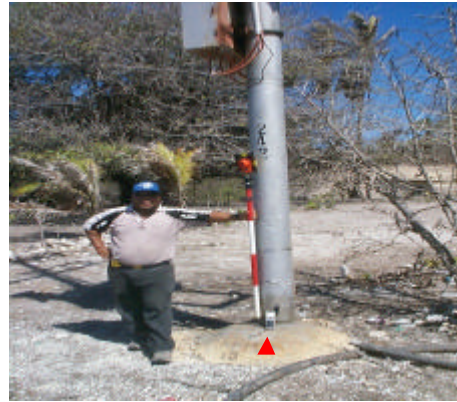
Control point of BP13

**Location:** Meneng, Nauru Island  
**Control Point:** Basement of Power pole 242  
**Position:** 00°32'46.6"S 166°56'48.9"E  
**Bearing:** 144°

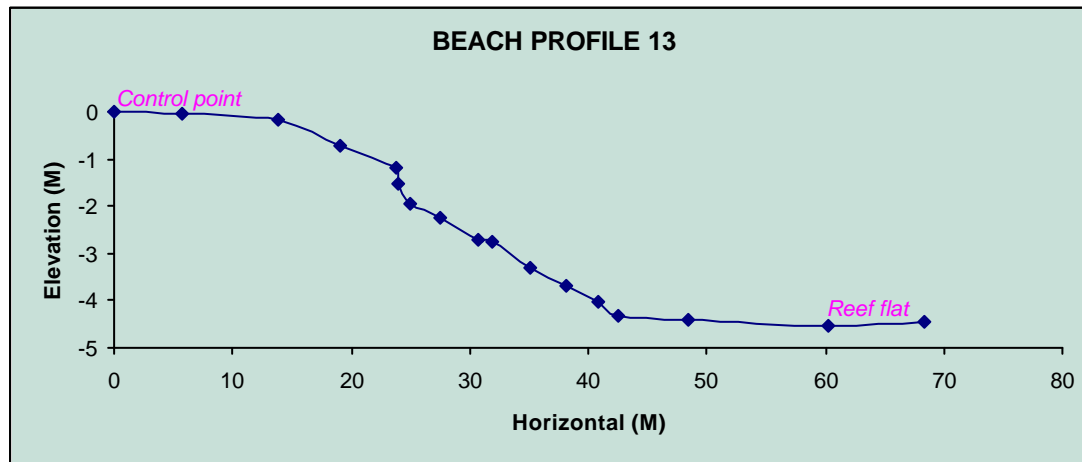
Horizontal	Elevation
0	0
5.742	-0.027
13.765	-0.181
19.129	-0.727
23.788	-1.194
23.888	-1.537
24.946	-1.934
27.545	-2.246
30.69	-2.72
31.927	-2.761
35.125	-3.284
38.107	-3.698
40.848	-4.043
42.513	-4.334
48.408	-4.407
60.197	-4.53
68.352	-4.469

Beach slope: 8.8°

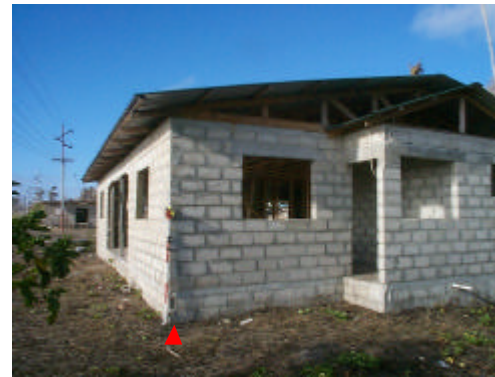
Control point of BP14

**Location:** Anibare, Nauru Island  
**Control Point:** Northeast corner of Mr. Robert Robidem's House  
**Position:** 00°32'06.9"S 166°57'0.00E  
**Bearing:** 93°

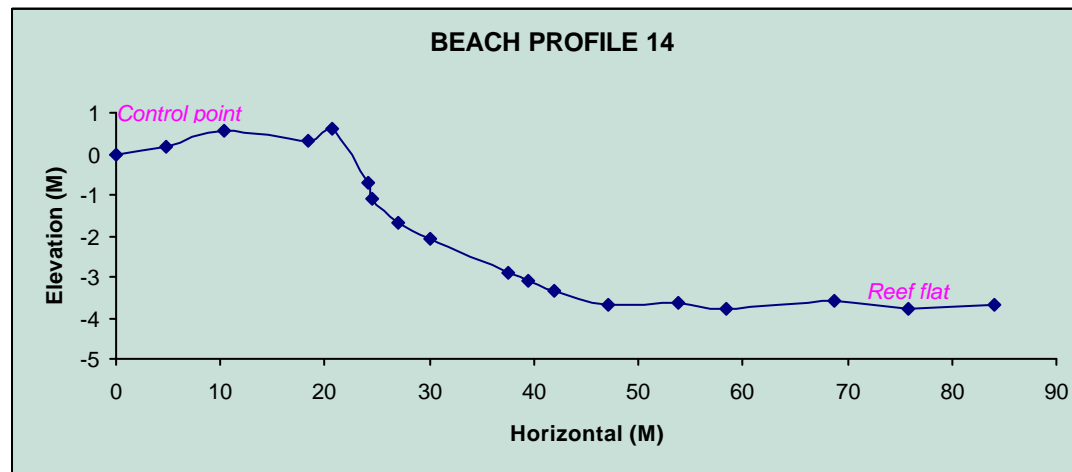
Horizontal	Elevation
0	0
4.78	0.149
10.375	0.555
18.418	0.324
20.716	0.63
24.06	-0.72
24.594	-1.113
27.047	-1.698
30.023	-2.096
37.468	-2.912
39.437	-3.109
41.863	-3.36
47.186	-3.7
53.782	-3.647
58.314	-3.793
68.824	-3.609
75.772	-3.777
84.139	-3.68

Beach slope: 5.7°

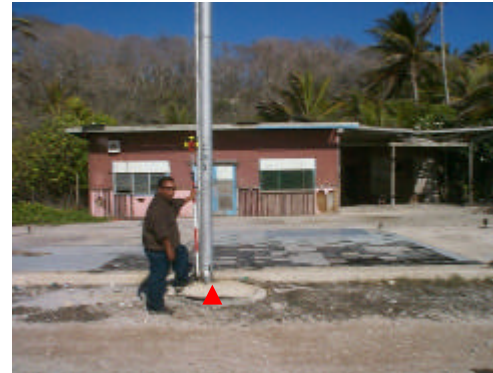
Control point of BP15

**Location:** Anibare, Nauru Island  
**Control Point:** Basement of Power pole 207  
**Position:** 00°31'59.24"S 166°57'03.1E  
**Bearing:** 98°

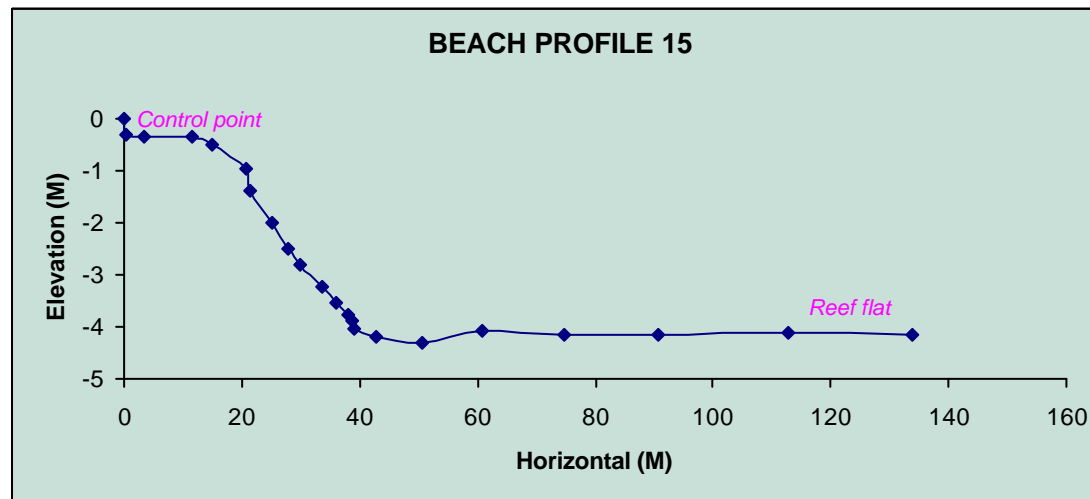
Horizontal	Elevation
0.001	0
0.335	-0.294
3.344	-0.341
11.382	-0.337
15.031	-0.509
20.642	-0.959
21.404	-1.372
25.061	-1.983
27.873	-2.509
29.956	-2.822
33.512	-3.248
35.995	-3.525
38.036	-3.771
38.624	-3.868
38.911	-4.042
42.824	-4.207
50.724	-4.312
60.961	-4.087
74.892	-4.151
90.569	-4.169
112.828	-4.106
133.778	-4.162

Beach slope: 8.3°

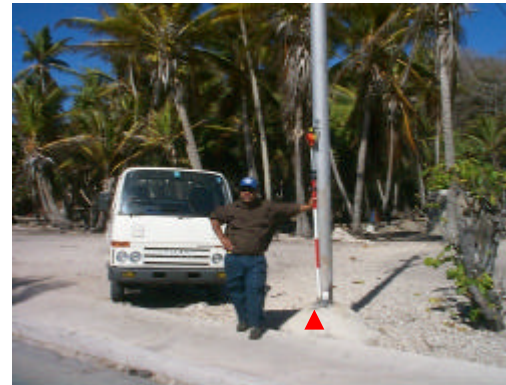
Control point of BP16

**Location:** Anibare, Nauru Island  
**Control Point:** Basement of Power pole 201  
**Position:** 00°31'49.9"S 166°57'05.2E  
**Bearing:** 104°

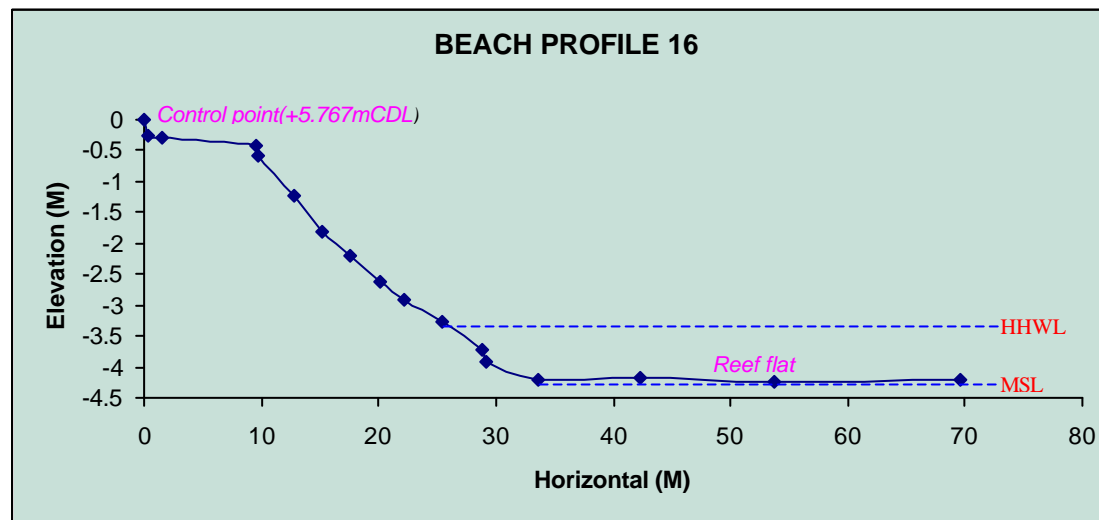
Horizontal	Elevation
0.001	0
0.259	-0.259
1.537	-0.287
9.569	-0.413
9.673	-0.579
12.752	-1.217
15.244	-1.805
17.603	-2.204
20.138	-2.609
22.141	-2.908
25.385	-3.277
28.807	-3.716
29.226	-3.91
33.569	-4.195
42.277	-4.175
53.672	-4.231
69.644	-4.196

Beach slope: 9.7°

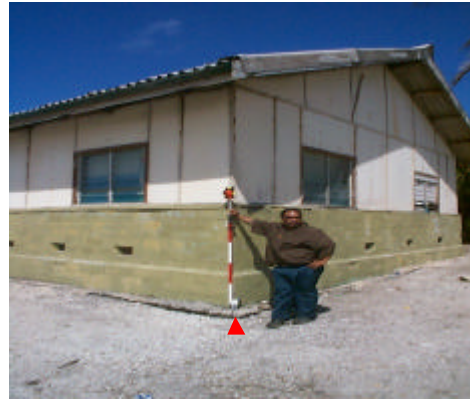
Control point of BP17

**Location:** Anabare, Nauru Island  
**Control Point:** Northwest corner of Miss Etaleamon's Property  
**Position:** 00°31'42.5"S 166°57'08.9"E  
**Bearing:** 110°

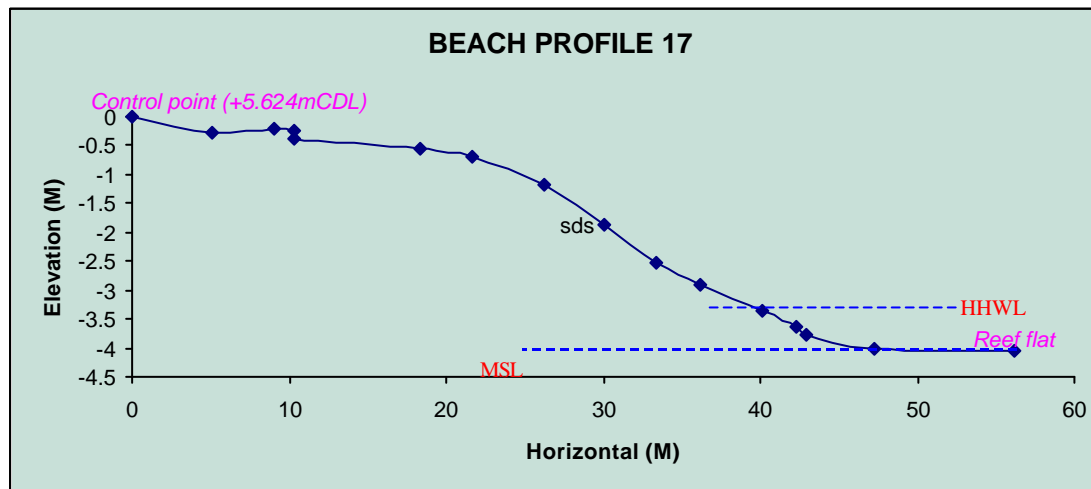
Horizontal	Elevation
0.004	0
5.1	-0.284
9.034	-0.22
10.348	-0.232
10.376	-0.379
18.369	-0.542
21.706	-0.685
26.199	-1.162
30.056	-1.879
33.377	-2.515
36.15	-2.915
40.087	-3.35
42.252	-3.642
42.945	-3.79
47.282	-4.006
56.127	-4.049

Beach slope: 8.9°
