Assessing vulnerability and adaptation to sea-level rise: Lifuka İsland Ha'apai, Tonga

# B 1: Physical resources1.1: Shoreline assessment

Zulfikar Begg and Jens Krüger

Secretariat of the Pacific Community Suva, Fiji 2014 SPC Secretariat of the Pacific Community

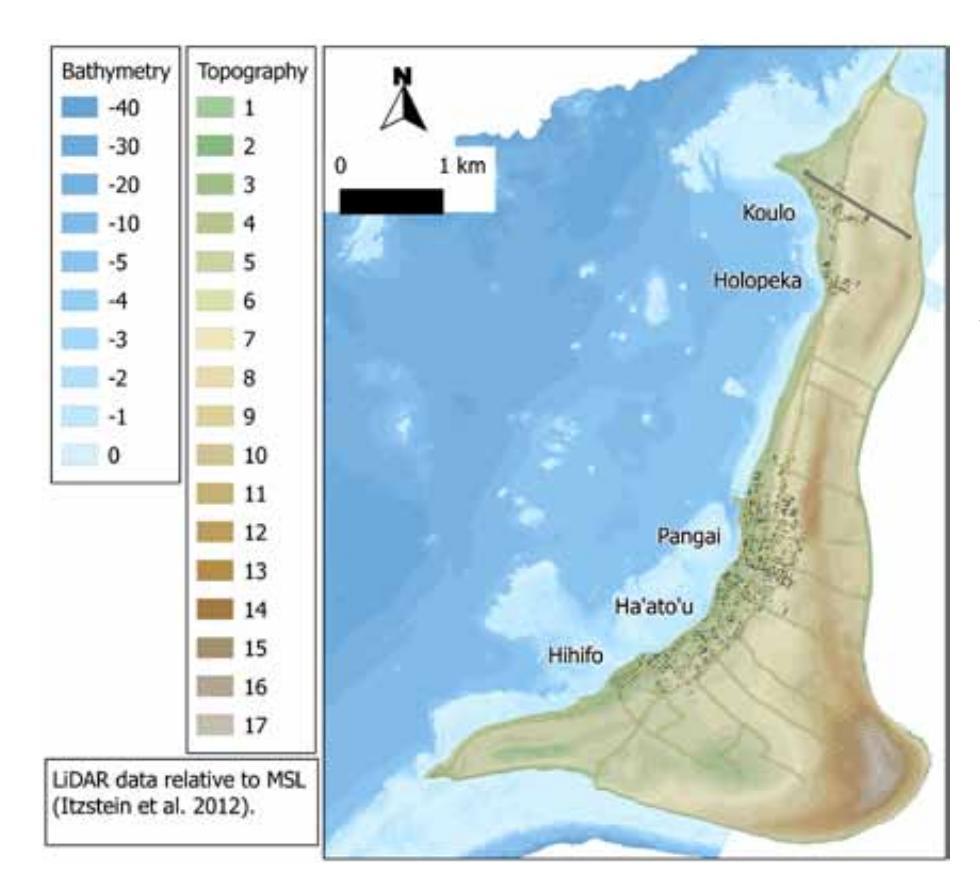
Figure 1: Coastal terrain model of Lifuka showing LiDAR bathymetry and topography collected under the PASAP project. The map also shows the location of major infrastructure such as houses, roads and the airport. Note that the majority of buildings are located on the low-lying western coastline.

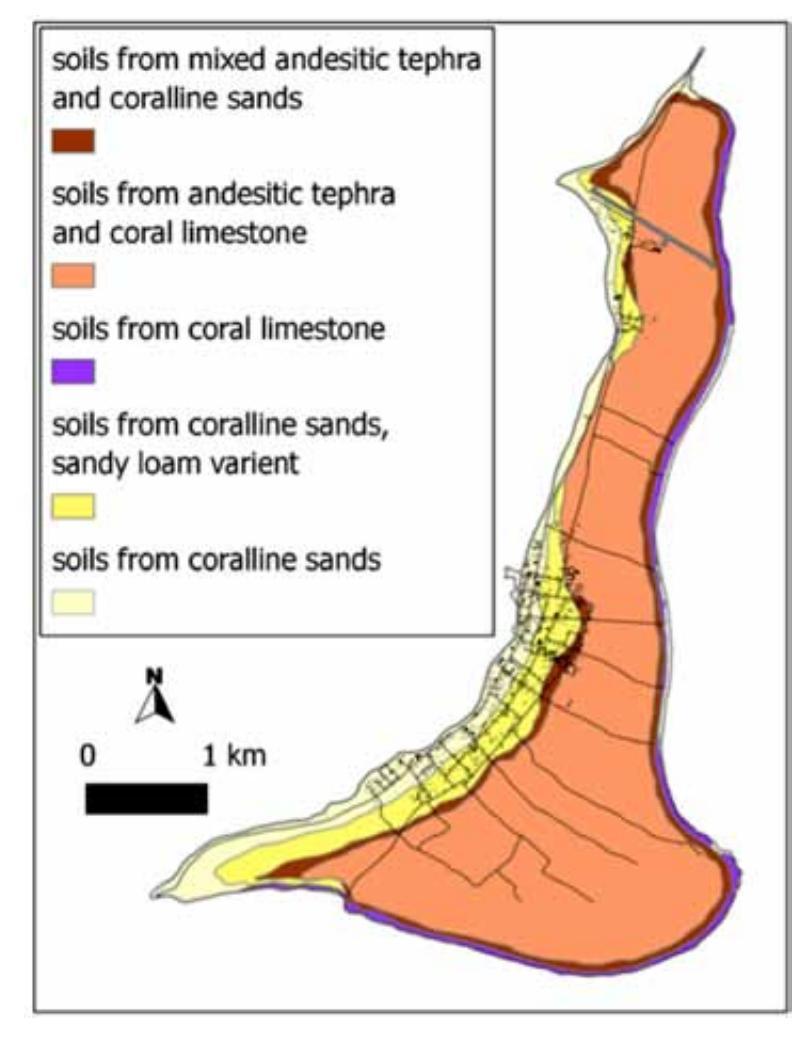
Figure 2: Soil map of Lifuka (redrawn from Wilson and Beecroft 1983) overlain with infrastructure (houses, roads, and airport). Note that the majority of buildings are situated on the sandy soils of the coastal plain. Lifuka is a raised limestone island (maximum elevation of 17 m above mean sea level), and comprises a coastal plain of varying width (generally 200–500 m) along the western leeward shoreline (Figures 1 and 2). The island experienced relative sea level rise in the order of 23 cm due to tectonic subsidence associated with the May 2006 earthquake (Cummins et al. 2006).

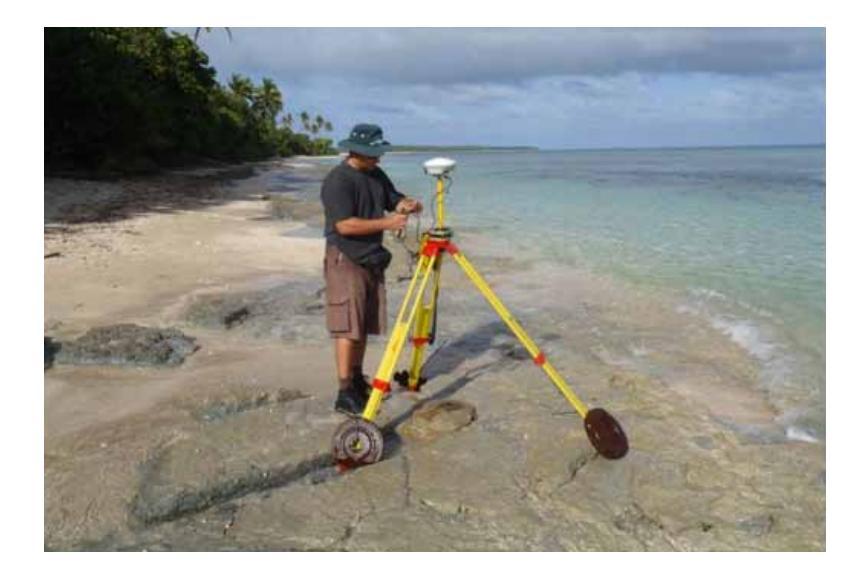
*Figure 8: Trimble SPS852 set up at the GPS monument, Lifu*

The Lifa and Lifu benchmarks were used as the primary benchmarks during the GNSS survey. The Lifa station was observed with a Trimble R8 system (Figure 7), and the Lifu station was observed with a Trimble SPS852 system (Figure 8). Both stations were observed simultaneously for at least 24 hours. While the primary benchmark observations were being conducted, the secondary beach profiling benchmarks were observed with additional Trimble R8 units for at least one hour each. This provided survey grade horizontal positions at all locations, and the vertical heights were later adjusted to mean sea level as derived from the temporary tide gauge described below. Since the location of the LiDAR benchmark was not known at the time of the GNSS survey, the vertical correction was achieved later by transferring the height of the LiDAR benchmark to the height of the bollard benchmark using a levelling run (standard land survey technique) between the two benchmarks.

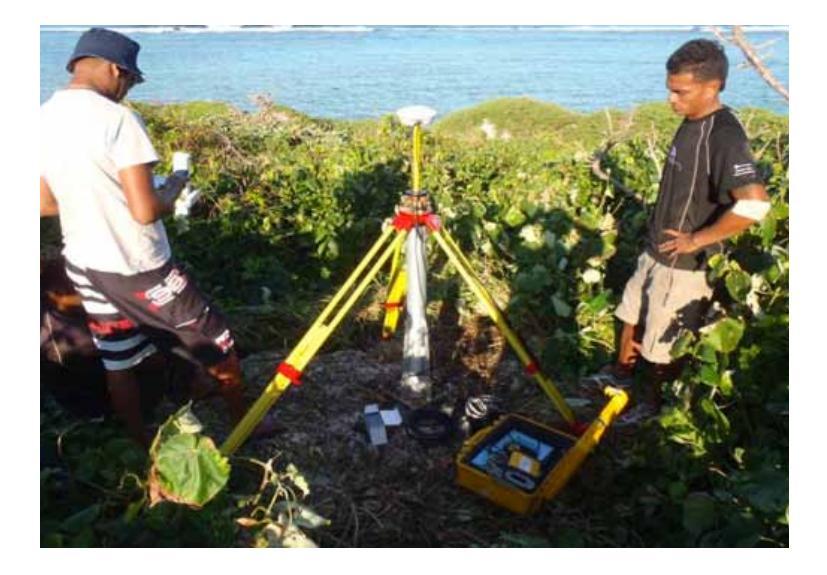
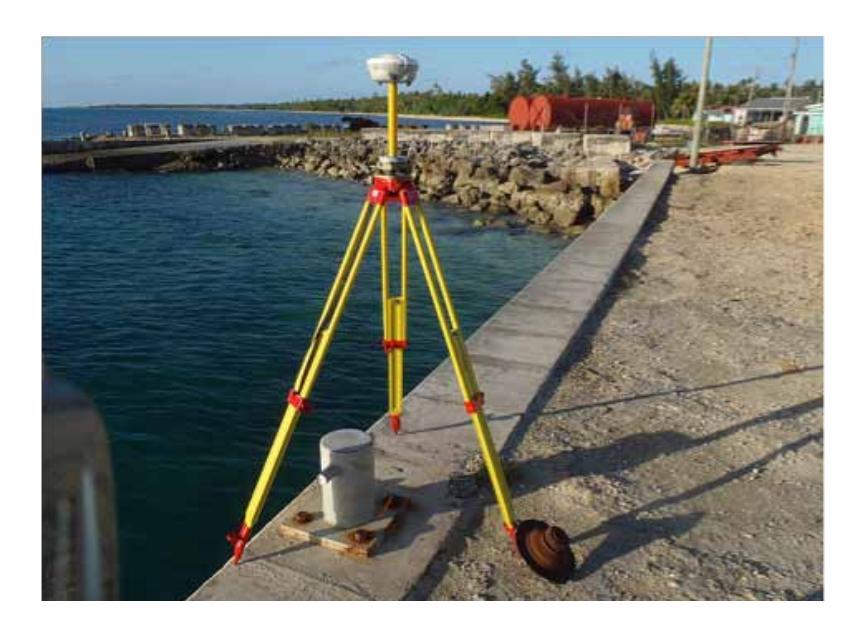
Figure 9: Trimble R8 GNSS set up over the bolt at the bollard on the northern edge of Pangai wharf. The location of the bolt is indicated by the pen immediately to the right of the bollard. The old ramp and location of the LiDAR benchmark can be seen in the top lefthand corner of the photograph.

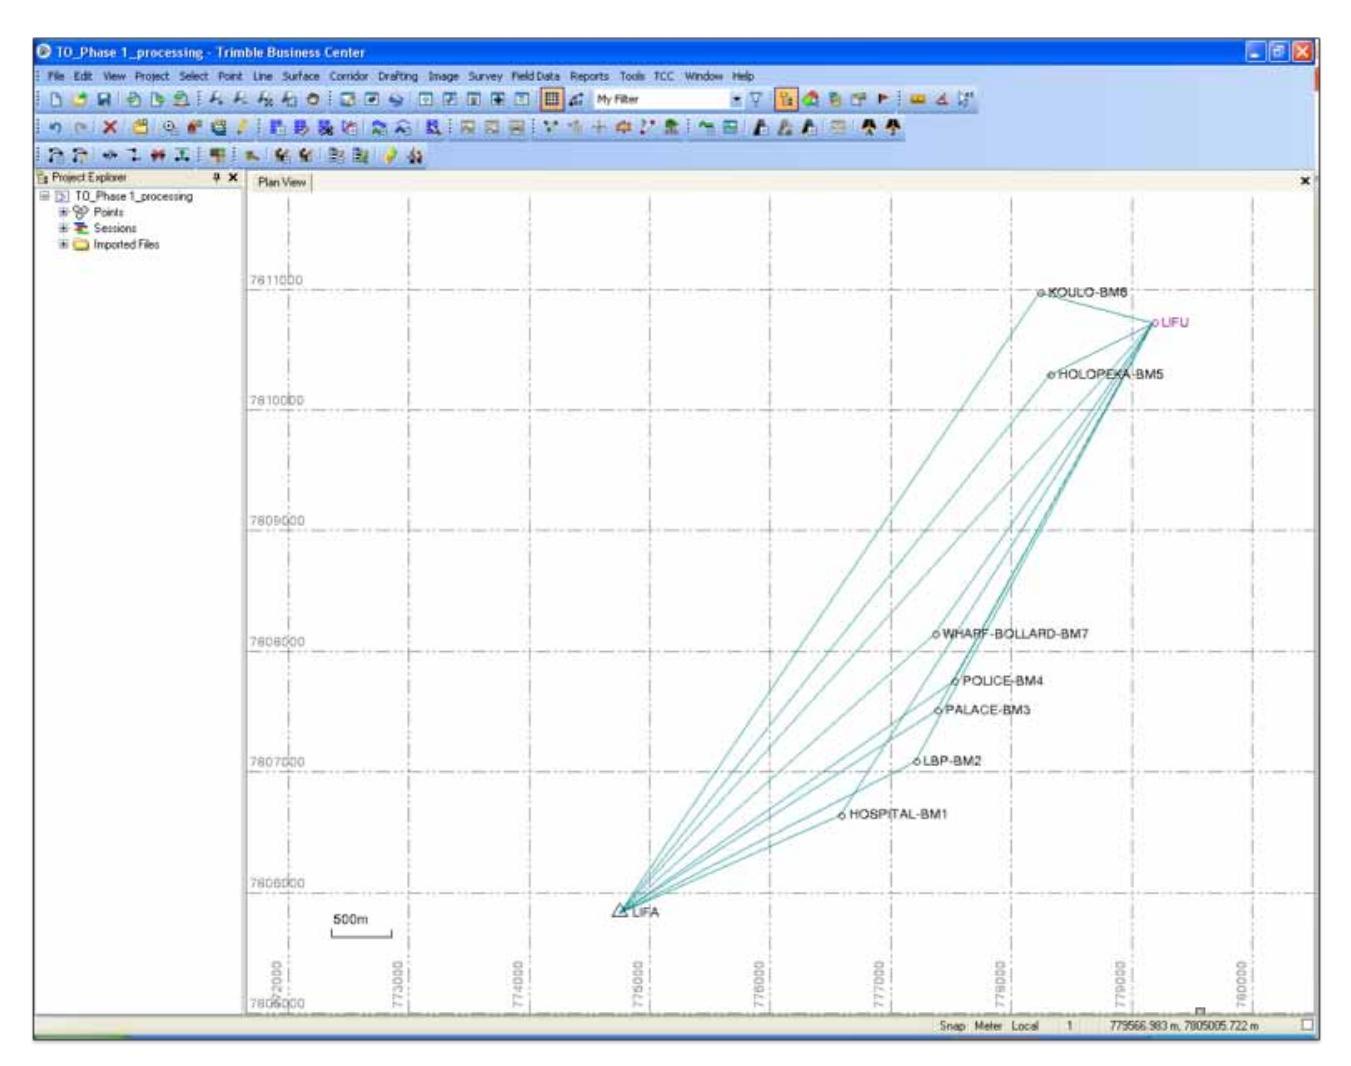
*Figure 10: Screenshot of the Trimble Business Centre, showing the network of baselines using Lifu as the primary benchmark. Note that the bollard was later used as the primary height in adjusting the network.*

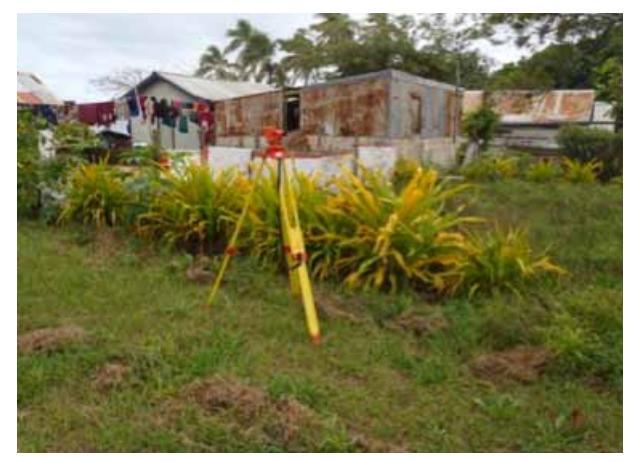
*Figure 11: Set-up of the tripod and FOIF level along the profile line*

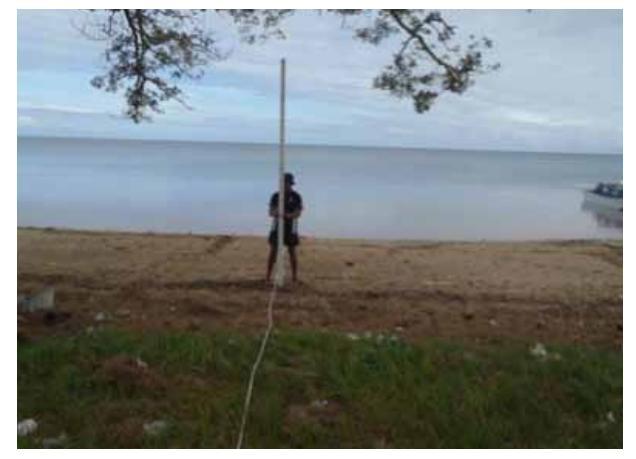
Figure 12: Features such as the edge of vegetation, height of a scarp were noted.

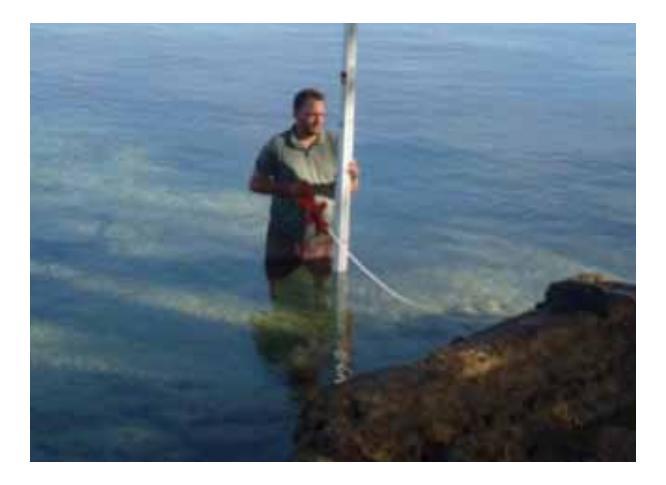
Figure 13: The profile line was measured right up to the base of the beach. Measurements were timed to be taken during low tide whenever possible.

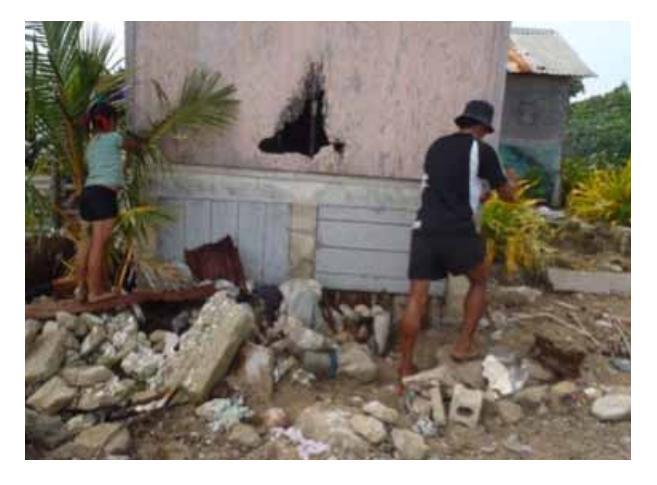
Figure 14: Distances from structural features such as buildings and water tanks were measured to the beach to show changes in the width of beaches over the survey period.

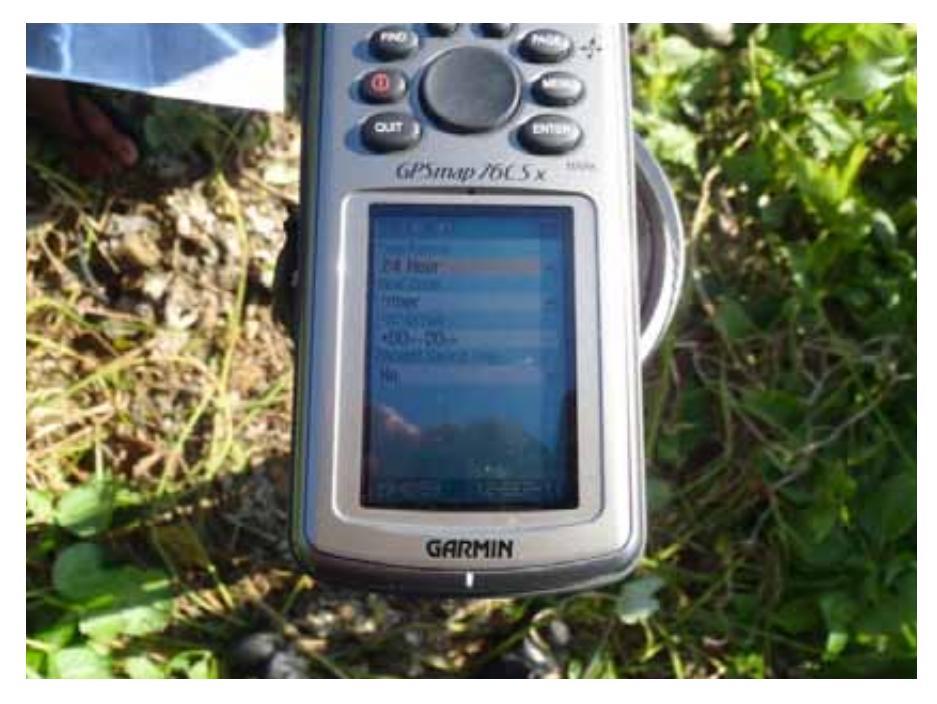
Figure 15: A photo was taken of the handheld GPS displaying the time of day in local standard time at the start of each survey day. This enables geocoding of any subsequent photos by way of matching the GPS location and time with the time stamp embedded in the EXIF information of the JPG photo file.

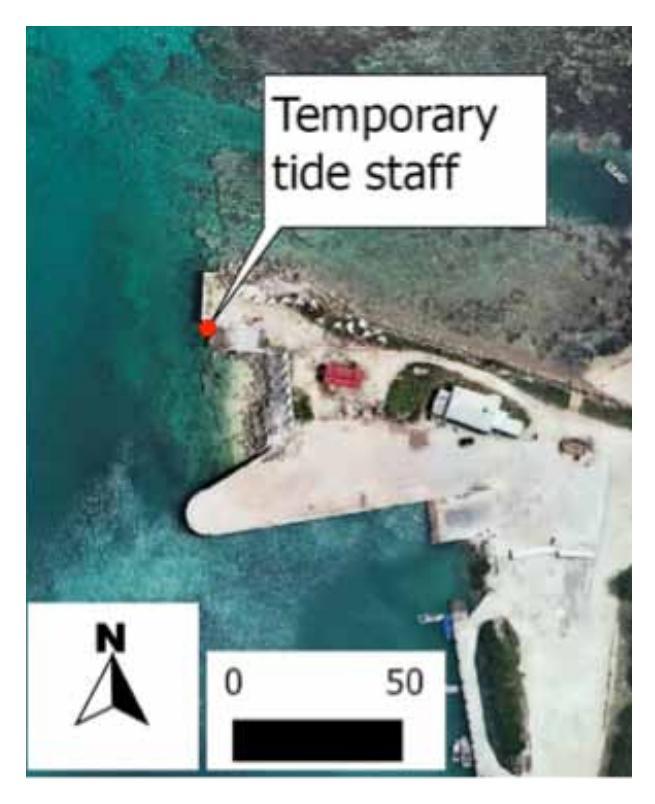
Figure 16: Location of the temporary tide staff on the old northern ramp of Pangai Harbour. This was the same position used for the LiDAR tide gauge.

A tide staff was installed at the wharf in Pangai and observed for 24 hours at ten-minute intervals (Figures 16 and 17). Pressure observations were also made using a Nortek Aquadopp profiler at a nearby location (see the Oceanographic assessment companion report) for 42 days.

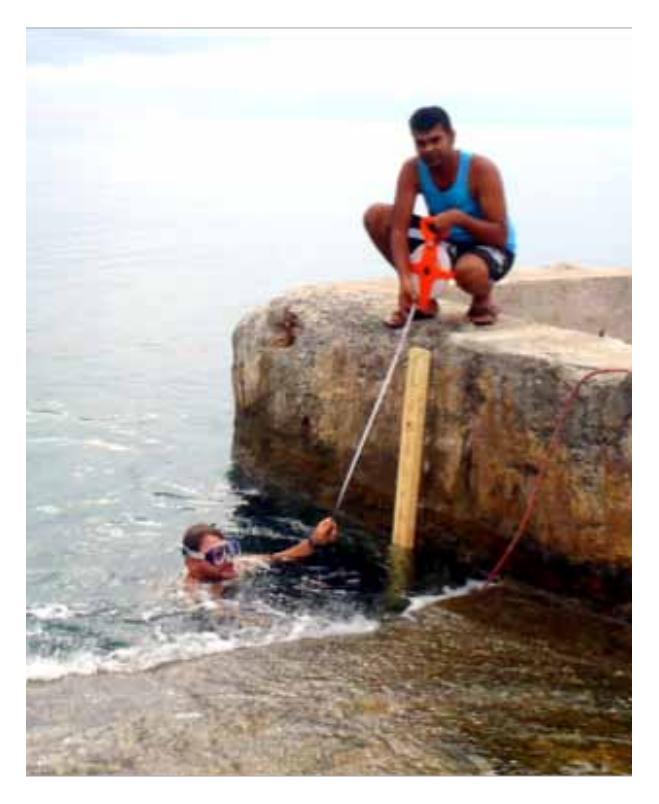
*Figure 17: Placement of the tide staff at the ramp on the northern edge of the Pangai wharf*

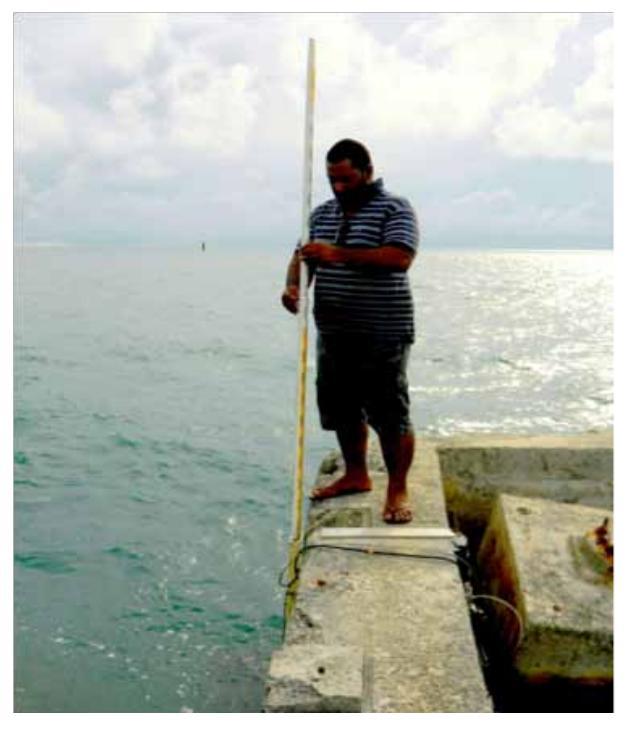
*Figure 18: Levelling run, top of tide staff to LiDAR BM*

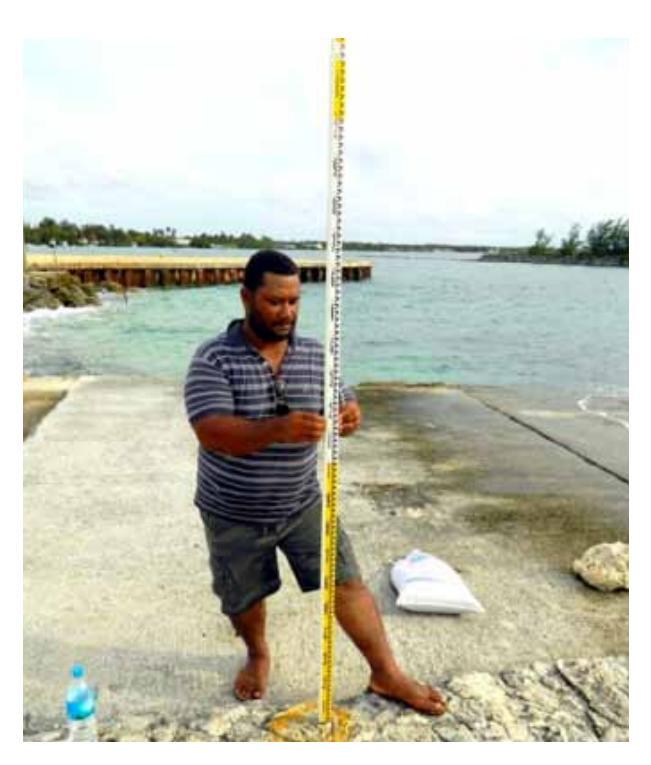
*Figure 19: Levelling run, LiDAR BM to top of tide staff*

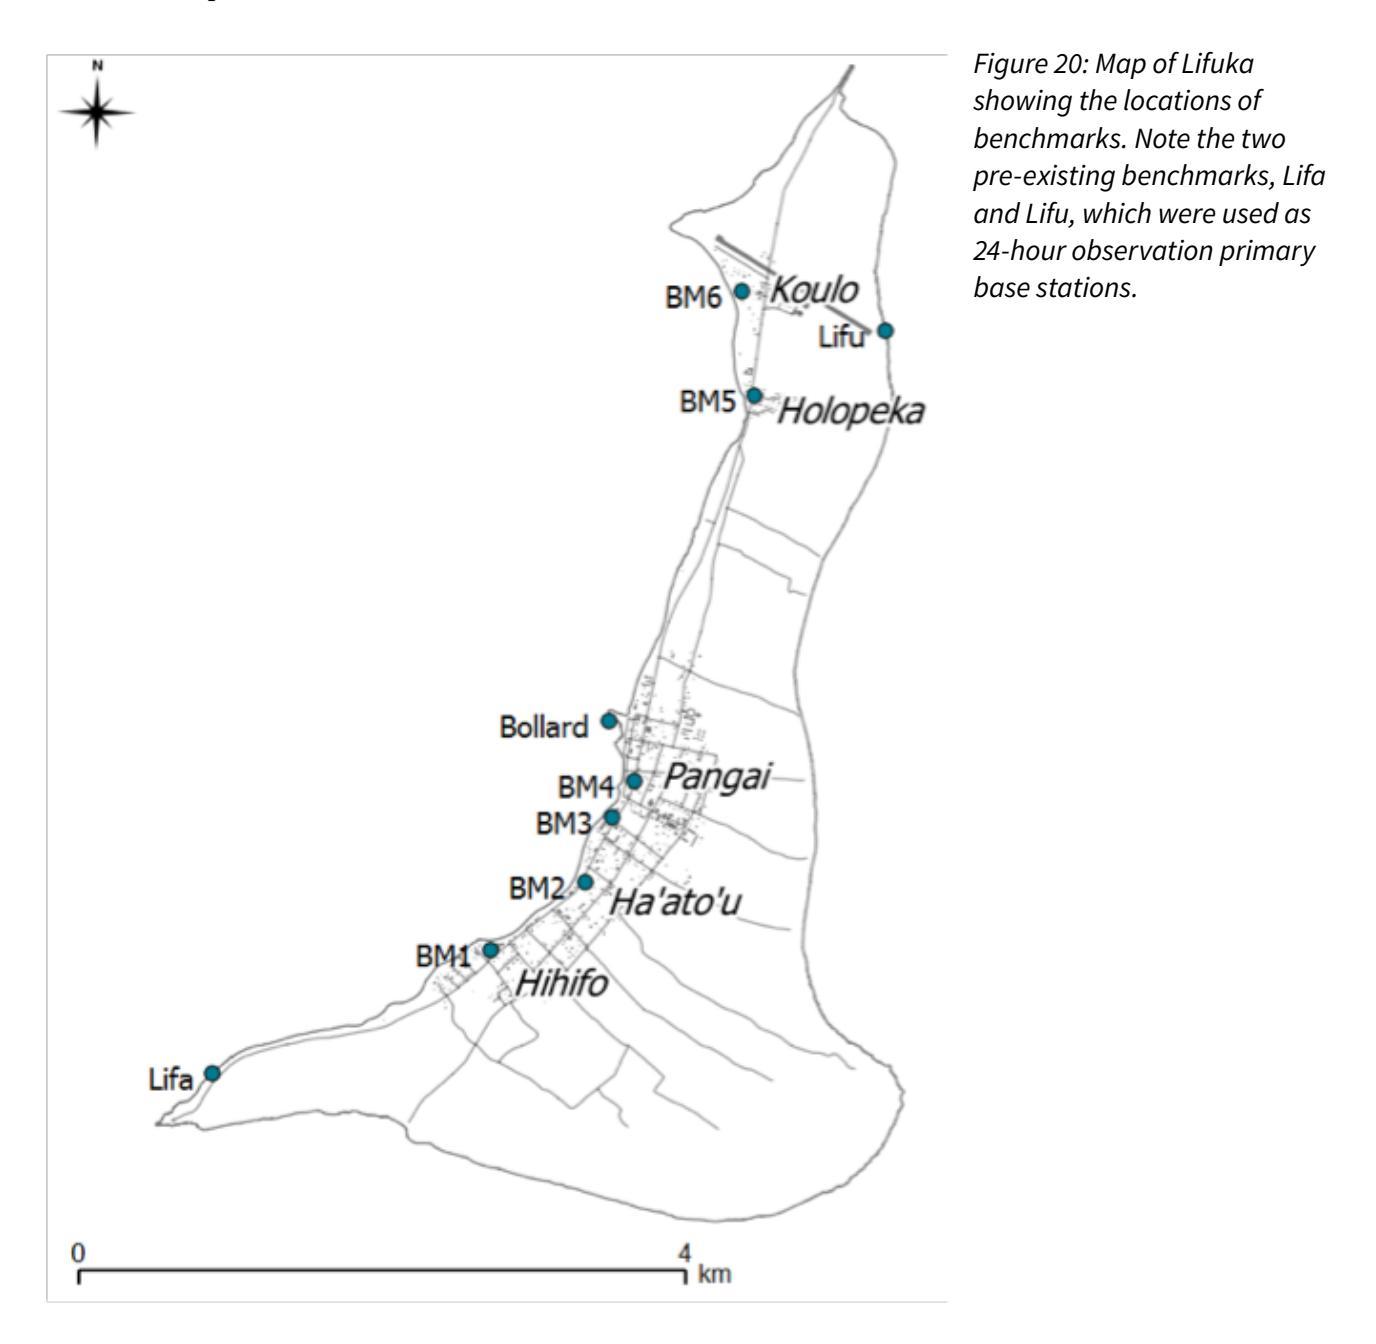
Figure 20 shows the location of the benchmarks that were surveyed during the project. Benchmarks one to six were used for the repeat beach profiling, whereas benchmarks Lifa and Lifu were used for horizontal control. The bollard benchmark was tied in to the LiDAR benchmark and the Lifuka Vertical Datum 2012 and therefore provided vertical control of the network.

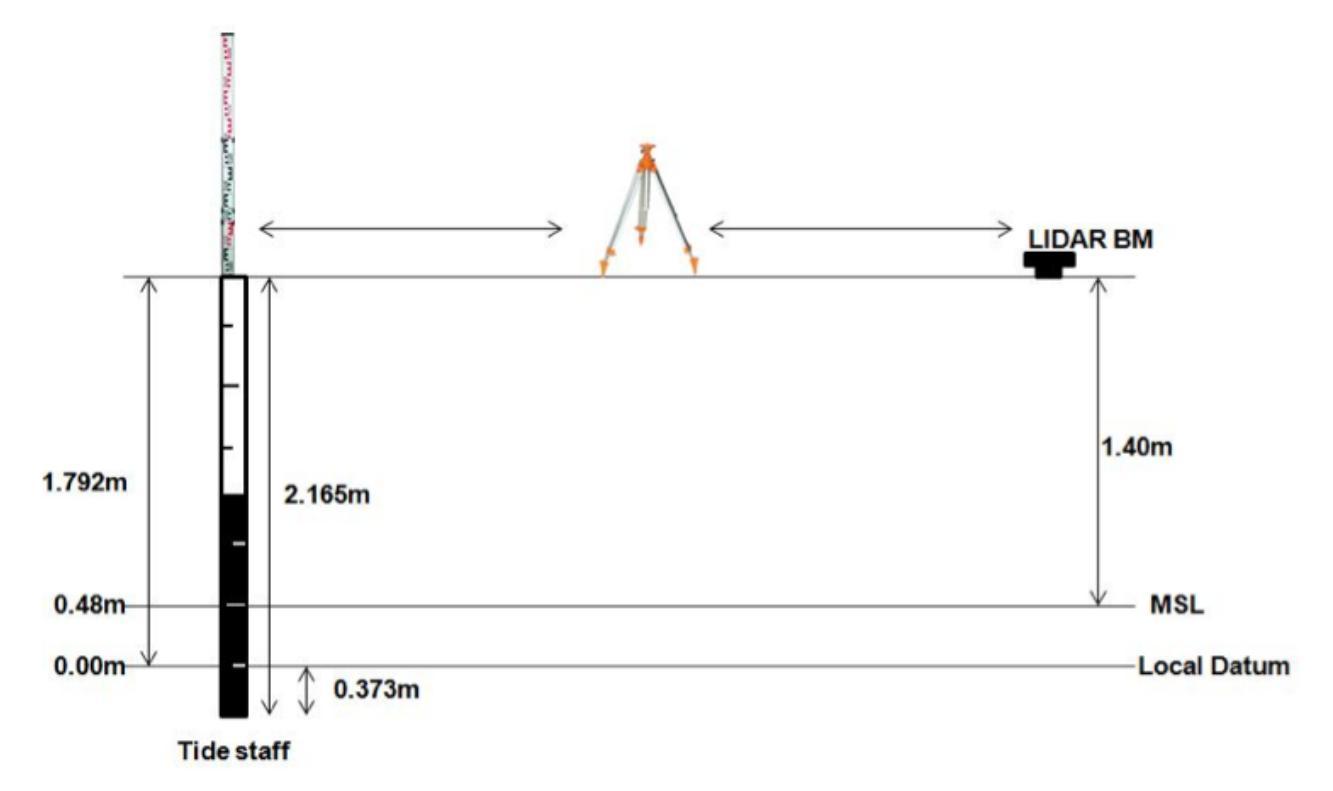
*Figure 28: Schematic diagram of the tide staff in relation to the LiDAR benchmark. The mean sea level was derived to be 1.40 m below the LiDAR benchmark.*

The final results of the tidal analysis are shown in the table below. The mean sea level was found to be 1.40 m below the brass pin referred to as the LiDAR benchmark, and is the definition of the Lifuka Vertical Datum 2012.

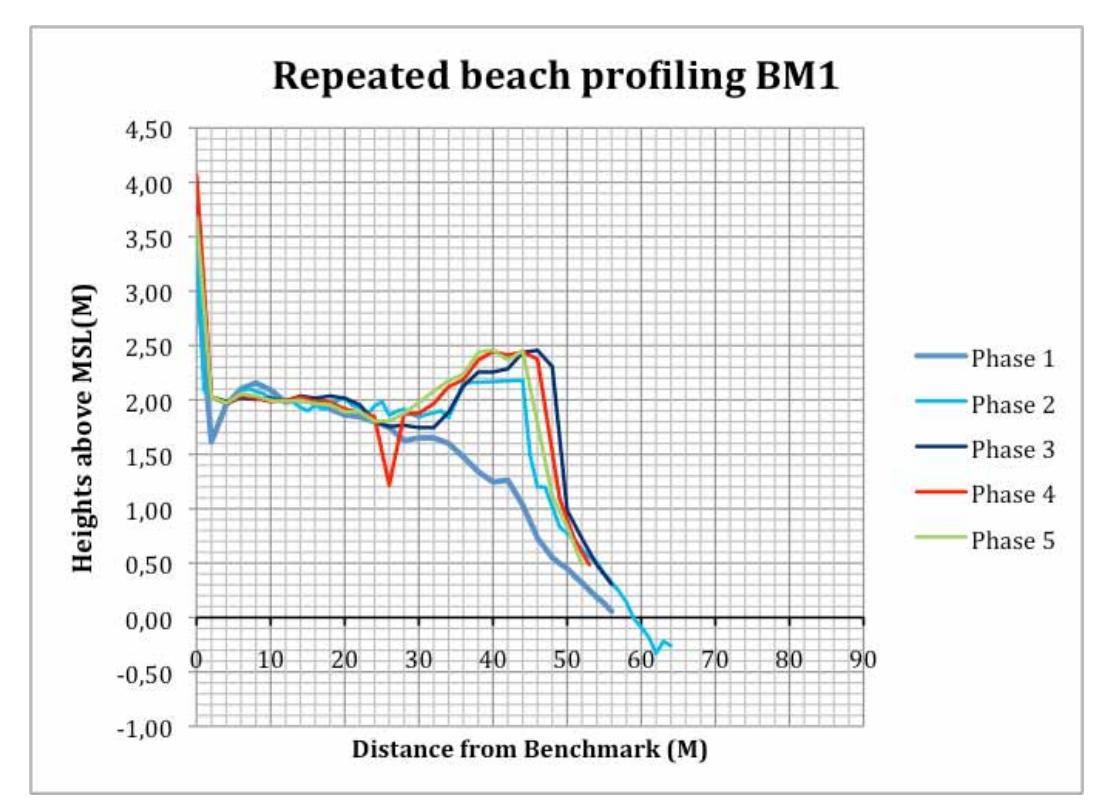
Figure 31: Beach profile plot for the five repeated surveys at benchmark 1

For benchmark 1, at the hospital, most of the changes observed resulted from land reclamation and construction of a sandbag revetment. During the first phase of the survey, erosion and inundation were evident in the hospital compound, mainly in front of the ward section. During high tide, seawater was seen to be reaching the vegetation line, and the two water tanks nearest to the lagoon were undercut by erosion. This prompted action from the government and reclamation was initiated, with temporary protection using cement mix sandbags. With regard to beach morphology (Figure 31), minimal change was observed. Towards the end of the survey, an accumulation of sand was observed on the south corner of the beach, which is presumed to be a result of sand from sandbags being washed away.

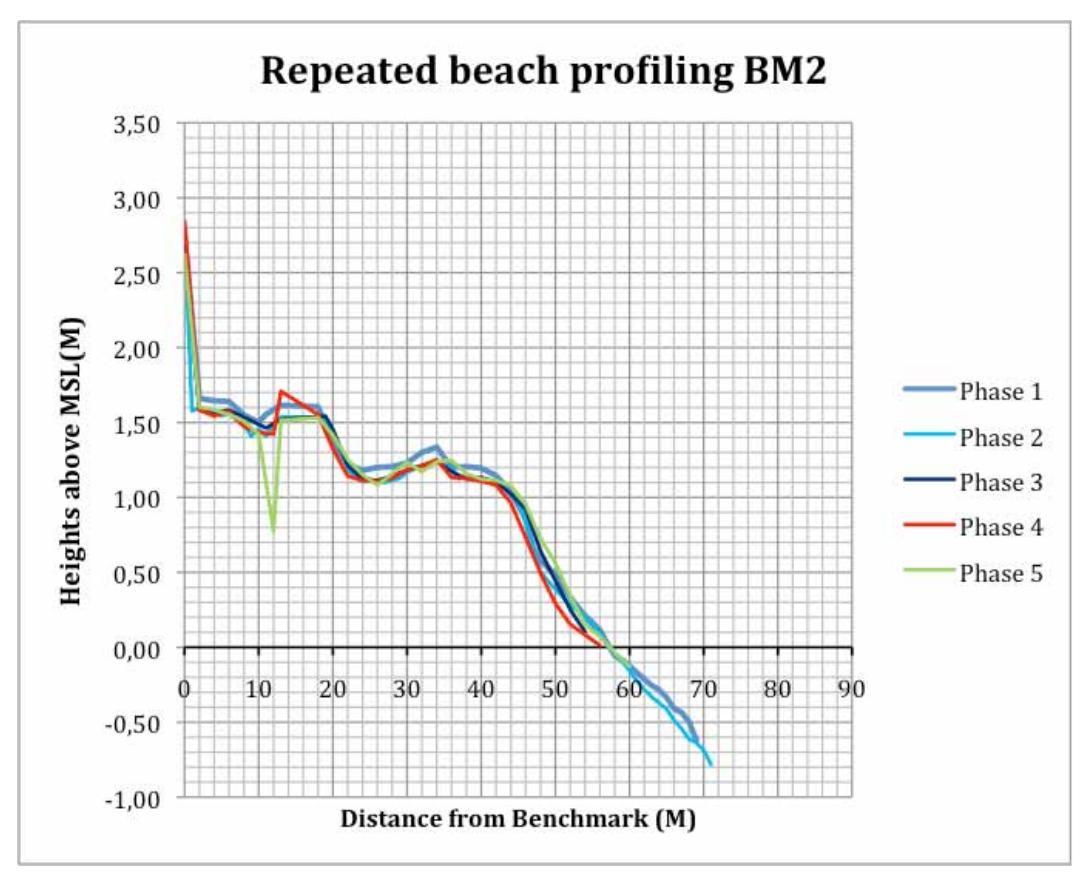
Figure 32: Beach profile plot for the five repeated surveys at benchmark 2

Changes in beach morphology were observed for benchmark 2, at the old store in Ha'ato'u. Data from the survey show that the width of the beach decreased over the survey period (Figure 32). The decrease was observed after TC Cyril in February, 2012. Waves from the cyclone may have washed the sand away, probably southwards. As a result, waves now frequently reach the vegetation line during high tides. This also affects nearby homes.

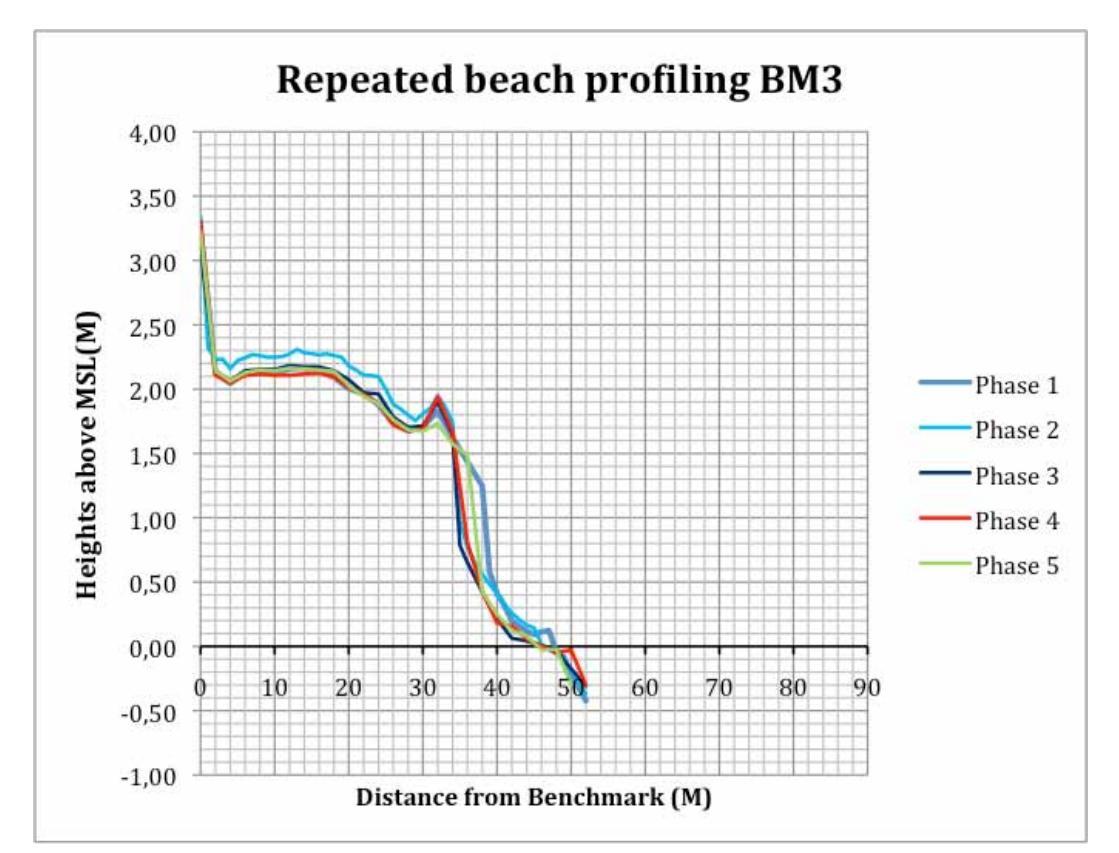
Figure 33: Beach profile plot for the five repeated surveys at benchmark 3

Benchmark 3, located at the King's Palace, showed some changes to the morphology of the profile line. Noted was an increase in height as seen in Figure 33, resulting probably from soil and aggregates accumulating after TC Cyril. Minor erosion was observed on the scarp. A few palm trees were observed to have fallen over in that area as a result of the erosion.

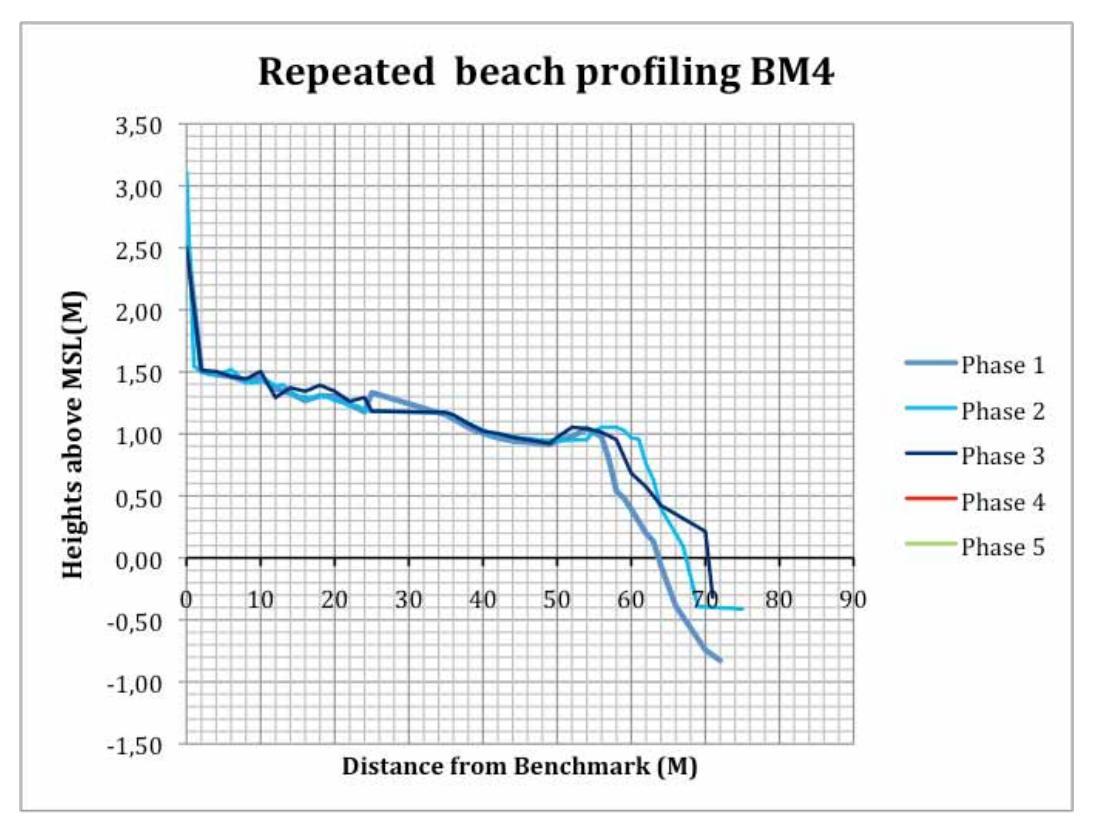
Figure 34: Beach profile plot for the five repeated surveys at benchmark 4

Only three phases of survey were completed for benchmark 4 at the police station. The reference point was removed due to extension of the police building; therefore, surveys could not be repeated. From Figure 34, it can be noted that there were minimal changes to the morphology of the profile. Boulders and concrete slabs have been placed on the beach face and there is sea-wall protection, which shelters the beach and land from high-energy waves.

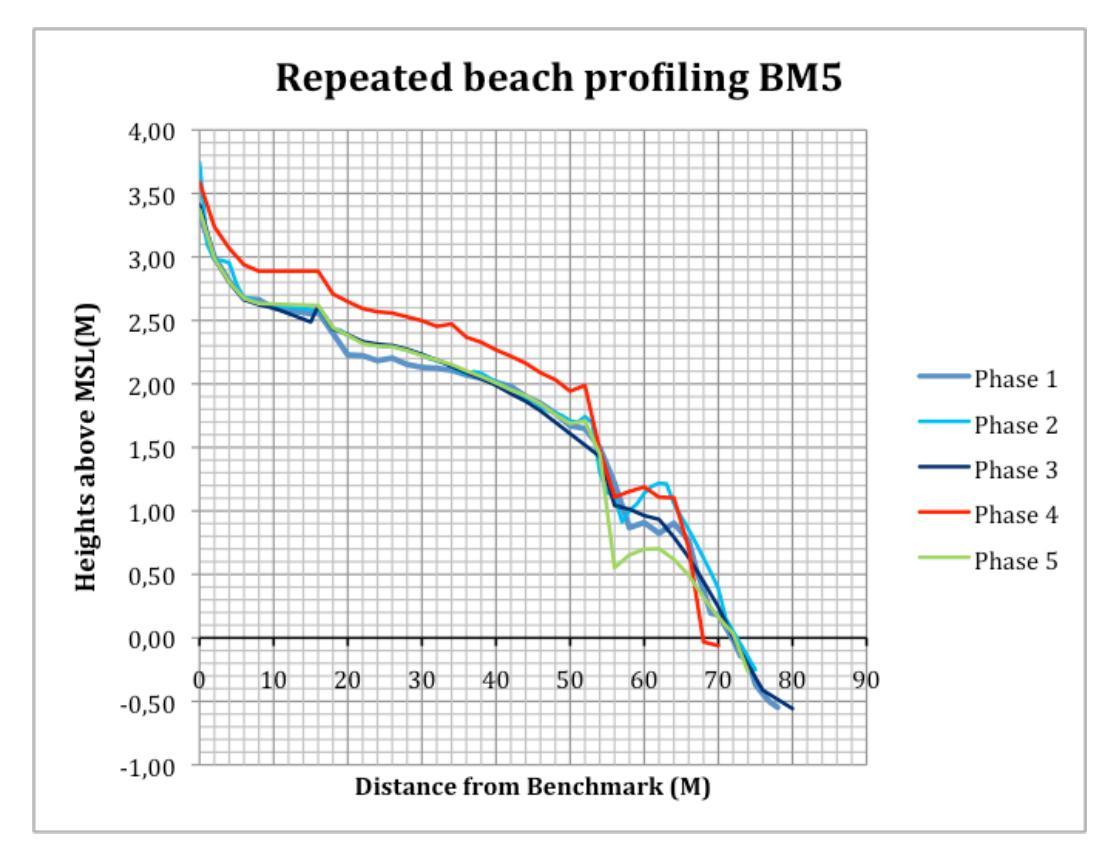
*Figure 35: Beach profile plot for the five repeated surveys at benchmark 5*

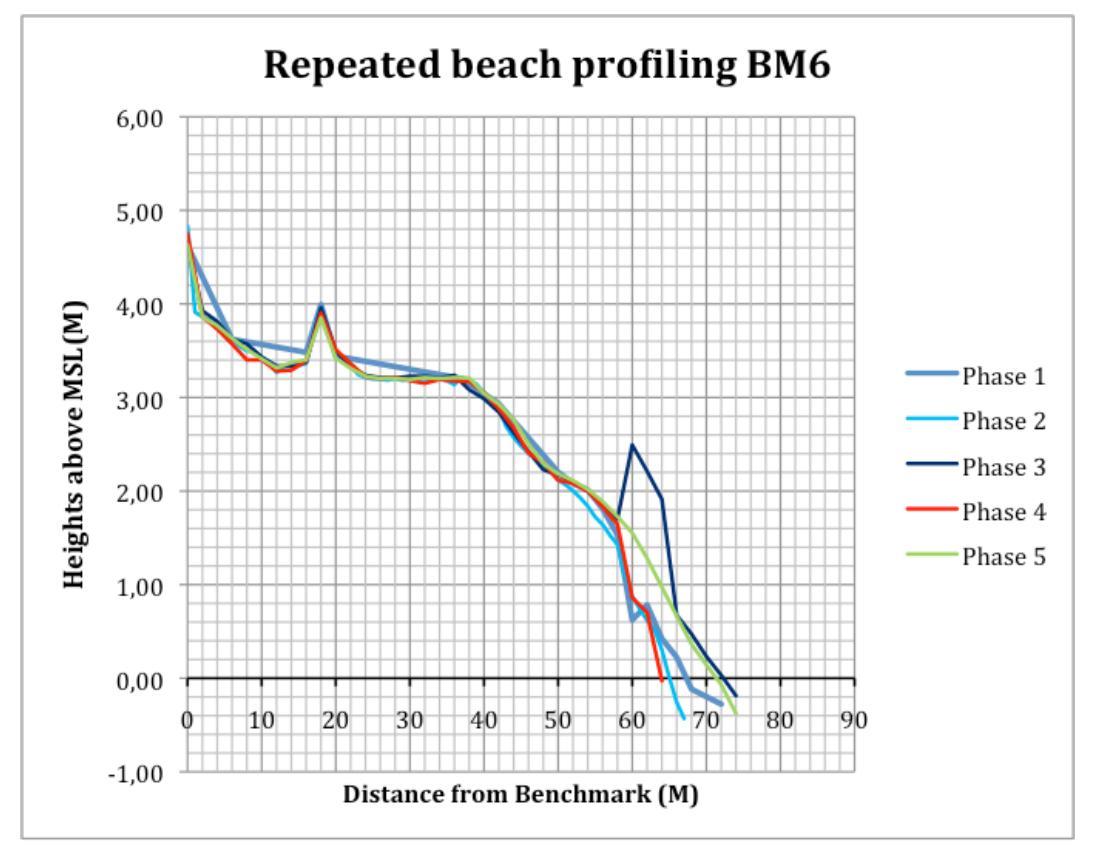
*Figure 36: Beach profile plot for the five repeated surveys at benchmark 6*

With regard to benchmark 6 (Figure 36), some changes were observed on the third phase of the survey. Large amounts of sand were piled up on the beach face, probably during TC Cyril. In later parts of the survey, the area seemed to normalising. Beach size remained consistent. Minor or minimal changes in the morphology were noted.

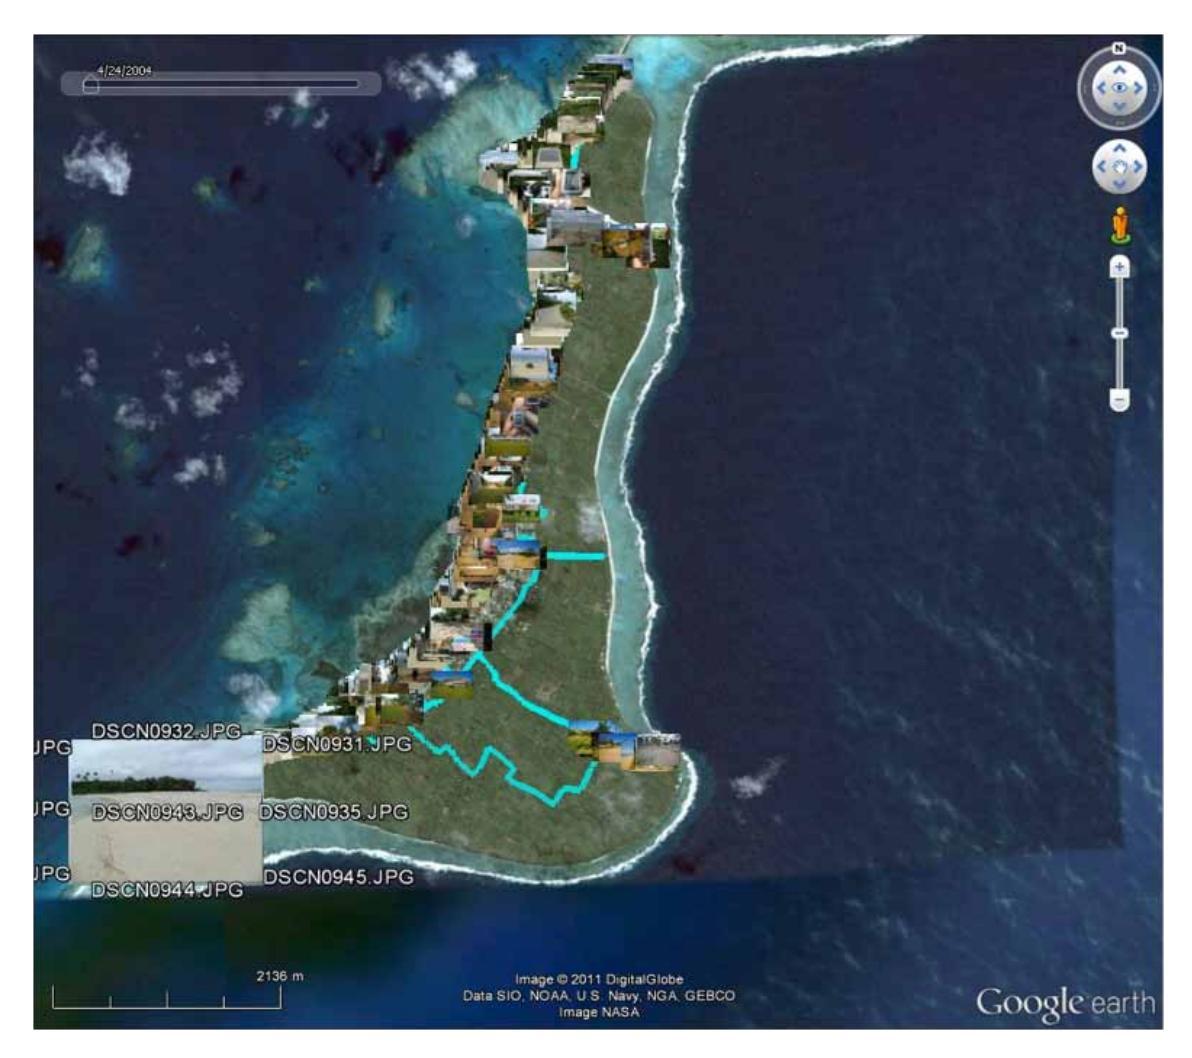
Figure 37: GPS track and geocoded picture thumbnails of photos taken from 12–21 September 2011, displayed as an example from the KMZ file in Google Earth. Clicking on individual photos or groups of photos causes Google Earth to display larger size pop-outs (e.g. the picture DSCN0931 in the lower left-hand corner). Full-resolution photos can also be displayed. Geocoded photos were generated with GPicSync (see Methods section for details).

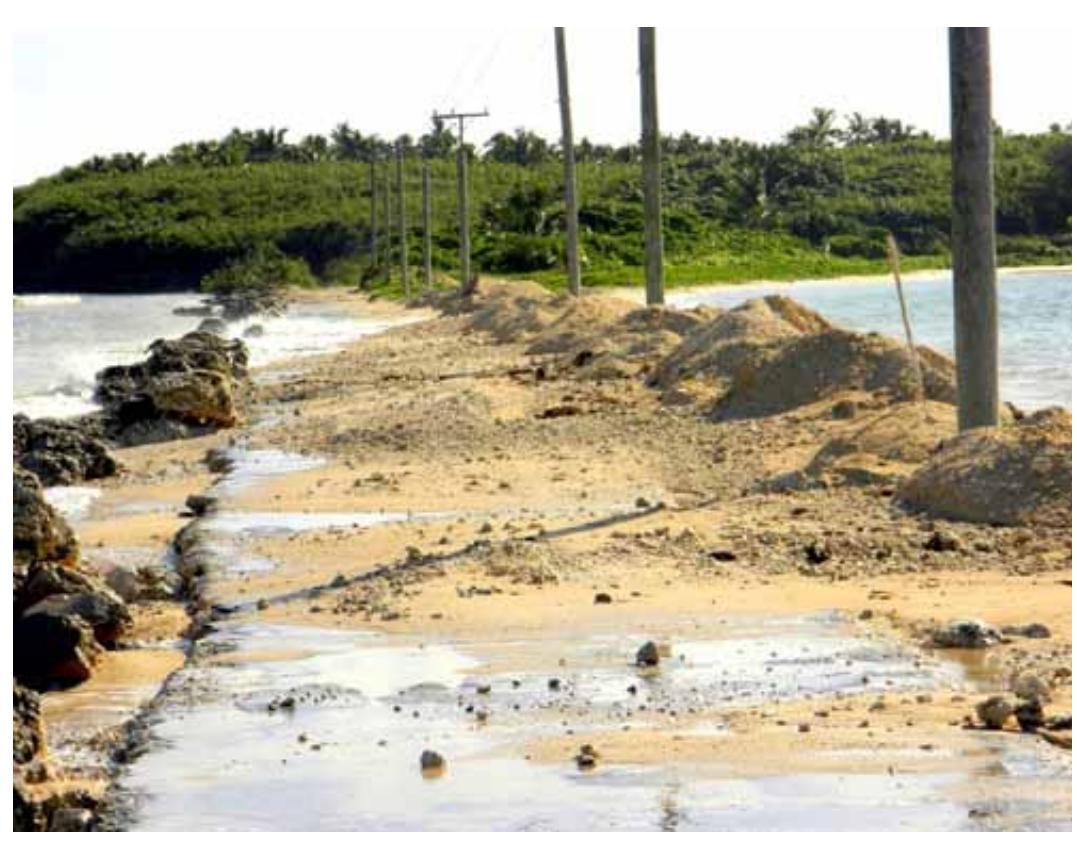
*Figure 38: Causeway, north from Lifuka, after TC Cyril, February 2012. Sand piled up and seawater flooded parts of the causeway.*

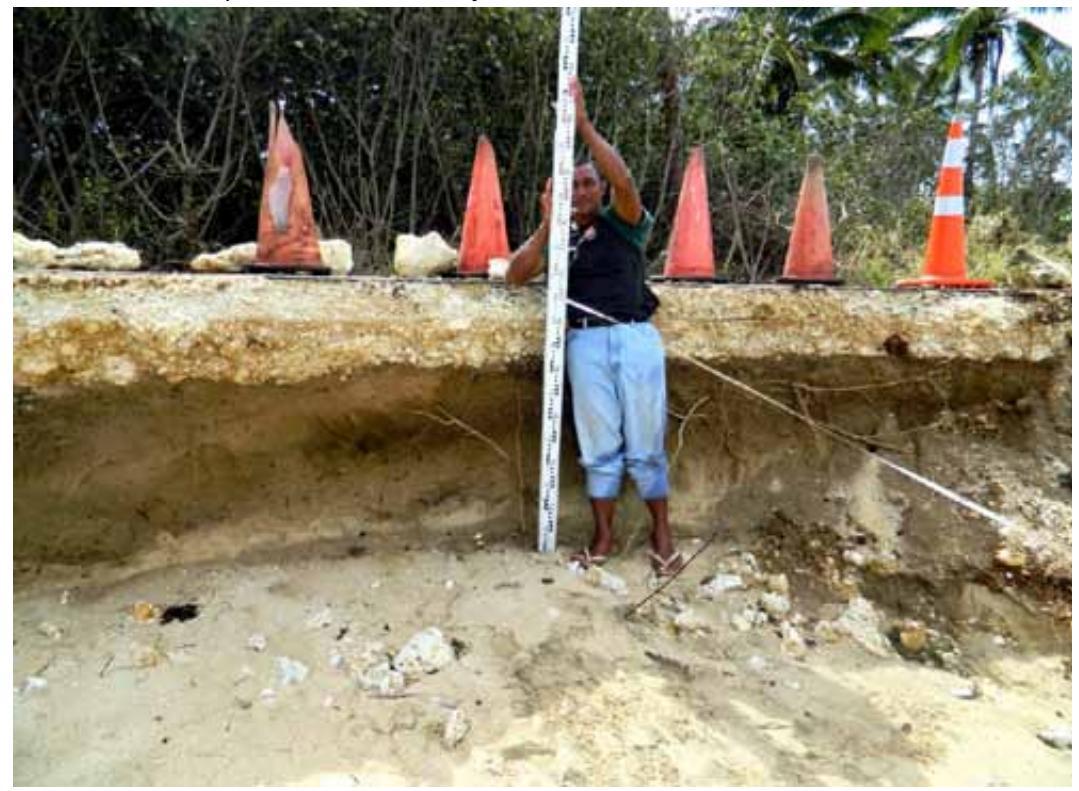
*Figure 39: Erosional scarp undercutting the road surface next to the road in Holopeka. Photo was taken after TC Cyril in February 2012.*
