Assessing vulnerability and adaptation to sea-level rise: Lifuka İsland Ha'apai, Tonga

# B 1: Physical resources1.1: Shoreline assessment

Zulfikar Begg and Jens Krüger

Secretariat of the Pacific Community Suva, Fiji 2014 SPC Secretariat of the Pacific Community

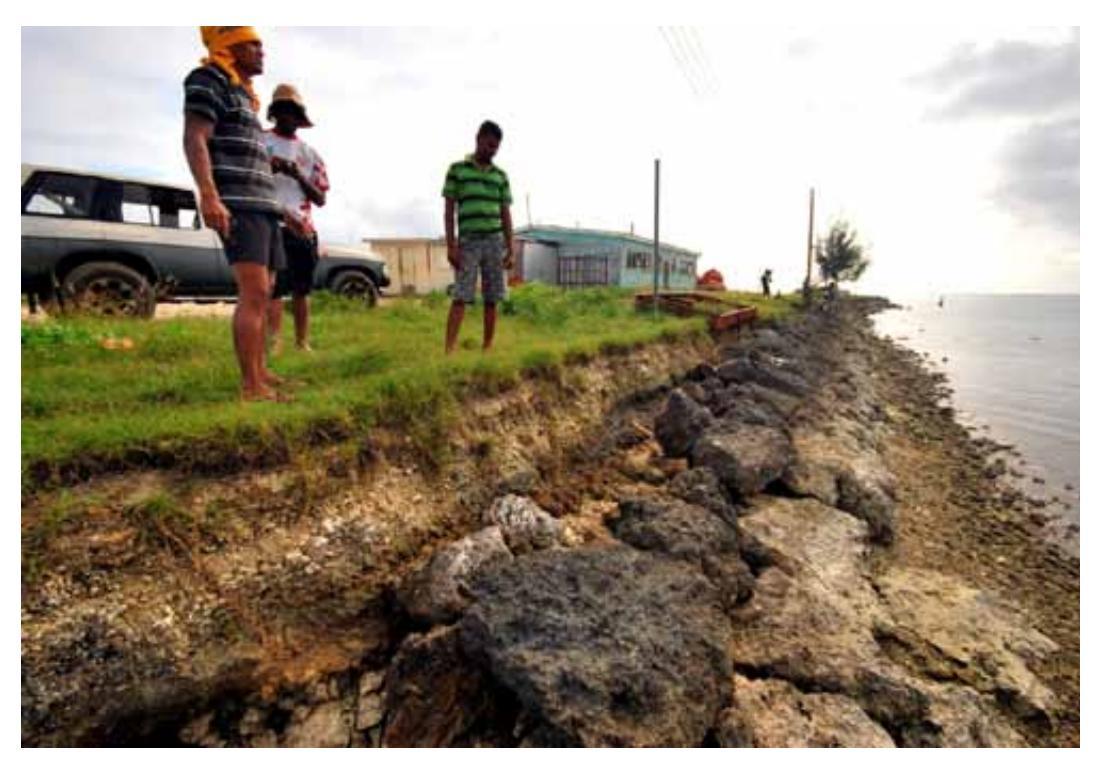
*Figure 40: North side of Pangai wharf, in front of the fisheries building. Limestone boulders have been stacked up to protect erosion.*

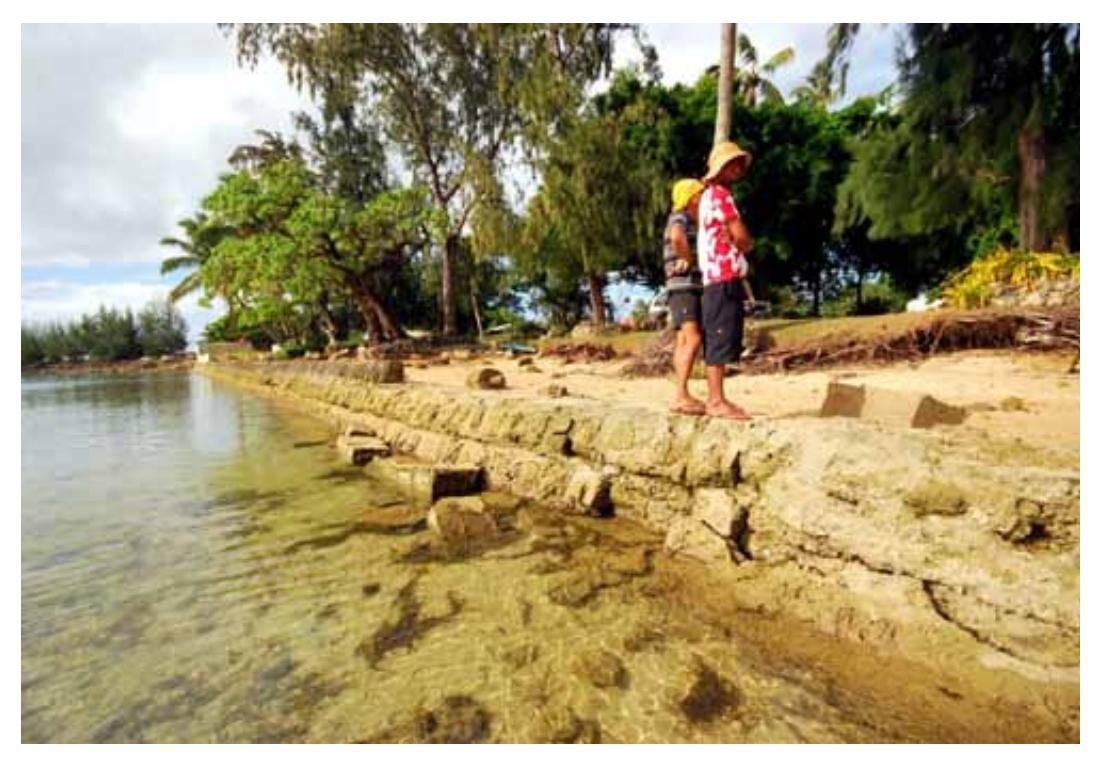
Figure 41: Crumbling sea wall in front of the government centre in Pangai. Parts have been temporarily repaired with concrete mix. Note the erosion scarp and exposed tree roots landward of the sea wall.

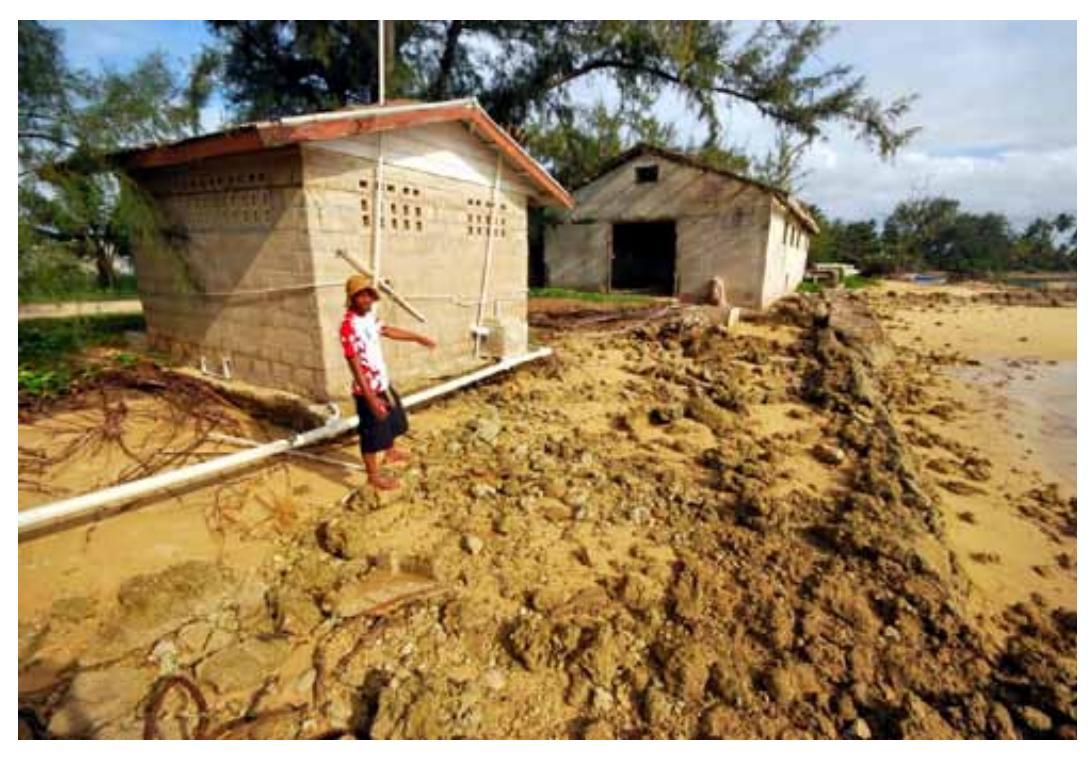
*Figure 42: Public amenity in Pangai. The sea wall in front has been damaged. Limestone boulders and concrete slabs have been placed to protect against wave impacts.*

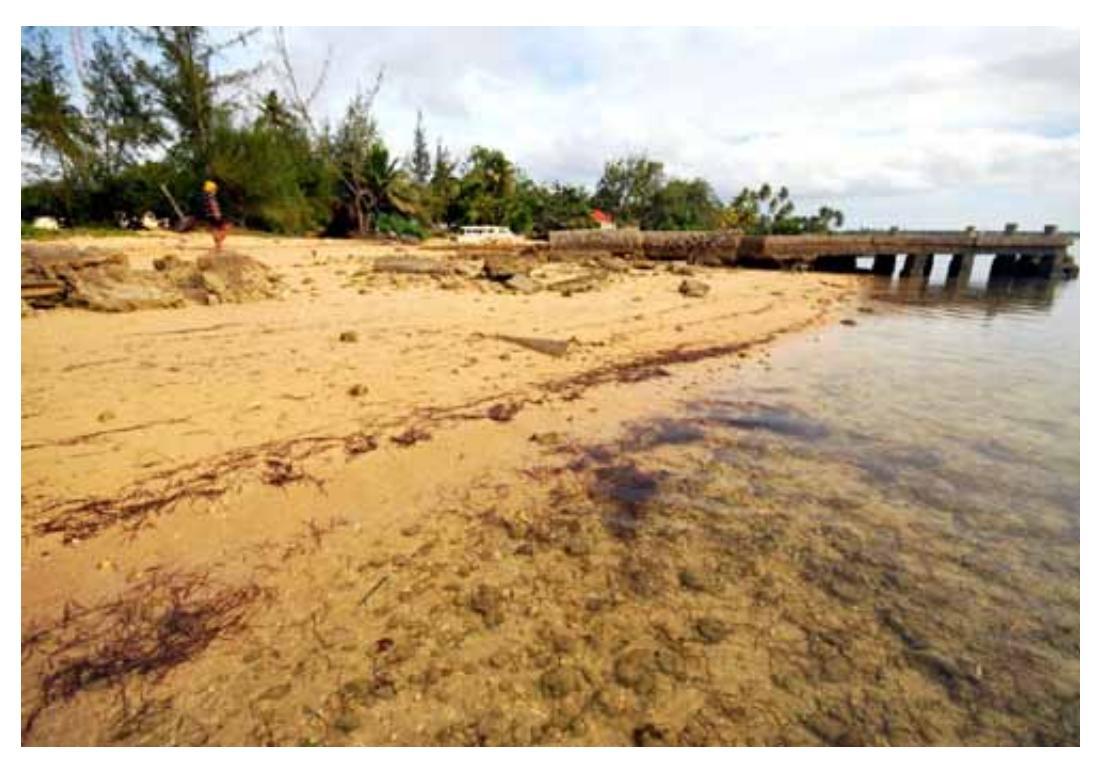
Figure 43: Old jetty, looking southwards from Pangai wharf. The end of the jetty has broken off and pillars have been damaged. Note that the open construction of the jetty (piling) allows sediment to bypass this structure.

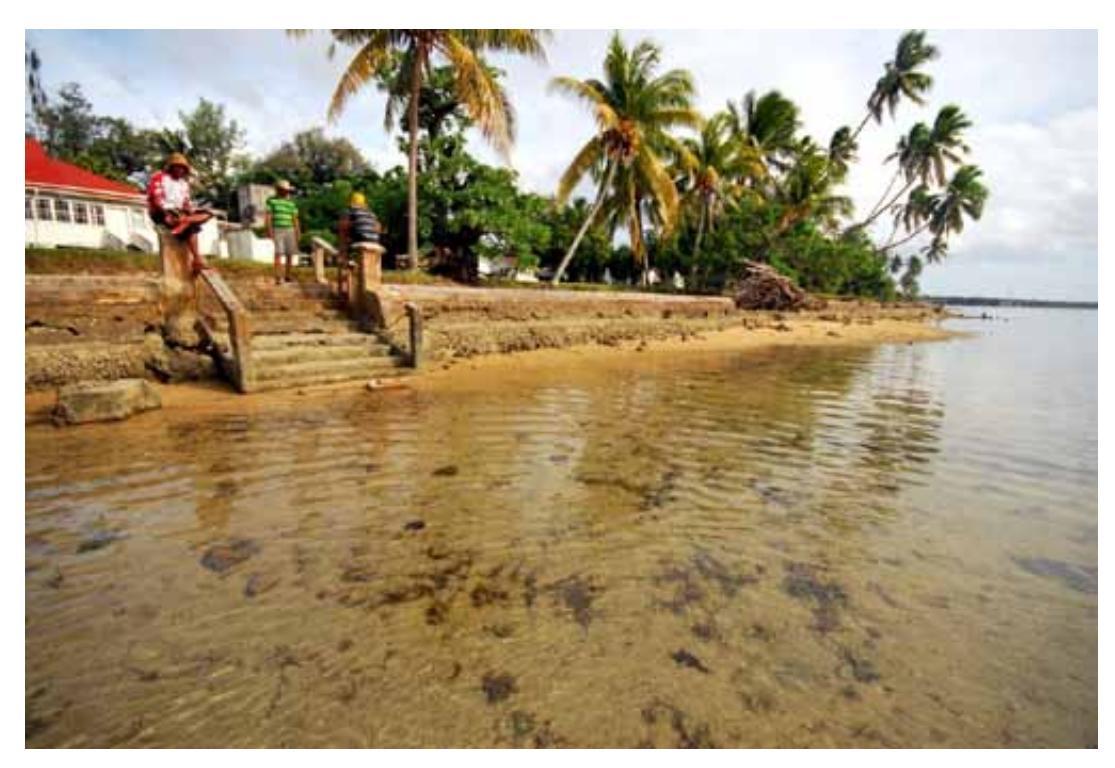
*Figure 44: Sea wall in front of the Royal Palace. Slabs are falling apart and the southern down-drift shoreline is experiencing chronic erosion.*

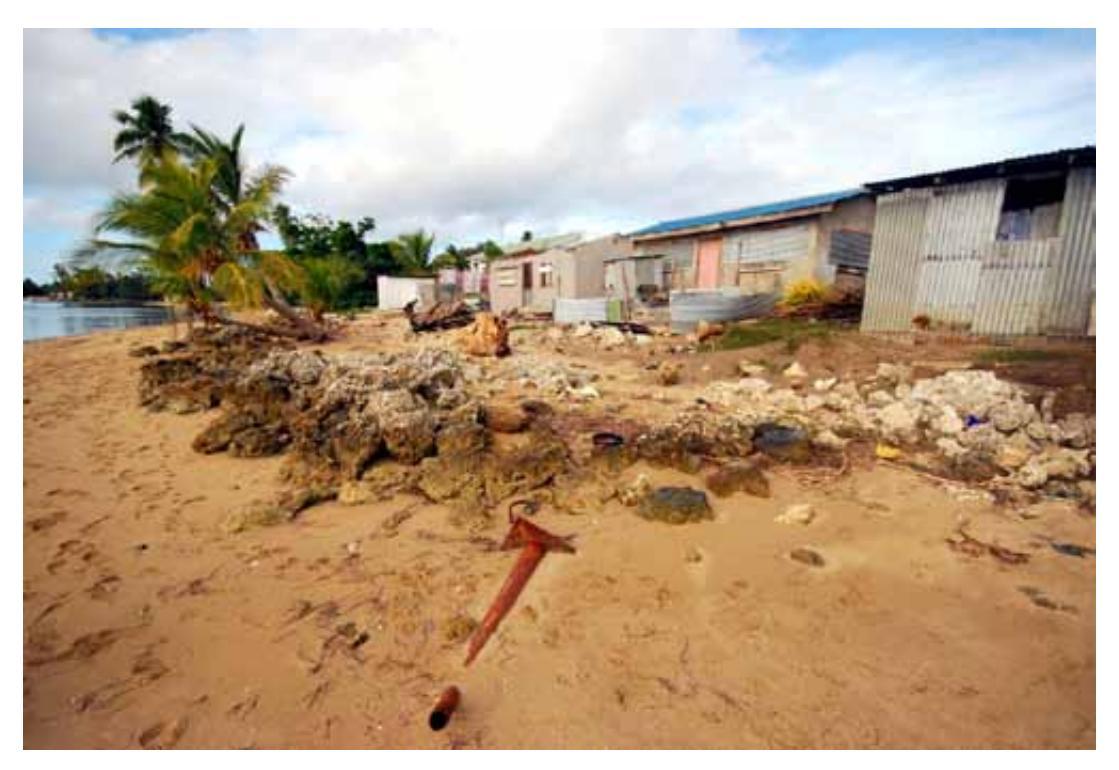
*Figure 45: Southwest Hihifo. Boulders have been placed to protect homes from wave inundation. During spring tides or extreme events, waves reach the base of the houses.*

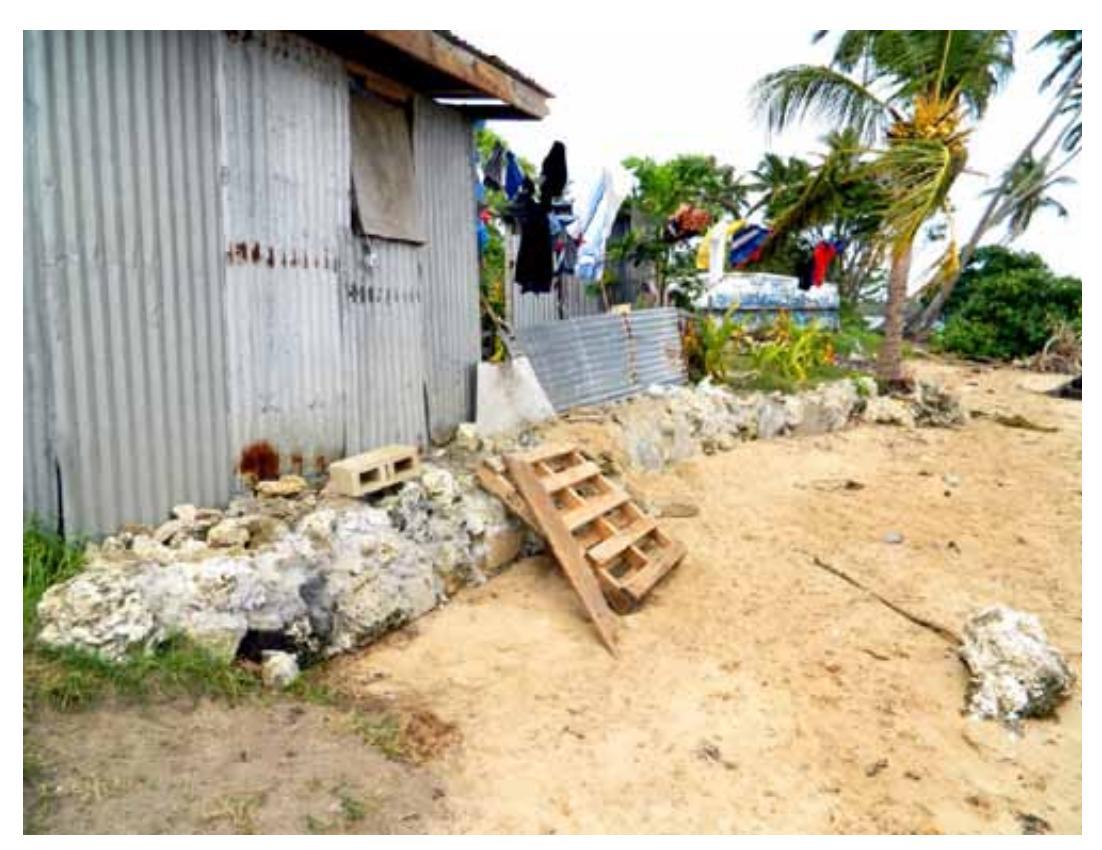
*Figure 46: Coral cemented together for wall protection. Wave overtopping is a regular occurrence in this area.*

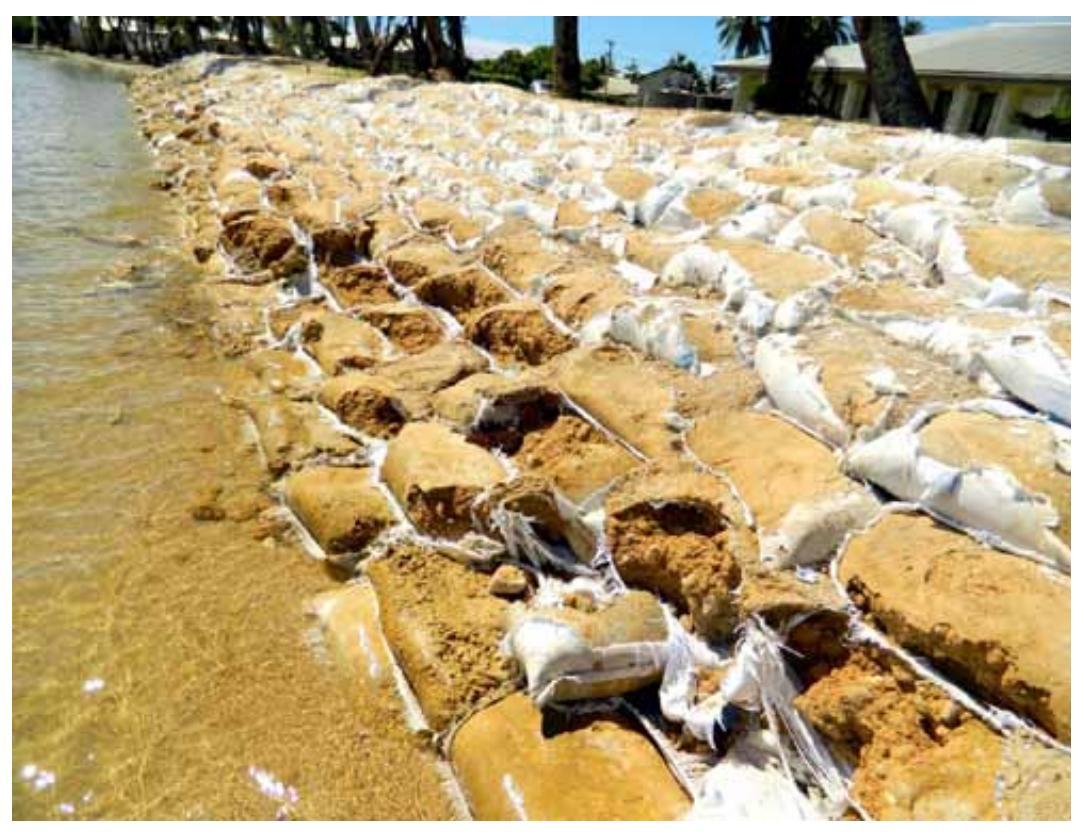
*Figure 47: Sand-concrete mix put into bags and stacked up in front of the hospital. Photo shows the state of the protection two months after construction.*

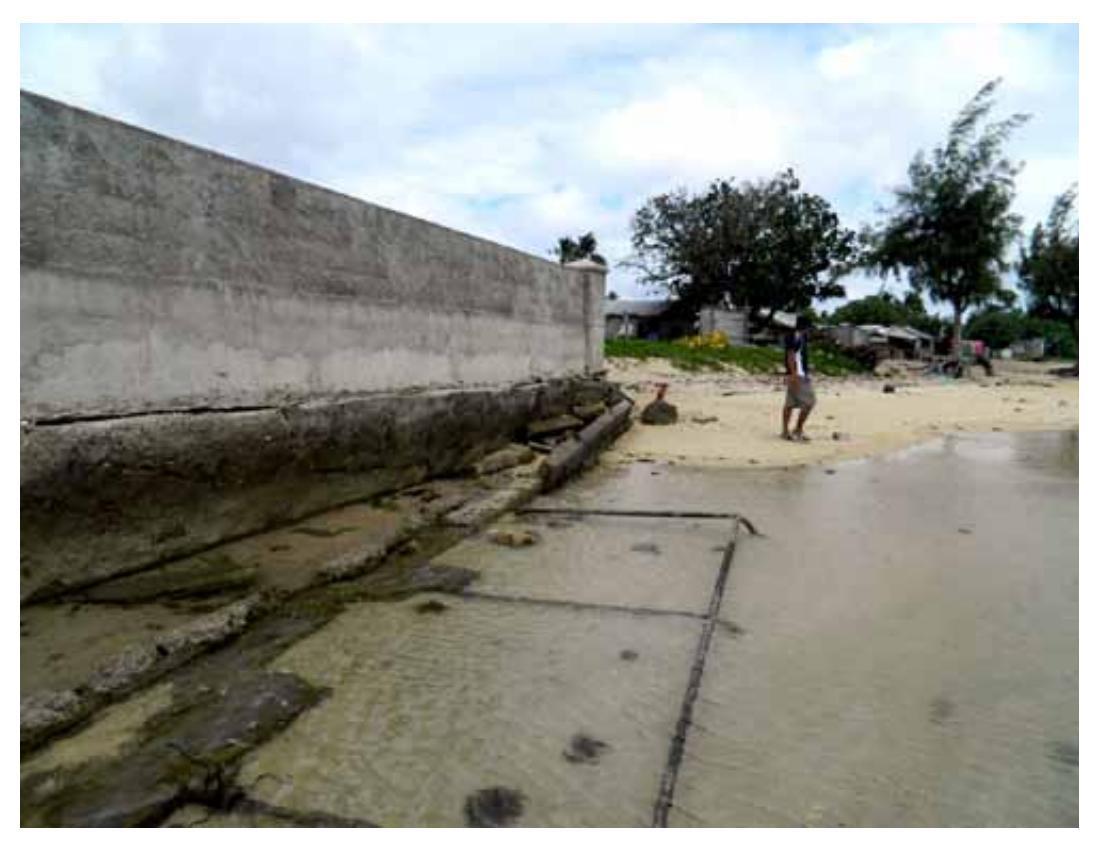
*Figure 48: Concrete fence of the TCC building. Parts are deteriorating, with cracks appearing.*

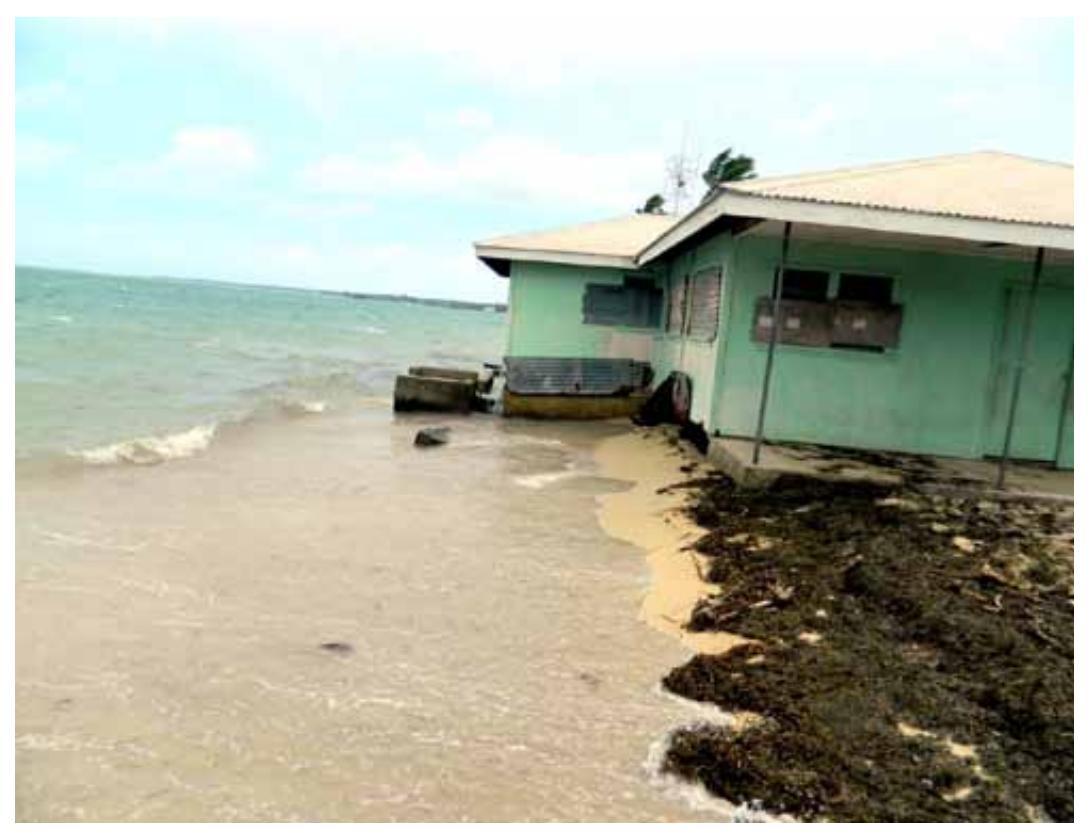
*Figure 49: Waves at high tide reach the foundation of a house. The house is now vacated and used for bêche de mer processing.*

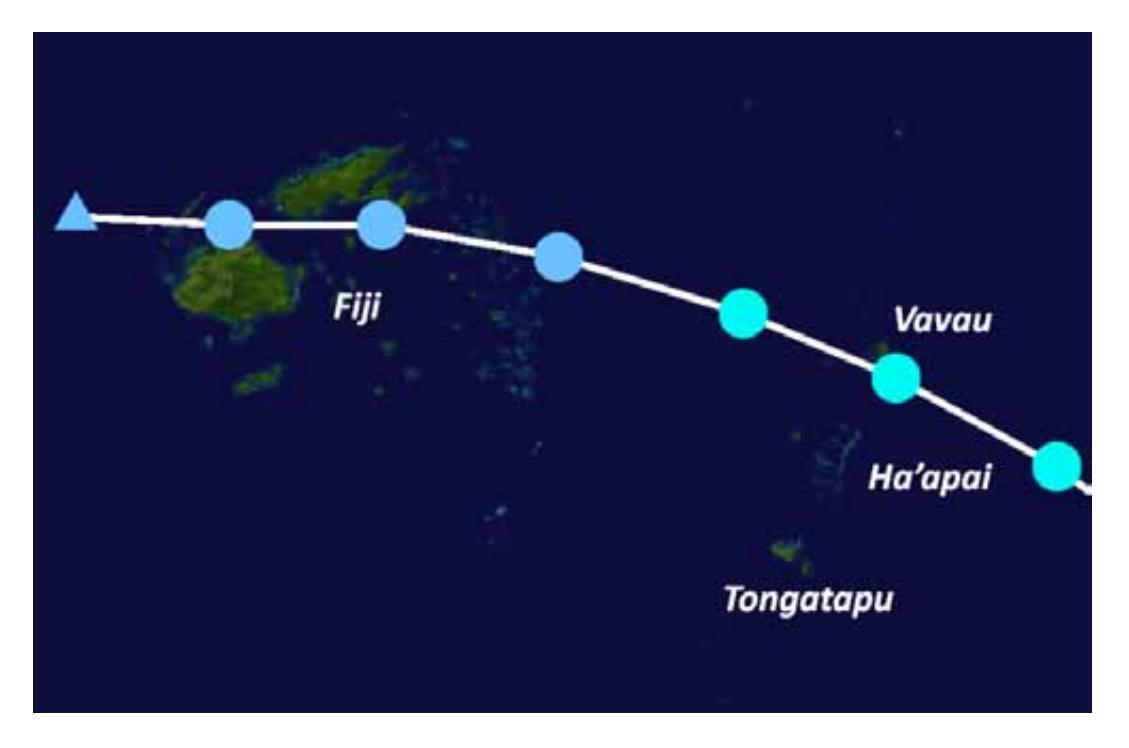
*Figure 51: Track of TC Cyril, which was active in the Fiji–Tonga region from 5–8 February 2012. (Source: www.wikipedia.org)*

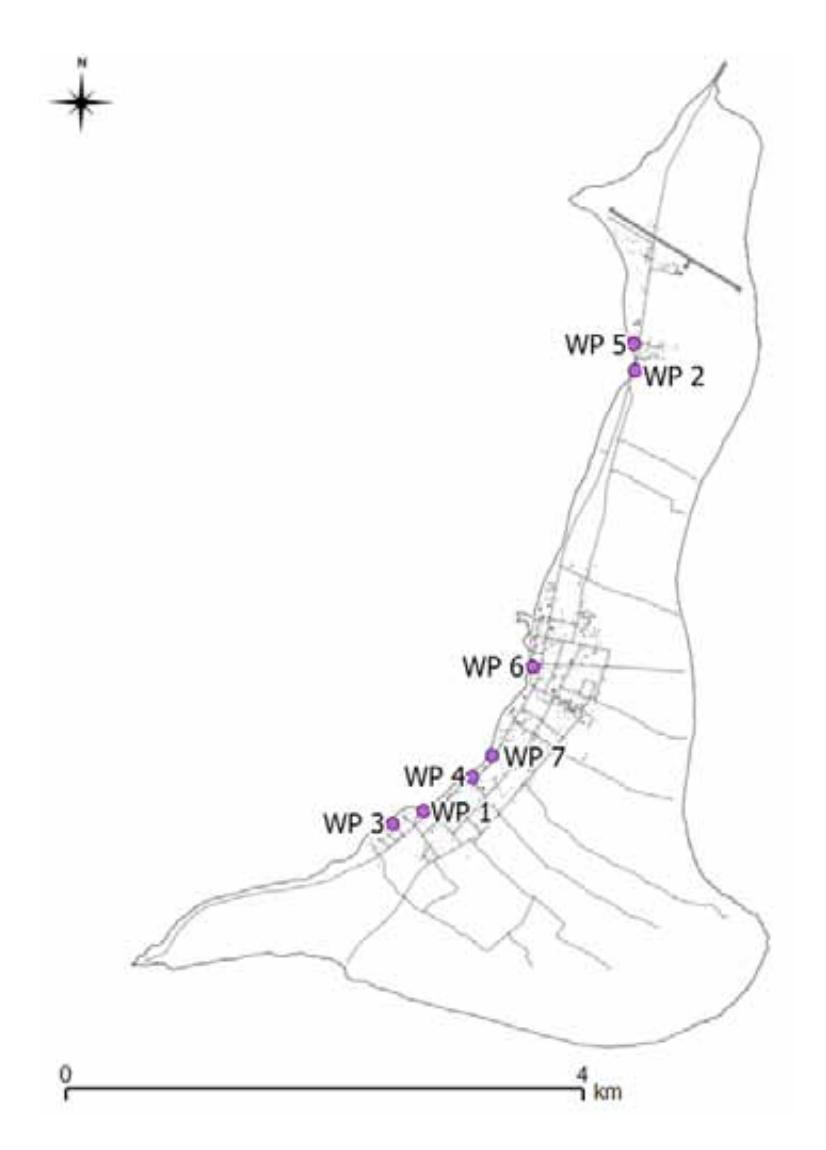
Figure 52: Map of Lifuka showing locations of waypoints where inundation and wave run-up levels were measured on 14 and 15 February 2012 following TC Cyril.

Tropical Cyclone Cyril moved into Tongan waters from the northwest and was reported as a category two tropical cyclone, passing north of the Ha'apai group during the first week of February 2012 (Figure 51). Inundation and run-up measurements were made on 14 and 15 February 2012 at seven locations along the western shoreline of Lifuka (Figure 52). Standard land survey techniques were used to map the inundation, the distance from the base of the beach to the debris line, and run-up levels, being the height of the debris line above the base of the beach (Figure 53). The results of the survey are presented in Table 3.

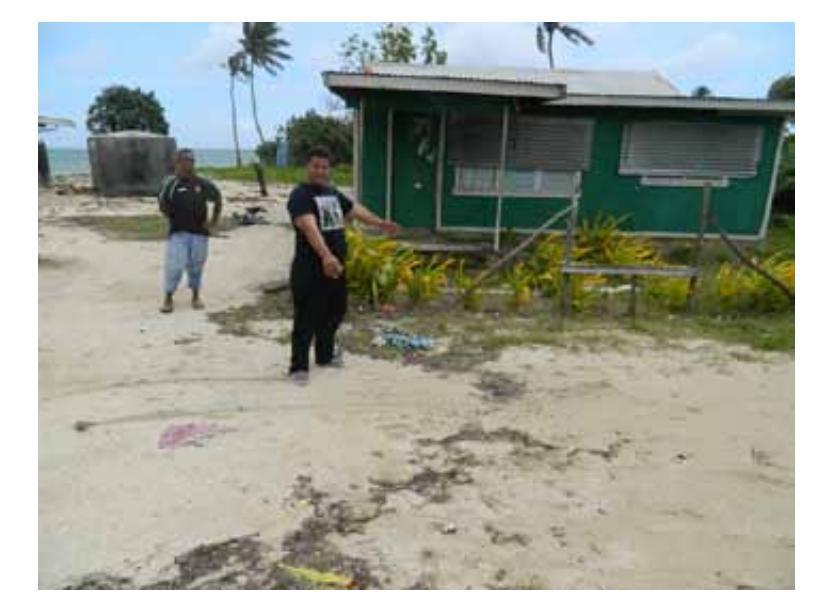
Figure 53: Example of debris line used as an indicator to establish inundation and run-up levels following TC Cyril.

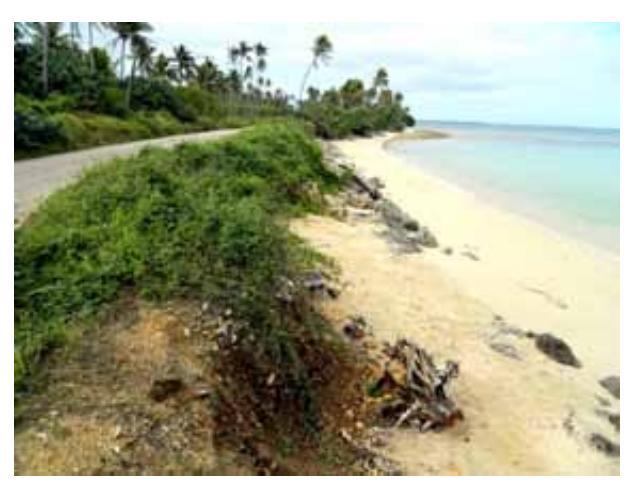
*Figure 54: Section of the main highway in Holopeka, September 2011*

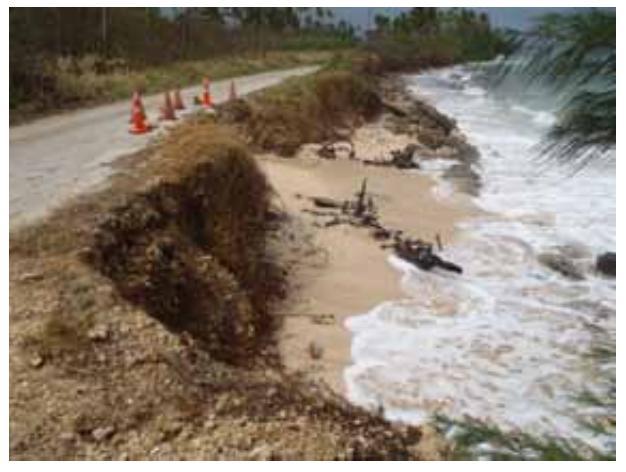
*Figure 55: Part of the road eroded after TC Cyril, February 2012*

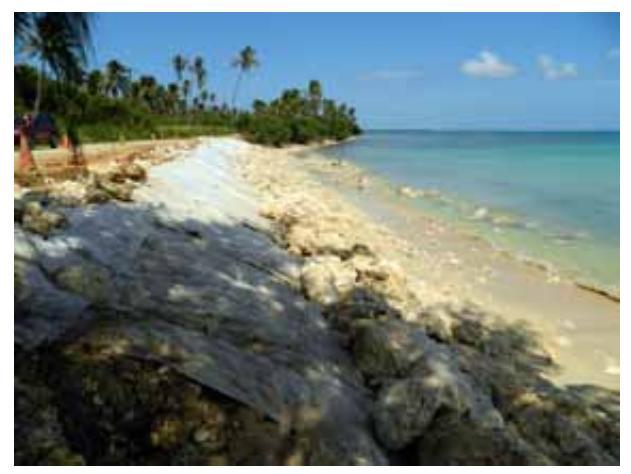
Figure 56: Restoration of road, March 2012

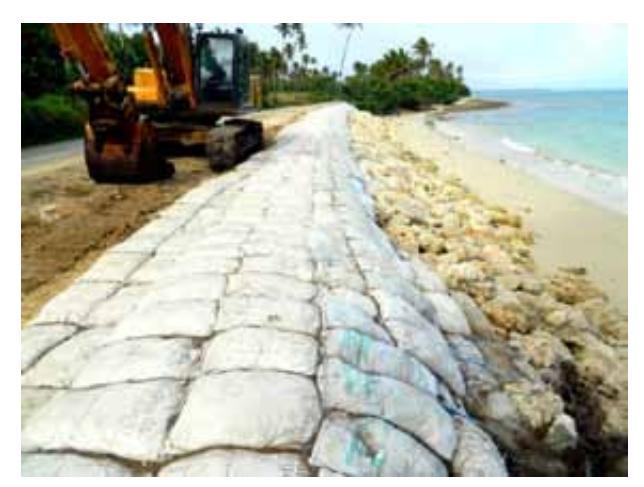
*Figure 57: Placement of concrete mix bags with boulders used as protection, June 2012*

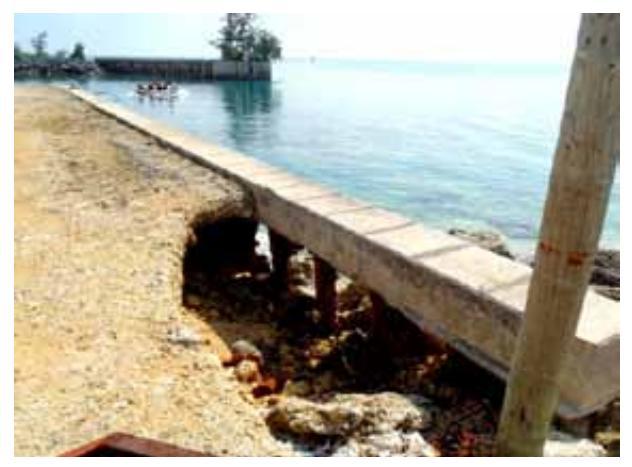
Figure 58: East side of the wharf in Pangai. Strong waves have washed over part of it, forming a deep hole, September 2011.

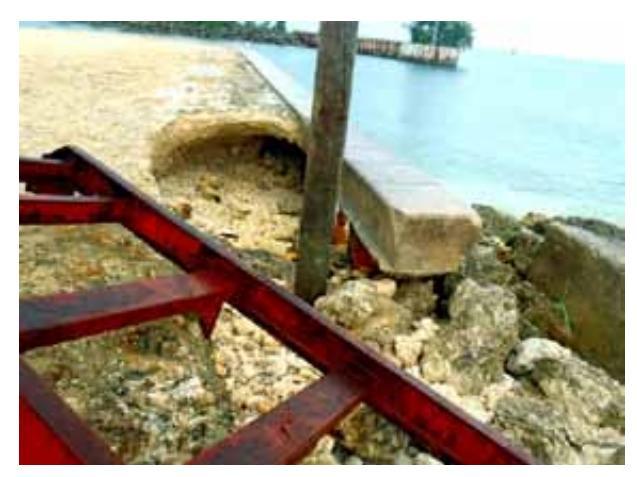
Figure 59: Damage caused by wave overtopping during TC Cyril. Materials are breaking from the wharf, February 2012.

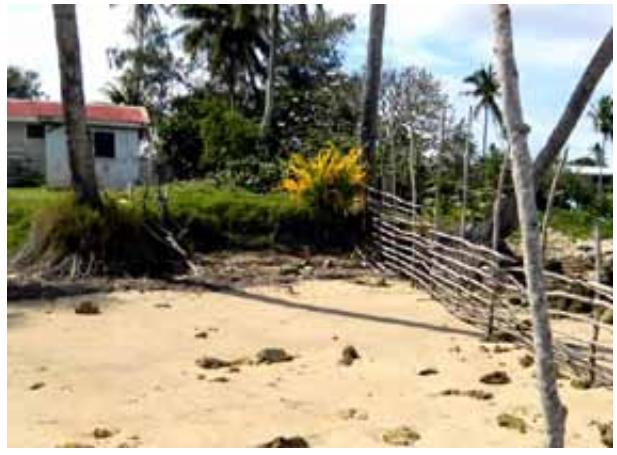
*Figure 60: Extent of erosion in front of benchmark 2, September 2011.*

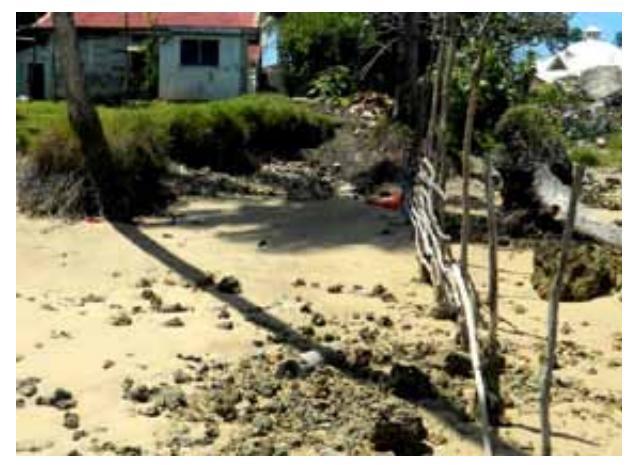
*Figure 61: Note the increase in scarp height and fallen tree. October 2012.*

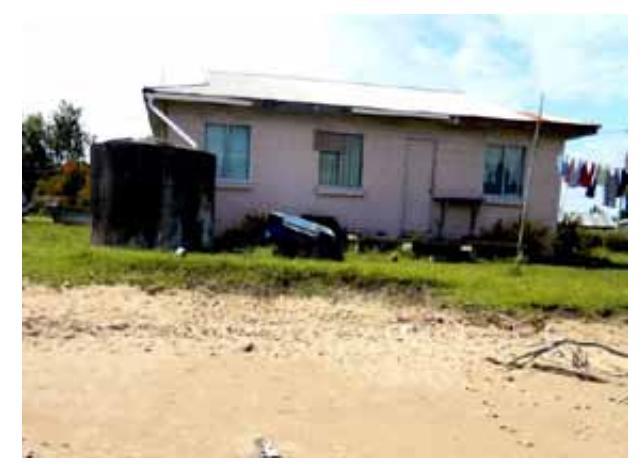
*Figure 62: Residential building in Hihifo, September 2011*

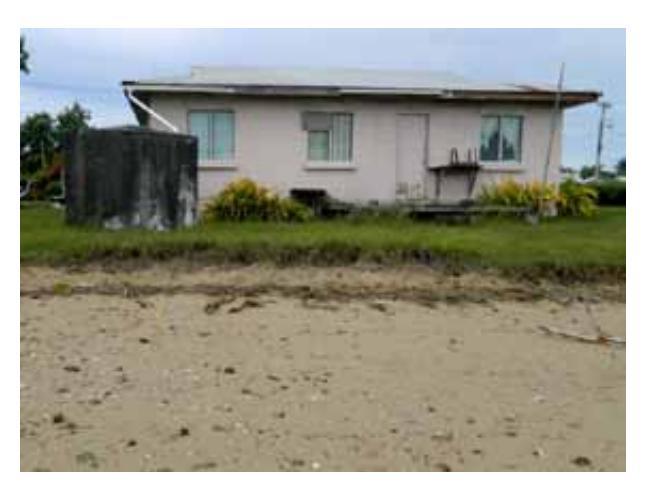
Figure 63: Beach erosion has formed a scarp in front of the building and the high water level mark has moved inland, June 2012.

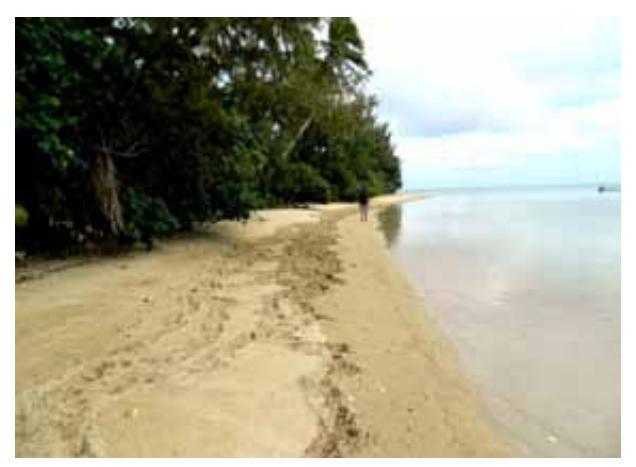
*Figure 64: Beach in front of the hospital in Lifuka, September 2011*

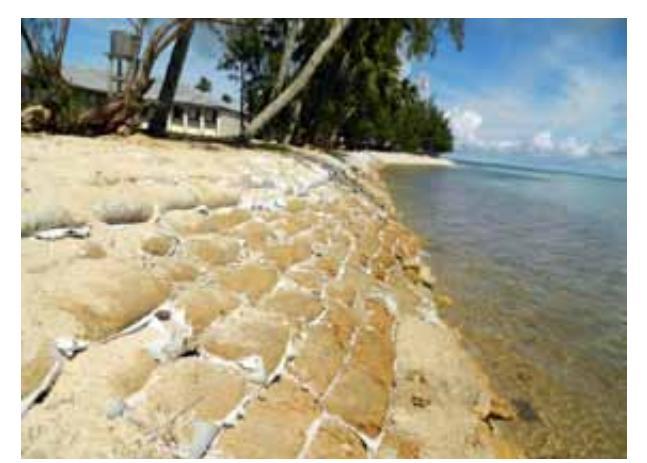
*Figure 65: Reclamation of the area and use of concrete mix sandbags for protection, March 2012.*

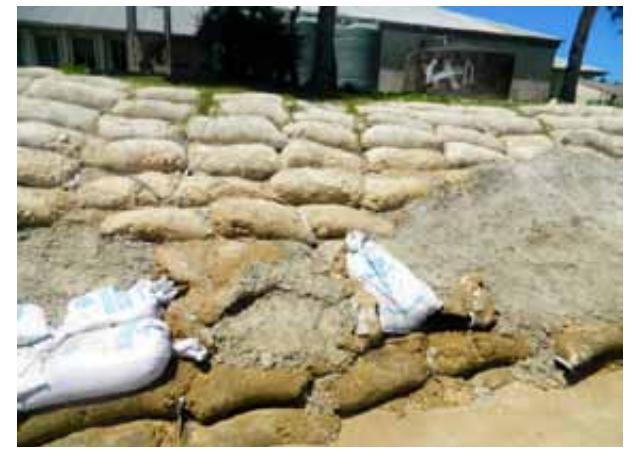
Figure 67: Some of the fallen sandbags have been replaced and concrete mix has been used as a matrix to hold the bags, October 2012.

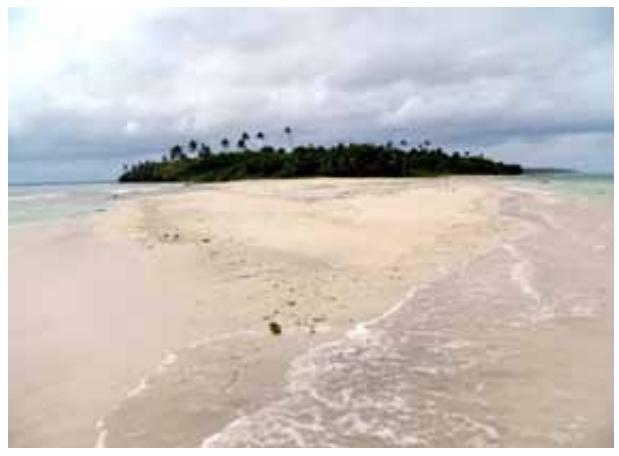
Figure 68: Southern tip of Lifuka, September 2011

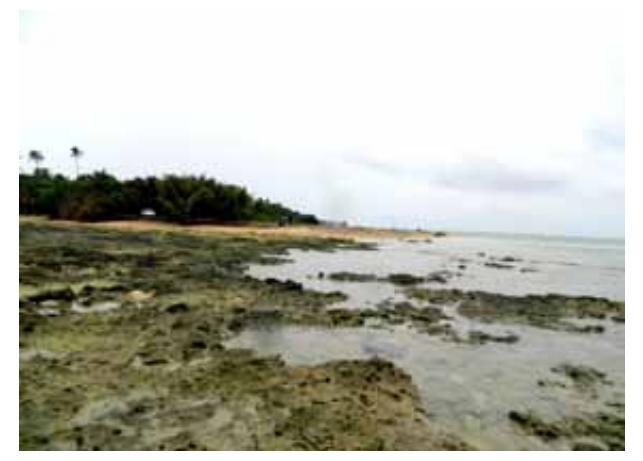
Figure 69: Southern tip of Lifuka after TC Cyril, February 2012

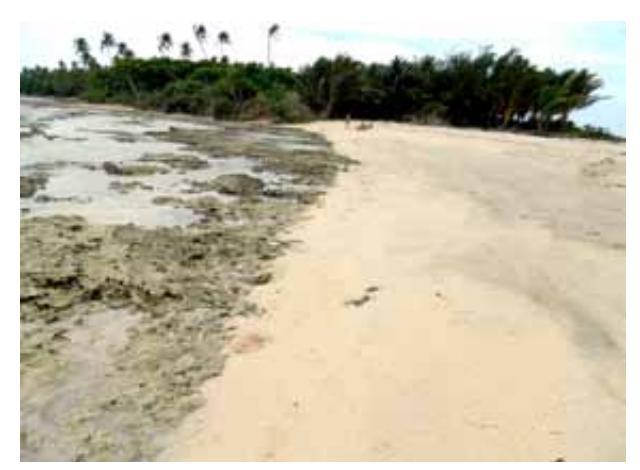
Figure 70: Sand building up to its original state, June 2012

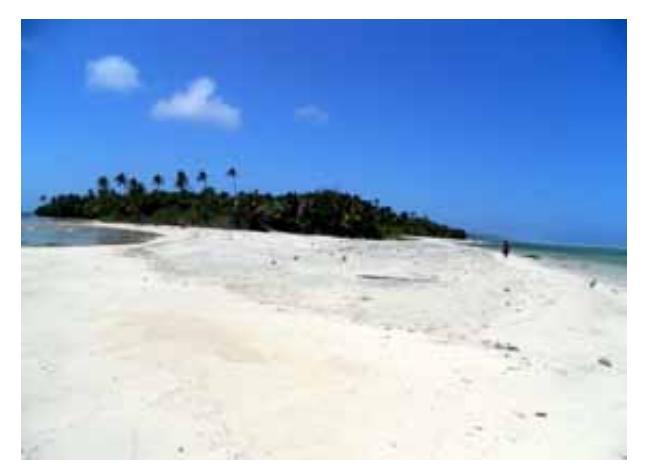
Figure 71: State of the southern end similar to Figure 68. Waves and current processes have moved the sand to its original state, October 2012.
