# Nabaka Village Water and Sanitation Assessment Report, Fiji 14 November 2012

## SOPAC SURVEY REPORT (PR153)

Rodney Lui & Iva Bakaniceva Applied Geoscience and Technology Division

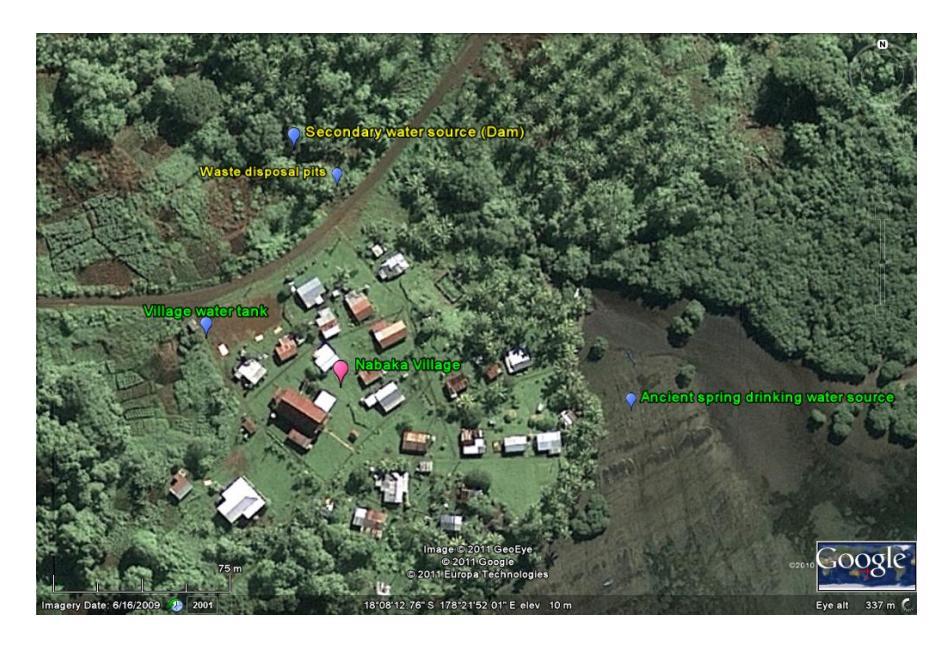
Figure 5. Locations of water sources and waste disposal pit on the map at Nabaka Village.

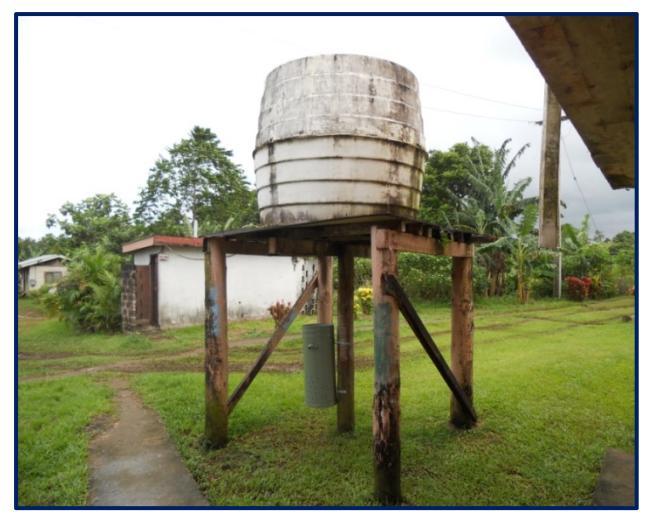
At the moment, the village relies heavily on rainwater for drinking and cooking. Nabaka Village is not connected to the reticulated water system by the Water Authority of Fiji but there are plans for

Figure 6: Rainwater is the major source of drinking water in the village.

- All houses should have their own rainwater tank. The tank installation should ensure that the entire roof catchment is guttered and a first flush device is installed. The size of the tank to be installed needs to take into account the roof area, amount of rainfall in the village, amount that needs to be captured to meet household water demand and to ensure sufficient storage to get through during small episodes of no rainfall.

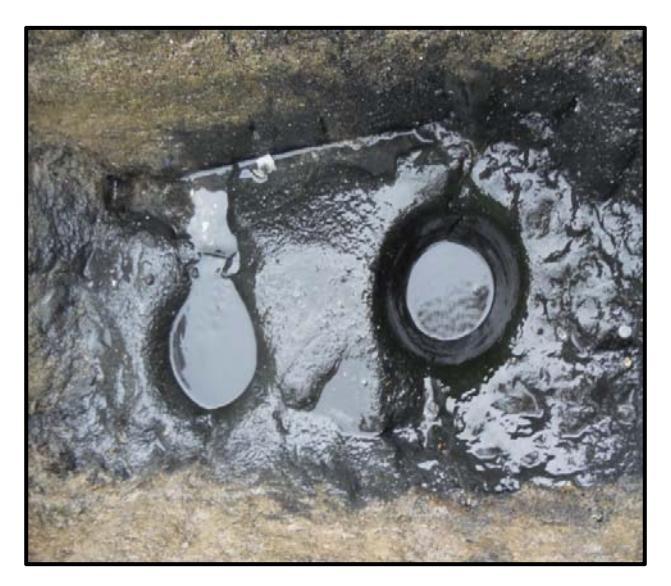
Figure 8: The spring water source that the village relies on during heavy droughts or dry season.

- The existing water sources such as the dam and spring should be developed further through source protection. This should be preceded by water quality testing of the source water for bacterial and chemical parameters. The community needs to work together in an integrated manner to look after their water resources.

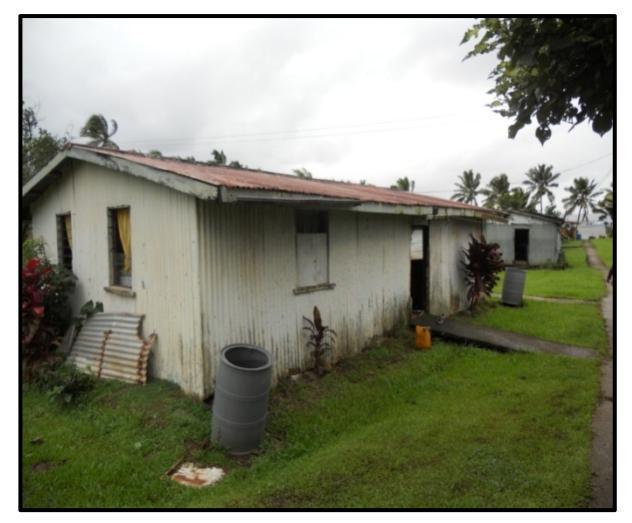
the village to be connected to the system; but some land issues with another village has currently halted the progress. From observation, it was noted that most households stored water in tanks or collected rainwater in empty containers and drums. There is a community rainwater tank which is attached to the village hall.

*Figure 7: Water is also collected in drums and empty containers.*

- The roof catchment of the village hall should be fully gutted to capture rainwater for communal storage and use.
- Education and awareness for the community members on proper household water storage and handling, wise use of water (water conservation) and strengthened hygiene practices.

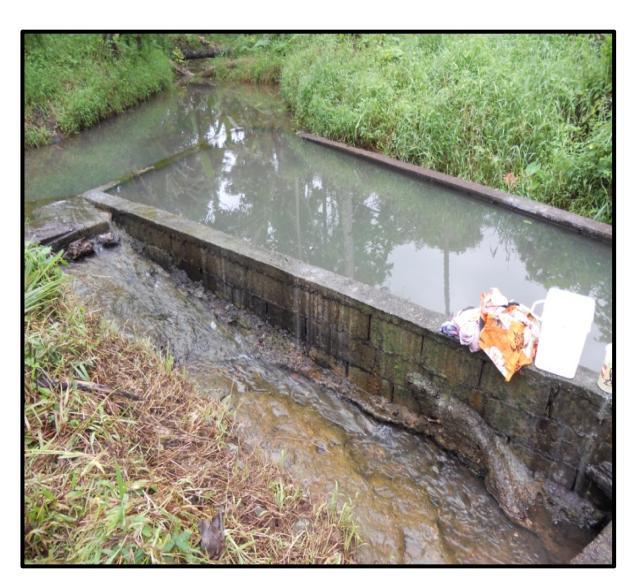
The village has a stream water supply via a dam constructed some 6 years ago.

*Figure 9: The dam that was constructed by the village and is now being used for bathing and washing.*

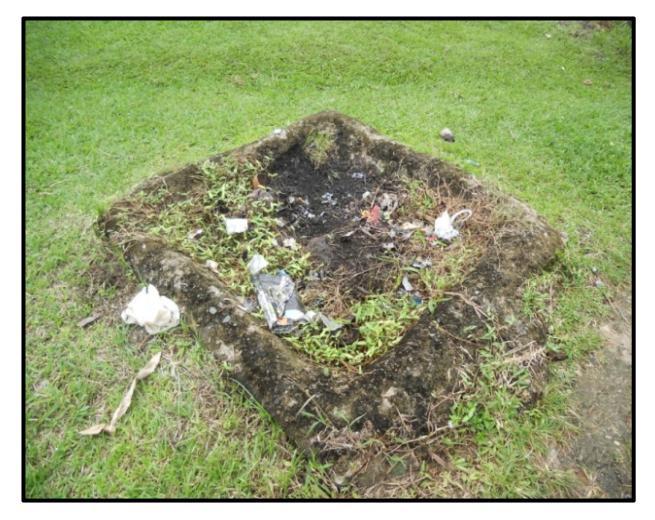
The main method of solid waste disposal is via burial pits. Solid wastes from households are gathered and taken daily to a burial pit (approximately 6 m x 4 m x 1 m) and dumped. These pits are located some distance away from the community but near the water source that is used for bathing and cleaning. The waste pits are managed by the youths in the village who keep track of the volume of waste and are also in charge of burial and digging of new pits once old ones have become unusable.

Figure 11: Some common types of waste disposal in the village such as burning.

- Villagers to practice recycling of plastic wastes especially bottles and juice cans.
- All households to practice vegetable composting for use in the vegetables gardens as source of plants nutrients.
- Carefully choose suitable site to locate the open dug pit so that it isnot located close to the water source.
- General community awareness training or campaign on proper waste and hygiene (hand washing).
- It is highly recommended that the idea of compost toilet be practiced in the village given the current water situations in the village.
- Ensure that septic tanks are made to the proper standard and inspection plan put in place to ensure they do not leak or overflow. Having wetlands to treat septic effluents could be explored in the absence of compost toilets.

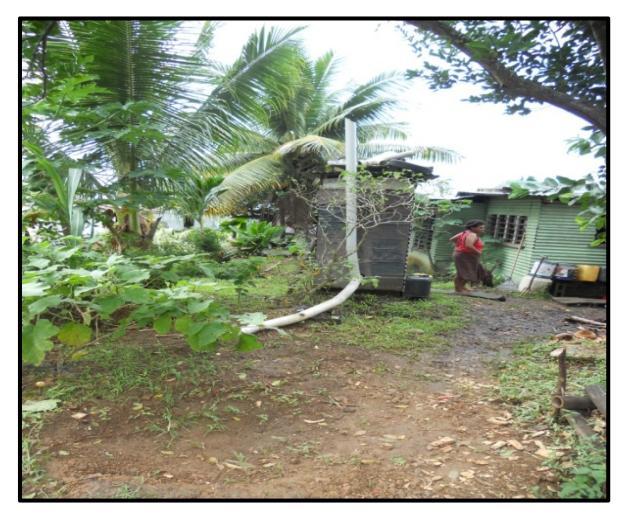
Liquid wastes from households are normally disposed of via plumbing into septic systems. Washing at the stream adds to grey water pollution into the stream. For water-seal and flush toilet systems, black water is disposed of into septic systems. Most pit toilets are located far away from the houses.

Figure 12: Black water are disposed into septic tank system.

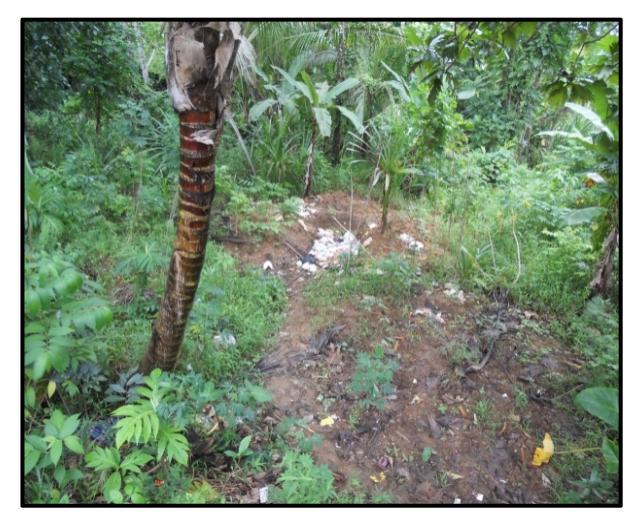
Figure 13: Some households also practice composting.

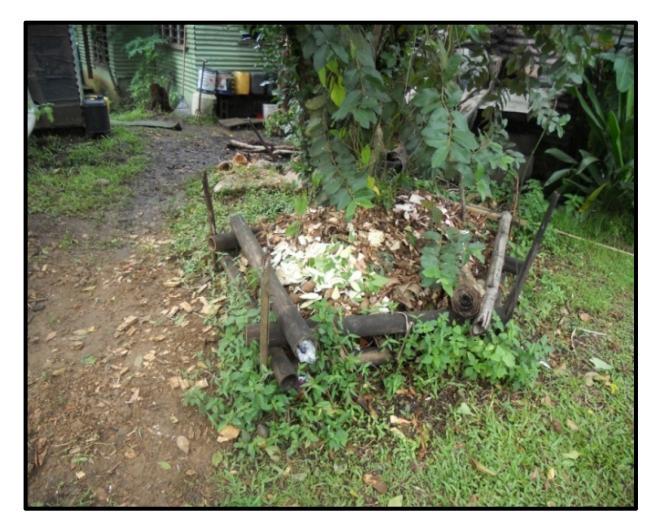
Figure 14: One of the communal pit.

- Poor solid waste disposal especially along the beach.
- The current rubbish pits are dug quiet close to the dam that was constructed to be used for washing and bathing.
- Not all households practice composting of vegetables peelings and kitchen wastes.
- Availability of water for use in the flush toilet.
- Poor design of septic tank which can allow seepage of wastewater into the ground.
- Absence of soap at hand washing basins.
