# Strengthening water security of vulnerable island states

Groundwater investigation  
Aitutaki, Cook Islands

(SPC Technical Report SPC00058)

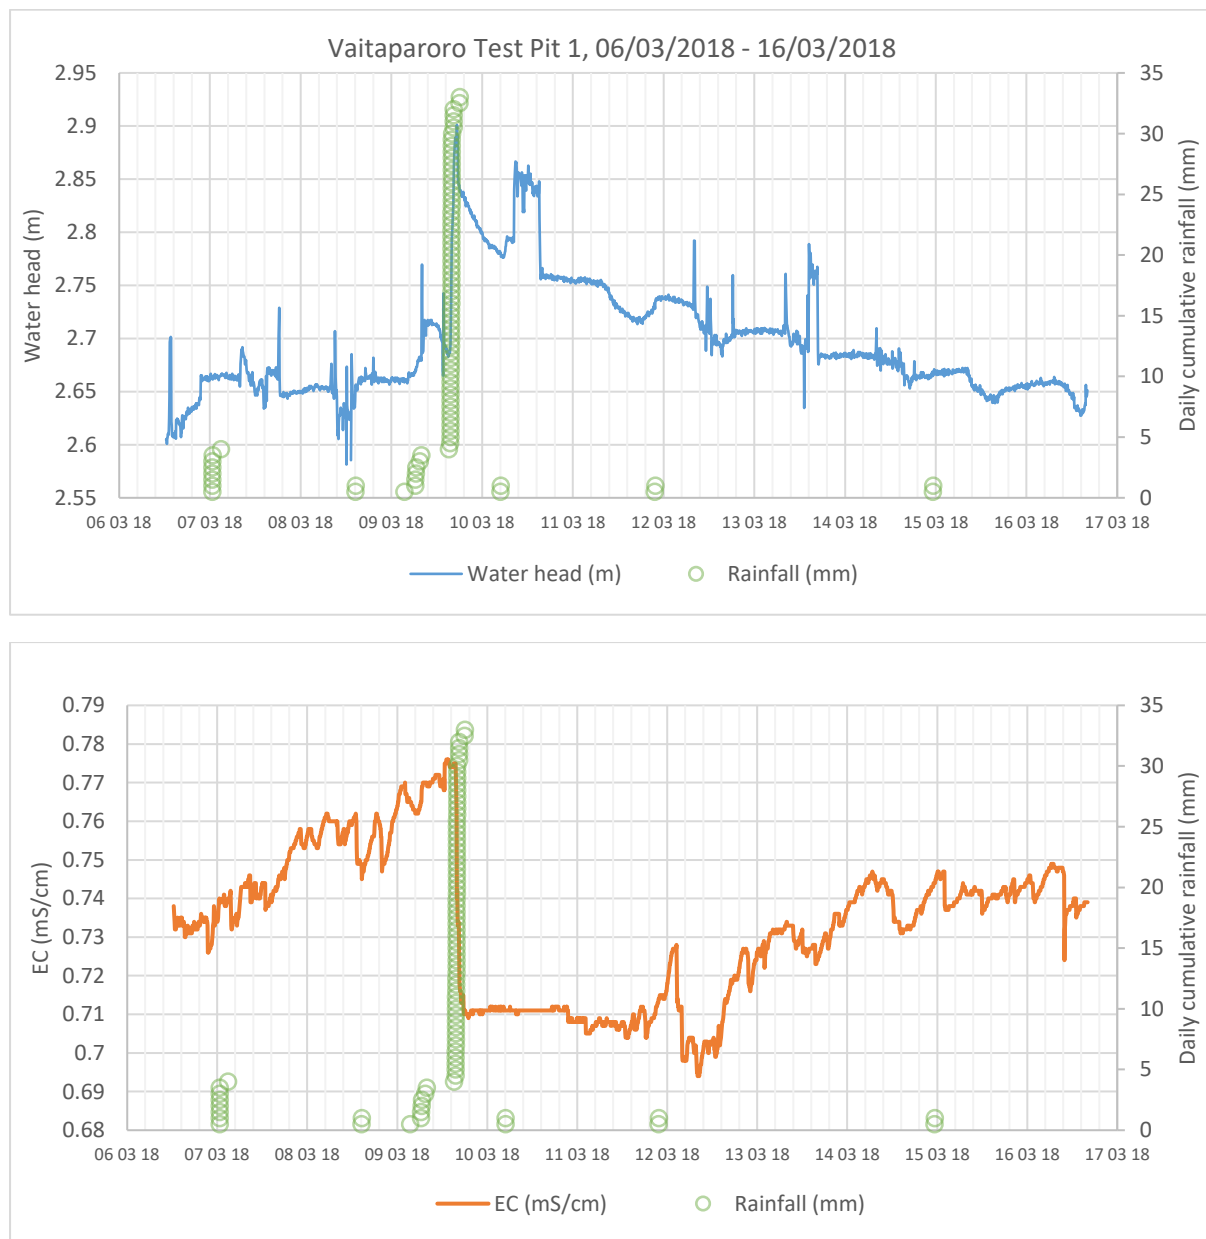
**Figure 6.** Variation in electrical conductivity and groundwater head above logger installed in Vaitaparoro test pit 1 plotted against observed tides.

The variation in EC and water head recorded in the Vaitaparoro test pit 1 are presented in Fig. 6. The cumulative daily rainfall is also plotted to assess its impact on groundwater. Both water level and EC are influenced by the relatively strong rainfall event recorded on 10 March 2018 (33 mm recorded at the Vaitekea rain station). The water table showed an increase of 20–25 cm, which gradually decreased to normal levels (~0.3 m below ground level) within five to six days. The EC showed a small decrease of 65  $\mu\text{S}/\text{cm}$  in response to the rainfall recharge; after a few days, salinity gradually increases, probably due to mixing with in-flowing groundwater and evaporation. Tidal impacts are not observed in the water level of the shallow groundwater.
